APPENDIX C:  
CONDITIONS ASSESSMENT

# **Certified Building Study 12 Brainard Street Hyde Park, Boston, MA**

**DCR Project No. P22-3471-S3A**

**December 27, 2022**

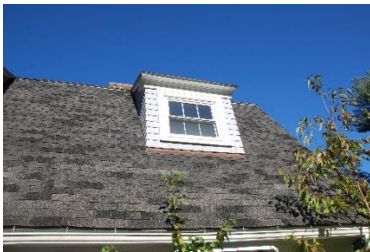
- A. Roofing: Asphalt Shingles, were installed approximately 10 years ago. The roof looks good and the gutters and downspouts are in good condition. It looks as though it has some useful life left but might need some repairs.

Asphalt Shingle Roof

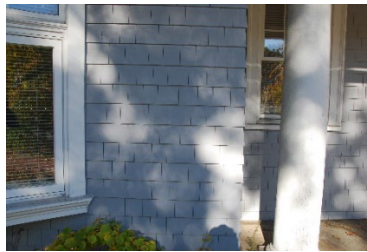
Wood Shingle Siding

- B. Exterior Walls: The exterior of the building is finished with stained wood shingles that are in very good condition and was part of the exterior renovation 10 years ago. Generally, the wood trim is in good shape with some minor peeling. The soffit above the front entrance, however, is peeling and should be repaired. There may be moisture above the soffit that is causing the paint to deteriorate. It should be looked at more closely, otherwise the exterior paint is in very good condition.
- C. Windows: Vinyl double-hung with storm windows. The sash and wood trim is in good shape with minor peeling. The window replacement was also part of the previous renovation. A few of the screens are torn and damaged and the one of the storm windows in the kitchen is cracked.

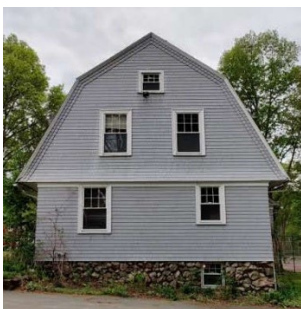
Double-hung windows w/storms

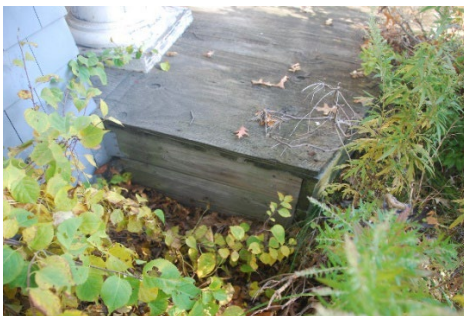
- F. Exterior Trim: Generally the exterior is in good condition with minor peeling. The trim can be repaired by spot priming and paint touch-up as needed.
- G. Wood decks: The wood deck off of the living room is very bad condition and needs to be replaced. The joints below the deck were not exposed, but there is a good possibility of deterioration from sitting water. The wood deck at the entry is not original. An early drawing (see the cover of this report) shows curved steps leading up to the front entry door. They were eventually removed and the current wood deck was installed we assume to provide accessibility. The entry deck is plywood over wood joists. The joists appear to be rotting and the plywood was completely inappropriate as a material in this location. It is recommended that the wood be replaced with a concrete pad that can drain surface water away from the entry.

Plywood deck at Entry

The recommendation is to remove the wood deck at the front entry porch and provide a concrete slab that pitches away from the entry door. Furthermore, the slab should be level with the first floor entry in order to be compliant with the accessibility code.

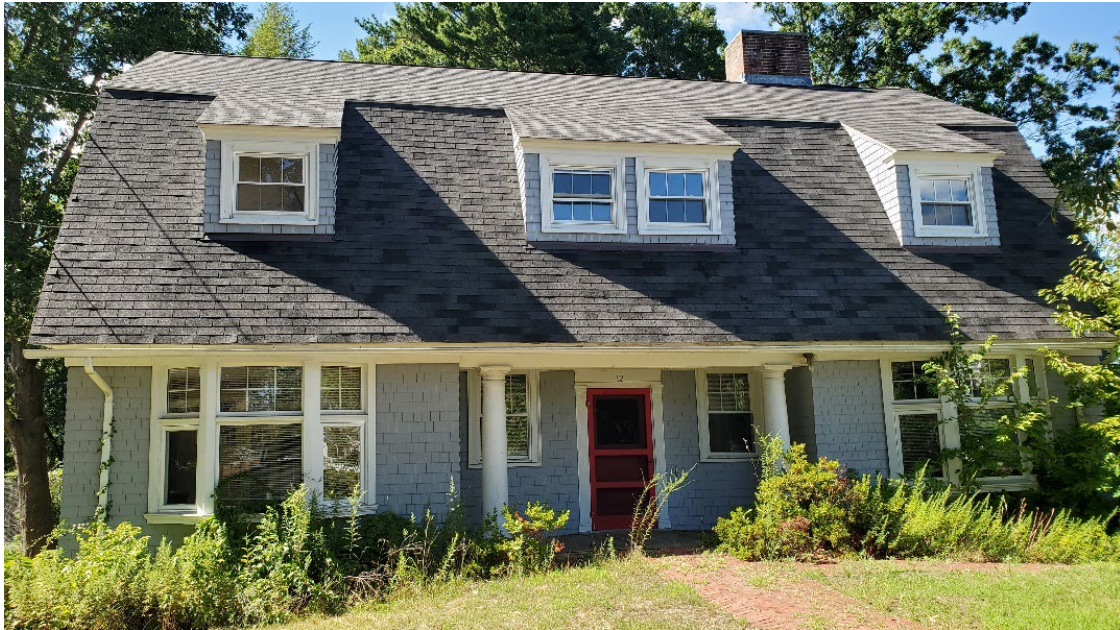
Existing Conditions: The front (main) entrance to the building currently has a wooden stoop which provides a no-threshold access at the front door. The stoop is in need of repair; our understanding is that HKT is recommending the replacement of the wooden structure with a more durable material, which CBA would support. Based on historical photographs, it appears that there had initially been a step up to the stoop which has been eliminated.

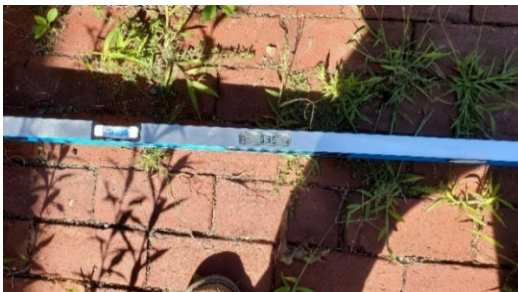
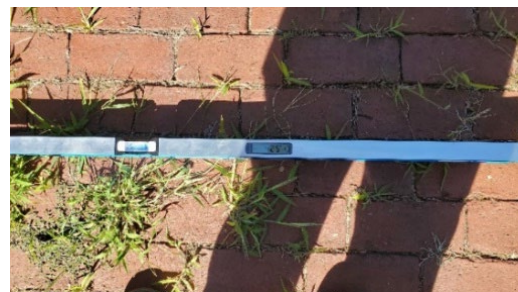
From the stoop, a brick walkway (overgrown) runs directly out to the asphalt sidewalk; a short distance out from the building (approximately 5 feet), a secondary brick walkway runs parallel to the front elevation to the driveway, where there is a single step down to the asphalt driveway. Both of these walkways vary slightly in pitch, but on-site measurements with a smart level taken at several points varied between 8.35% and 5.75%, on the main walk, and between 3.55% and 7.50% on the walk to the driveway. The average pitch in each case was clearly above the 5% maximum slope acceptable without a handrail.

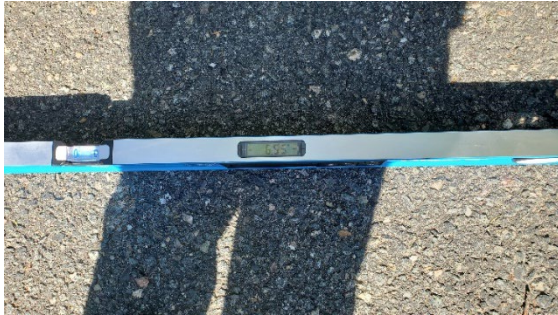
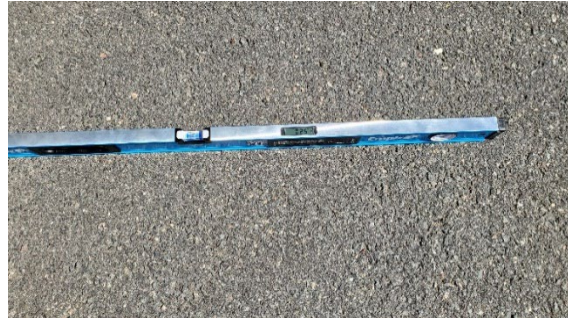
The driveway itself includes numerous areas where the pitch exceeds 5%, including measurements up to 6.55%, as well as areas with very minimal cross-pitch (0.25% at one spot). Provided the budget allows, the driveway and parking area may need to be regraded for ADA compliance.

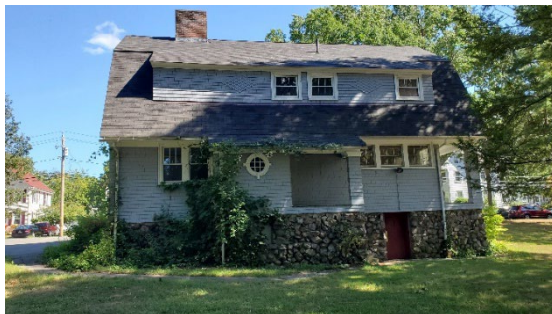
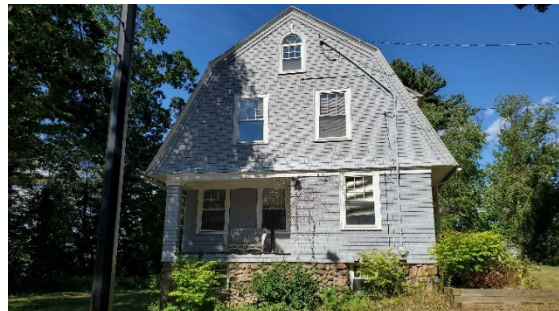
From the rear of the parking area, a curving sloped brick walkway leads down to a single door (shorter than typical) on the rear of the structure that appears to enter into the lower level. While the grade of the walkway was not directly measured by CBA, a visual analysis indicated that it is likely over 5% in places. Based on apparent ceiling height, CBA also anticipates that that door may not be accessible from the interior of the building (there may be stairs), which would preclude its use as an accessible route unless the door threshold is lowered down to the floor level. There is no access (at grade or via stairs) to a porch located on the southwest corner of the building.

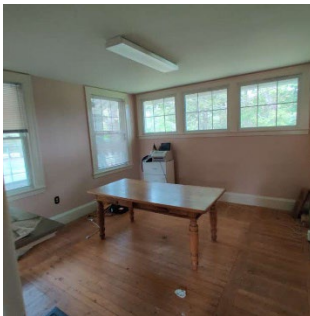
- A. Flooring: There are several rooms that will need new floor, specifically the kitchen, both bathrooms, the corridor on both floors and the former dining room that has a plywood subfloor at the present time. The other rooms with hardwood flooring needs moderate repairs and refinishing.

First Floor Hardwood Flooring

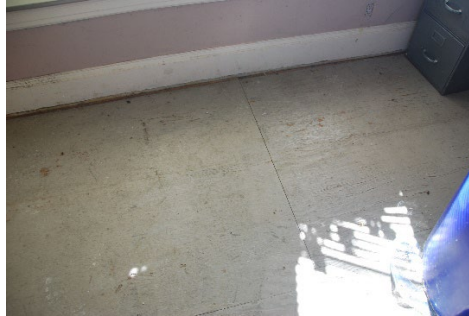
First Floor Dining Room: Plywood Subfloor

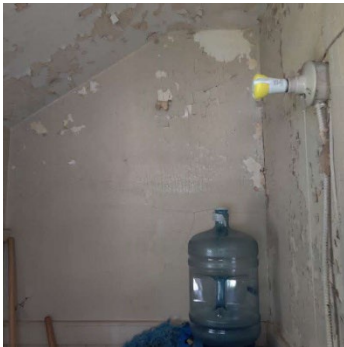
- B. Walls: The interior finished walls are plaster with some gypsum drywall. The condition of the walls are good requiring minor to major repairs including patching and repainting. There are areas that have peeling paint, especially around the stair and the rear vestibule entry off of the kitchen. There is a good deal of deteriorating paint and plaster patch at the main stair, possibly caused by water penetration and/or lack of heat during the past several winter months.

Rear Entry Vestibule

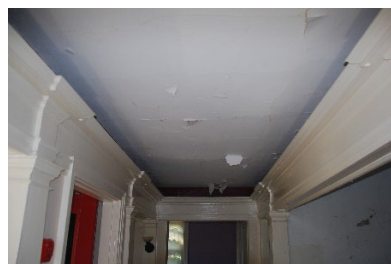
- C. Ceilings: Most of the ceilings on the second floor are in good condition. The kitchen needs significant repair and the ceiling in the front entry hall needs patching and repainting.

Ceiling at Front Hall

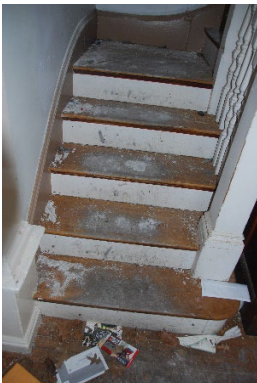
- E. Stairs: The main stair is in moderately good shape. The treads, risers are showing wear and the guard rails are too low as per code and newel post caps are missing, however that are stored on site and can be reinstalled. The stair to the basement also does not meet code.

General Condition of Stair

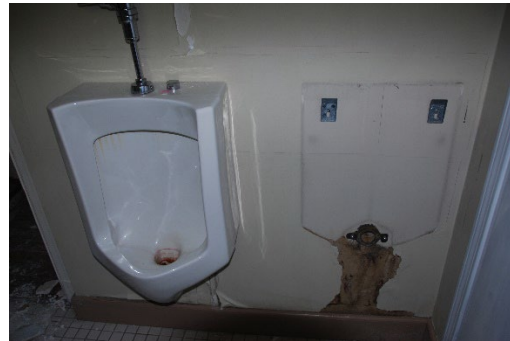
The bathrooms on both floors are in very poor condition. The second floor toilet room has been arranged as a men's room with toilet compartment (one toilet is missing) and two urinals (one is missing) and one shower stall. This toilet room is not very well laid out and the finishes are beyond repair. The first floor toilet room is off of the kitchen and it is also beyond repair. See the plumbing report in paragraph 5 below.

2<sup>nd</sup> Floor urinals

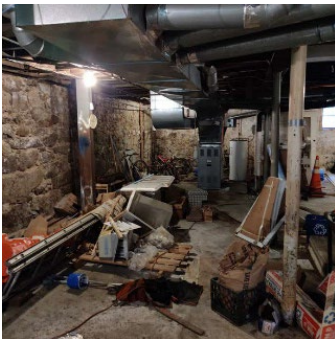
Both the basement and the attic are unfinished and used for miscellaneous storage. There is no insulation in the basement and the stair from the first floor includes winder treads that may need to be modified if any alteration occurs. The insulation in the attic is believed to be 6" (possibly 8") batts without any foil backing. See the two code reports in the appendices of this report and the brief summary in Section 6.

General view of basement

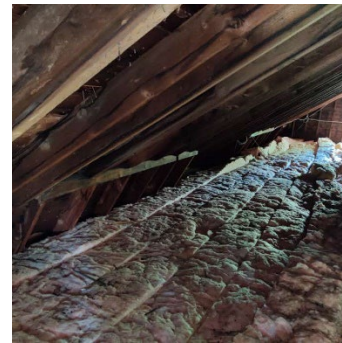
Attic with exiting insulation

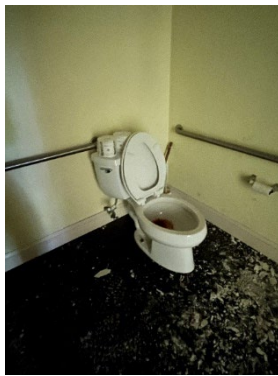
The plumbing systems are antiquated and near the end of their useful life. The plumbing fixtures are in poor condition.

First Floor bathroom

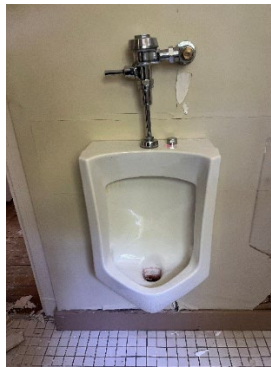
Urinal at second floor bath

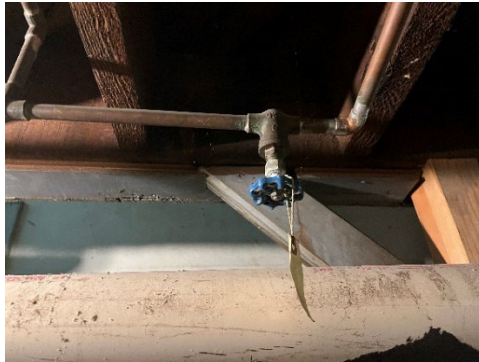
- H. Water Systems: The domestic water service is in the Basement. The service appears to be 1-inch in size and includes a 5/8-inch water meter. The main domestic cold-water distribution is 3/4-inch in size. Piping is copper with sweat joints. Valves are antiquated. The piping is not insulated.

Main Water Service

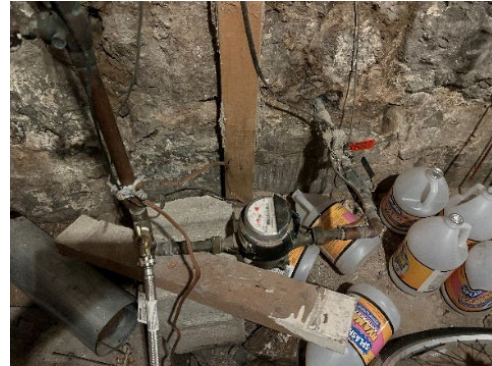
Water Meter and PRV

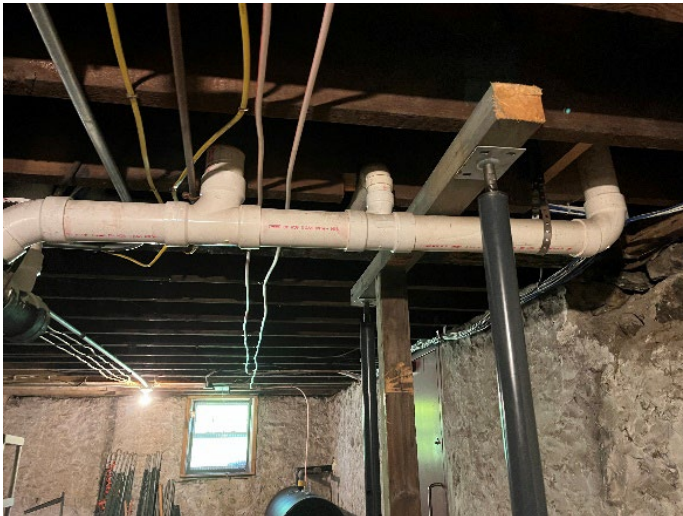
- D. Drainage Systems: PVC is used for sanitary, waste, and vent system. Where visible, the PVC pipe appears to be in good condition. PVC transitions to cast iron at the Basement floor slab.

PVC Waste Piping

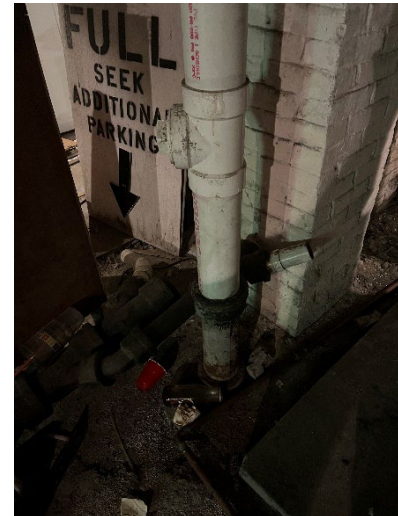
Transition from PVC to Cast Iron

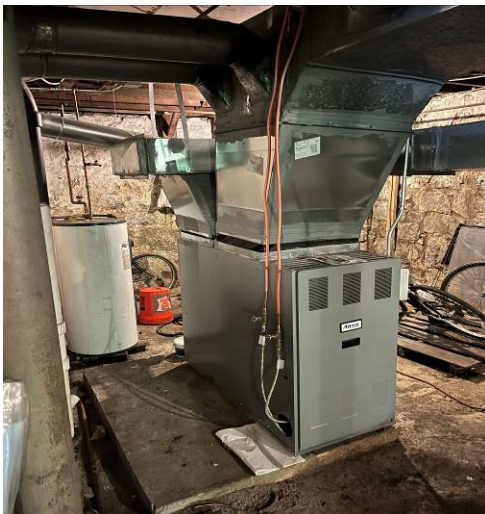
Oil Fired Furnace

- B. Heating: The building is heated from an oil fired furnace located in the basement. The furnace is an Airco Olsen model BCL14552, that provides 141 MBH of heating utilizing #2 home heating oil stored in a 275 gallon oil tank manufactured by Granby also located in the basement. The furnace has a Beckett oil burner. The oil furnace and burner were installed in 2016. The oil tank, supply and return lines were installed in 2010, at the same time a complete tune-up was performed on the air furnace. At optimal performance, the energy rating tag on the furnace rates the appliance at 84% efficient. While this is good for oil fired appliances, many other types of heating systems can reach higher efficiencies and be more environmentally friendly. This is a heating only system with no means of providing air conditioning.

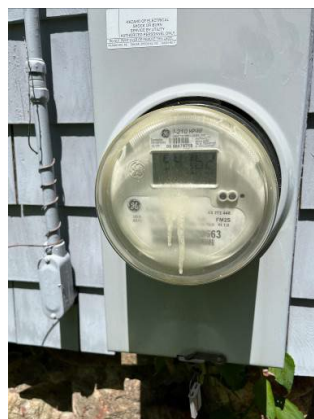
Meter

- A. Executive Summary: In general, the existing electrical infrastructure is in poor condition. Most of the electrical systems are in poor condition due to environmental conditions and no maintenance. Life safety systems such as fire alarm, emergency lighting, and exit signs are either non-existent or not code compliant.
- B. Electrical Distribution System: The building is serviced with a 200 Ampere main breaker, 120/240V, 1Ø, 3W, panelboard with 40 poles. The Load Center is located in the Basement. The utility meter is located outside. The service is coming in overhead from utility pole 1441/1. Distribution equipment is in poor condition.

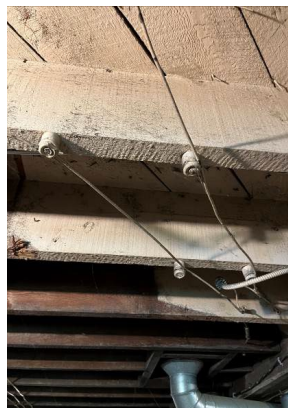
Knob and Tube

- G. Branch Circuitry: Branch circuits consists of Romex wiring and knob and tube. All knob and tube should be replaced. Branch circuitry is in poor condition. GFCI protection and arc fault protection is inadequate

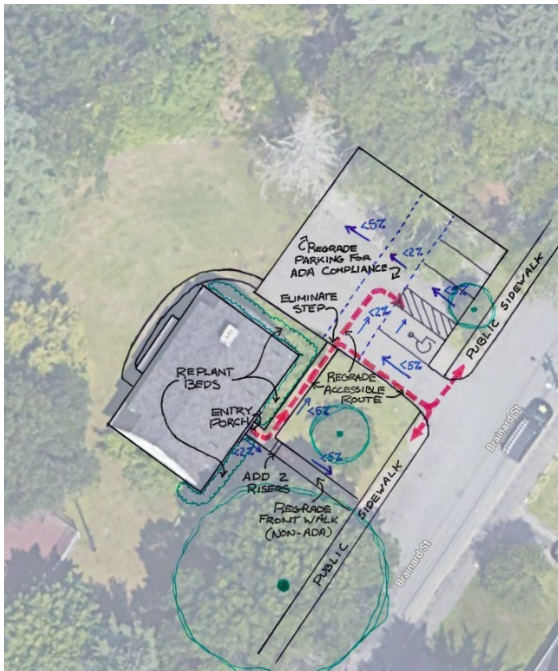
Conceptual regrading Plan

Our landscape architect has recommended re-grading the parking area to provide a more consistent and accessible pitch from the curbcut back (shown with the red broken line), which would have the potential benefit of eliminating the single step at the end of the walkway and allowing a re-graded walkway under a 5% slope from the driveway to the door. This will provide an ADA compliant connection from the parking lot (and, by extension, from the public sidewalk) to the front door of the building.

In summary, CBA would recommend that the driveway and parking be regraded for ADA compliance, which should permit an ADA-compliant walkway from the driveway to the front threshold along the eastern (front) façade of the building. If desired, an ADA walkway could also be created to provide access to the rear door. A non-ADA-compliant front walk leading out directly to the sidewalk should be included as well, for consistency with the house's historic appearance and means of approach. The plant beds at the foundation should be thoroughly cleaned out and replanted with appropriate low-maintenance plantings (a mix of shrubs and perennials); at a minimum, the weed trees and climbing vines need to be addressed.

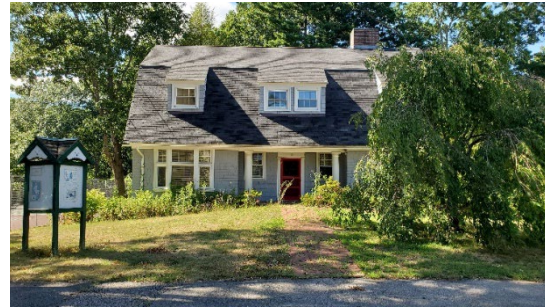
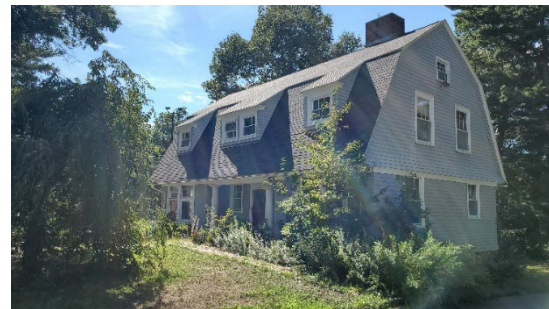
Below: Path from parking; Above: Path from Sidewalk

The main walkway out from the front door to the sidewalk could then be re-graded to provide a gentler slope with a visible 2 riser step, that would clearly differentiate it from the accessible route through the parking lot. For both walks, pavement materials could include cast concrete sidewalk, brick or precast pavers (as are currently in use) or asphalt.

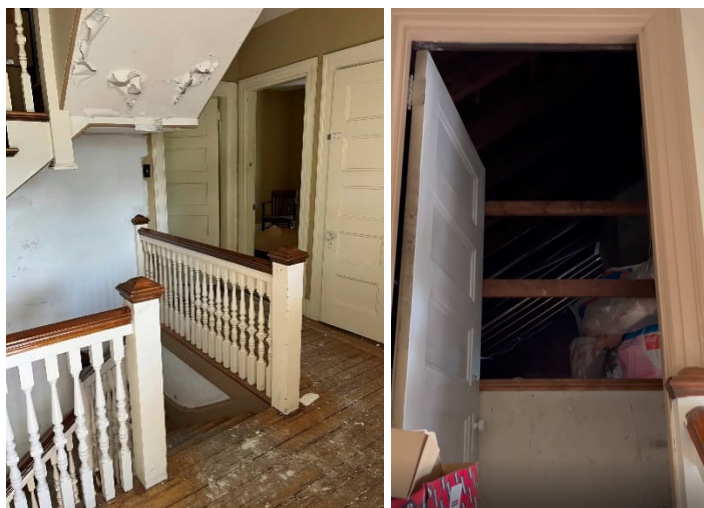
In addition, guards shall be 42" minimum in height, measured from the adjacent walking surface. The guards provided on Level 2 (measuring 33" in height) and at the attic (measuring 34" in height) are less than 42" high (Figure 4). The guard on the attic stair also has openings that exceed the 4" maximum (14½"). The guards on the second floor and attic must be raised, and the openings in the attic guard must be reduced if they're altered or if the existing guards are deemed unsafe by the building official.

*Figure 4: Low guard on Level 2 and in the Attic*
