Conditions Assessment Furnace Brook Parkway Substation

**1198 Furnace Brook Parkway
Quincy, MA**

DCR Project No. P25-3595-S2A

March 24, 2025

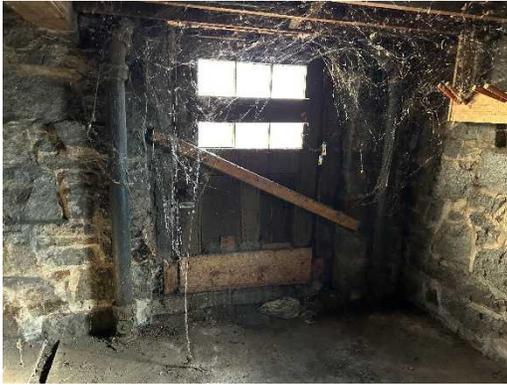
Cast Iron Storm Piping

Storm water had been served by gutters, downspouts, downspout boots and exterior cast iron storm drain piping. The gutters and downspouts no longer exist. Some cast iron piping inside the building is suspected to be storm drain piping.

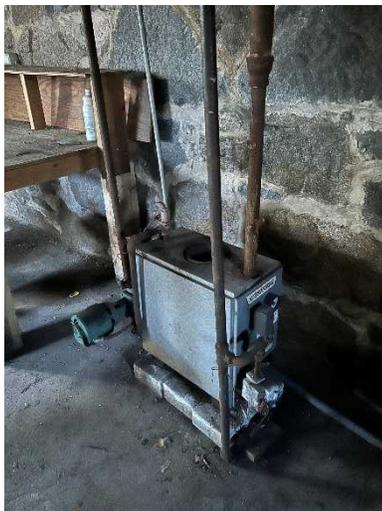
Boiler and Circulator

The heating system has been dismantled and is not operational. The gas service and gas piping are intact, but the gas meter has been removed. The boiler had been vented into a masonry chimney.

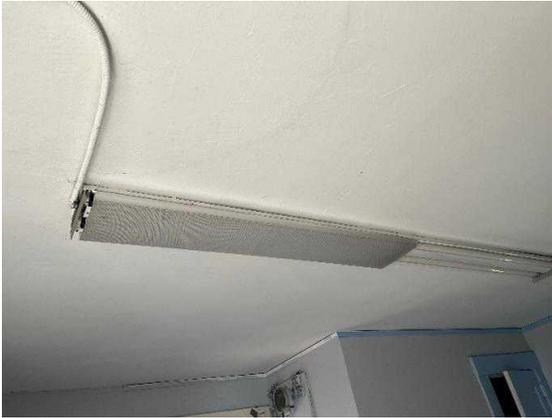
Primary Room Lighting

Lighting control is by wall mounted snap switches. The building's perimeter and porch lighting were missing. In general, the interior/exterior lighting system is barely functioning.

A rating of failed is assigned.

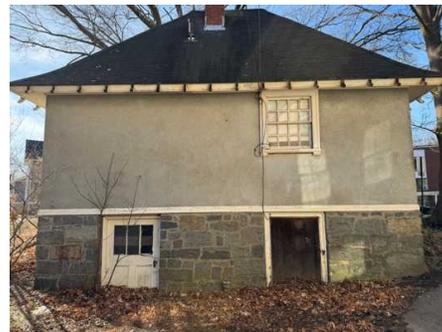
Rear of building; Infilled exterior stairwell and shrubs to be removed / cutback

At the rear of the building, the exterior stair well down to the basement doors is filled with debris, soil, and leaves. The condition was covered so the condition of the existing stair well could not be assessed. It needs to be cleared out, and it is assumed that the landing and steps will need to be rebuilt to step down to the basement level.

The bushes and shrubbery alongside the east and north portions of the building should be removed or cut back. At the rear of the building, the door well into the basement needs to be cleaned out. A new concrete door landing at the basement and steps up to grade needs to be provided. For the residential use, an exterior door needs to be provided from the first floor secondary room (bedroom) to provide a second means of egress from the building and an emergency escape from the bedroom. At the exterior, this door will need to be provided with a wood landing and set of stairs down to grade with a concrete landing. This will be supported on wood posts and concrete footings. Its configuration will need to be coordinated with access to the basement door below and compatibility with lot line setbacks and zoning.

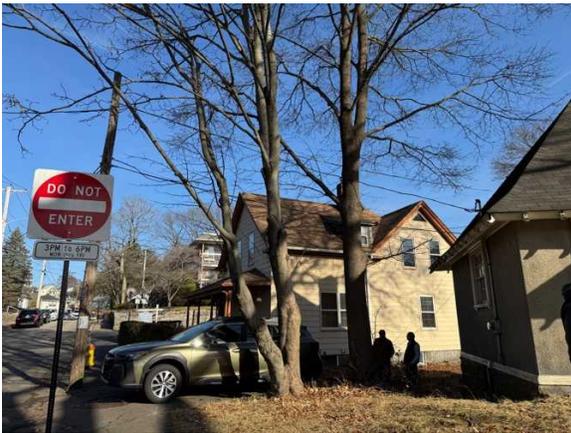
On site parking is limited to a single car in the narrow driveway at the north portion of the lot. The driveway is non-conforming in that it is extremely narrow and directly adjacent to the presumed lot line. The surface of the driveway is overgrown and the roots of the two trees directly adjacent to the driveway are affecting the driveway surface. The driveway is in an unusable condition.

Driveway on west side of building with trees adjacent

The existing asphalt one-car driveway needs to be removed, and a new asphalt driveway put in approximately the same location. The two trees directly adjacent to the existing driveway need to be removed and some regrading may be needed to provide sufficient width for the one car driveway. Additional zoning code provisions, including driveway setbacks from lot lines and number of parking spaces required, will need to be evaluated depending upon the proposed use of the building. The property appears to be within the Residential B zone but is not zoned as Residential. From visual observation of the property's corner location and spatial constraints, it will be challenging to provide more than one parking space. A survey with grades would be needed to evaluate how additional parking can be accommodated if desired or needed. For the commercial use, the parking space does not need to be accessible as Massachusetts 521 CMR first requires accessible parking space(s) if 15 or more spaces are provided.

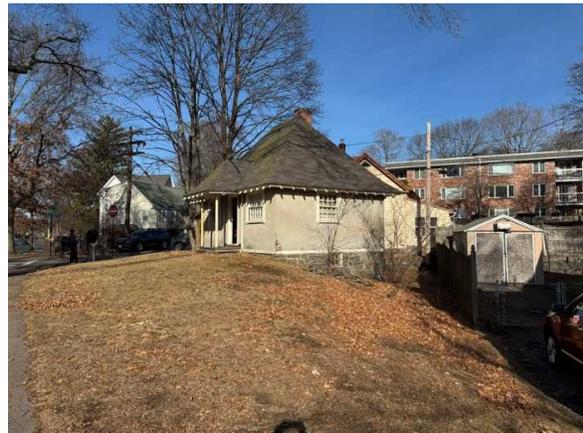
The entry to the building is currently not accessible from either the driveway or the street sidewalk. The grade of the walkway visually appears to be steeper than the maximum 5% permitted without a ramp. At the entry to the building, there are two steps plus a raised threshold that do not permit accessible access.

Side view of front of building where grade slopes up from sidewalk to front door

For residential use, the existing pathway from the Furnace Brook Parkway sidewalk and two stair wood entry porch are in serviceable condition and can remain. For the commercial use, an accessible path must be provided to the front door. From visual inspection, the existing sloped grade in combination with the need to eliminate the two steps leading up to the entry porch and the raised threshold at the front door, a ramp will be needed to provide an accessible path and entry into the front door. A survey with grades is required to determine how long a ramp would be needed and the possibility of navigating some of the required grade changes with a sloped path. For costing purposes, the ramp should be assumed to be concrete with metal handrails, and a concrete flush landing that accommodates the porch roof provided at the existing front door. Any of the remaining existing path is to be replaced with a concrete path of at least 3'-0" width and a slope of less than 5%.

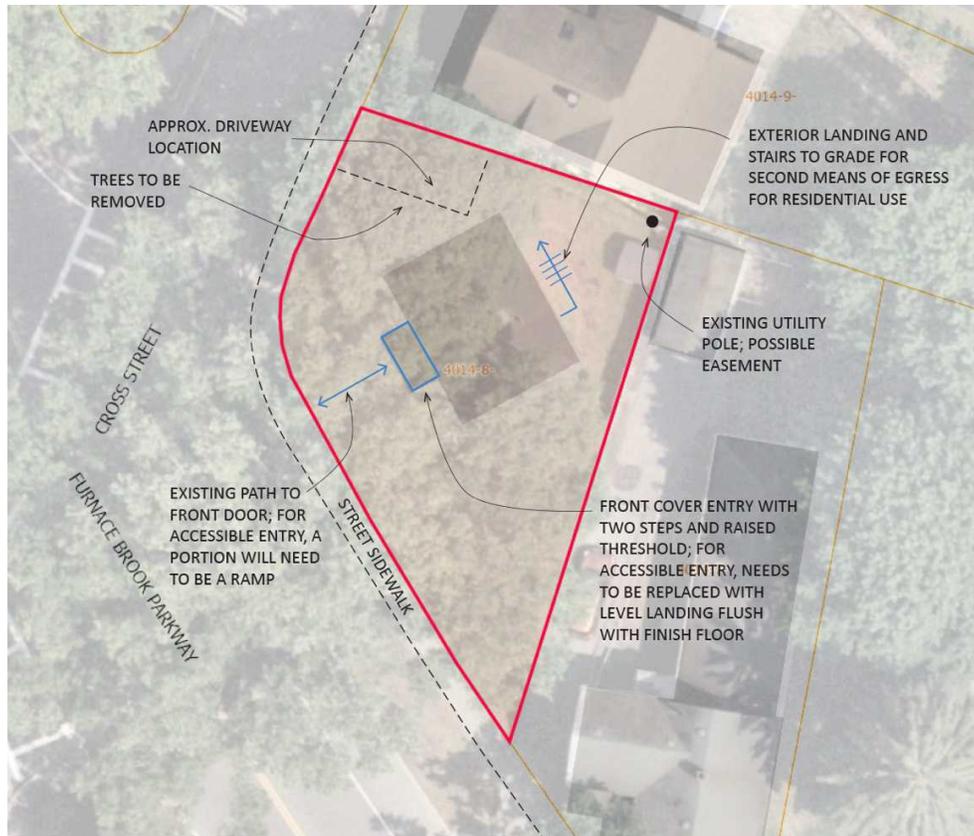
Site Diagram Noting Some of the Improvements Needed

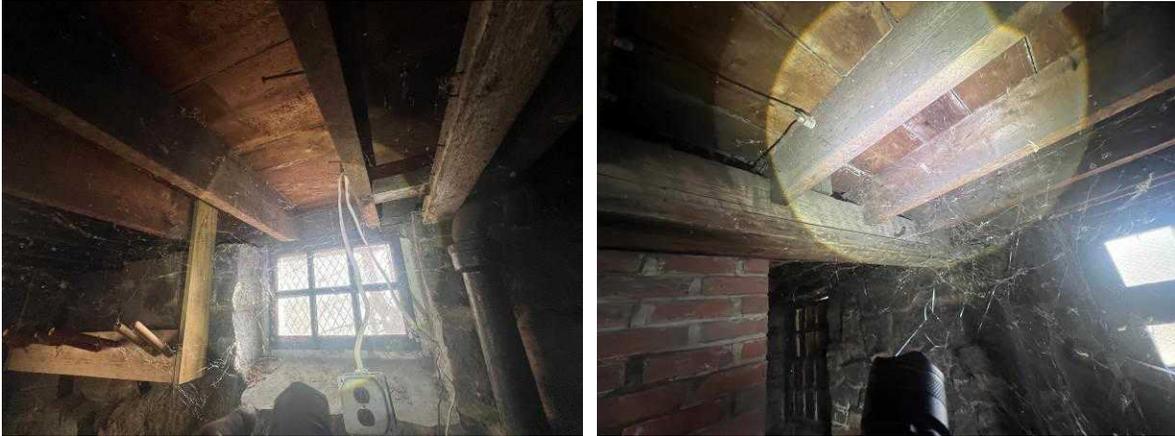
Existing First Floor Framing and Stone Foundation Walls

The existing structure is in good condition. We did not observe any distress in any of the members. We did not observe any signs of foundation settlement or undue vibrations due to footfall on the supported first floor. We did not observe any signs of water infiltrations through the roof or the

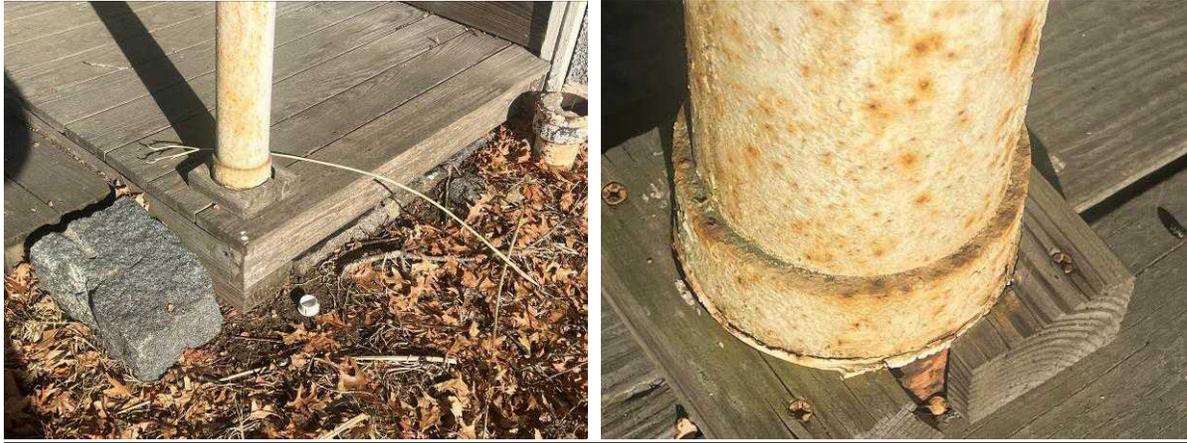
Base of Canopy Column

The existing structure appears to be in fair condition. All of the structural components that are visible appear to be in sound condition except the items noted above which include the Wood Column on the Basement and the Stair Structure from the First Floor to the Basement and the base of the Entrance Canopy columns.

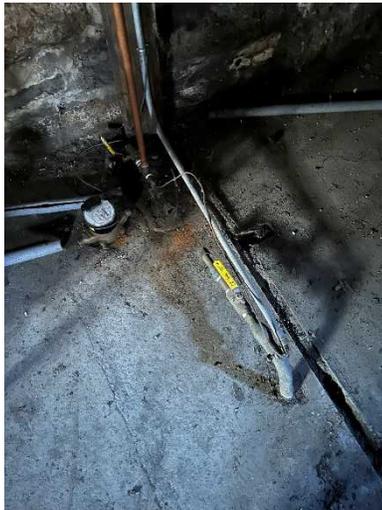
Water Service

The building's domestic water is supplied underground through a ¾-inch (¾") pipe which enters the basement through the slab. The domestic water supply was equipped with a meter which has been removed and sits on the floor next to the water service. The water service piping appears to be of unknown metal.

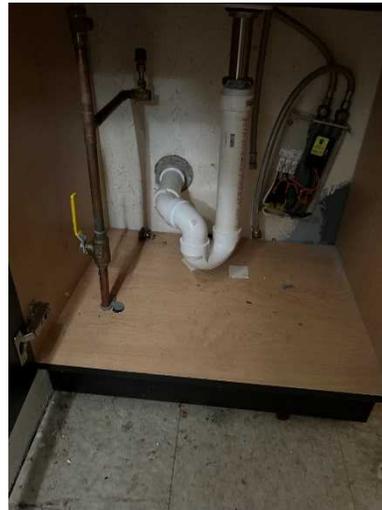
Water Heater

The domestic water heater is an electric point-of-use heater located within the restroom vanity.

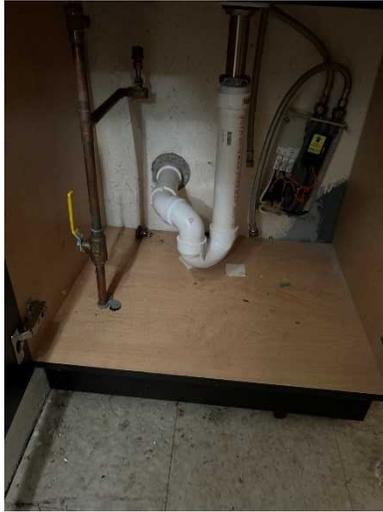
PVC Piping

What could be seen of the existing sanitary drain, waste and vent system appears to be a combination of PVC and hub and spigot cast iron with leaded and caulked joints. PVC is limited to the lavatory drain. Visible piping appeared

to be in fair condition, with little evidence of active leaks.

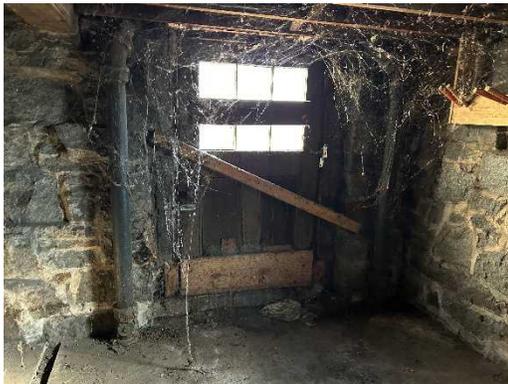
Cast Iron Storm Piping

Storm water is served by gutters, downspouts, downspout boots and exterior cast iron storm drain piping. Some cast iron piping inside the building is suspected to be storm drain piping.

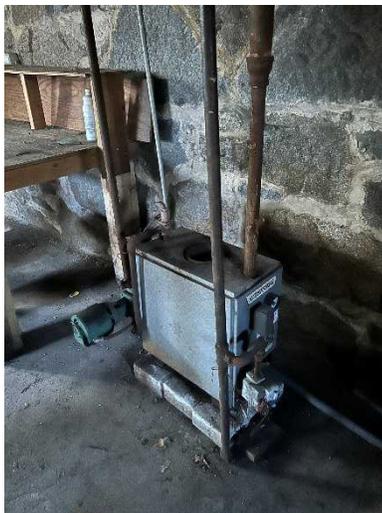
Boiler and Circulator

The heating system has been dismantled and is not operational. The gas service and gas piping are intact but the gas meter has been removed. The boiler had been vented into a masonry chimney.

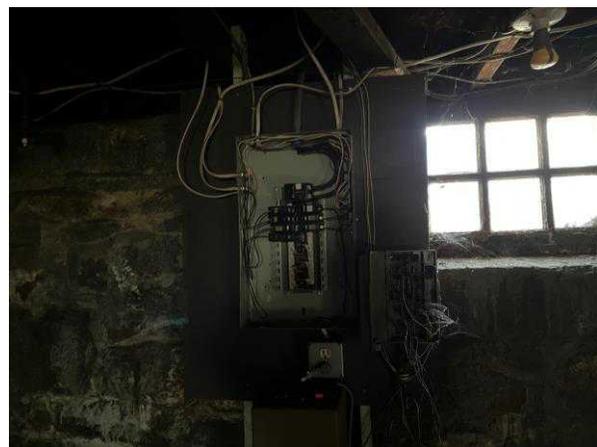
Westinghouse Panel

Rating: Failed

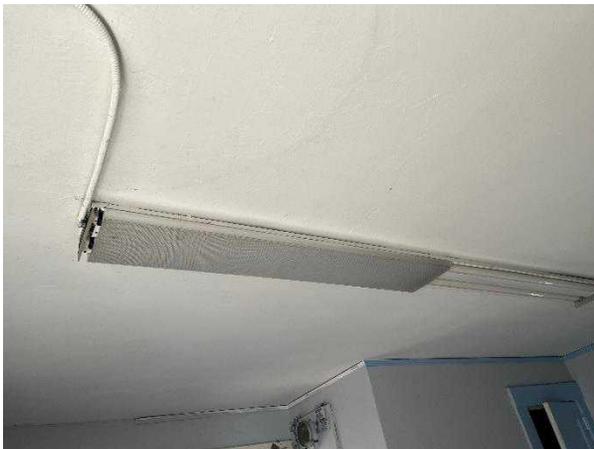
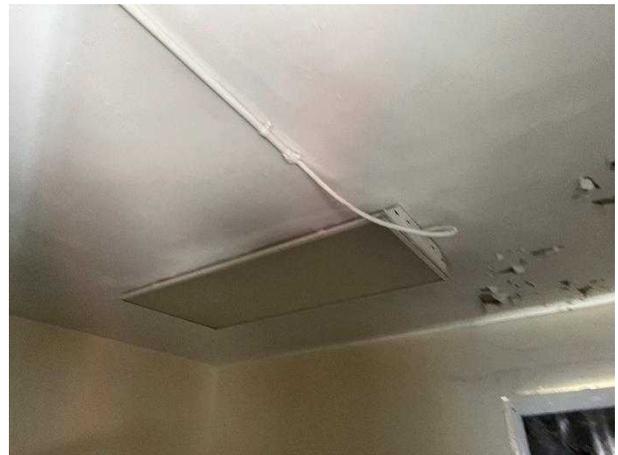
Lighting control is by wall mounted snap switches. The building's perimeter and porch lighting were missing. In general, the interior/exterior lighting system is barely functioning.
