ROAD SAFETY AUDIT

Arborway - West of South Street to West of Eliot Street

City of Boston

September 9, 2019

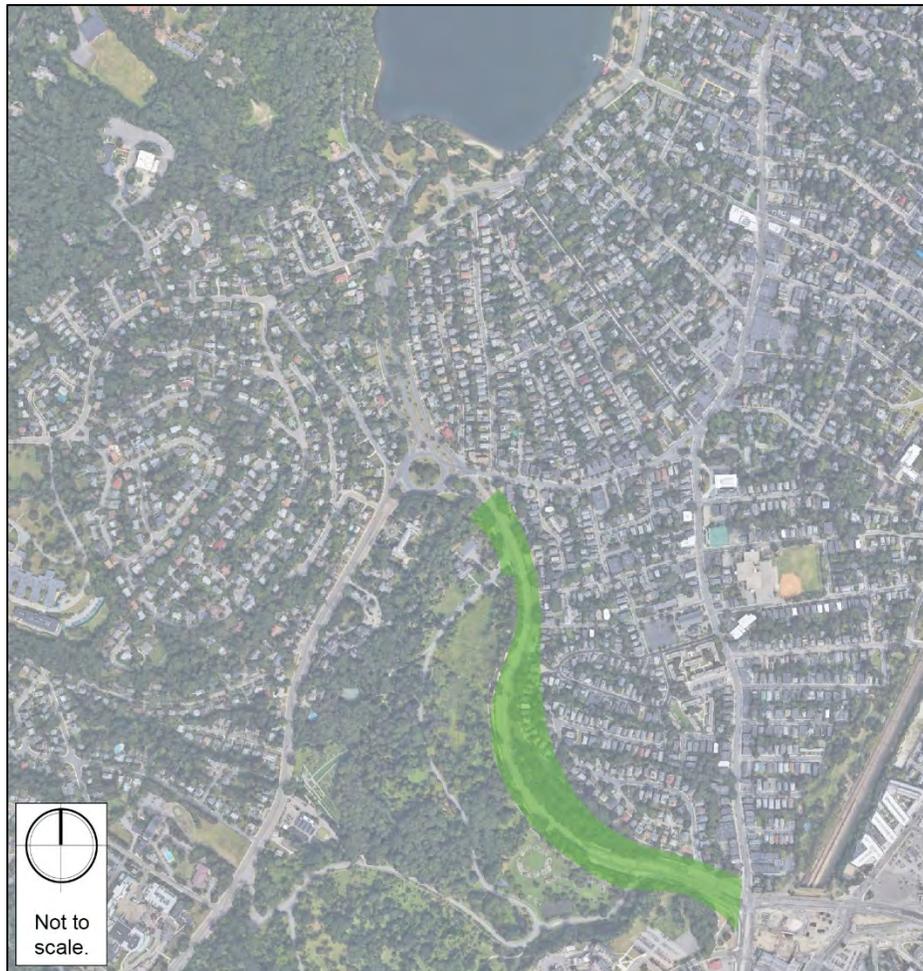
Figure 5: Section Between Murray Circle and South Street

Existing roadway geometry, unclear pavement marking and signage, and the lack of pedestrian, bicycle, and ADA accommodations were safety issues that were identified for the area and are discussed in more detail in the following sections.

Four of the 27 crashes were reported as exceeding the authorized speed limit or driving too fast for conditions. All four crashes were single-vehicle crashes, all vehicles involved in these crashes were traveling northbound, and three crashed along the horizontal curve approaching the signalized pedestrian crossing approximately 400 feet south of the Arnold Arboretum driveway. Northbound vehicles may not have adequate sight distance to the midblock pedestrian crossing signal due to roadway geometry. This, combined with the high speeds vehicles travel along the roadway, may have led to the seven crashes involving the midblock pedestrian crossing. All seven crashes either involved pedestrians or vehicles stopping for pedestrians.

During the site walk, attendees observed that the grade and curvature on the Upper Arborway northbound at St. Rose Street may reduce the available sight distance. Two crashes, or 7%, occurred at the intersection, and one of the two involved a cyclist.

Audit members also discussed the unclear parking regulations along the shoulders along the Arborway. There is nowhere to patrol or pull over vehicles along the roadway except in the wide shoulder used as a parking lane. The shoulder provides signage implying the shoulder is a parking lane but the lane appears to be of inadequate width, also negatively affects the sight distance of vehicles traveling southbound toward the signalized pedestrian crossing. Three crashes, or 11%, involved a parked car or vehicle exiting the shoulder.

Approximately 1,000 feet west of South Street, the Arborway has an approximately 1,500 feet long horizontal curve. There is signage to warn drivers of the upcoming curve traveling on the Arborway northbound, but the signage is not present at the point where vehicles were noted to crash into the fence and median separating the Arborway from the Upper Arborway and the opposing Arborway direction, respectively. Four of the 27 crashes involved a vehicle crashing into the fence. In addition, there is no warning or object marker signage along the median with the fence facing the Arborway, which may impair visibility along the median, especially at night.

1. Evaluate traffic calming measures along the Arborway to encourage motorists to travel at or below the speed limit, including reduced lane widths to an 11' maximum width, reducing to a single lane in each direction, and rumble strips approaching crossings.
2. Evaluate shoulder width to formalize a parking lane and restrict parking where width is inadequate and additional width cannot be taken from travel lanes.
3. Consider restricting parking in close proximity to pedestrian crossings to improve sight distance for approaching vehicles.

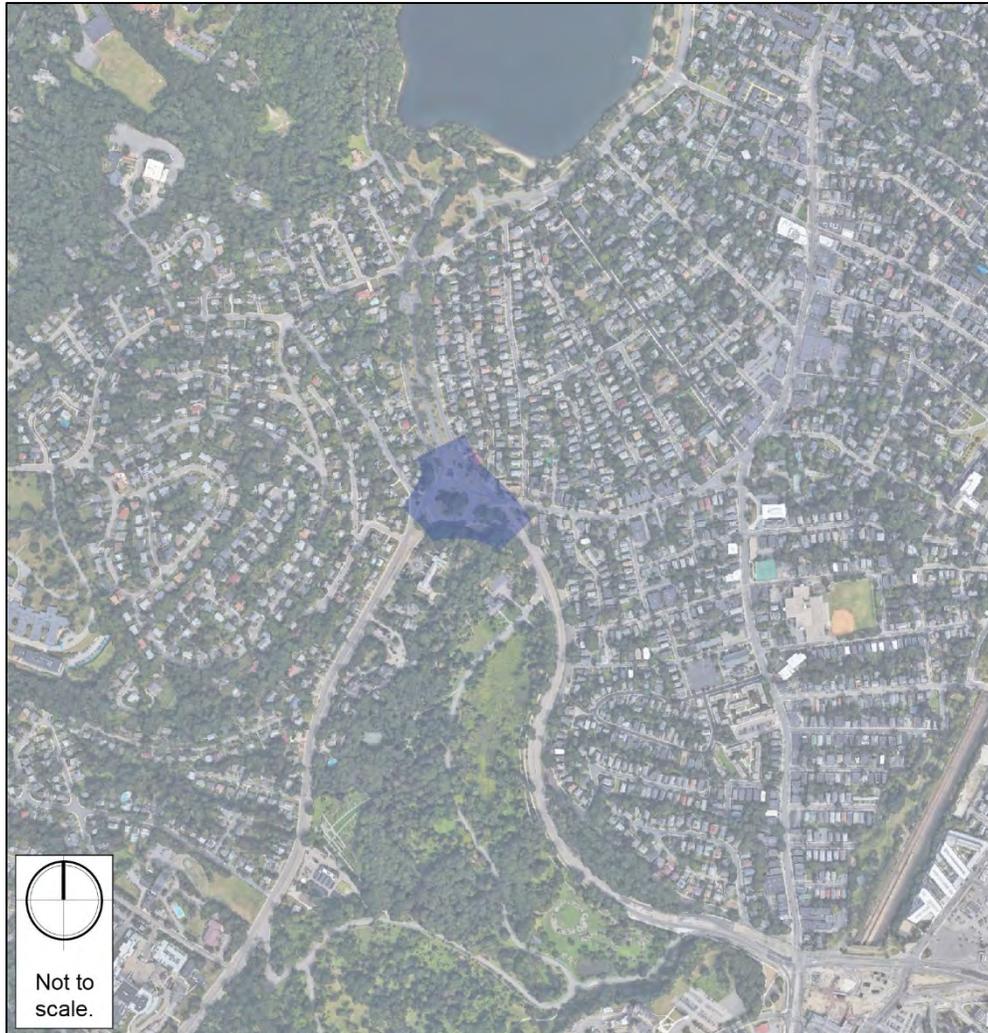
Figure 6: Section at Murray Circle and the Centre Street at Arborway Intersection

Signalized intersection operations, pedestrian, bicycle, and ADA accommodations, and geometry were safety concerns that were identified for the circle and adjacent intersection with Centre Street, and are discussed in more detail in the following sections.

The signalized intersection of Centre Street at the Arborway is located east of Murray Circle. The Centre Street eastbound approach, the eastern exit leg of Murray Circle, consists of two lanes; however, it was observed that the majority of vehicles queue in the right lane because Centre Street eastbound merges to

one lane after the intersection. This causes vehicles to back up into Murray Circle, which was observed to cause congestion within the circle.

The signals are all post-mounted, which may affect motorists' sight distance of the signal indications. Although the signals are equipped with visors, a signal head facing Centre Street westbound on the Centre Street east/westbound splitter island is present and is visible as drivers approach the rotary from the Arborway northbound approach. Most of the signals are outside of the motorists' direct line of sight, which may lead to confusion. Two of the five crashes at the intersection were caused by vehicles making opposing movements believing they had the right of way, and one involved an emergency vehicle was hit trying to travel through the intersection, as there is no Opticom for emergency vehicles to travel through the intersection.

In addition, there is only one signalized pedestrian crossing across the Arborway approach. There is no crosswalk across Centre Street, which may cause eastbound delay if vehicles have to stop for crossing pedestrians, and it creates additional conflicts for pedestrians who are forced to cross without a protected phase.

Murray Circle has a varied circulating width between approximately 30-60 feet. Without pavement markings, the circulating traffic lane usage varies from one to three or four lanes. There was queuing observed at the Centre Street eastbound approach during the RSA due to the circulating traffic using the rotary as one lane, even though the circulating width is approximately 40 feet near the approach. Although the circle did not appear to be congested, the entering traffic did not have an adequate gap due to the lack of lane usage signage and markings. There were 18 of the 44 crashes involving switching lanes sideswipes within the rotary or while entering or exiting the rotary.

The wide layout of the circle and lack of deflection also encourages high speeds through the rotary. Two crashes were caused due to vehicles driving too fast for conditions, and RSA attendees noted that speeds were a major concern traveling through the circle. The high entry and exit speeds also pose a safety risk for pedestrians and cyclists attempting to cross the rotary legs. The southbound Arborway exit is only 200 feet south of the Centre Street eastbound approach of Murray Circle. The close proximity between the entrance and exit corresponds with the crash cluster present, with 14 of 44 crashes occurring at this part of the rotary, with the majority being sideswipes. Ten of these 14 crashes involved vehicles attempting to exit the rotary onto the Arborway southbound.

In addition to the lack of markings and wide circulating width, no lane-use or guide signage is provided at approaches to inform motorists which lane they should be in to reach their desired exit leg of the rotary. Yield signs are present at all approaches, but most only have one yield sign and there are no yield lines. Ten of the 44 crashes occurred because a motorist failed to yield the right of way at the entry points to the rotary and while within the rotary. Five of 44 crashes occurred because a motorist, while attempting to enter Murray Circle, followed too closely and rear-ended the lead motorist. This may be due to the second vehicle seeing a gap in circulating traffic with the first vehicle not entering the rotary.

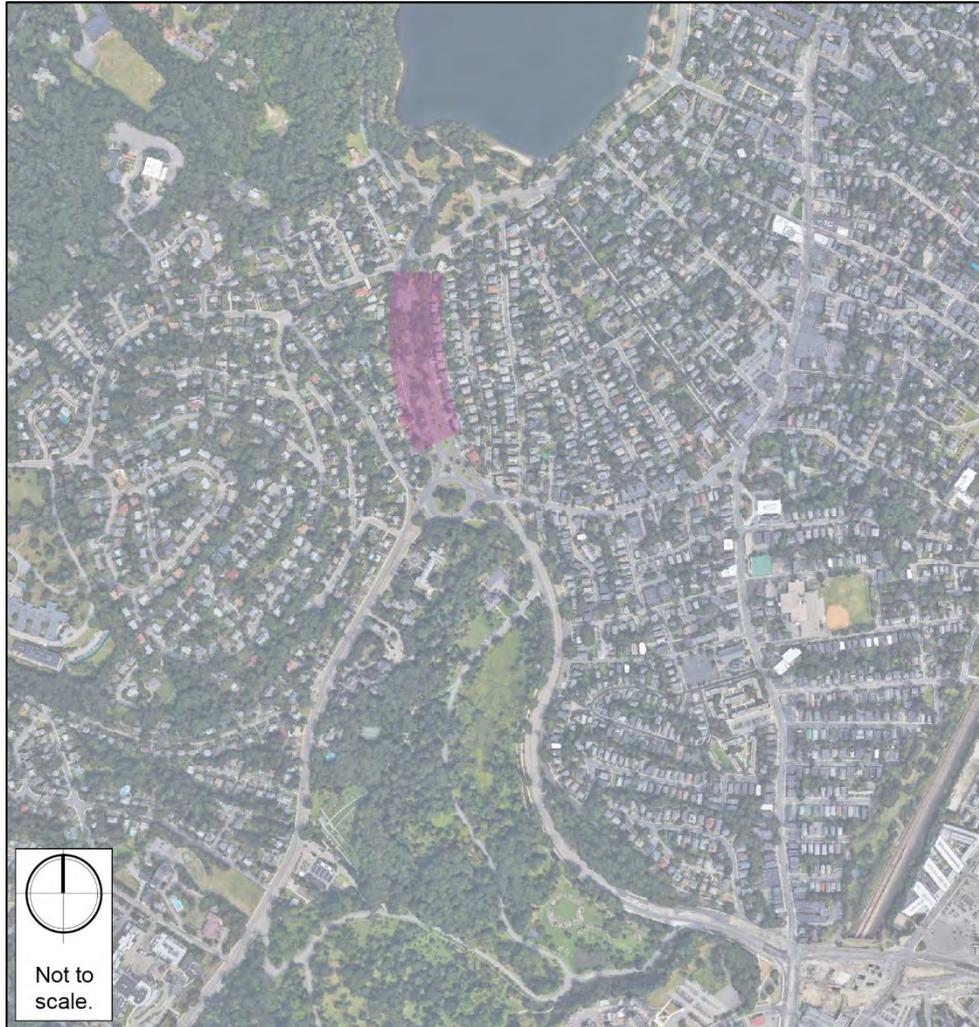
Figure 7: Section Between Kelley Circle and Murray Circle

Roadway geometry, and pedestrian, bicycle, and ADA accommodations were safety concerns that were identified in this segment of the roadway and are discussed in more detail in the following sections.

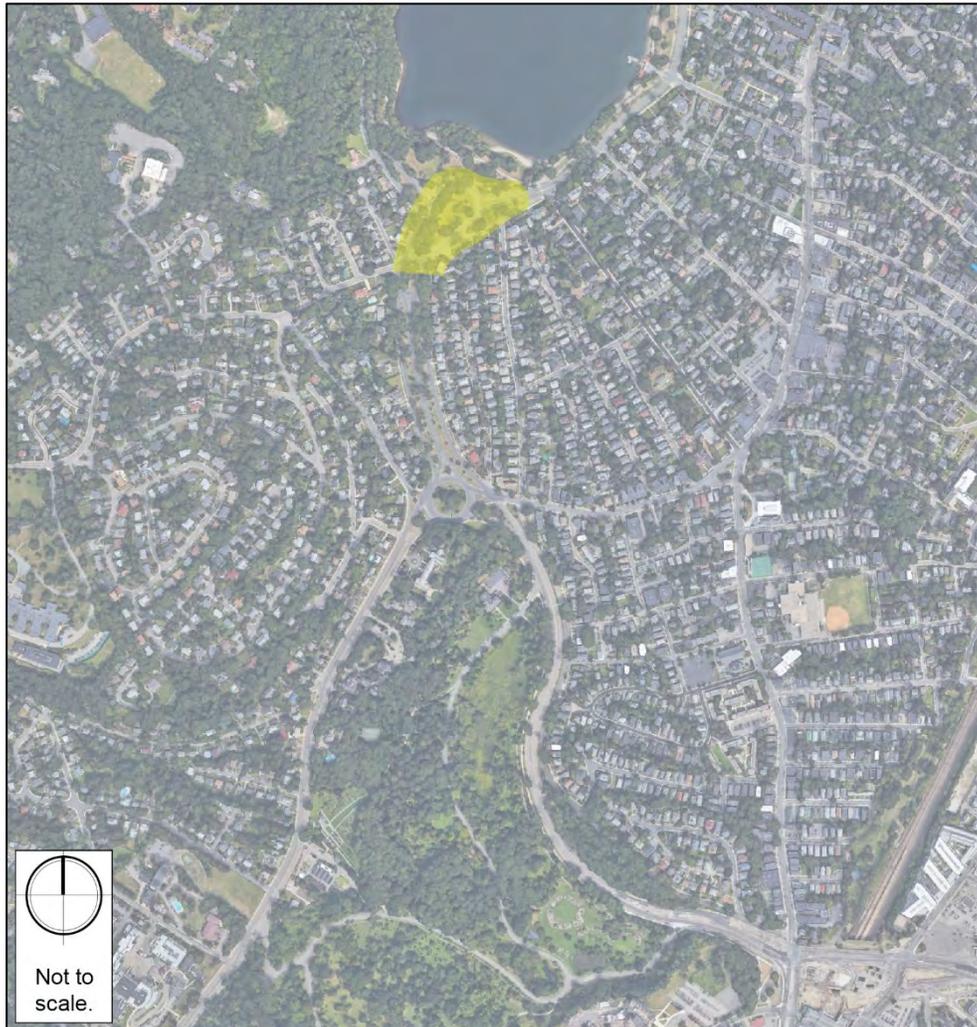
Figure 8: Section at Kelley Circle and Pond Street/Jamaicaway

Geometry and pedestrian, bicycle, and ADA accommodations were safety concerns that were identified and are discussed in more detail in the following sections.
