## BOSTON HARBOR WATERSHED

# Boston Harbor Watersheds

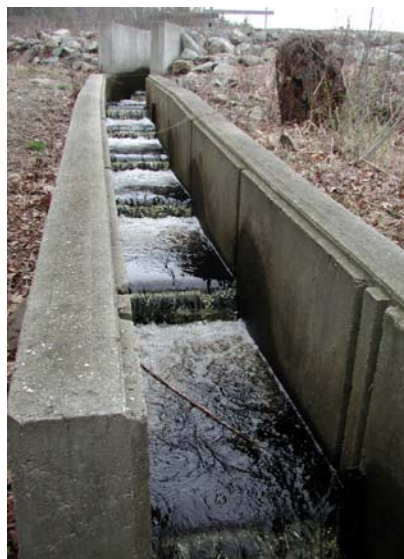
Design	Material	Length (ft)	Inside W (ft)	Outside W (ft)	# of Baffles	Baffle H (ft)	Notch W (ft)	Pool L (ft)	Condition/Function
Weir-pool	Concrete with wooden baffles	58.0	2.5	4.4	10	Varied (1.7, 2.2, 3)	-	6.0	Good Passable

Fishway at Triphammer Pond Dam

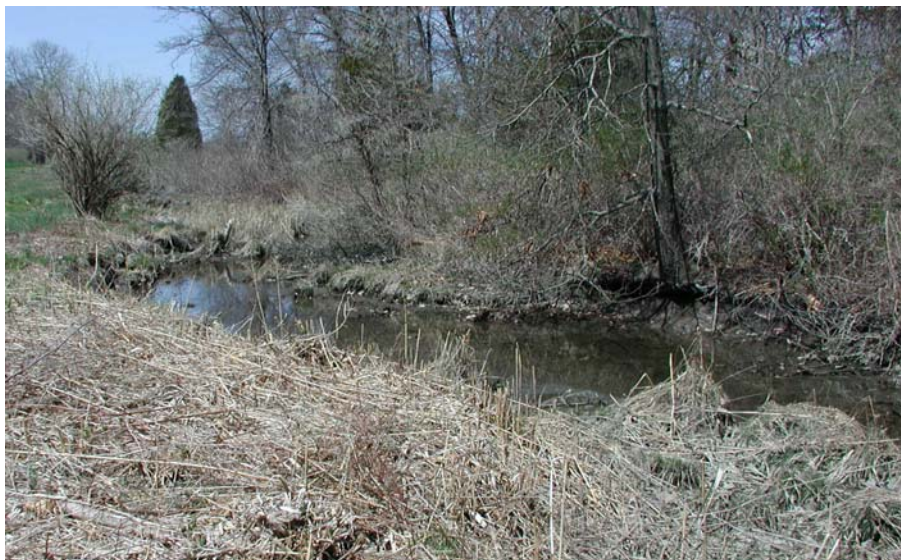
Broad Cove is an inland extension of Hingham Harbor. A small, unnamed stream drains into the cove and smelt have been known to spawn there in the past. No recent spawning has been observed, probably due to degraded habitat, and there is little potential for further development.

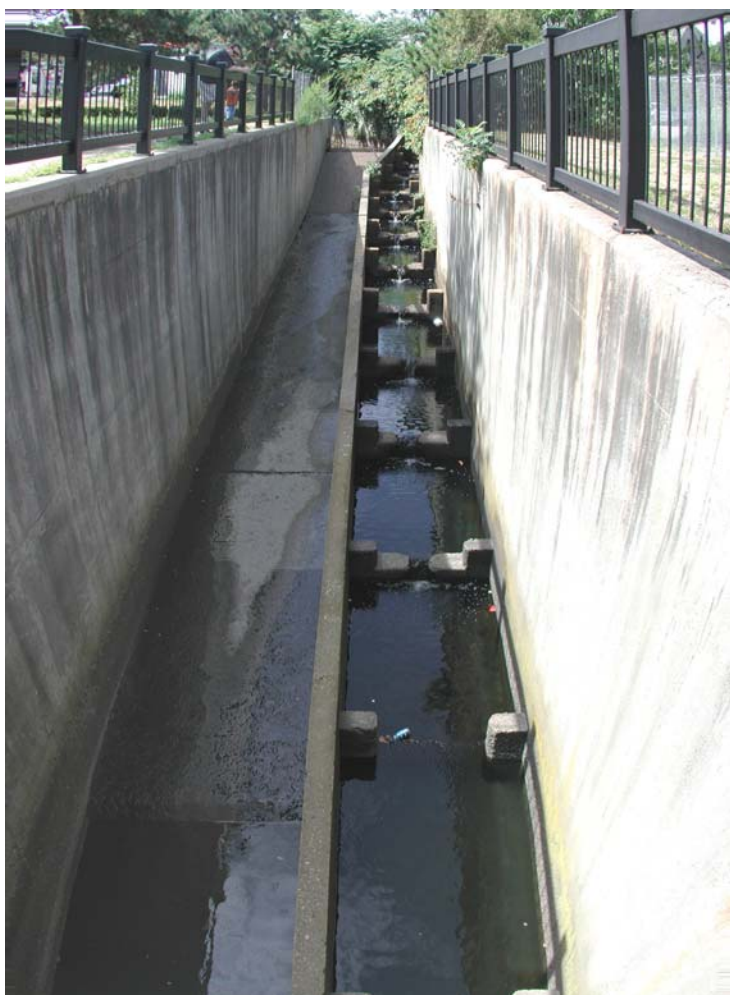
Broad Street Dam and Fishway

Design	Material	Length (ft)	Inside W (ft)	Outside W (ft)	# of Baffles	Baffle H (ft)	Notch W (ft)	Pool L (ft)	Condition/Function
Notched weir-pool	Concrete	130	4.8	6	14	-	3	7	Good Passable

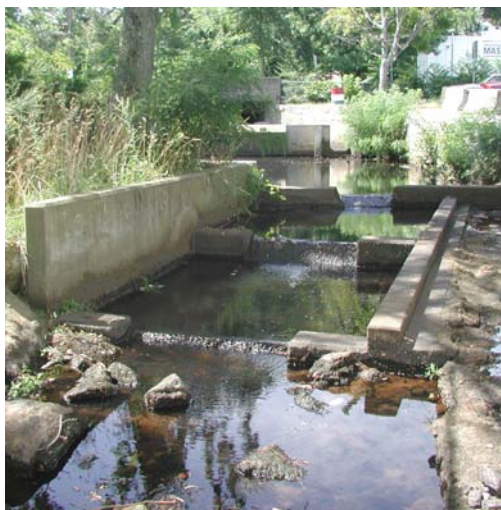
<b>Design</b>	<b>Material</b>	<b>Length (ft)</b>	<b>Inside W (ft)</b>	<b>Outside W (ft)</b>	<b># of Baffles</b>	<b>Baffle H (ft)</b>	<b>Notch W (ft)</b>	<b>Pool L (ft)</b>	<b>Condition/ Function</b>
Notched weir-pool	Concrete	21.0	Varied (7.9-10.6)	Varied (9.0-12.0)	3	1.8	4.0	9.9	Fair Passable

Fishway and dam at Weymouth Youth Center

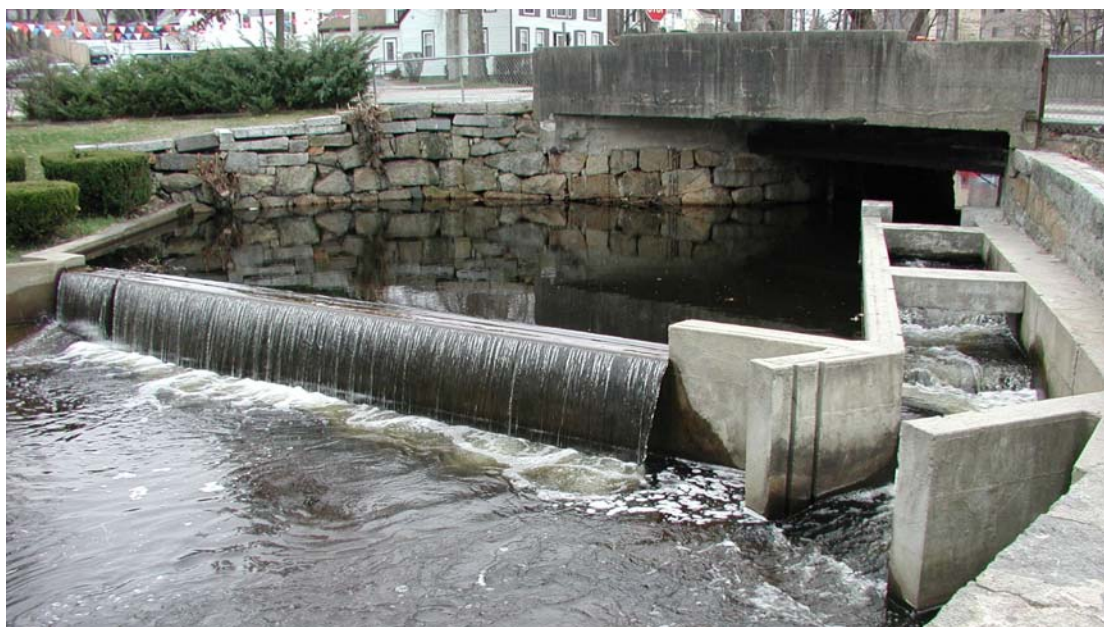
Design	Material	Length (ft)	Inside W (ft)	Outside W (ft)	# of Baffles	Baffle H (ft)	Notch W (ft)	Pool L (ft)	Condition/Function
Notched weir-pool	Concrete with wooden baffles	35.0	4.0	5.7	6	Varied (1.6-3.7)	2.0	Varied (6-7)	Good Passable

Jackson Square Dam and fishway

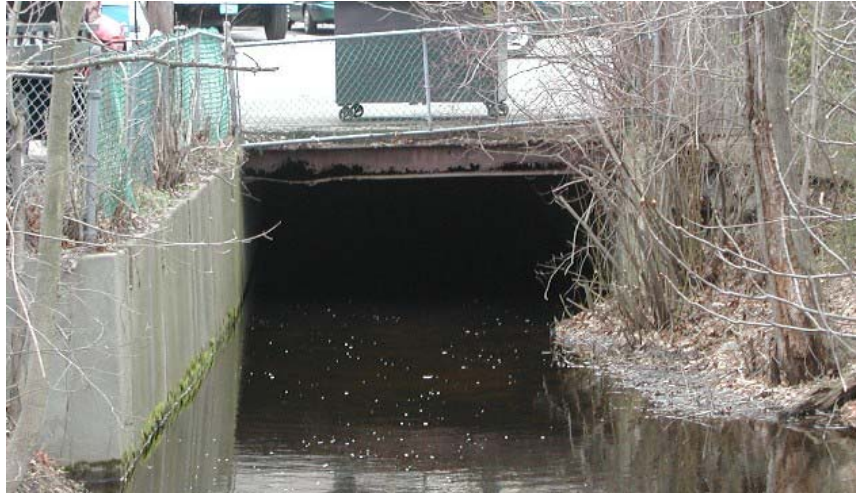
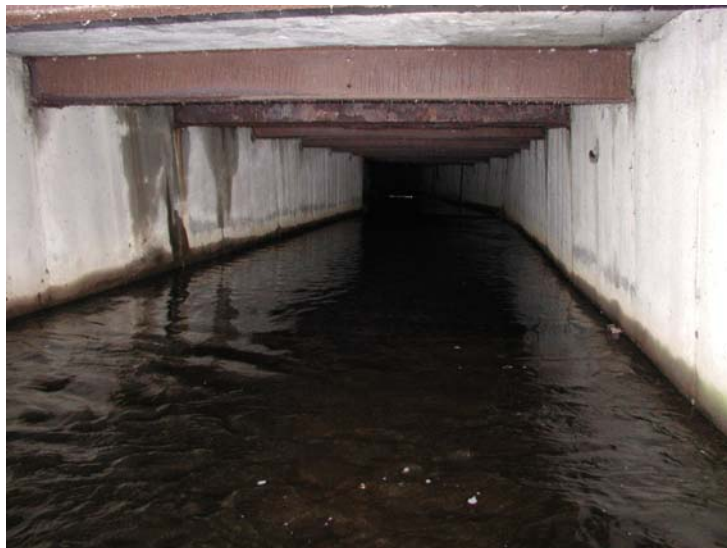
Entrance to Jackson Square elevation change

Design	Material	Length (ft)	Inside W (ft)	Outside W (ft)	# of Baffles	Baffle H (ft)	Notch W (ft)	Pool L (ft)	Condition/Function
Stream baffles	Wooden baffles	146	12.5	12.5	3	1	-	Varied (44' and 80')	Good Passable

Jackson Square elevation change

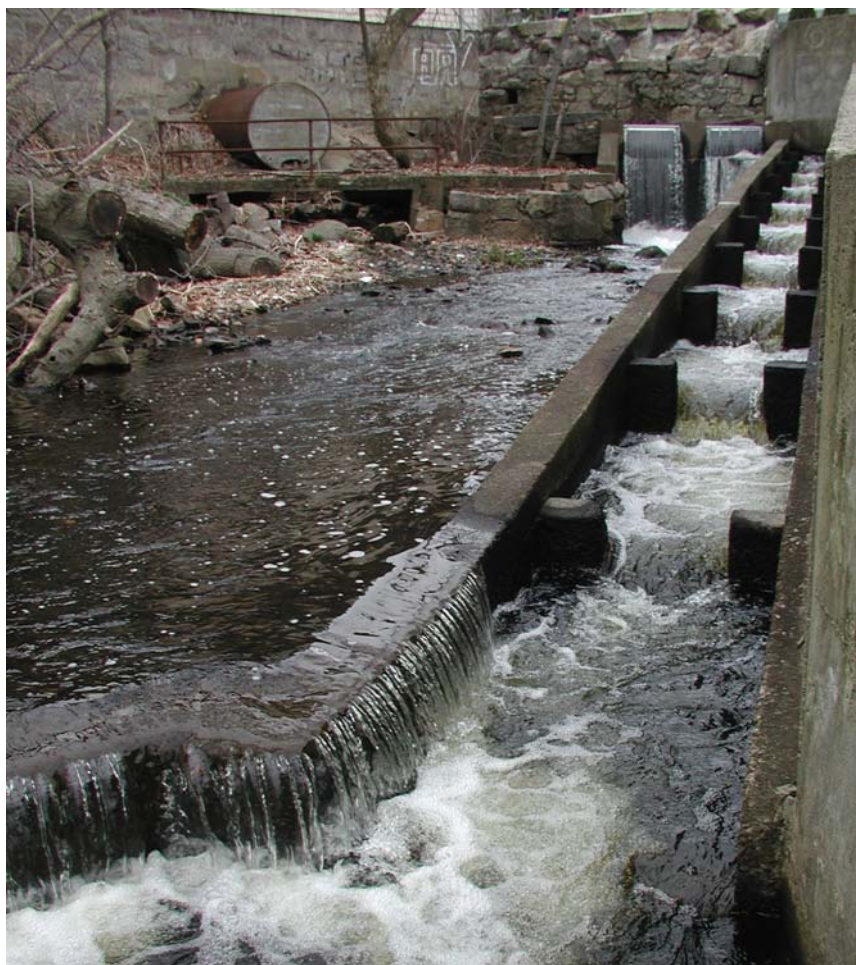
Design	Material	Length (ft)	Inside W (ft)	Outside W (ft)	# of Baffles	Baffle H (ft)	Notch W (ft)	Pool L (ft)	Condition/Function
Notched weir-pool	Concrete	89.2	3.0	4.0	13	2.2	1.5	7.0	Fair Passable

Fishway and dam at Pleasant Street

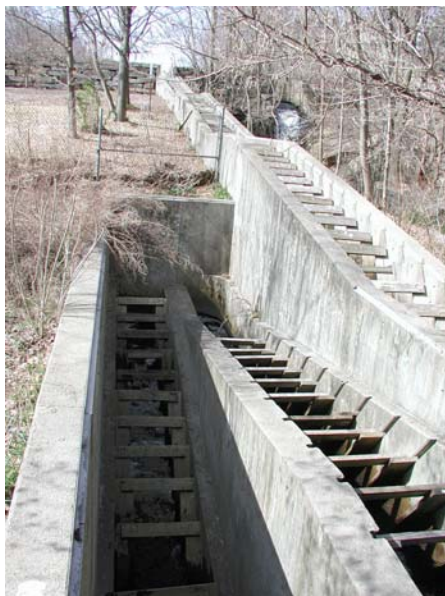
<b>Design</b>	<b>Material</b>	<b>Length (ft)</b>	<b>Inside W (ft)</b>	<b>Outside W (ft)</b>	<b># of Baffles</b>	<b>Baffle H (ft)</b>	<b>Notch W (ft)</b>	<b>Pool L (ft)</b>	<b>Condition/Function</b>
Denil	Concrete with wooden baffles	288.5	3.0	4.9	86	5.0	-	-	Good Passable

Fishway sections at Iron Hill Dam

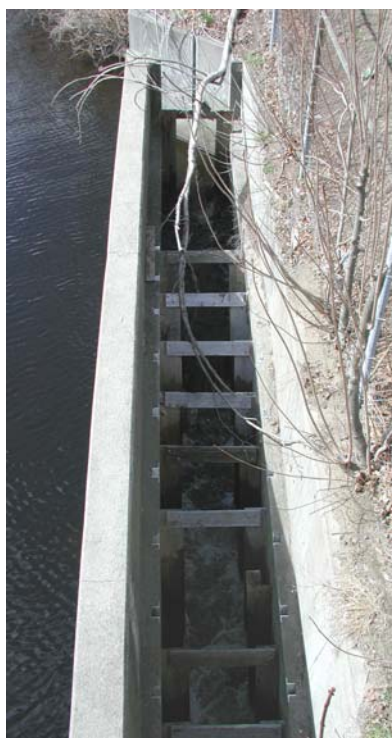
Design	Material	Length (ft)	Inside W (ft)	Outside W (ft)	# of Baffles	Baffle H (ft)	Notch W (ft)	Pool L (ft)	Condition/Function
Denil	Concrete with wooden baffles	85.8	3.0	4.0	26	5.0	-	-	Good Passable

Fish ladder at Whitman's Pond Dam

Another factor which certainly affects productivity is the blocking of the portion of Whitmans Pond south of Washington Street to spawning river herring. This extension of the pond is used as a water supply and, in order to isolate it from the poorer quality water in the northern section, a sluice gate prevents any back flow. While river herring could conceivably enter this area in spring without risking contamination of the water supply, any young herring produced would have a difficult time exiting the upper system when the levels were drawn down. As a result, it was decided to confine spawning to the main pond and avoid losses of juveniles.

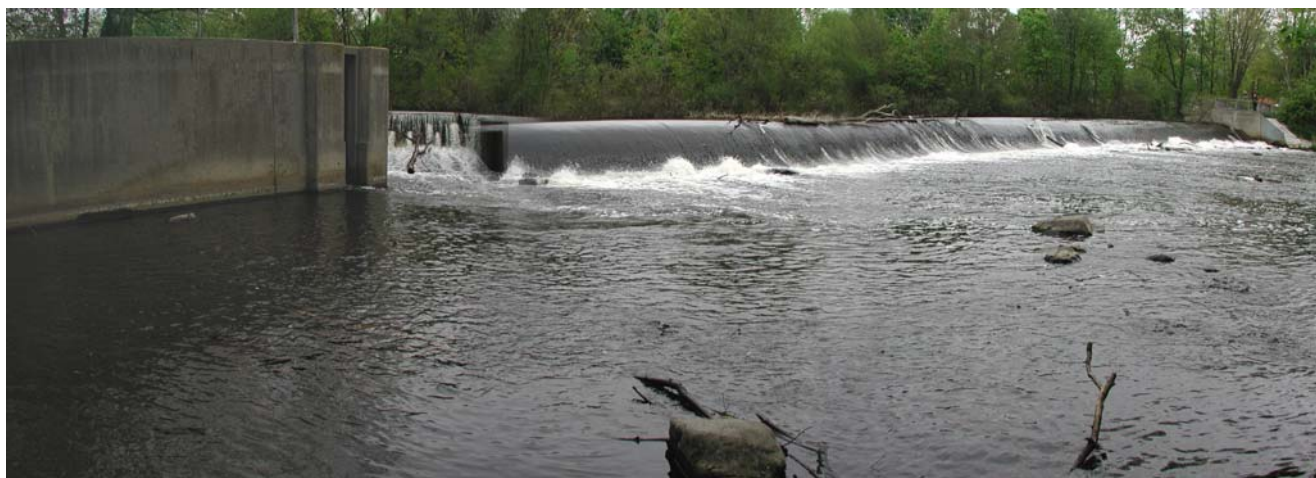
Watertown Dam

<b>Design</b>	<b>Material</b>	<b>Length (ft)</b>	<b>Inside W (ft)</b>	<b>Outside W (ft)</b>	<b># of Baffles</b>	<b>Baffle H (ft)</b>	<b>Notch W (ft)</b>	<b>Pool L (ft)</b>	<b>Condition/Function</b>
Denil	Concrete with plastic baffles	83	4	6	15	7			Good Passable

Approximately 8.5 miles above the first obstruction fish encounter the Watertown Dam. While the Denil fishway at this location functions well, the width of the spillway and river make it difficult for river herring and shad to locate the entrance and it is likely that a large percentage of these populations fail to ascend the river beyond this point. The smelt population spawns below this dam and is not affected by the fishway's shortcomings.

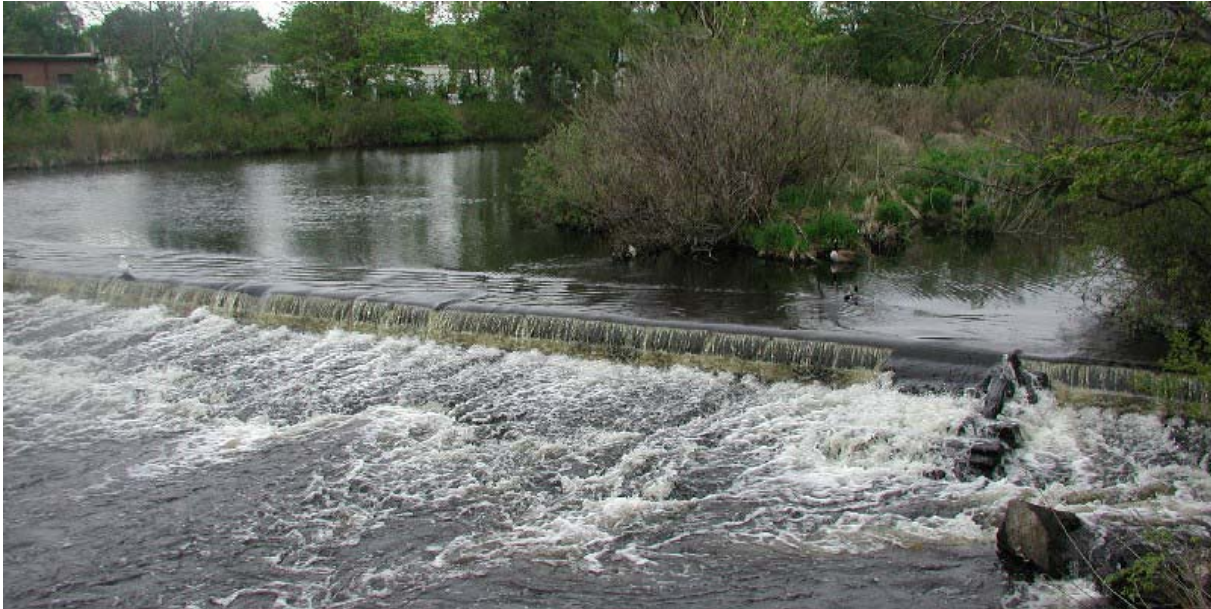
Bleachery Dam (breach not shown)

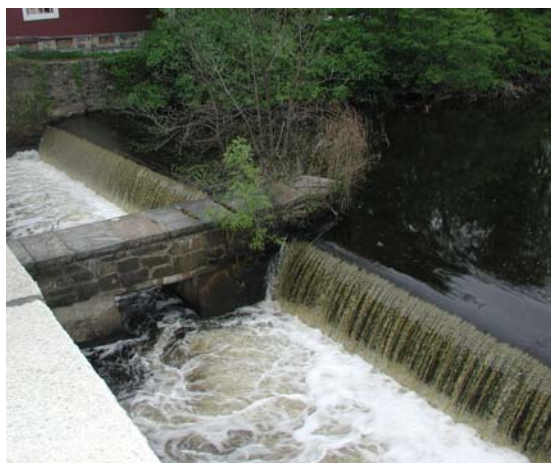
Finlay Dam (Newton Lower Falls)

Design	Material	Length (ft)	Inside W (ft)	Outside W (ft)	# of Baffles	Baffle H (ft)	Notch W (ft)	Pool L (ft)	Condition/Function
Denil	Concrete with composite baffles and granite block cap	93.0	4.5	6.5	16	7	-	-	Good Passable

The next two obstructions, the Finlay (Newton Lower Falls) and the Cordingly (Newton Upper Falls) Dams, are both equipped with Denil fishways. The wooden Denil baffles in the first ladder had badly deteriorated and have recently been replaced with an experimental design incorporating a recycled plastic material. The upper fishway is currently scheduled for a similar renovation. It should be noted that, to date, there is no documentation of anadromous species reaching the Newton Lower Falls. Two large dams, Metropolitan Circular Dam at river mile 20.0 and the Silk Mill Dam at river mile 20.2, have no fish passage facilities and eliminate any potential for further upstream migration.

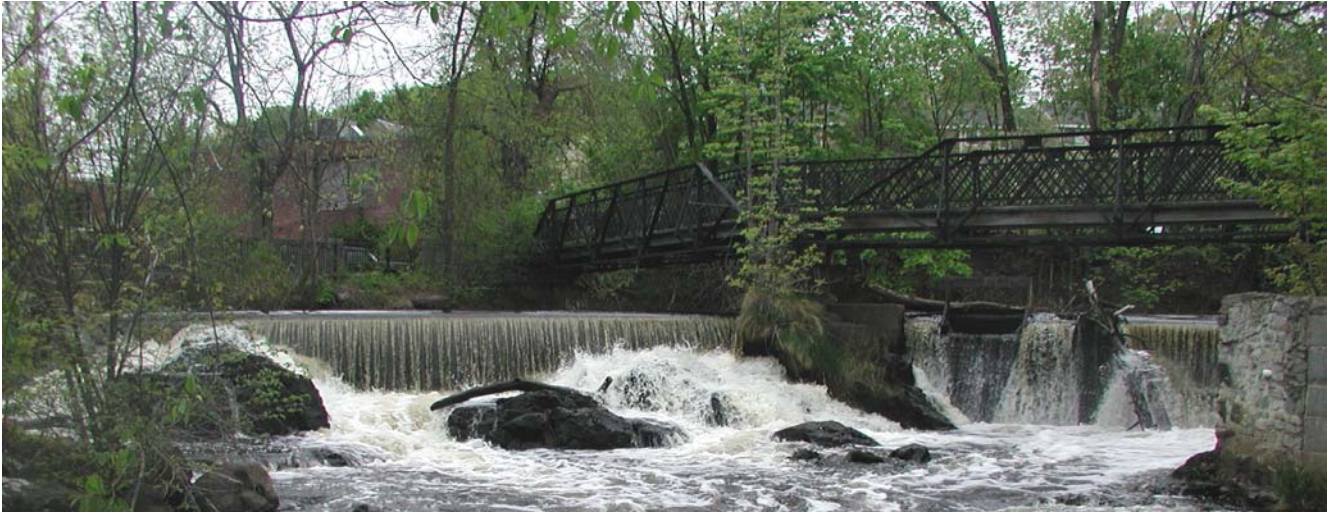
Cordingly Dam (Newton Upper Falls)

Design	Material	Length (ft)	Inside W (ft)	Outside W (ft)	# of Baffles	Baffle H (ft)	Notch W (ft)	Pool L (ft)	Condition/Function
Denil	Concrete with wooden baffles and a granite cap	166	4.6	7.5	40	7	-	-	Fair Not passable

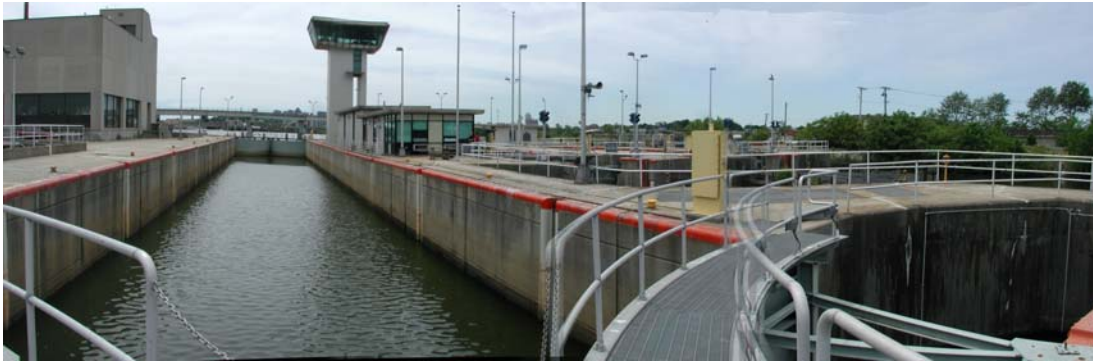
Amelia Earhart Dam and Locks

A 5.8 foot dam separates 85 acre Lower Mystic Lake from 165 acre upper Mystic Lake and prevents herring from reaching the larger habitat. Deterioration of the dam has caused DCR to initiate planning for repair or replacement of the structure. A fishway should be included in any future modifications. A locking protocol should also be instituted to insure ongoing passage at the Amelia Earhart Dam.
