*Massachusetts Coastal Infrastructure
Inventory and Assessment Project
Massachusetts Department of Conservation and Recreation
Office of Waterways*

Upper Cape Cod

Bourne
Sandwich
Mashpee

July 6, 2009

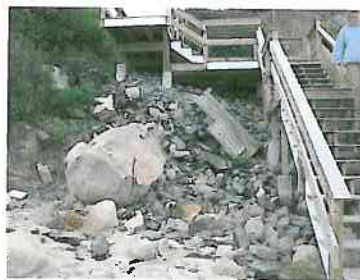
The riprap is dumped below the stair access to the beach. The stones are 6 inches in diameter and mixed with debris from the previous stairs. The stones are at a 1 on 10 slope.

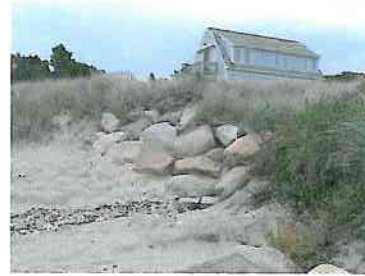
15 feet of stones at a 1 on 3 slope are securing a dune adjacent to beach stair access. The stones are on average 3 feet by 1 foot by 2 feet. There is a house and parking lot behind the structure.

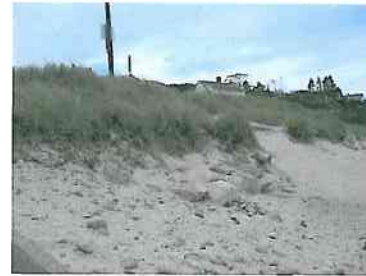
Scattered stones make up a partially buried revetment. The stones are there to secure the slope from the parking lot above to the beach. The stones are on average 1 foot by 2 feet in size and at a 1 on 5 slope. There is a boat ramp adjacent and a road behind the parking lot being secured.

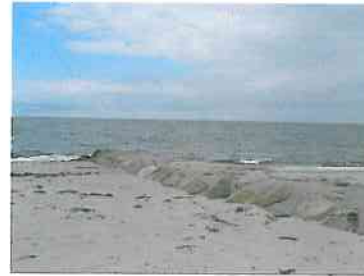
The 10 groins are made up of stones that average 3 feet by 2 feet by 2 feet in size. The crest of the groin is one stone width. Concrete mortar is holding the stones in place. The groins extend out to mean low water.

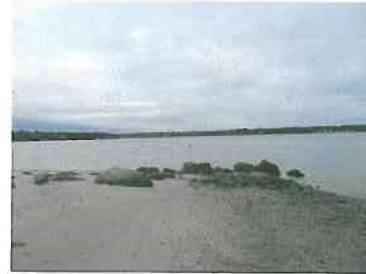
The Town renourished the private beach in order to gain public access. The beach is not well graded, on average at a 1 to 25 slope. It is made up of coarse sand and gravel. The beach is separated by private groins. There is section loss throughout.

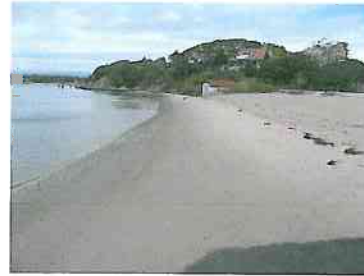
The sand beach is well graded at a 1 on 30 slope. Inshore of the beach is a concrete seawall and small park.

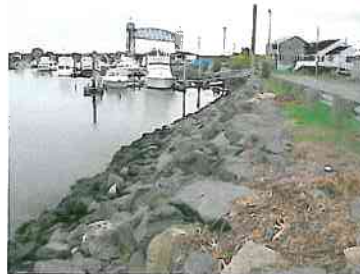
The revetment is made up of stones that are approximately 2 feet by 1 foot in size. The slope of the revetment is 1 on 2. There is major section loss, especially at the corner of the harbor and Buzzards Bay. There is exposed understone and filter fabric lining. Above is a marina. Adjacent is a boat ramp and railroad.

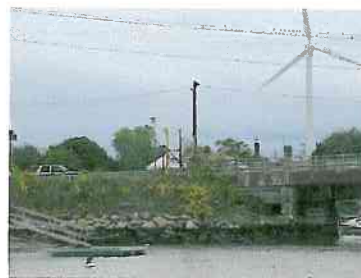
The bridge abutment is surrounded by placed stones. The stones are on average 1 foot by 1 foot. There is slight stone movement visible. Unraveling is visible at the toe.

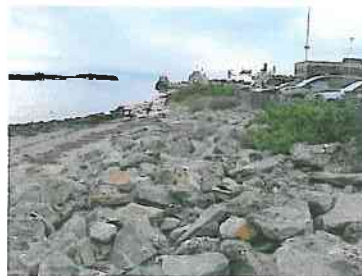
The dumped stone revetment is made up of stones that average 1 foot by 1 foot by 6 inches. The stones are at a 1 on 5 slope. There is no visible stone movement. The beach in front is visible at low tide. There is a parking lot and school directly behind the structure.

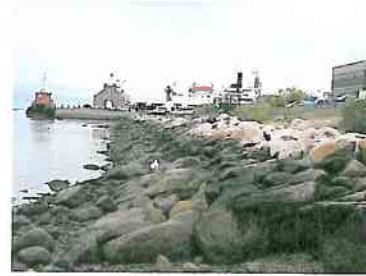
The dumped stone revetment is at a 1 on 5 slope. The stone are on average 2 feet by 1 foot in size. The toe is visible at low tide and is coming unravelled. Behind the structure is a parking lot and school buildings.

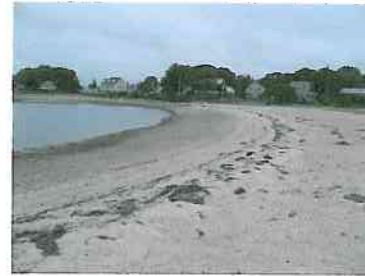
The coarse sand beach is not well graded. The slope drops from 1 on 50 to 1 on 10 at the high tide line. There are houses directly behind the beach

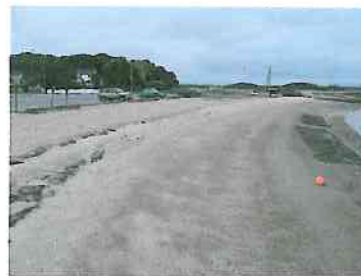
The coarse sand beach is evenly graded. There is a parking lot and railroad behind it. In the middle of the beach is a pier built over a jetty with a marina outshore.

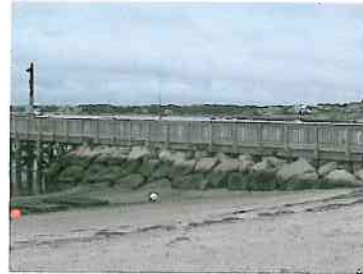
The stone groin is made up of stones that are approximately 3 feet by 2 feet by 1 foot in size. There is no visible stone movement or scour. A timber pier is built on top of the jetty and has floats attached outshore of the jetty.

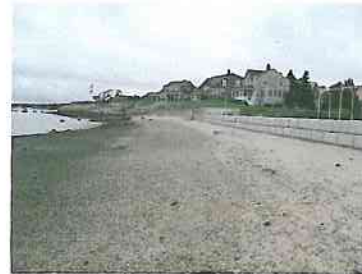
The beach is made up of sand and gravel. It is well graded. There is a seawall, small park and tennis courts inshore of the beach.

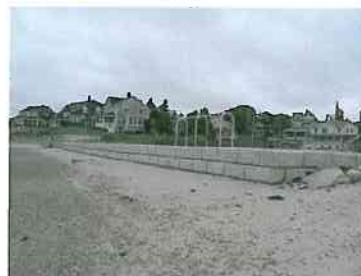
The precast concrete blocks are 3 feet by 1 foot by 1 foot stacked on top of each other. The wall appears to be newly constructed. There is a small park above it, tennis court behind it, and a beach outshore.

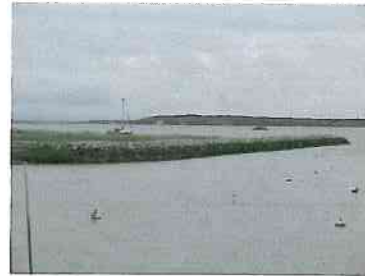
The stone groin is located at the southside of the inlet to the Pocasset River. The stones vary in size, but are on average 2 feet by 1 foot by 1 foot in size. The crest is 5 feet wide. There is minor undermining at the toe.

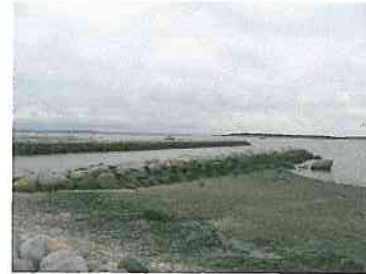
The stone groin is located at the north side of the inlet to the Pocasset River. It is made up of stones that average 2 feet by 1 foot by 1 foot in size. There is undermining at the toe. The crest is 5 feet wide.

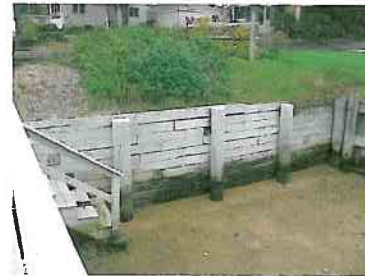
The timber bulkhead is supported by timber piles. There is minor erosion at the top and buckling. There is no visible scour. There is a gangway, floats and stairway that extend off the bulkhead. The roadway comes to an end 10 feet before the bulkhead.

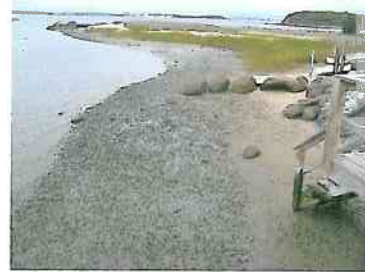
The sand beach is visibly layered with gravel. The slope is 1 on 30. There are seawalls and houses directly behind the beach.

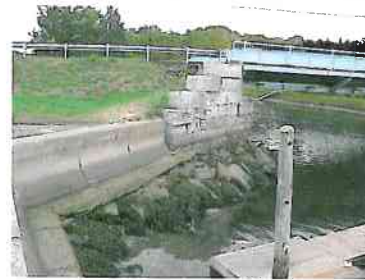
The stone revetment is surrounding a bridge abutment. The stones are 1 foot by 1 foot by 2 feet on average. The slope is 1 on 3. There is stone movement. Excessive growth at the tidal zone.

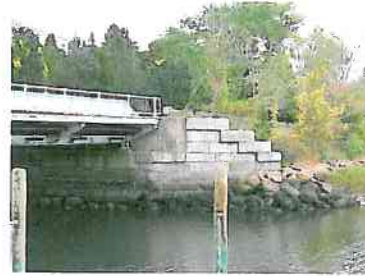
The dumped stones surround the bridge abutment. The stones are approximately 1 foot by 1 foot by 2 feet. The slope is 1 on 3. There is stone movement throughout. Excessive growth in the tidal zone.

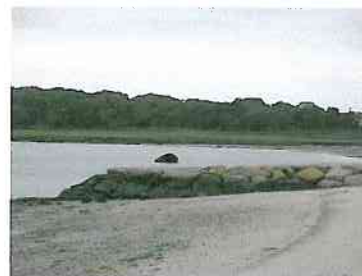
The groin is made up of stones that are on average 3 feet by 2 feet. The crest is one stone width. There is slight unraveling at the end of the groin.

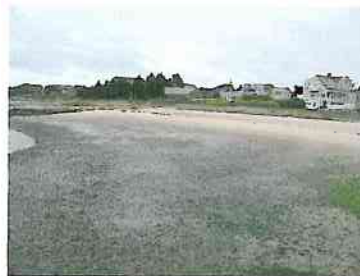
The beach is made up of coarse sand and gravel. It is evenly graded. The slope is 1 on 20. There is a parking lot located behind the beach.

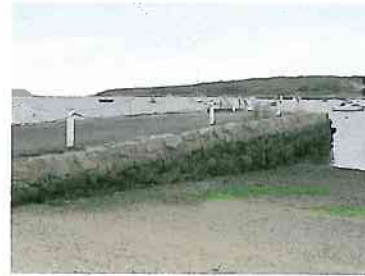
The stones are mortared together with concrete. The stones average 2 feet by 1 foot in size. There is erosion behind the top of the wall. There is normal growth along the tidal zone. A gangway attached to floats extends from the middle of the bulkhead. The bulkhead forms the perimeter of a parking lot.

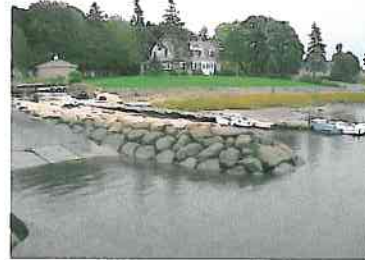
A boat ramp has two groins extending along each side. The stones are 3 feet by 4 feet on average with smaller stones used for filling. There is no sign of stone movement.

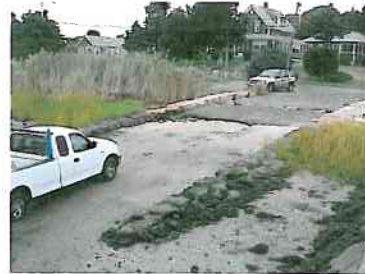
The boat ramp is surrounded by placed stones. Concrete mortar is used as fill. There is minor stone movement and mortar loss. There is no visible scour.

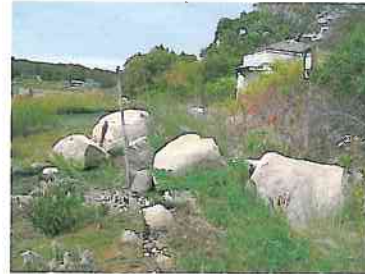
The dumped stones are located at the end of Ocean Avenue. The stones are approximately 3 feet by 3 feet by 2 feet on average. The structure is one stone in width and height, and six stones in length. There are smaller stones scattered around the larger stones.

*Condition***D***Rating***Poor***Level of Action***Major***Description*

Structure exhibits advanced levels of deterioration, section loss, cracking, spalling, undermining, and/or scour. Structure has strong risk of significant damage and possible failure during a major coastal storm. Structure should be monitored until repairs/reconstruction can be initiated. Actions taken to reconstruct structure to regain full capacity to resist a major coastal storm. Landform eroded, stability threatened. Landform not adequate to provide protection during major coastal storm. Actions taken to recreate landform to adequate limits for full protection from a major coastal storm.

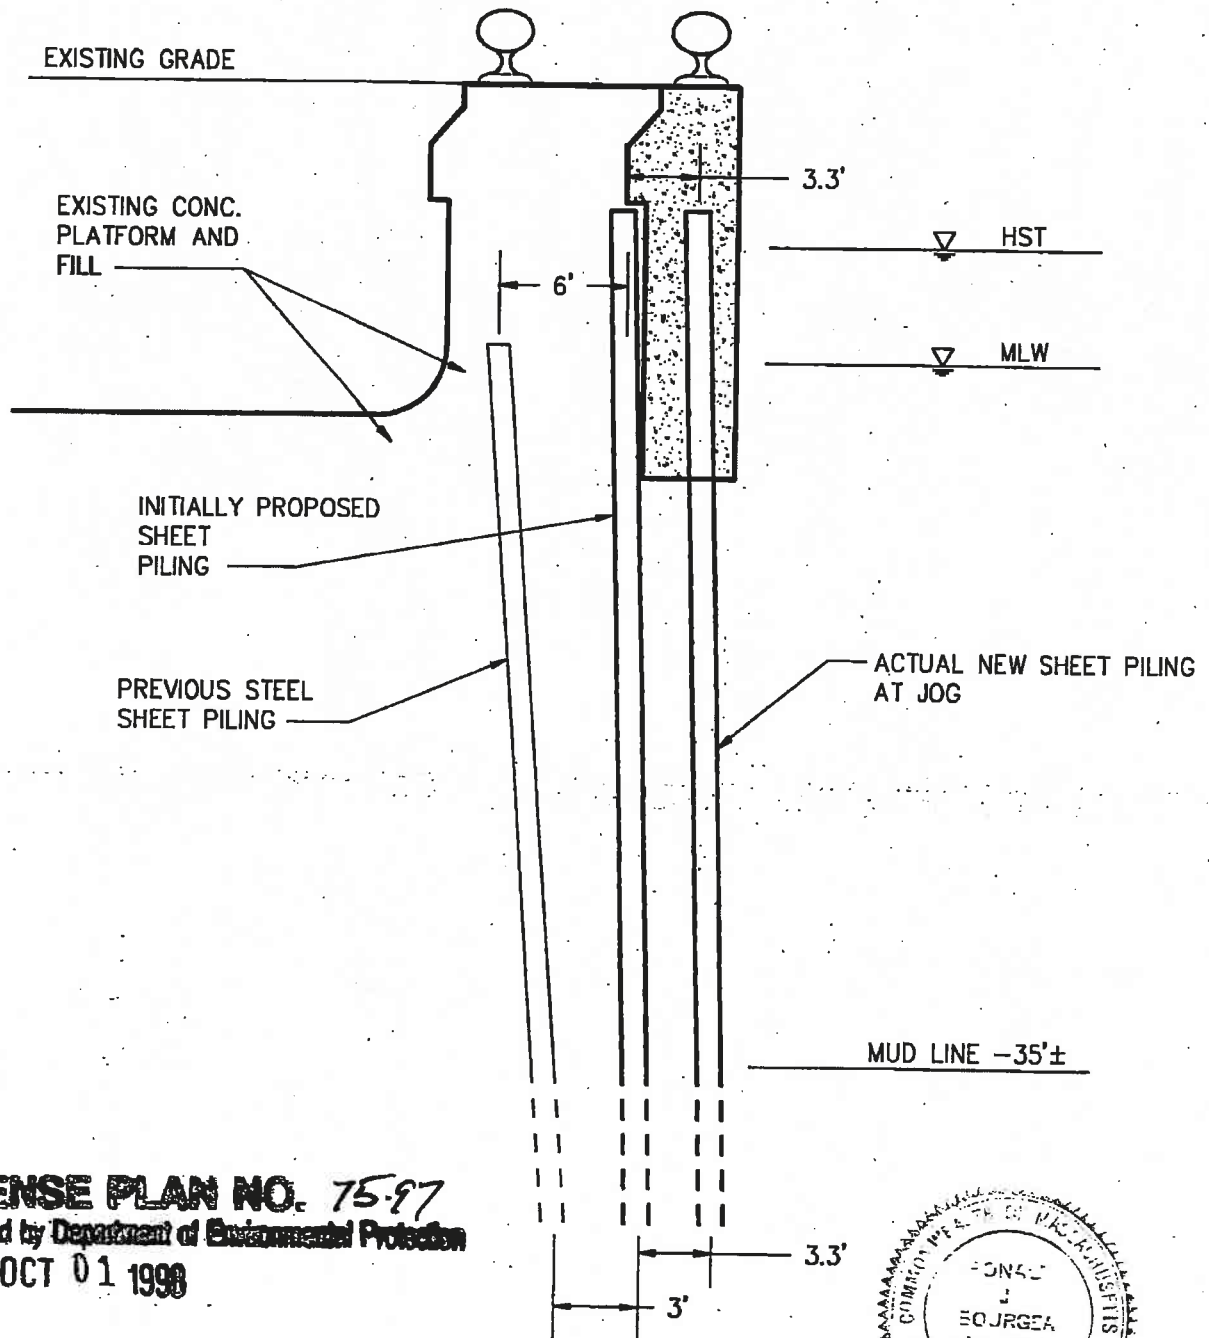
CROSS SECTION A

TYPICAL CROSS-SECTION OF 36-FOOT LONG, 40-INCH
WIDE JOG IN BULKHEAD ALIGNMENT BETWEEN STATION
5+28 AND 5+64.
RESULTED IN INCREASE IN FILL OF 140 CY
BELOW MLW AND 165 CY BELOW MHW IMPACTED
AREA = 120 SF.

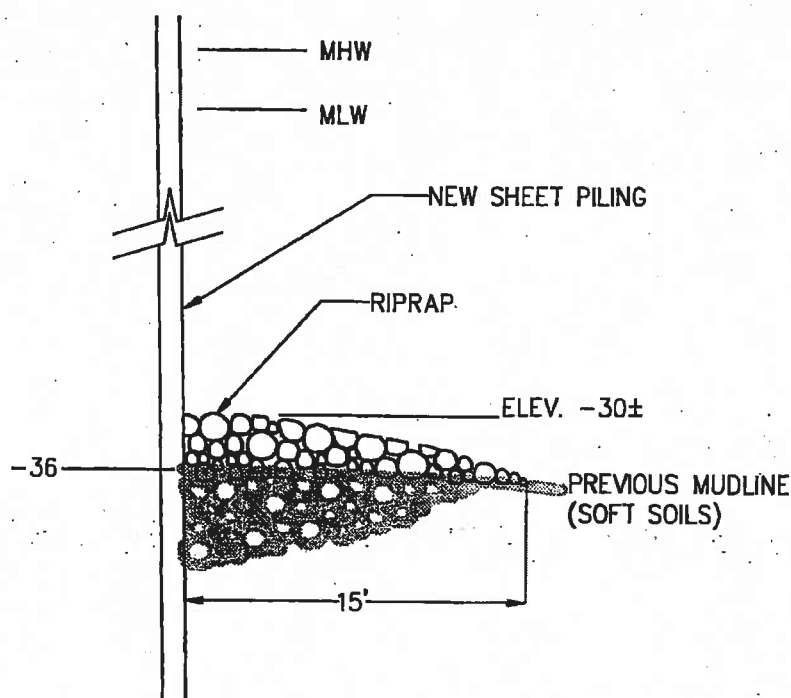
CROSS SECTION B

APPROXIMATELY 225 CY OF FILL WERE PLACED
BETWEEN -30 AND -36. AN UNDETERMINED
QUANTITY OF RIPRAP SUNK BELOW THE EXISTING
MUDLINE.

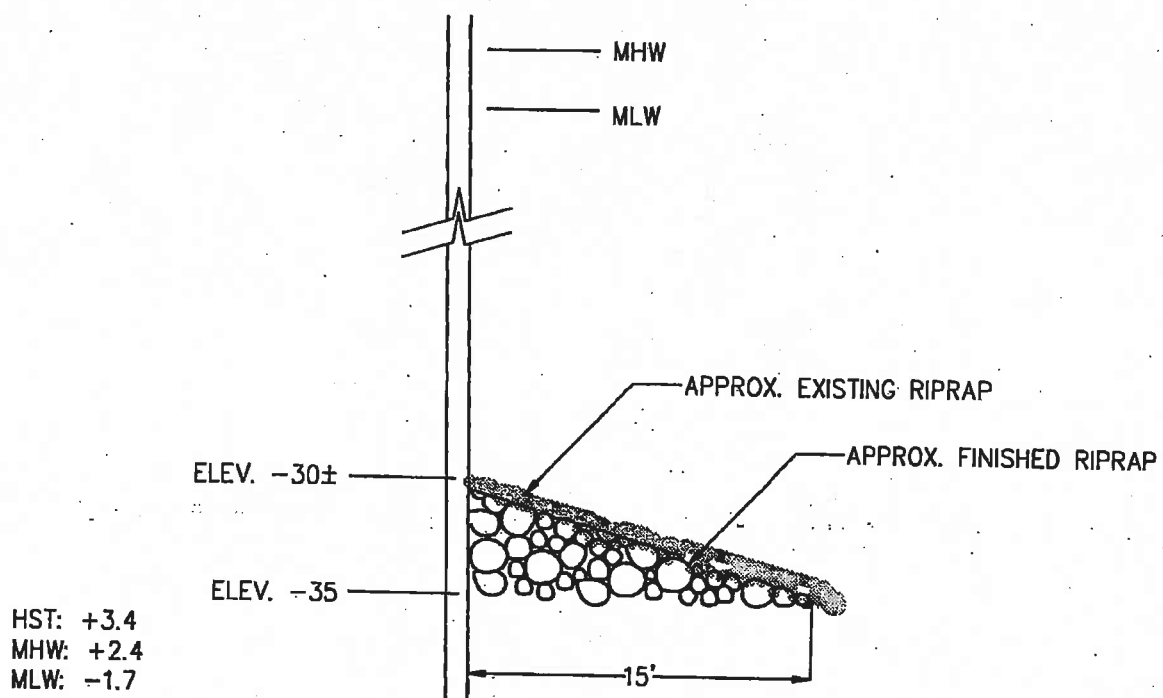
CROSS SECTION C

TYPICAL CROSS-SECTION OF RIPRAP REPLACEMENT
BETWEEN STATION 6+50 AND 7+42

NO CHANGE IN THE VOLUME OF FILL, APPROXIMATELY
130 CY OF RIPRAP WERE REPLACED TO LOCATION
THAT WAS RIPRAPPED PRIOR TO CONSTRUCTING
THE NEW BULKHEAD.

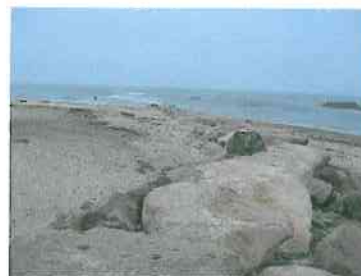
This structure is the west jetty at Scorton Creek. The crest elevation is low and the armor is becoming unraveled at structure head. The beach has filled in the updrift side of the jetty.

Structure is sound but may exhibit minor deterioration, section loss, cracking, spalling, undermining, and/or scour. Structure adequate to withstand major coastal storm with little to moderate damage. Actions taken to reinforce structure to provide full protection from major coastal storm and for extending life of structure. Moderate wind or wave damage to landform exists. Landform may not be sufficient to fully protect shoreline during a major coastal storm. Actions taken to provide addition material for full protection and extended life.

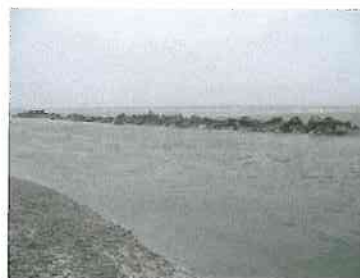
This structure is the east jetty at Scorton Creek. The armor stone is completely unraveled and shows no interlocking. There is no distinct crest or side slopes.

Structure exhibits advanced levels of deterioration, section loss, cracking, spalling, undermining, and/or scour. Structure has strong risk of significant damage and possible failure during a major coastal storm. Structure should be monitored until repairs/reconstruction can be initiated. Actions taken to reconstruct structure to regain full capacity to resist a major coastal storm. Landform eroded, stability threatened. Landform not adequate to provide protection during major coastal storm. Actions taken to recreate landform to adequate limits for full protection from a major coastal storm.

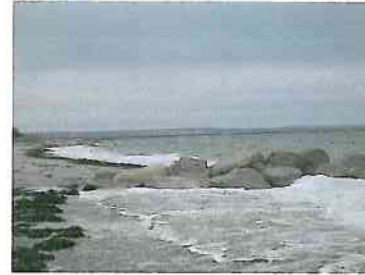
This structure is the 9 groins from turn in Freeman Avenue, east to Old Harbor. All groins exhibit unraveled armor stone. Many are becoming flanked at high tide.

Structure exhibits advanced levels of deterioration, section loss, cracking, spalling, undermining, and/or scour. Structure has strong risk of significant damage and possible failure during a major coastal storm. Structure should be monitored until repairs/reconstruction can be initiated. Actions taken to reconstruct structure to regain full capacity to resist a major coastal storm. Landform eroded, stability threatened. Landform not adequate to provide protection during major coastal storm. Actions taken to recreate landform to adequate limits for full protection from a major coastal storm.

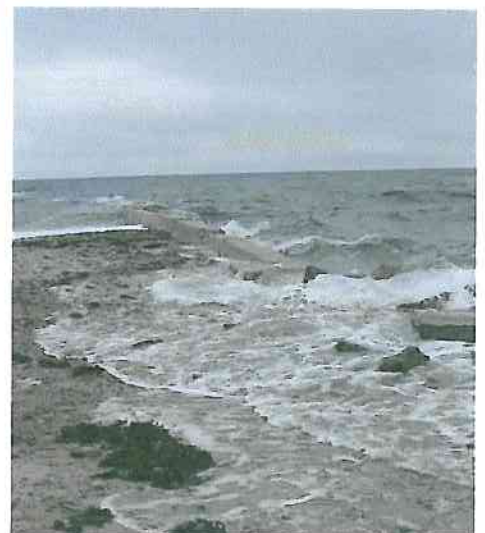
066-093-000-012-100-PHO1A

This structure is the stone jetties at the entrance to Old Sandwich Harbor. The inlet is no longer contained within the jetties and so the structures are non-functional. The west jetty is exposed at low tide and in poor condition. The east jetty is submerged at all tides.

Conditions of structure/landform may warrant emergency stabilization as failure may result in potential loss of property and/or life. Landform eroded, loss of integrity. Structure exhibits critical levels of deterioration, section loss, cracking, spalling, undermining, and/or scour. Structure provides little or no protection from a major coastal storm. Actions taken to totally reconstruct structure to regain full capacity. Landform stability is severely compromised, rate of erosion/material loss may be increasing, and landform does not provide adequate protection from a major coastal storm. Actions taken to recreate landform to adequate limits for full protection from a major coastal storm.

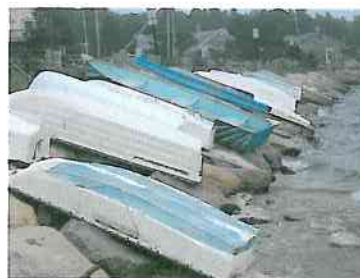
This structure is a revetment along Seconsett Island Road. There is some slumping in the central section of structure resulting in a minor loss of crest elevation.

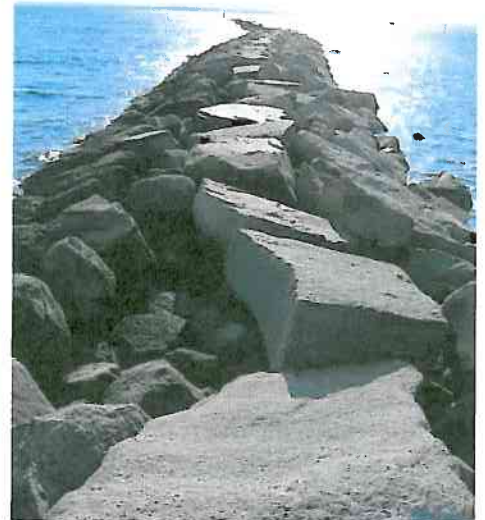
043-130-000-001-100-PHO1A

This structure is the East Jetty at Wauquoit Bay. There are multiple sections with damaged armor. These damaged areas show slumped sideslopes and loss of crest elevation. There is minimal interlocking between armor stones in the damaged sections.
