BUZZARDS BAY DRAINAGE

Buzzards Bay Drainage

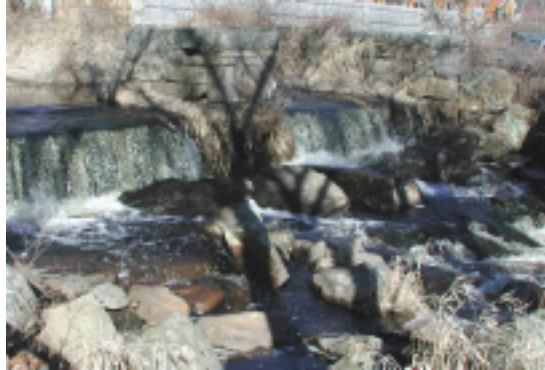
Smith Mills Dam

River Mile	Type	Material	Spillway W (ft)	Spillway H (ft)	Impoundment Acreage	Year Built	Owner	GPS
6.8	Dam	Granite blocks	28	4.0	9.2	-	-	41° 38' 24.271" N 70° 59' 06.675" W

Fishway None

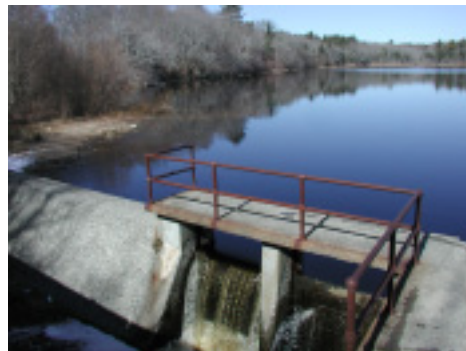
Turner's Pond Dam

River Mile	Type	Material	Spillway W (ft)	Spillway H (ft)	Impoundment Acreage	Year Built	Owner	GPS
10.2	Dam	Concrete with wooden boards	6.0	5.6	86.7	1949	City of New Bedford	41° 40' 43.884" N 70° 58' 38.814" W

Fishway None

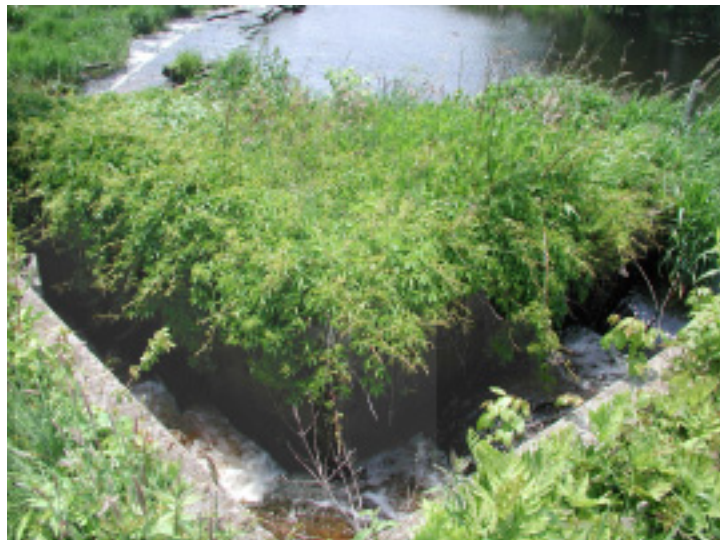
Acushnet Sawmill Ladder

Design	Material	Length (ft)	Inside W (ft)	Outside W (ft)	# of Baffles	Baffle H (ft)	Notch W (ft)	Pool L (ft)	Condition/Function
Notched weir-pool	Concrete	33.0	3.0	4.2	6	1.8	0.8	Varied (2.0-3.0)	Fair Inefficient passage

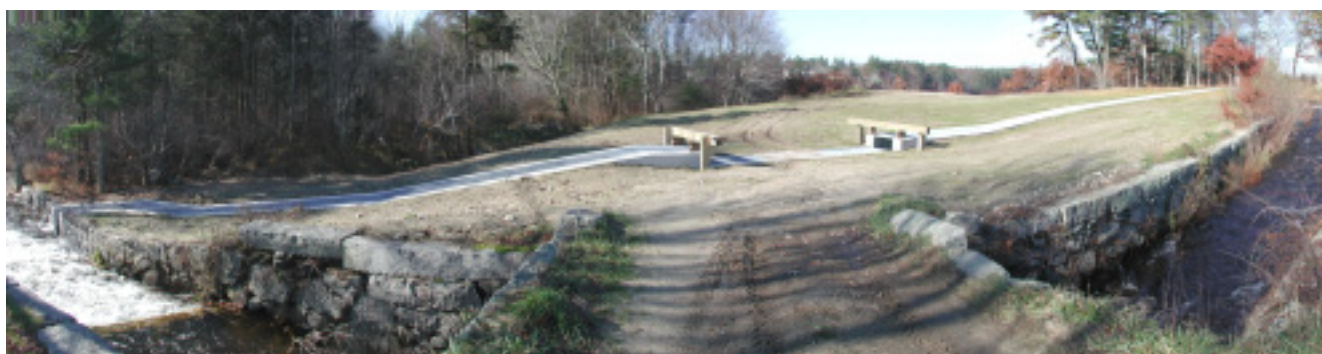
New Bedford Reservoir Ladder

Design	Material	Length (ft)	Inside W (ft)	Outside W (ft)	# of Baffles	Baffle H (ft)	Notch W (ft)	Pool L (ft)	Condition/Function
Denil	Concrete with wooden baffles	264.0	3.0	5.0	26	5.0	-	-	Excellent Passable

An 11 foot dam at 220 acre New Bedford Reservoir is the third and last obstruction on the system. Although the spillway at this dam has passed fish under ideal flow conditions, this structure has severely limited the number of fish spawning in the Reservoir. A state-of-the-art Denil fishway, designed by DMF with assistance from the U.S. Fish and Wildlife Service and funded by the New Bedford Harbor Cleanup Fund, was constructed in 2002. In anticipation of the fishway installation, DMF initiated alewife stocking at the Reservoir in 1999 in order to accelerate the recovery of this population.

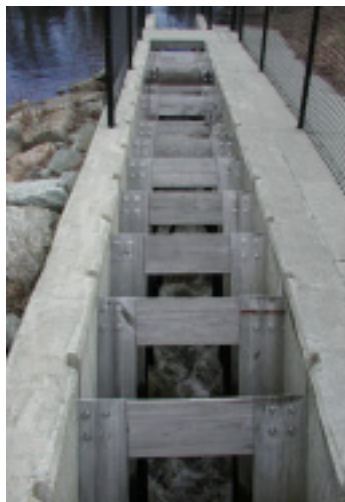
Ladder at Route 6 Crossing

Design	Material	Length (ft)	Inside W (ft)	Outside W (ft)	# of Baffles	Baffle H (ft)	Notch W (ft)	Pool L (ft)	Condition/Function
Denil	Concrete with wooden baffles	58.0	3.0	5.0	16	8.6	-	-	Excellent Passable

The dam and fishway at the first impoundment on the Mattapoissett River at Route 6 were both replaced in 1996. The new fishway is a Denil design which provides optimal passage around this obstruction. Water levels in the impoundment are controlled by the Fairhaven Water Department and must continue to be regulated with fish passage in mind.

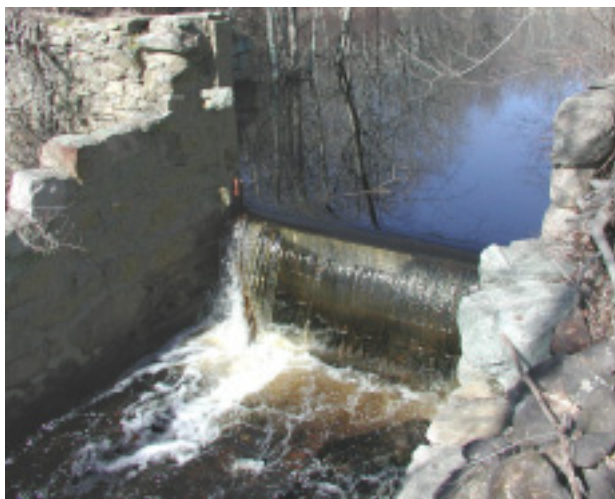
Dam at Rounseville Road Crossing

River Mile	Type	Material	Spillway W (ft)	Spillway H (ft)	Impoundment Acreage	Year Built	Owner	GPS
8.7	Dam	Stone with wooden boards	11.0	4.0	0.0	-	-	41° 44' 10.582" N 70° 51' 45.888" W

Fishway None

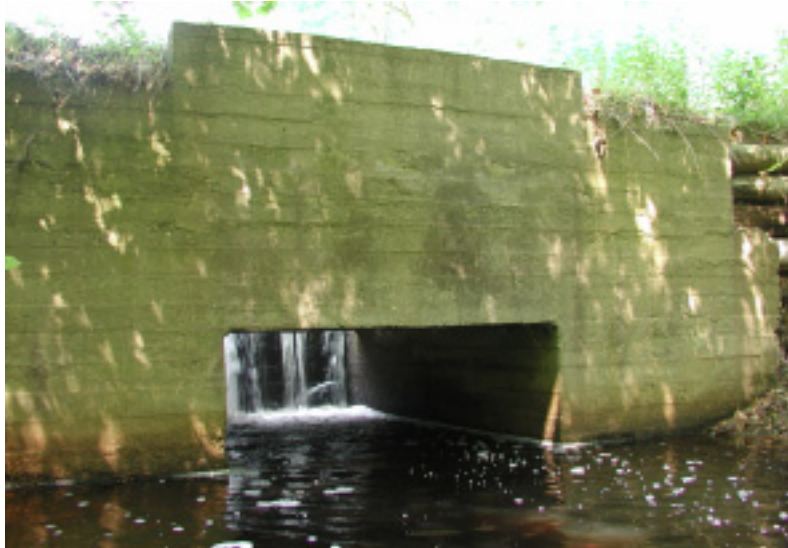
Rochester Fish Hatchery Dam

River Mile	Type	Material	Spillway W (ft)	Spillway H (ft)	Impoundment Acreage	Year Built	Owner	GPS
9.7	Dam	Concrete with wooden boards	7.0	5.6	31.8	-	MA Department of Fish & Wildlife	41° 44' 53.016" N 70° 51' 49.382" W

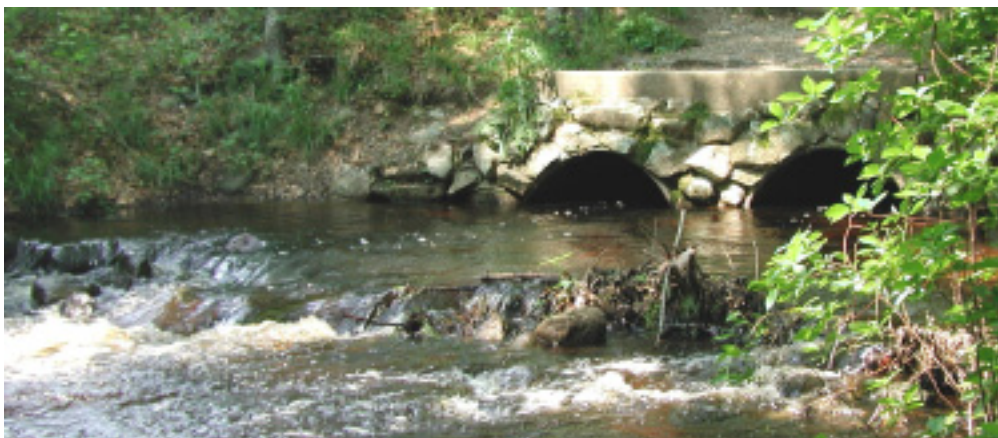
Stream Baffles at Rochester Fish Hatchery

Design	Material	Length (ft)	Inside W (ft)	Outside W (ft)	# of Baffles	Baffle H (ft)	Notch W (ft)	Pool L (ft)	Condition/Function
Stream baffle	Stone	1790	10	10	15	Varied (0.5-1)	-	Varied (10-50)	Good Passable

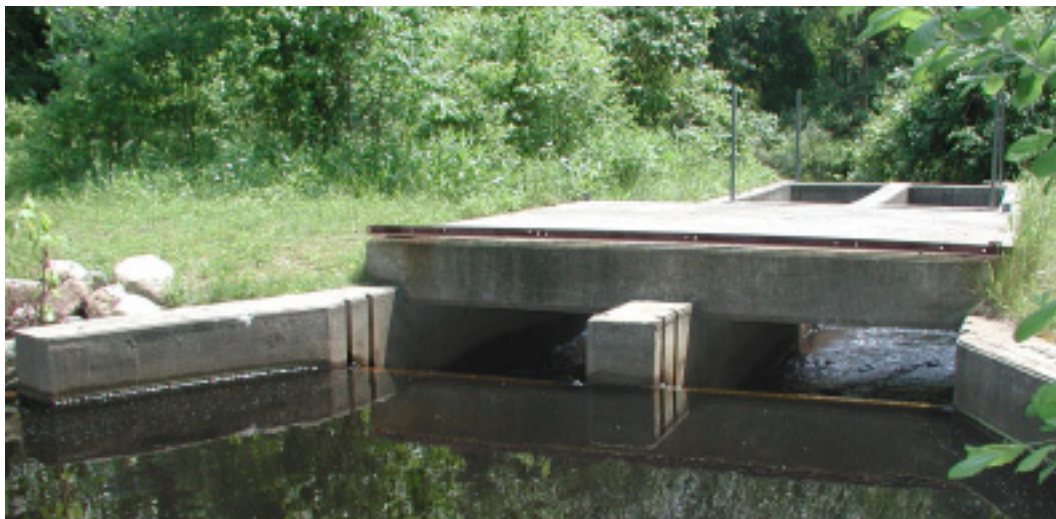
Snipatuit Pond Dam and Ladder

River Mile	Type	Material	Spillway W (ft)	Spillway H (ft)	Impoundment Acreage	Year Built	Owner	GPS
11.1	Dam control structure	Concrete with wooden boards	4.0	2.4	710.0	1986	Private	41° 45' 45.877" N 70° 52' 09.022" W

Design	Material	Length (ft)	Inside W (ft)	Outside W (ft)	# of Baffles	Baffle H (ft)	Notch W (ft)	Pool L (ft)	Condition/Function
Weir-pool	Concrete with wooden baffles	44.0	4.0	5.3	6	Varied (2.4)	-	8.0	Excellent Passable

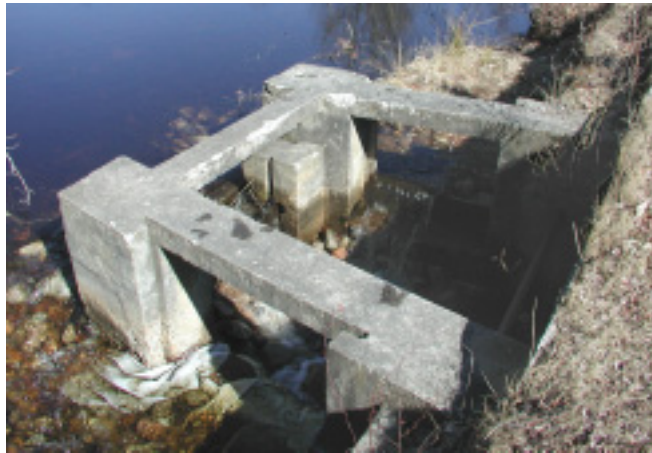
Dam control structure at Tinkham Pond

River Mile	Type	Material	Spillway W (ft)	Spillway H (ft)	Impoundment Acreage	Year Built	Owner	GPS
1.2	Dam control structure	Concrete and stone with wooden boards	2.4	1.6	16.8	1932	Mattapoisett Cranberry Co.	41° 40' 56.092" N 70° 51' 23.814" W

Fishway None

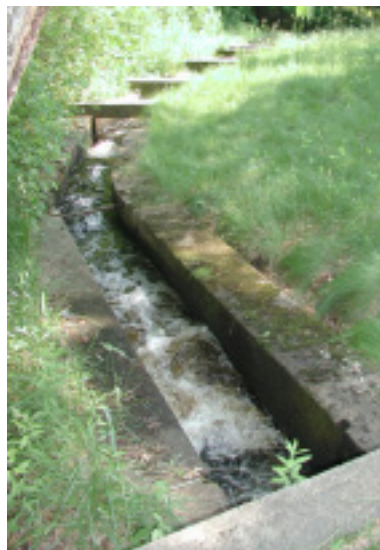
Hathaway Pond Ladder

Design	Material	Length (ft)	Inside W (ft)	Outside W (ft)	# of Baffles	Baffle H (ft)	Notch W (ft)	Pool L (ft)	Condition/Function
Weir-pool	Concrete with wood baffles	85.0	2.0	4.8	8	Varied (2.6)	-	Varied (9.5-30.7)	Fair Inefficient passage

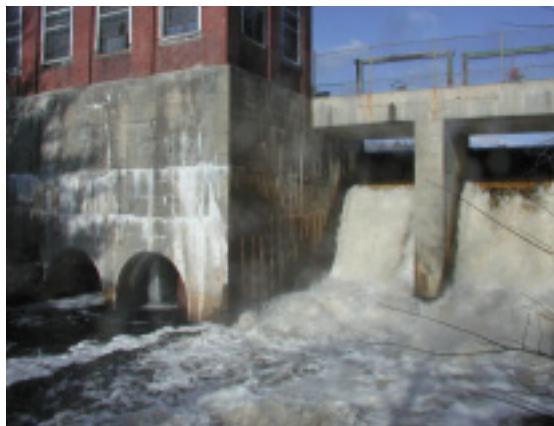
Tremont Mill Pond Dam

River Mile	Type	Material	Spillway W (ft)	Spillway H (ft)	Impoundment Acreage	Year Built	Owner	GPS
7.5	Dam	Concrete	32	24	30.5	1920	Town of Wareham	41° 47' 22.583" N 70° 45' 51.720" W

Fishway None

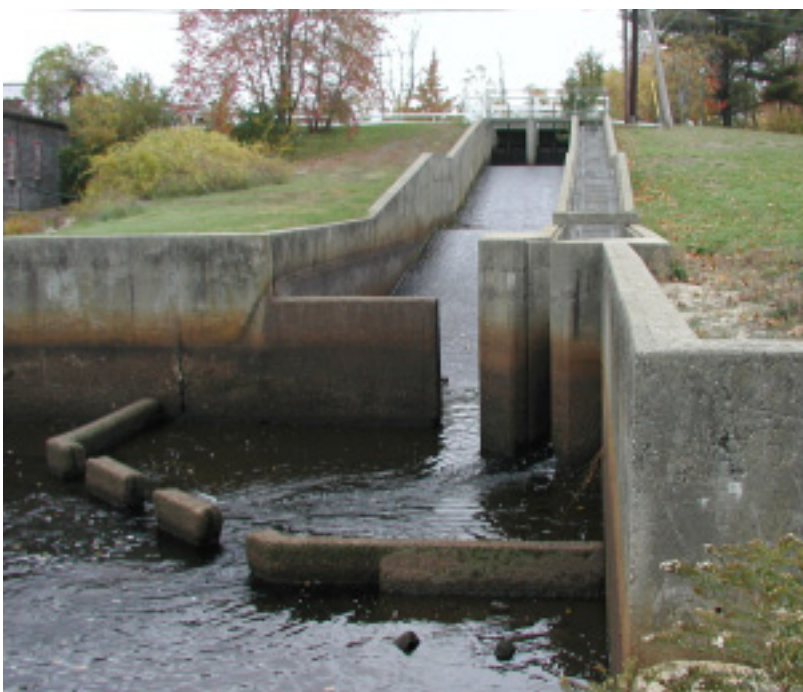
Parkers Mills Dam and Ladder

River Mile	Type	Material	Spillway W (ft)	Spillway H (ft)	Impoundment Acreage	Year Built	Owner	GPS
0.7	Dam	Concrete with wooden boards	10.8	7.5	74.7	1900	Town of Wareham	41° 46' 01.789" N 70° 43' 19.891" W

Design	Material	Length (ft)	Inside W (ft)	Outside W (ft)	# of Baffles	Baffle H (ft)	Notch W (ft)	Pool L (ft)	Condition/Function
Denil	Concrete with wooden baffles	123.7	3.0	4.5	42	4.8	-	-	Good Passable

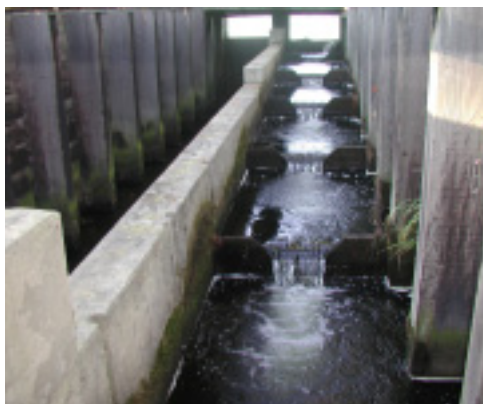
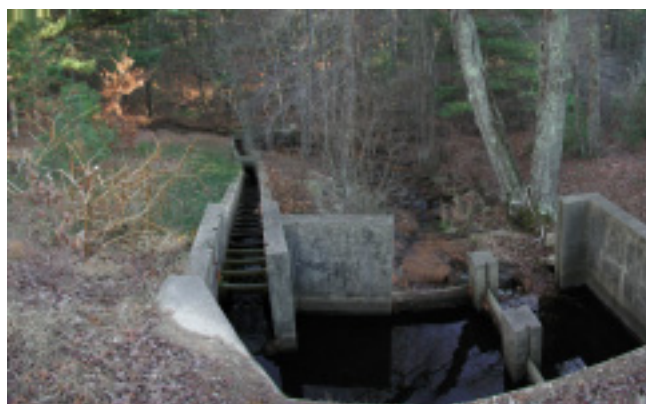
Design	Material	Length (ft)	Inside W (ft)	Outside W (ft)	# of Baffles	Baffle H (ft)	Notch W (ft)	Pool L (ft)	Condition/Function
Denil	Concrete with fiberglass and wooden baffles	86.0	2.0	3.8	37	8.0	-	-	Good Inefficient passage
Notched weir-pool	Concrete with wooden baffles	62.0	4.5	8.0	7	1.9	1.5	6.6	Good Inefficient passage

Upper (weir-pool) Section of Tihonet Pond Ladder

Lower (Denil) section of Tihonet Pond Ladder

Tihonet Pond has two outlets, the eastern-most of which is equipped with a fishway. This combination weir-pool and Denil style ladder functions adequately with proper flow adjustment. The problem that occurs at this impoundment is the attraction flow from the west outlet which causes migrating herring to be diverted into a dead end channel. Careful adjustment of flows from the two outlets could increase the numbers of fish which reach the spawning area. Further development within this system is not justified due to numerous small obstructions and competing water usage by the cranberry growers.

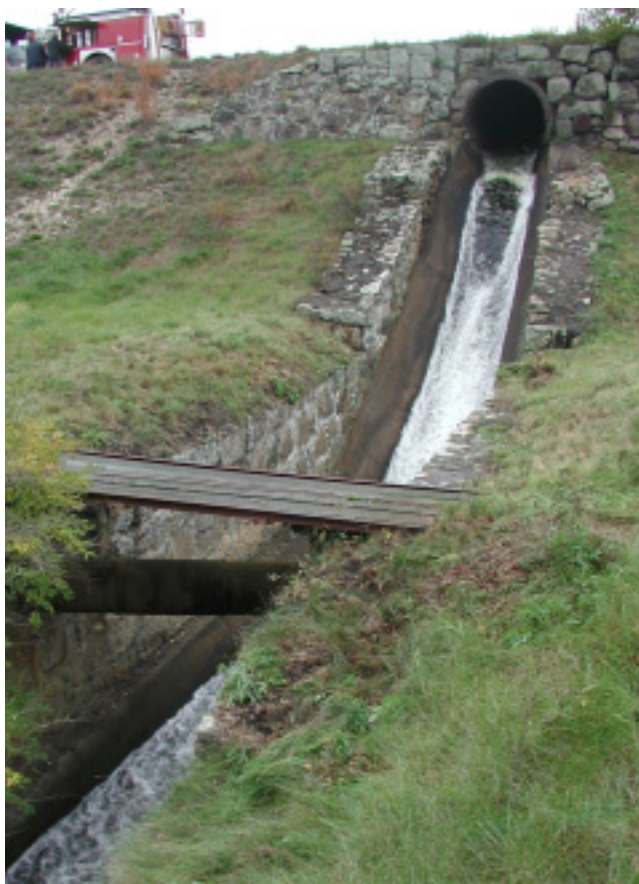
Tihonet Pond Outlet

River Mile	Type	Material	Spillway W (ft)	Spillway H (ft)	Impoundment Acreage	Year Built	Owner	GPS
2.5	Dam	Earth, stone and concrete	4.5	15	90.0	1900	A.D. Makepeace Co.	41° 47' 14.612" N 70° 43' 07.677" W

Fishway None

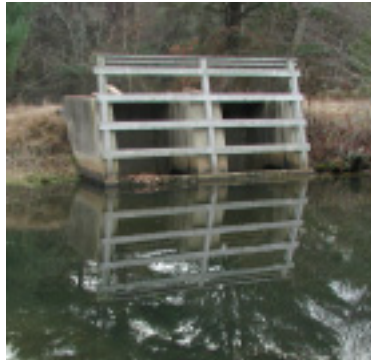
Bog Sluice at base of impoundment
Upstream of Tihonet Pond

River Mile	Type	Material	Spillway W (ft)	Spillway H (ft)	Impoundment Acreage	Year Built	Owner	GPS
4.0	Bog sluice	Concrete with wooden baffles	10.0	6.2	6.9	1955	A.D. Makepeace Co.	41° 48' 30.678" N 70° 42' 59.225" W

Fishway None

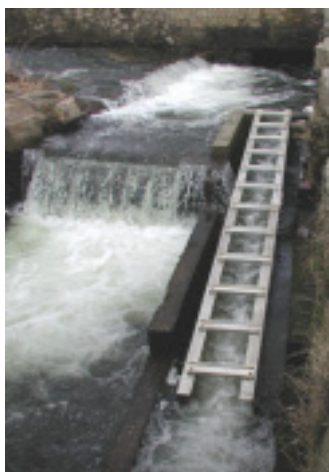
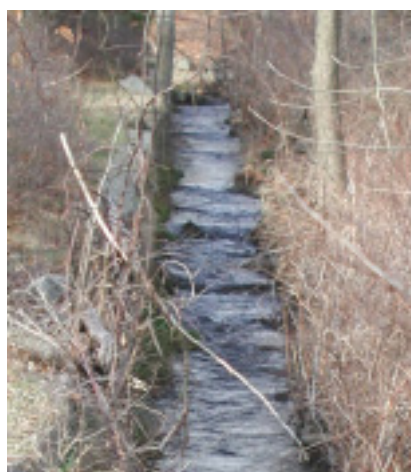
Design	Material	Length (ft)	Inside W (ft)	Outside W (ft)	# of Baffles	Baffle H (ft)	Notch W (ft)	Pool L (ft)	Condition/Function
Alaskan Steeppass	Aluminum	20.0	1.2	1.85	-	2.3	-	-	Excellent Passable
Notched weir-pool	Concrete and wood	117.0	6.0	Stream width	10	3.0	1.0	12	Poor Inefficient passage
Stream baffle	Stone	445.0	4.4	6.0	9	1	-	Varied (20-55)	Poor Inefficient passage

Lower (Steeppass) section of at Mill Pond

Upper (stream baffle) section of ladder at Mill Pond

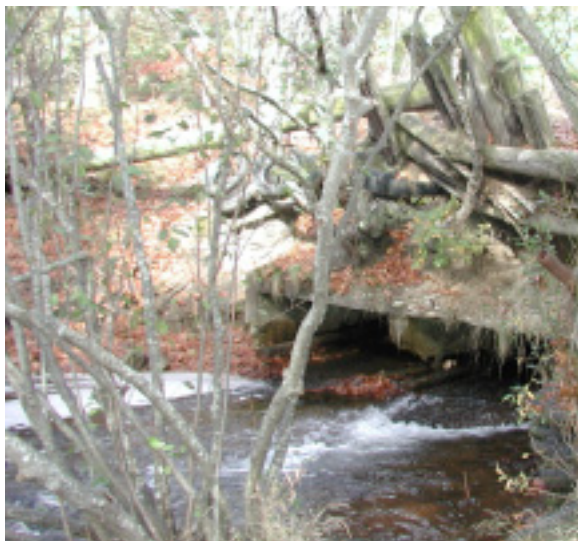
Maple Park Dam

River Mile	Type	Material	Spillway W (ft)	Spillway H (ft)	Impoundment Acreage	Year Built	Owner	GPS
5.0	Dam	Earthen with wood pilings	12.7	10.4	2.5	-	-	41° 46' 58.735" N 70° 39' 19.076" W

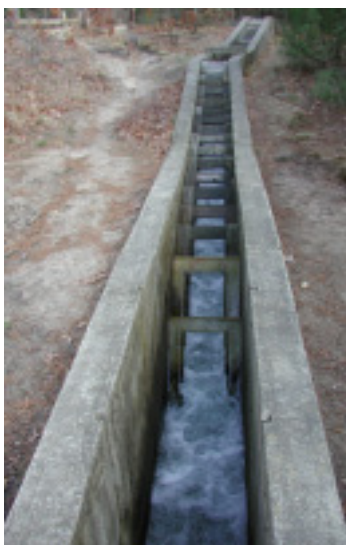
Ladder at Maple Park Dam

Design	Material	Length (ft)	Inside W (ft)	Outside W (ft)	# of Baffles	Baffle H (ft)	Notch W (ft)	Pool L (ft)	Condition/Function
Denil	Concrete with wooden and fiberglass baffles	93.0	2.1	3.7	34	5.9	-	-	Good Passable

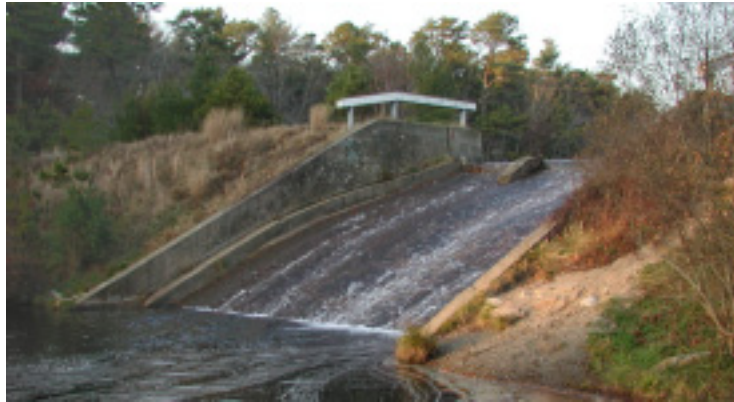
Glen Charlie Pond Dam

River Mile	Type	Material	Spillway W (ft)	Spillway H (ft)	Impoundment Acreage	Year Built	Owner	GPS
5.1	Dam	Concrete with wooden boards	33	16	154.9	1900	AD Makepeace Co.	41° 47' 05.315" N 70° 39' 15.228" W

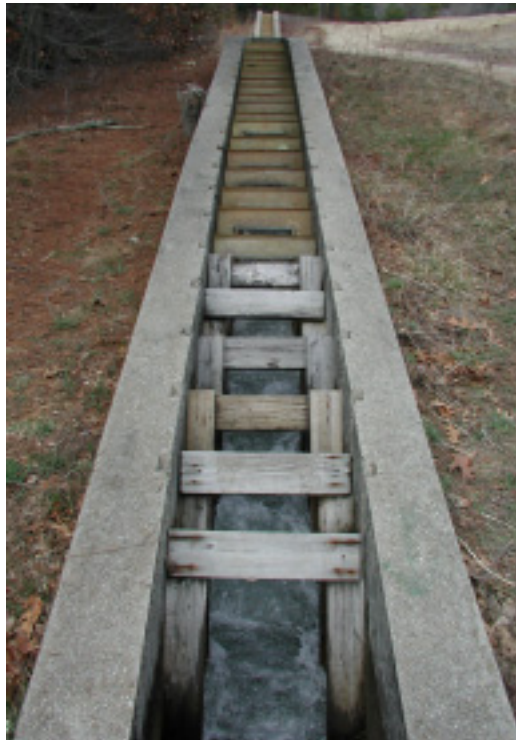
Glen Charlie Pond Ladder

Design	Material	Length (ft)	Inside W (ft)	Outside W (ft)	# of Baffles	Baffle H (ft)	Notch W (ft)	Pool L (ft)	Condition/Function
Denil	Concrete with wooden and fiberglass baffles	579.0	2.1	3.7	50	5.9	-	Varied (16.0-43.0)	Good Passable

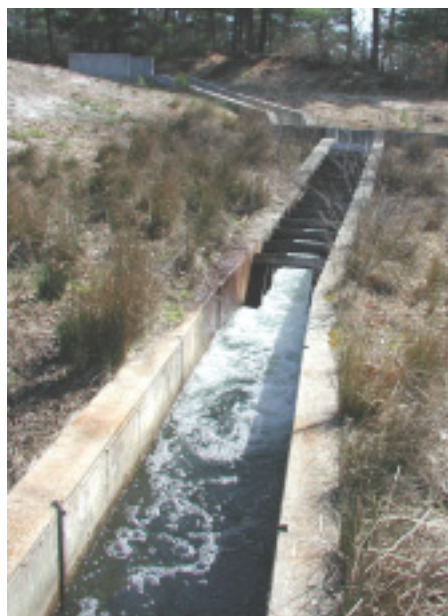
Ladder at Besse Bog

Design	Material	Length (ft)	Inside W (ft)	Outside W (ft)	# of Baffles	Baffle H (ft)	Notch W (ft)	Pool L (ft)	Condition/Function
Denil	Concrete with wooden baffles	157.0	3.0	4.5	36	5.0	-	-	Excellent Passable

A deteriorated wooden ladder at Besse Bog Reservoir was replaced by DMF in 1994 with a concrete and wood Denil fishway. This ladder functions efficiently but requires careful adjustment of flow to provide sufficient attraction to the entrance.

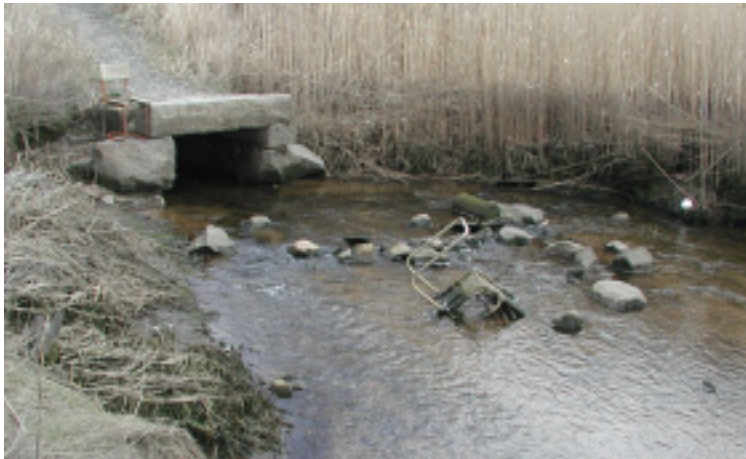
Downstream end of Gibbs Brook Culvert

River Mile	Type	Material	Spillway W (ft)	Spillway H (ft)	Impoundment Acreage	Year Built	Owner	GPS
0.1	Culvert	Concrete	4.1	0.0	0.0	-	-	41° 45' 20.484" N 70° 39' 12.952" W

Fishway None

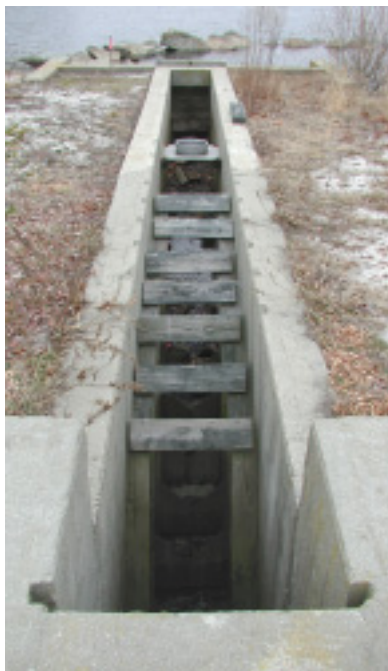
White Island Pond Ladder

Design	Material	Length (ft)	Inside W (ft)	Outside W (ft)	# of Baffles	Baffle H (ft)	Notch W (ft)	Pool L (ft)	Condition/Function
Denil	Concrete with wooden baffles	103.0	2.0	3.5	28	Varied (4.3 and 7.0)	-	-	Excellent Inefficient passable

The first obstruction on the stream is actually a stream baffle which backs water up into the Route 25 culverts. A notch in this baffle allows fish to pass under spring flow conditions. Baffles in the culverts themselves increase water depth for passage but are poorly maintained and create difficulties for migrating fish. The Town of Wareham and DMF are aware of the difficulties in passage here, and attempt to make adjustments as needed. A third ladder at the outlet of White Island Pond enables fish to access the headwater pond if properly adjusted. Sediment deposited at the ladder's exit at the time of this survey made it temporarily inoperable.

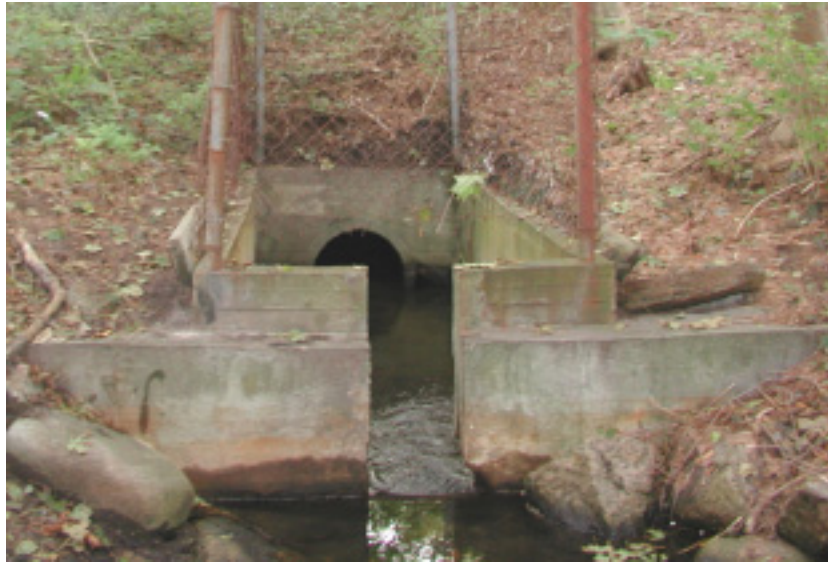
Bourne Pond outlet

River Mile	Type	Material	Spillway W (ft)	Spillway H (ft)	Pond Acreage	Year Built	Owner	GPS
0.4	Dam control structure	Concrete with wooden boards	1.1	1.0	10.6	-	-	41° 44' 56.681" N 70° 35' 53.879" W

Fishway None
