**CAPE COD WATERSHEDS (Western)**

# Cape Cod Watersheds

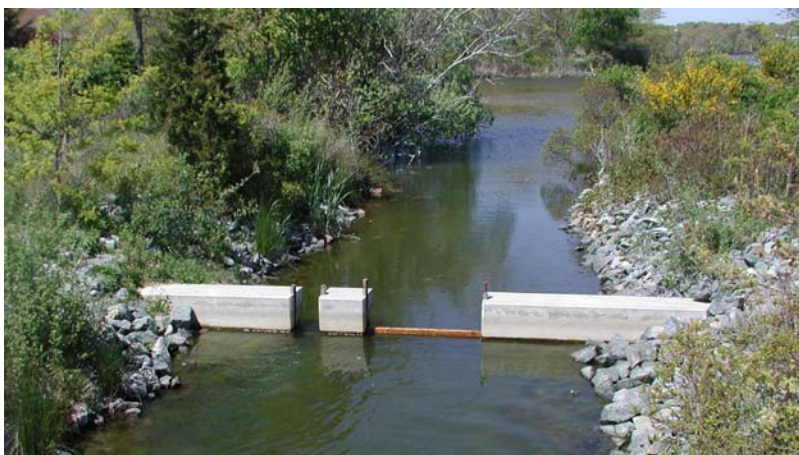
Oyster Pond control structure and fishway

Design	Material	Length (ft)	Inside W (ft)	Outside W (ft)	# of Baffles	Baffle H (ft)	Notch W (ft)	Pool L (ft)	Condition/Function
Notched weir	Concrete with wooden baffles	-	15	Edge of channel (15)	1	1.3	1.0	-	Excellent Passable

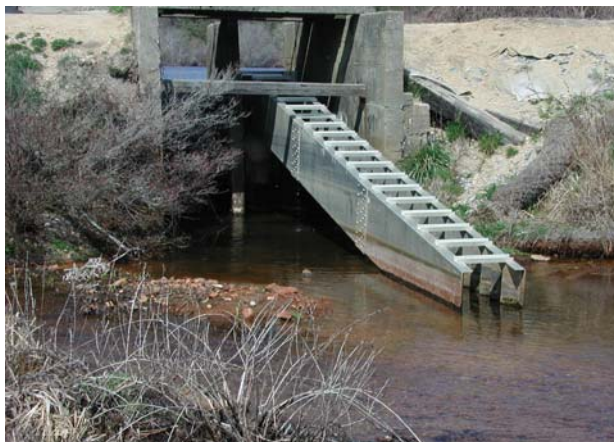
Pond 14 dam and Alaskan Steeppass ladder

<b>Design</b>	<b>Material</b>	<b>Length (ft)</b>	<b>Inside W (ft)</b>	<b>Outside W (ft)</b>	<b># of Baffles</b>	<b>Baffle H (ft)</b>	<b>Notch W (ft)</b>	<b>Pool L (ft)</b>	<b>Condition/Function</b>
Alaskan Steeppass	Aluminum	30.0	1.8	-	-	-	-	-	Excellent Passable
Weir-pool	Concrete with wooden baffles	8.5	2.9	4.3	2	~0.6	-	7.0	Good Passable

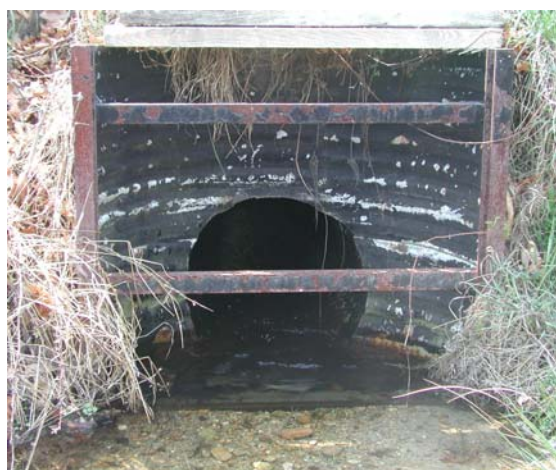
John Parker Road bog sluice

Design	Material	Length (ft)	Inside W (ft)	Outside W (ft)	# of Baffles	Baffle H (ft)	Notch W (ft)	Pool L (ft)	Condition/Function
Stream baffle	Stone and metal with a wooden baffle	126.3	3-4	Stream edge	1	0.5	0.6	N/A	Fair Inefficient passage

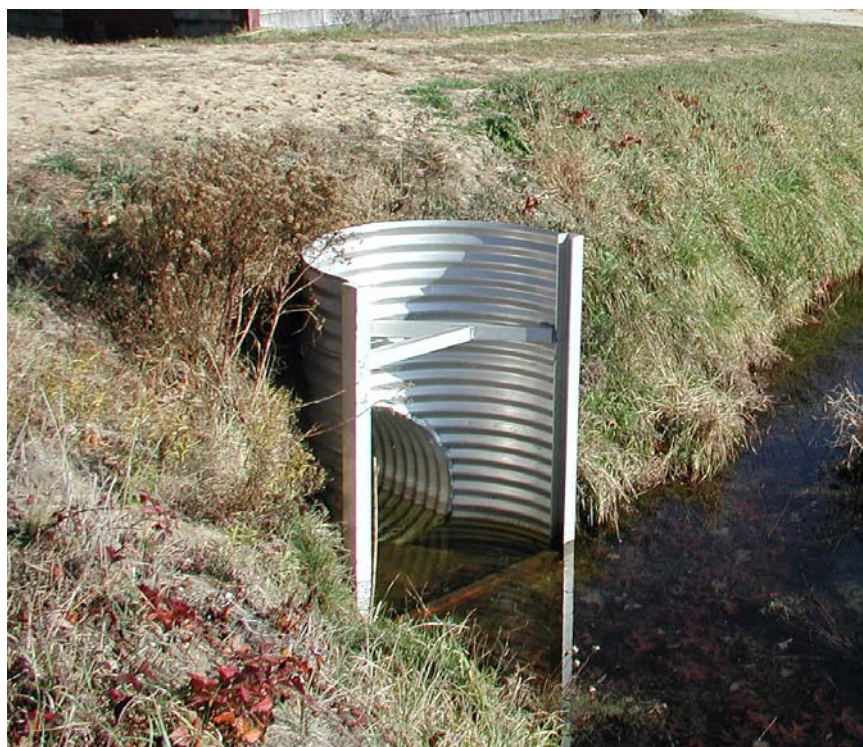
Flax Pond Culvert and fishway

Design	Material	Length (ft)	Inside W (ft)	Outside W (ft)	# of Baffles	Baffle H (ft)	Notch W (ft)	Pool L (ft)	Condition/ Function
Weir pool	Steel with wooden baffles	32	2.6	2.6	2	2	-	32	Excellent Passable

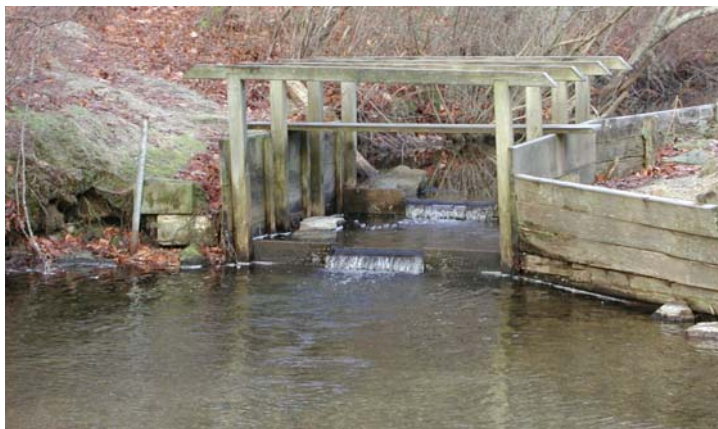
Bog Sluice and Ladder above Washburn Pond

<b>Design</b>	<b>Material</b>	<b>Length (ft)</b>	<b>Inside W (ft)</b>	<b>Outside W (ft)</b>	<b># of Baffles</b>	<b>Baffle H (ft)</b>	<b>Notch W (ft)</b>	<b>Pool L (ft)</b>	<b>Condition/ Function</b>
Notched weir-pool	Wood	8.0	6.0	6.2	2	0.7	2.4	8.0	Poor Inefficient passage

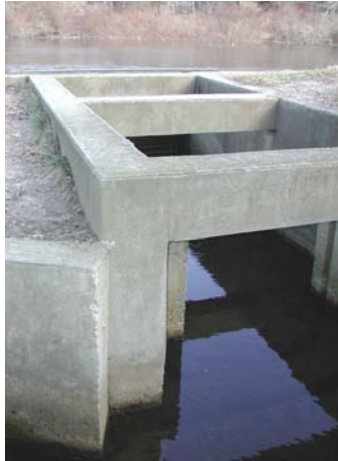
Dam at Route 130 Crossing

<b>Design</b>	<b>Material</b>	<b>Length (ft)</b>	<b>Inside W (ft)</b>	<b>Outside W (ft)</b>	<b># of Baffles</b>	<b>Baffle H (ft)</b>	<b>Notch W (ft)</b>	<b>Pool L (ft)</b>	<b>Condition/Function</b>
Weir-pool	Concrete with wooden baffles	219.0	Varied (3.0 and 5.0)	Varied (4.6 and 6.6)	10	Varied (1.1-2.1)	-	Varied (8.0-35.0)	Excellent Passable

A small impoundment at Route 130 is made accessible by a concrete and wood weir-pool ladder. The lower section of the fishway was modified and the upper section completely replaced by DMF in 1997. This ladder now functions very well with proper flow adjustment. A short section of stream connects this impoundment to the outlet of Mashpee-Wakeby Pond. The control structure at the outlet is equipped with wooden baffles to allow fish to access the pond. Jetties have been installed at the outlet to reduce sand build up in the stream, a condition which has prevented juvenile out migration on a number of occasions.

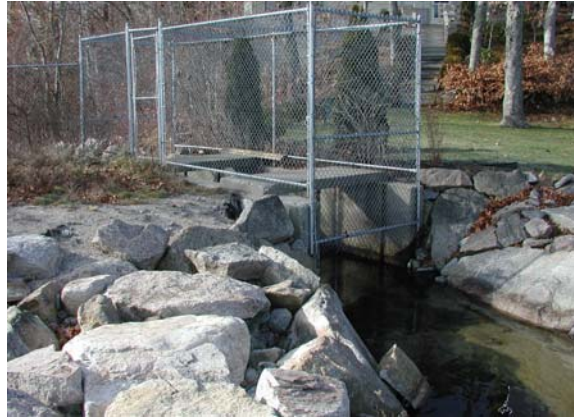
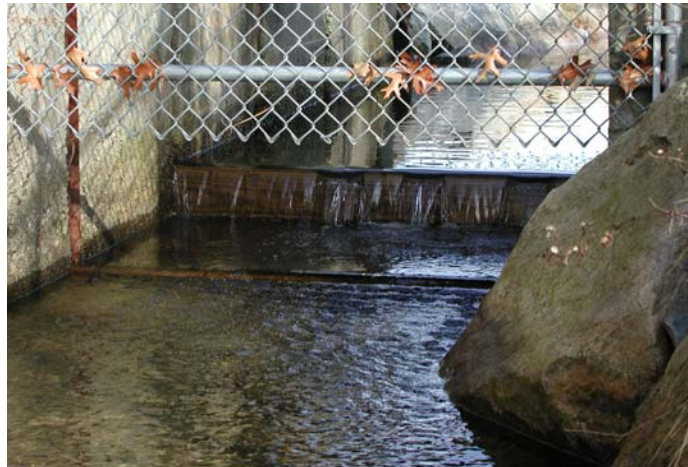
Mashpee Pond Control Structure

<b>Design</b>	<b>Material</b>	<b>Length (ft)</b>	<b>Inside W (ft)</b>	<b>Outside W (ft)</b>	<b># of Baffles</b>	<b>Baffle H (ft)</b>	<b>Notch W (ft)</b>	<b>Pool L (ft)</b>	<b>Condition/Function</b>
Weir-pool	Concrete with wooden baffles	20	5.6	7.6	5	0.5	-	3	Excellent Passable

Fishway at Mashpee Pond Control Structure

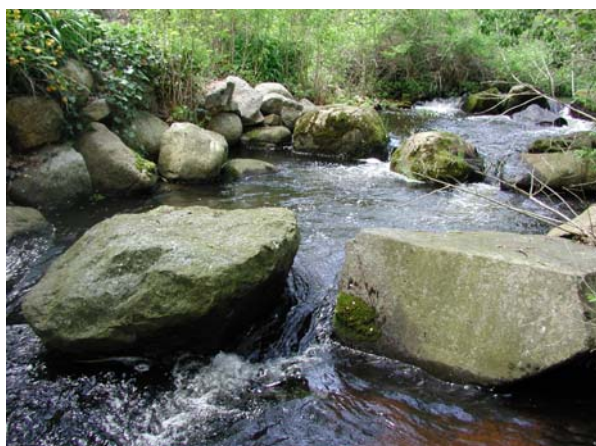
Stream Baffles below Route 28

Design	Material	Length (ft)	Inside W (ft)	Outside W (ft)	# of Baffles	Baffle H (ft)	Notch W (ft)	Pool L (ft)	Condition/Function
Stream baffle	Stone	130	Varied (16-18)	Varied (16-18)	6	1.6	Varied (1.3-1.8)	15	Good Passable

The first obstruction on the stream is an elevation change at Route 28. This is nicely surmounted with stone stream baffles. After passing this and moving through the Route 28 culvert, fish must ascend a concrete, notched weir-pool ladder which is in poor condition and not functioning well. A third barrier is a large concrete flume which, though passable, presents a difficult elevation change.

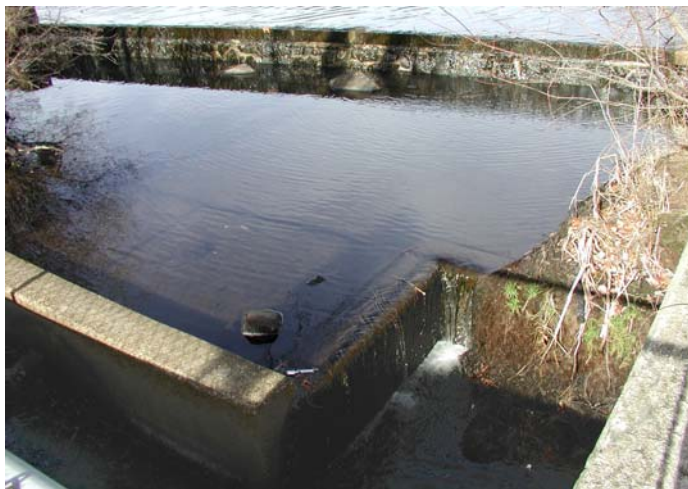
Mill Pond Dam

Design	Material	Length (ft)	Inside W (ft)	Outside W (ft)	# of Baffles	Baffle H (ft)	Notch W (ft)	Pool L (ft)	Condition/Function
Notched weir-pool	Concrete	53.0	4.0	6.0	6	Varied (1.8-2.3)	1.5	5.0	Poor Inefficient passage

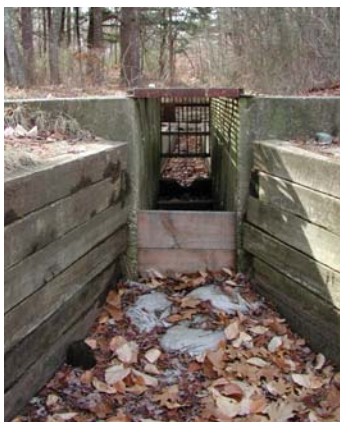
Middle Pond Control Structure

Design	Material	Length (ft)	Inside W (ft)	Outside W (ft)	# of Baffles	Baffle H (ft)	Notch W (ft)	Pool L (ft)	Condition/Function
Notched weir-pool	Wood	1001	1.9	2.2	13	2.5	0.8	Varied (11.8-425)	Fair Inefficient passage
Denil	Concrete and wood	10.0	1.9	3.5	4	4.5	-	-	Fair Inefficient passage

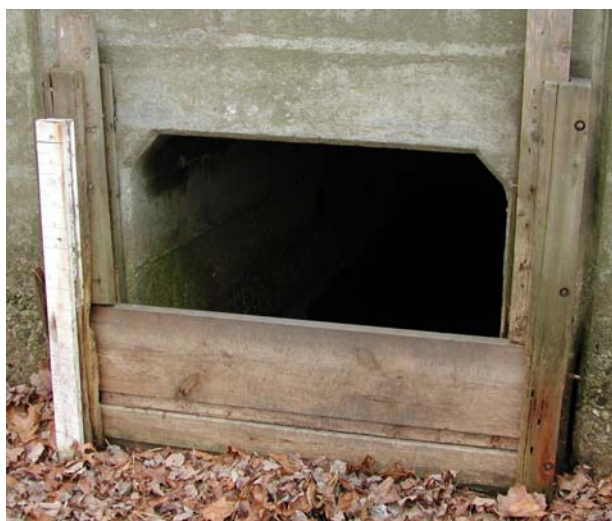
Wequaquet Lake Control Structure/Ladder

Design	Material	Length (ft)	Inside W (ft)	Outside W (ft)	# of Baffles	Baffle H (ft)	Notch W (ft)	Pool L (ft)	Condition/ Function
Weir-pool	Concrete	60	3.0	-	2	1.4	-	60	Fair Inefficient passage

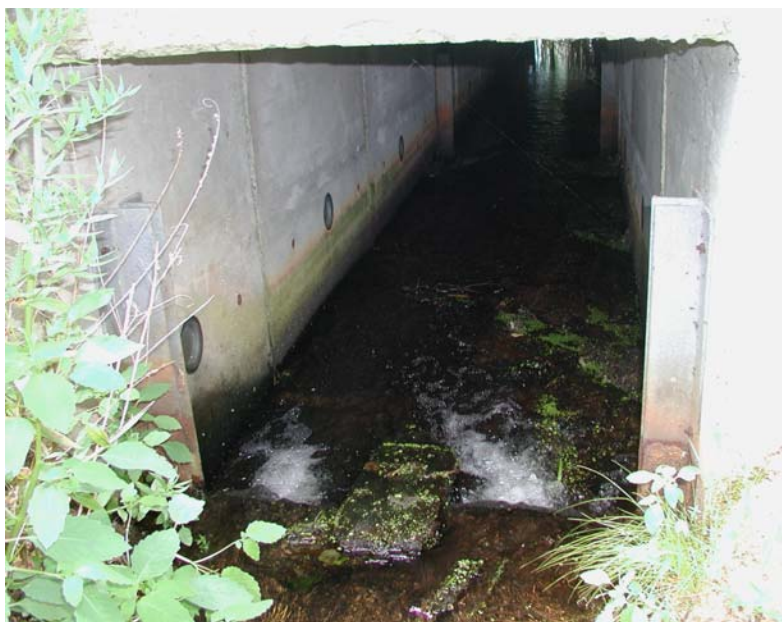
Dam/Ladder above Mill Pond

Design	Material	Length (ft)	Inside W (ft)	Outside W (ft)	# of Baffles	Baffle H (ft)	Notch W (ft)	Pool L (ft)	Condition/Function
Box culvert with baffles	Concrete with metal slots and wooden baffles	49.0	4.0	5.0	1	0.6	-	N/A	Excellent Passable

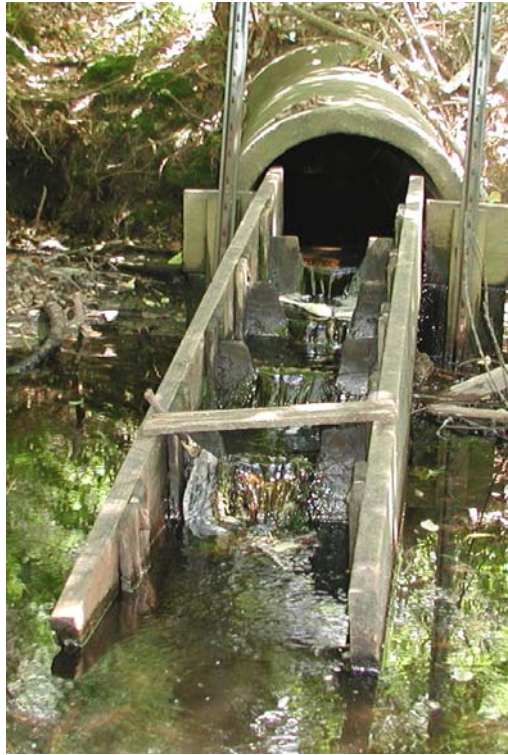
Clear Brook Road Culvert and Ladder

Design	Material	Length (ft)	Inside W (ft)	Outside W (ft)	# of Baffles	Baffle H (ft)	Notch W (ft)	Pool L (ft)	Condition/ Function
Notched weir-pool	Wood	8.0	2.0	2.4	4	0.4	0.7	1.2	Good Inefficient passage

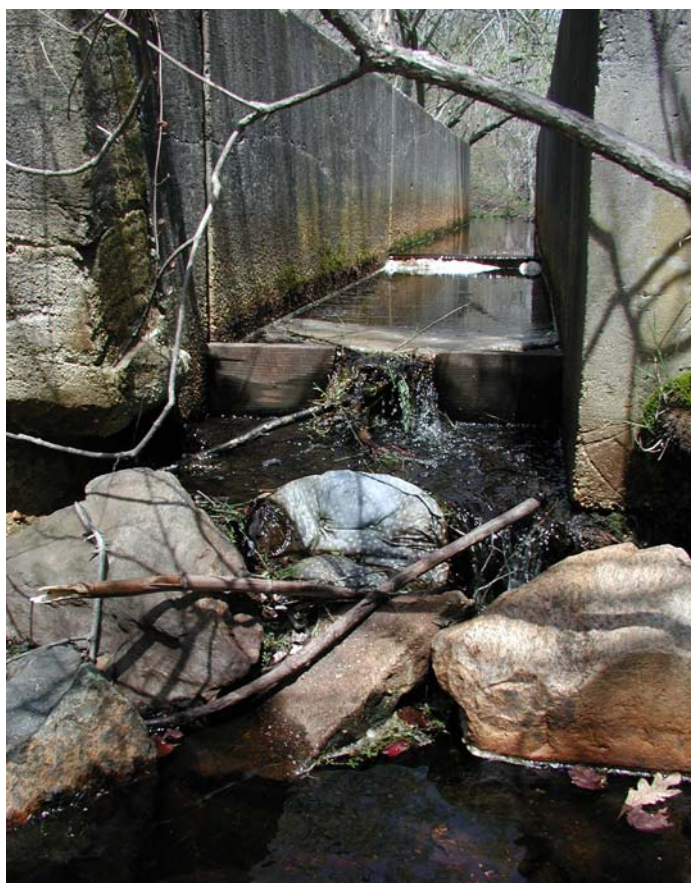
Winslow Gray Road Dam and Ladder

Design	Material	Length (ft)	Inside W (ft)	Outside W (ft)	# of Baffles	Baffle H (ft)	Notch W (ft)	Pool L (ft)	Condition/ Function
Weir-pool	Concrete with wooden baffles	38.0	2.8	4.4	2	0.7	-	11.0	Good Inefficient passage

Plashes Brook is a small tributary to the lower Parkers River. A concrete control structure at Winslow Gray Road forms a 1.9 acre impoundment. Wooden baffles incorporated into the structure create a fishway which allows herring to reach the impoundment. In order to reach the headwater, 44 acre Plashes Pond, fish would have to negotiate a complex system of cranberry bogs with numerous impassable culverts. While access to Plashes Pond is desirable, the difficulty of ensuring passage through the bogs reduces it to a low priority site.

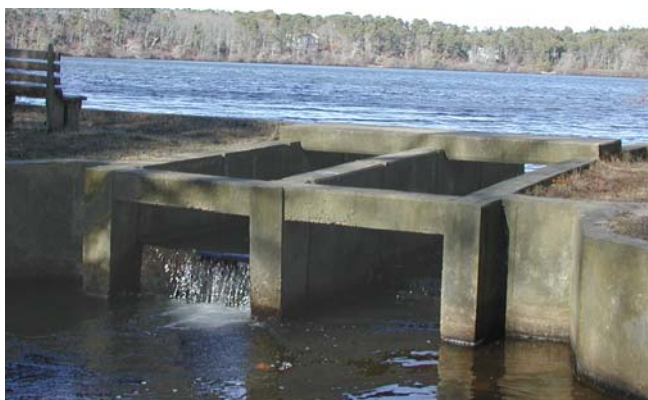
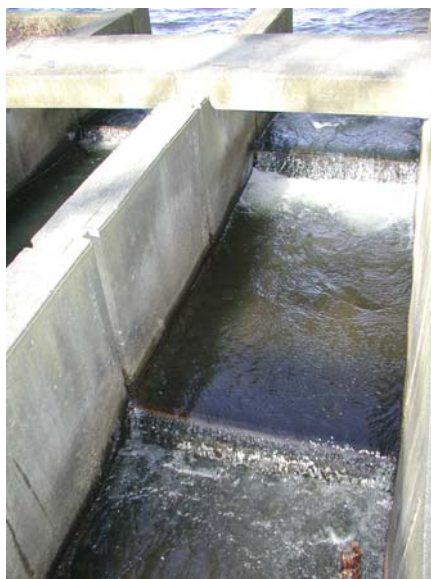
Hinckleys Pond Control Structure and Ladder

Design	Material	Length (ft)	Inside W (ft)	Outside W (ft)	# of Baffles	Baffle H (ft)	Notch W (ft)	Pool L (ft)	Condition/Function
Weir-pool	Concrete with wooden baffles	18.0	4.0	6.0	5	1.2	-	8.0	Excellent Passable

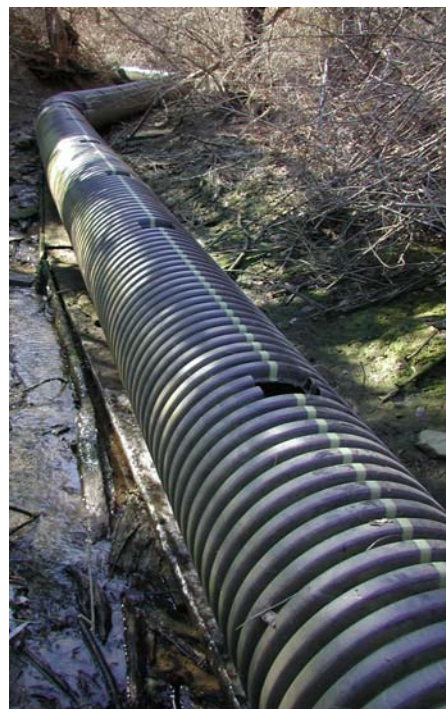
Vertical Slot at Stillwater Pond Elevation Change

Notched Weir-pool at Stillwater Pond Elevation Change

Design	Material	Length (ft)	Inside W (ft)	Outside W (ft)	# of Baffles	Baffle H (ft)	Notch W (ft)	Pool L (ft)	Condition/Function
Vertical slot	Wood	8.0	1.0	1.0	8	1.0	0.3	1.0	Poor Inefficient passage
Notched weir-pool	Corrugated plastic pipe with wooden baffles	147.0	1.4	1.4	28	0.8	0.5	5.0	Good Passable

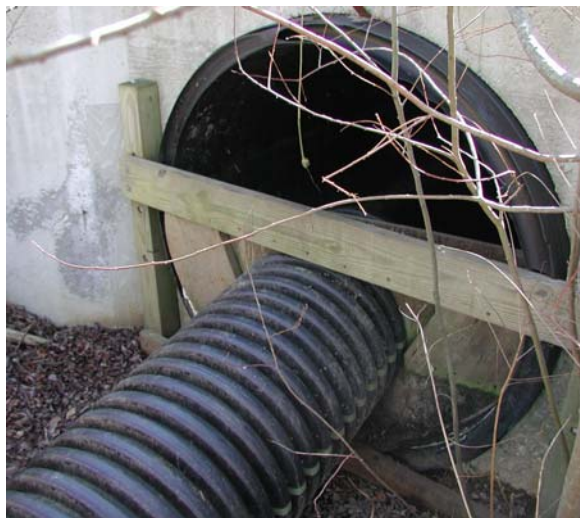
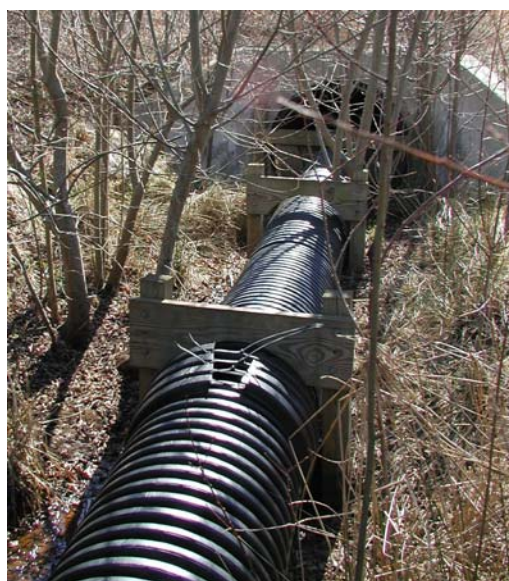
Lovers Lake Culvert

Design	Material	Length (ft)	Inside W (ft)	Outside W (ft)	# of Baffles	Baffle H (ft)	Notch W (ft)	Pool L (ft)	Condition/Function
Notched weir-pool	Corrugated plastic with wooden baffles	60.0	1.4	2.0	6	0.3	0.7	6.0	Good Passable

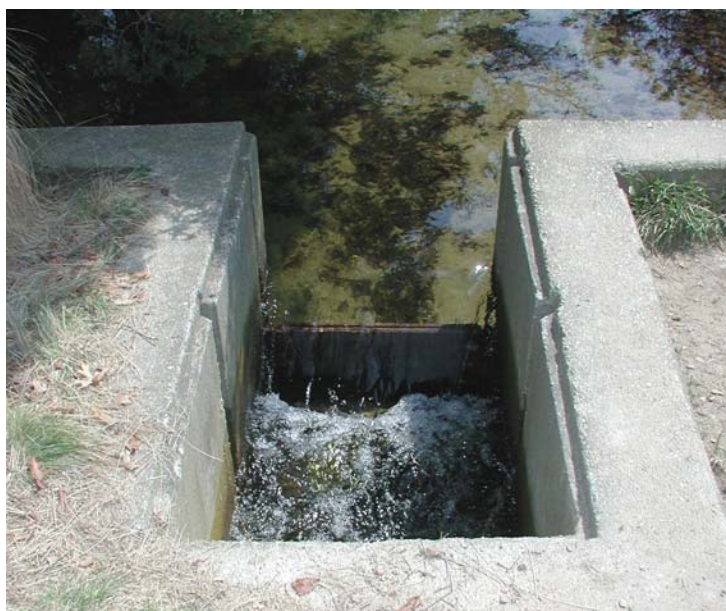
Herring Brook Road Control Structure/Ladder

Design	Material	Length (ft)	Inside W (ft)	Outside W (ft)	# of Baffles	Baffle H (ft)	Notch W (ft)	Pool L (ft)	Condition/Function
Weir-pool	Concrete with wooden baffles	5.4	2.9	4.6	1	2.2	-	-	Good Passable

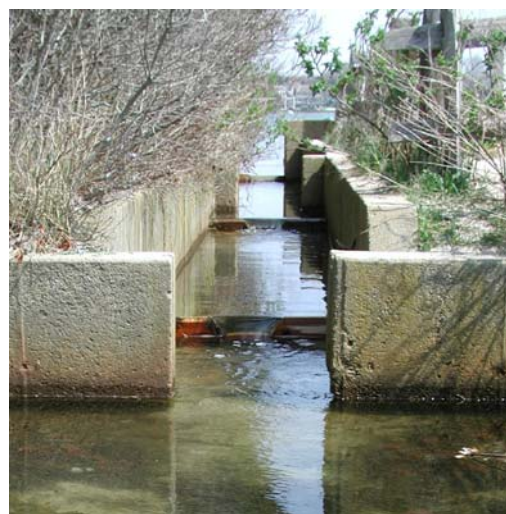
Notched Weir-pool at Herring Pond

Design	Material	Length (ft)	Inside W (ft)	Outside W (ft)	# of Baffles	Baffle H (ft)	Notch W (ft)	Pool L (ft)	Condition/Function
Stream baffle	Wood	86.0	8.6	8.6	2	2.0	1.0	Varied (35.0 and 51.0)	Good Passable
Notched weir-pool	Concrete with wooden baffles	66.0	3.4	4.8	3	2.8	-	Varied (14.2-24.7)	Good Passable

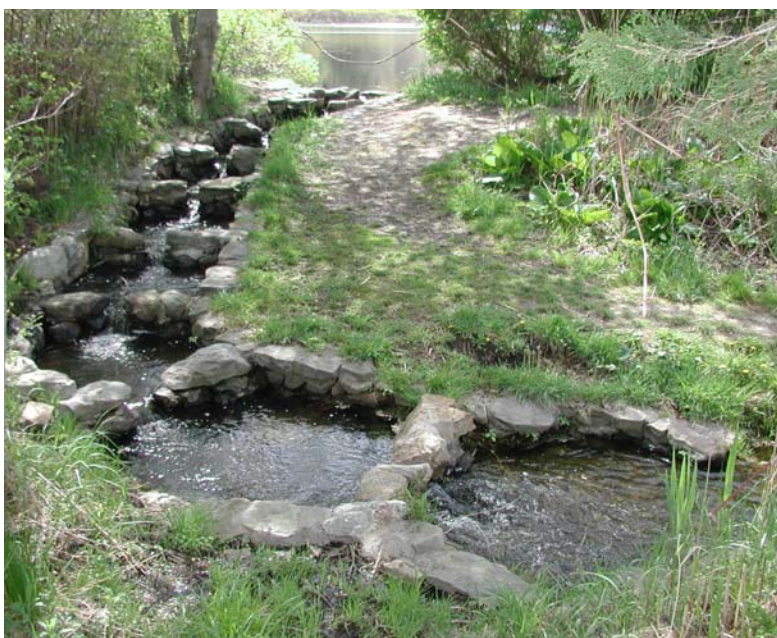
Airline Road Fishway

Design	Material	Length (ft)	Inside W (ft)	Outside W (ft)	# of Baffles	Baffle H (ft)	Notch W (ft)	Pool L (ft)	Condition/Function
Notched weir-pool	Stone	55.0	3.3	4.0	11	2.3	0.5	Varied (4 – 15)	Good Passable

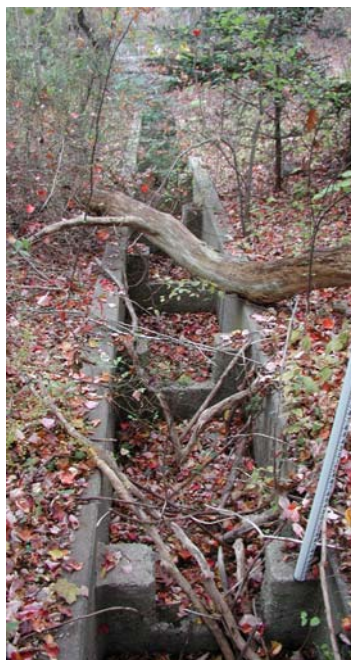
Upper Shawme Fishway

Design	Material	Length (ft)	Inside W (ft)	Outside W (ft)	# of Baffles	Baffle H (ft)	Notch W (ft)	Pool L (ft)	Condition/ Function
Notched weir-pool	Concrete	71.9	3.0	4.3	11	1.1	1.6	7.0	Poor Not passable

Mill Creek is largely a tidal stream that drains Upper and Lower Shawme Ponds. A fishway leading into 24.1 acre Lower Shawme Pond was reconstructed by DMF in 1993 and currently provides adequate passage. A fishway that formerly connected the two ponds has been bypassed and the upper pond is inaccessible. The dam at Upper Shawme Pond has been designated unsafe and is being considered for replacement. A functional fishway should be incorporated into a design for a new dam. This stream has historically supported a small American shad run in its lower reaches.
