Appendix A: Assessment Summaries for BMPs

HW Site ID#: 1	
Type of BMP: Constructed wetland

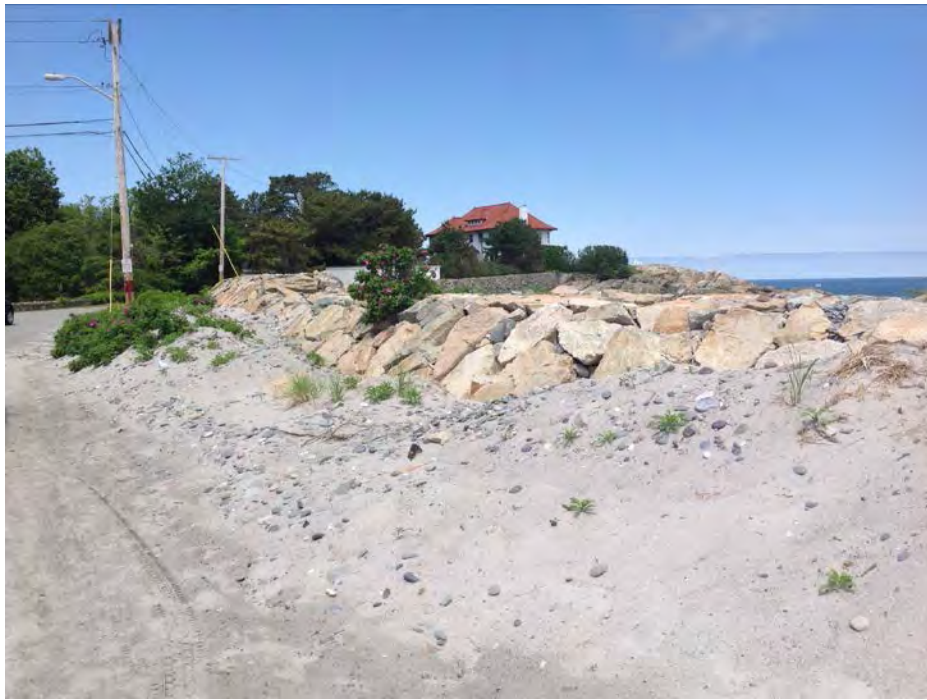
Sand appears to wash over lower section of sea wall, across Atlantic Ave. from BMP.

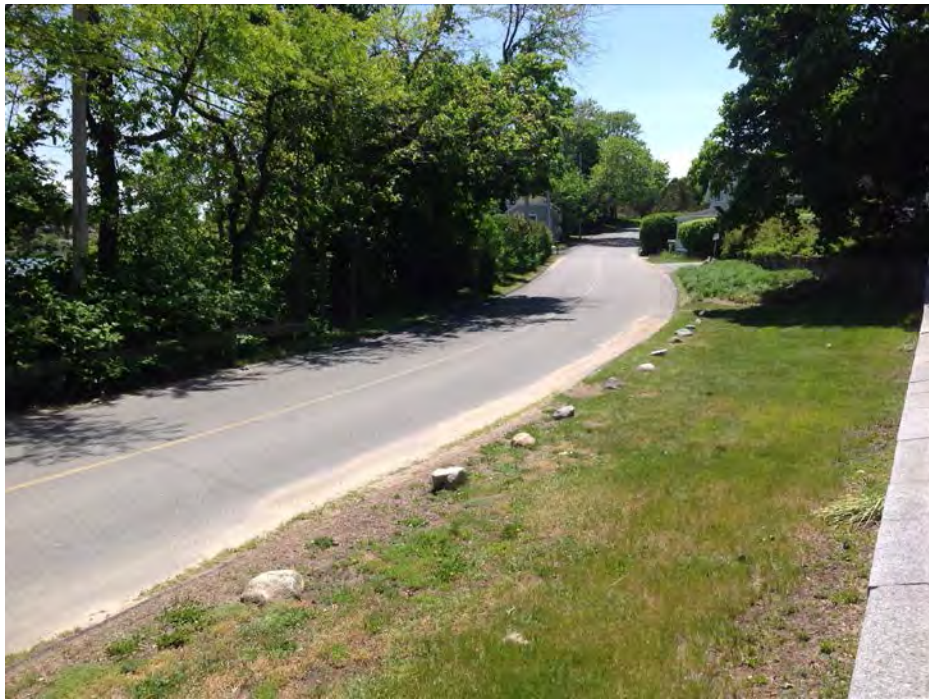
Opposite side of the street. Potential retrofit location.

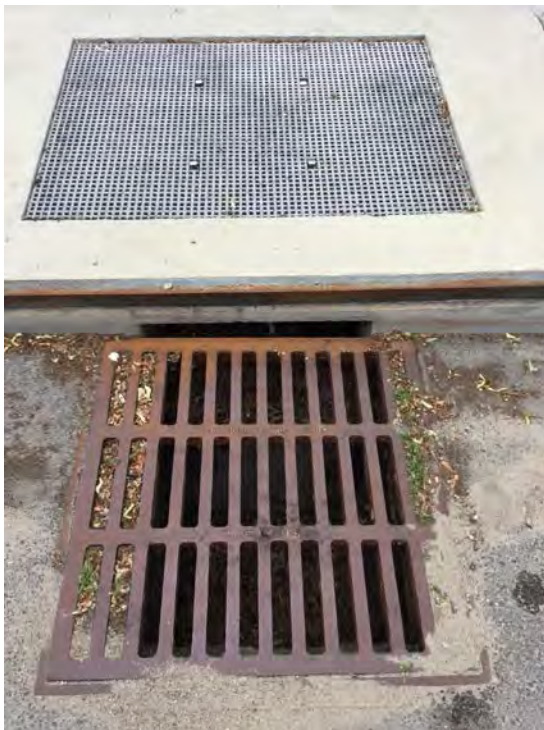
Site 11B, Dover Street. Trees not installed.

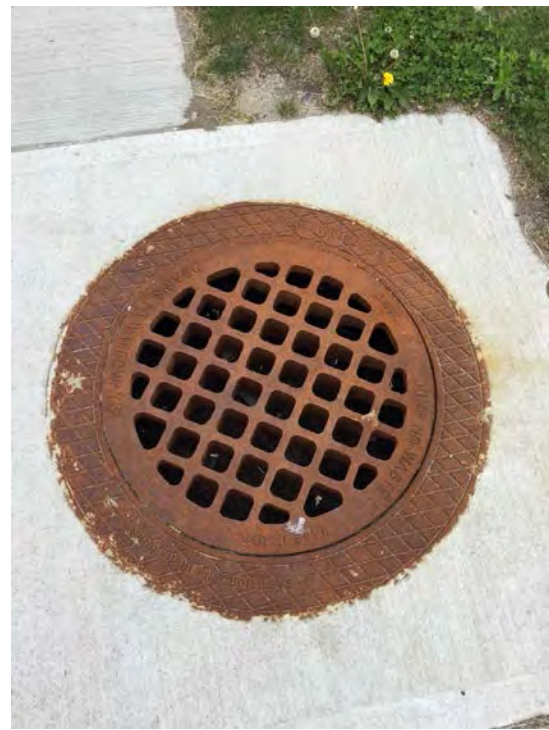
Site 11C, Morgan Street. Trees not installed.

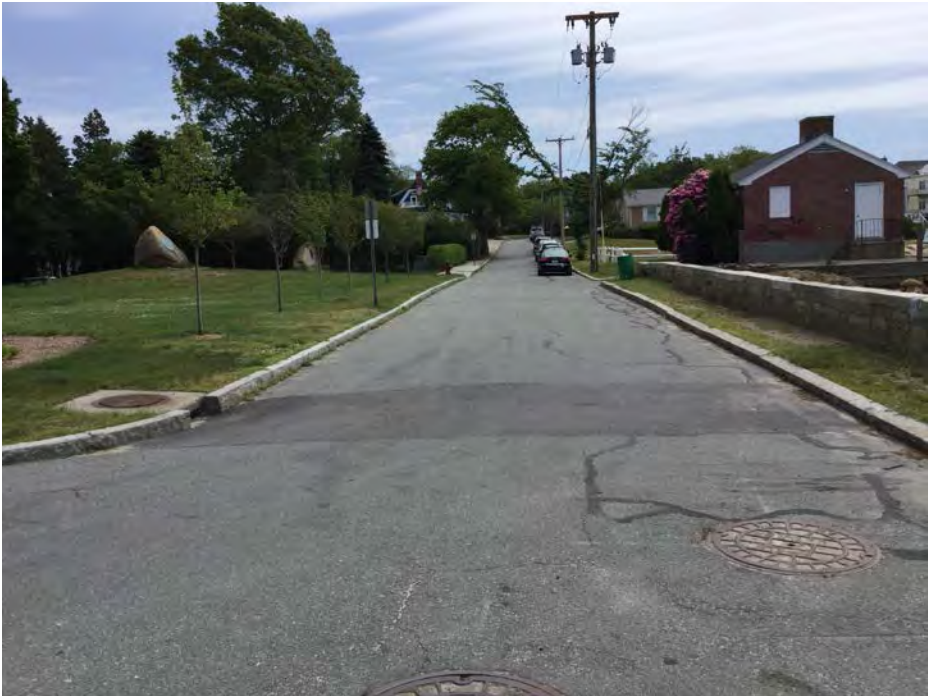
Drains to catchbasin at rain garden outlet.

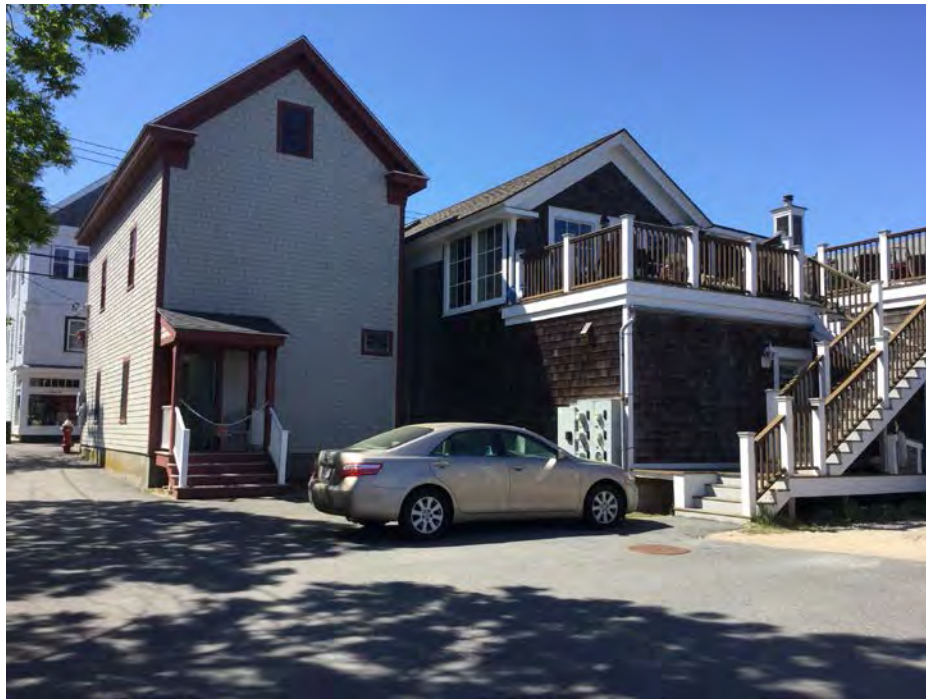
Two buildings in drainage area to practice.

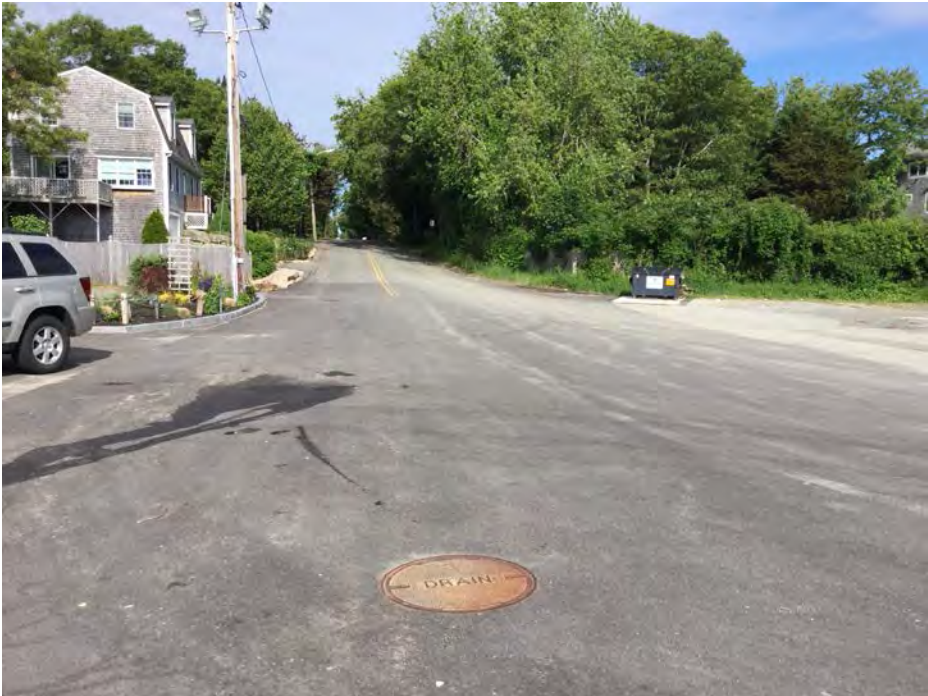
Looking uphill at drainage area.
