***South Shore Coastal Infrastructure Inventory  
and Assessment Demonstration Project  
Coastal Hazards Commission***

**Town of Cohasset**

**Prepared for:  
Office of Coastal Zone Management  
Boston, MA**

**Presented by:  
Bourne Consulting Engineering  
Franklin, Massachusetts**

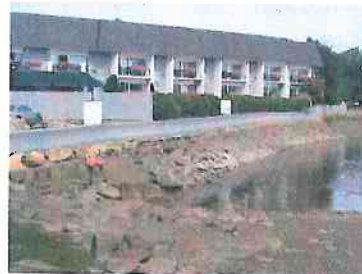
Stone block seawall (mortarted) with road directly inshore. Town pier and floats extend out from wall. Minor undermining on portions of wall.

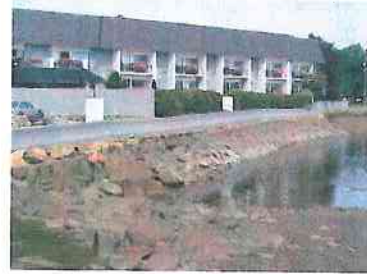
Placed rip rap slope (45 degree) with precast concrete barriers at top of slope. Concrete headwall with tide valves on outfalls located near east end of structure.

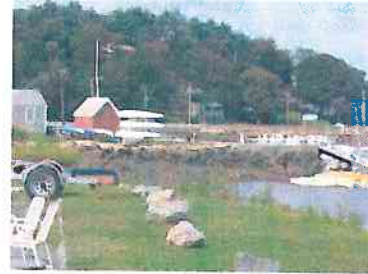
Stone block seawall mortared with concrete. Concrete patching along top inshore edge. Cohasset Sailing Club set back behind seawall. Fill loss occurring (patching of pavement).

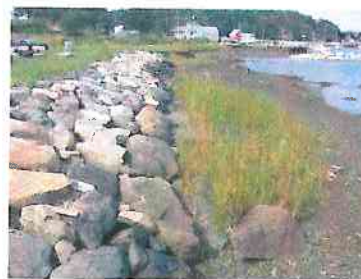
Placed rip rap slope (1 vertical to 3 horizontal) with gravel parking lot inshore ( houses inshore of lot). 500 to 1000 lb stone. Slope not toed into beach (slope ends about mean high water). Minor erosion along top of slope.
