Bridge Assessment and Ranking

Town of Colrain

July 2018

BSC GROUP

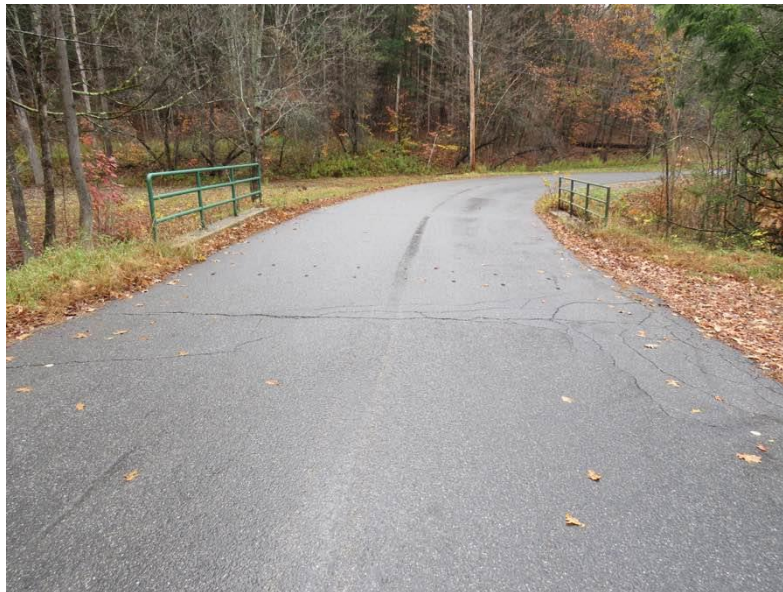
Figure 1.1 C-18-029 Roadway and Approach

This structure runs from east to west and is intersected by Sanders Brook flowing from North to South. The superstructure consists of a 15" thick concrete reinforced deck slab topped with bituminous concrete (asphalt) of an unknown thickness. The abutments and wingwalls are also reinforced concrete. This bridge is approximately 17 feet in length and carries two-way traffic. The bridge features concrete safety curbs on either side with steel pipe bridge railing and posts [see figure 1.1].

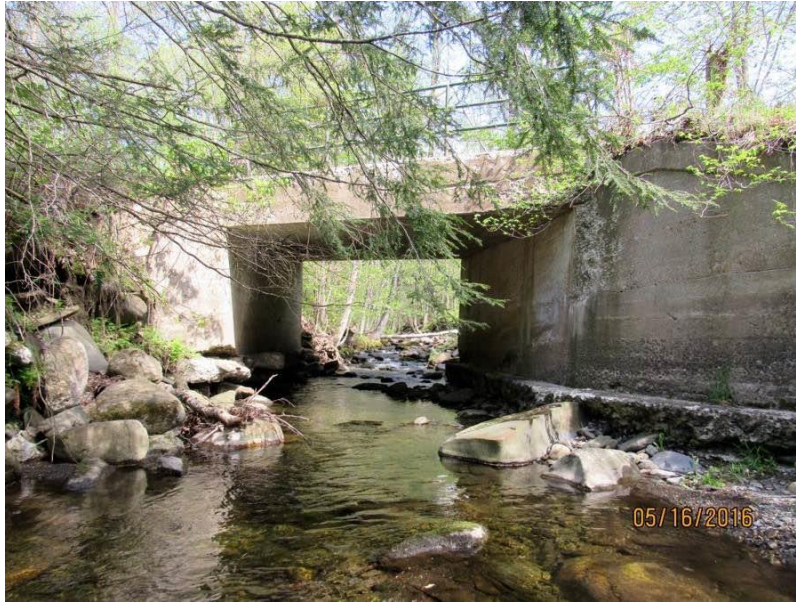
Figure 1.2 C-18-029 Elevation

The reason for the serious condition rating of a 3 is due to the severe scour along the abutments [see Figure 1.2-1.5]. The structure is being inspected annually due to the low condition rating. A further advancement of the scour could potentially result in a bridge closure. Both abutments have scour along the entire footing with depths up to 3 feet and widths up to 6 feet.

- Remove spalled and deteriorated concrete by removing loose areas until sound concrete is found.
- Replace rebar that is showing signs of section loss.
- Apply an epoxy bounding compound to the areas of concrete excavation and place new concrete in the areas that have been removed.
- Repair the existing footings by filling the voids with concrete.
- Excavate existing streambed material and construct scour protection in conformance with the MassDOT LRFD Bridge Manual.

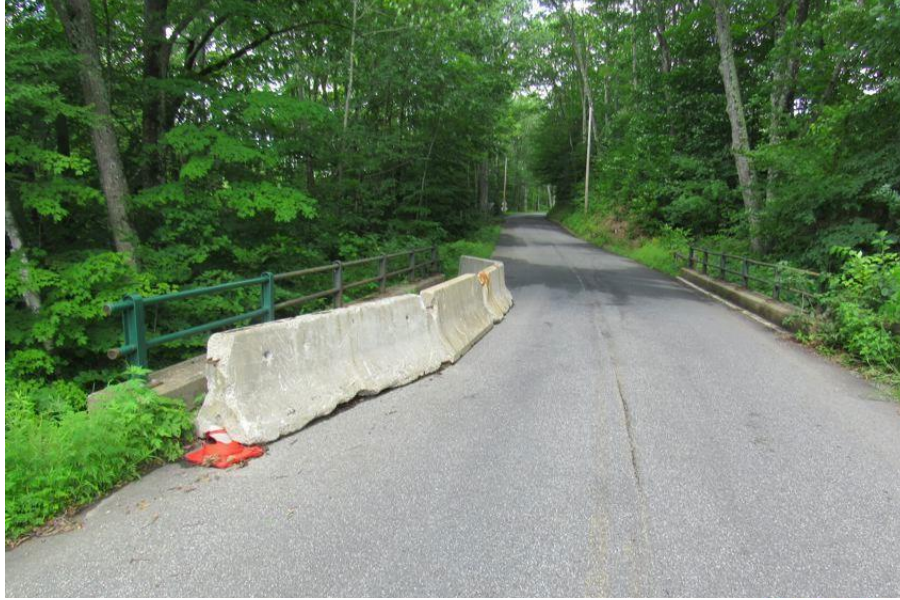
Figure 2.1 C-18-033 General Roadway

This bridge superstructure consists of two exterior steel 21WF63 beams with five interior steel 21WF59 beams and a non-composite cast-in-place concrete deck approximately 23 feet in span length. The steel beams are supported by gravity abutments to the east and west. The bridge wearing surface is bituminous concrete and has concrete safety curbs on both sides. Supported by the curbs are steel pipe railings connected intermediately with steel posts [see Figures 2.1 and 2.2].

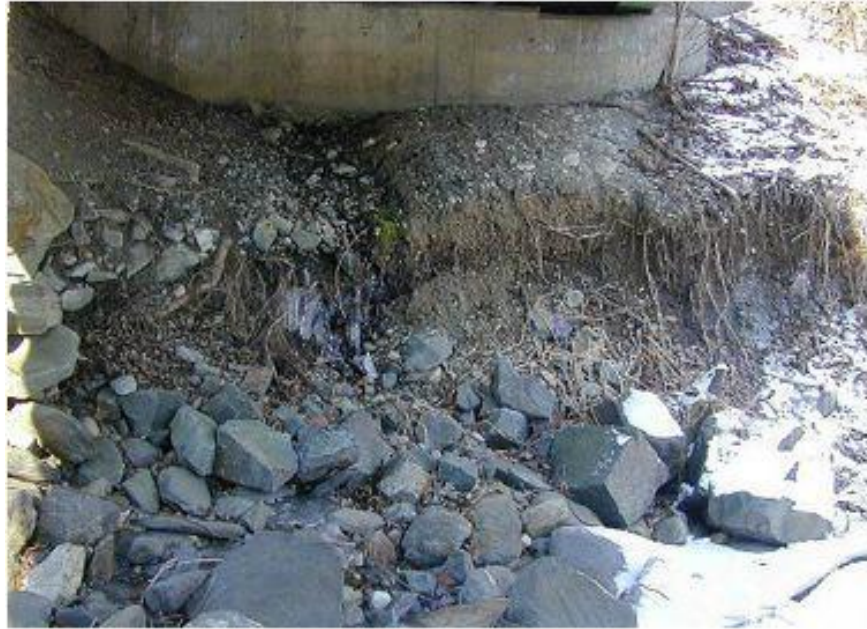
Figure 3.5 North Abutment in 2002

The amount of erosion is significant and if allowed to continue will result in serious problems and bridge closure. Due to the scour/erosion, the northeast abutment cap is completely undermined and one of the vertical columns of the stub abutment is exposed [see Figure 3.4]. Figure 3.5 shows the amount of cover the abutment had in 2002, which has since been removed. The north abutment is out of plumb and leaning forward towards the brook.

It is recommended to repair and replace the embankment as soon as possible. Repair should consist of riprap, crushed stone, and geotextile fabric. Riprap should contain stone that conforms to M2.02.0 as described in the materials section of the MassDOT standard specifications. MassDOT standards should be followed as shown in Figure 3.7. A minimum height of 3'-0" riprap is recommended. During riprap installation it is important that the existing abutment not be undermined or disturbed.

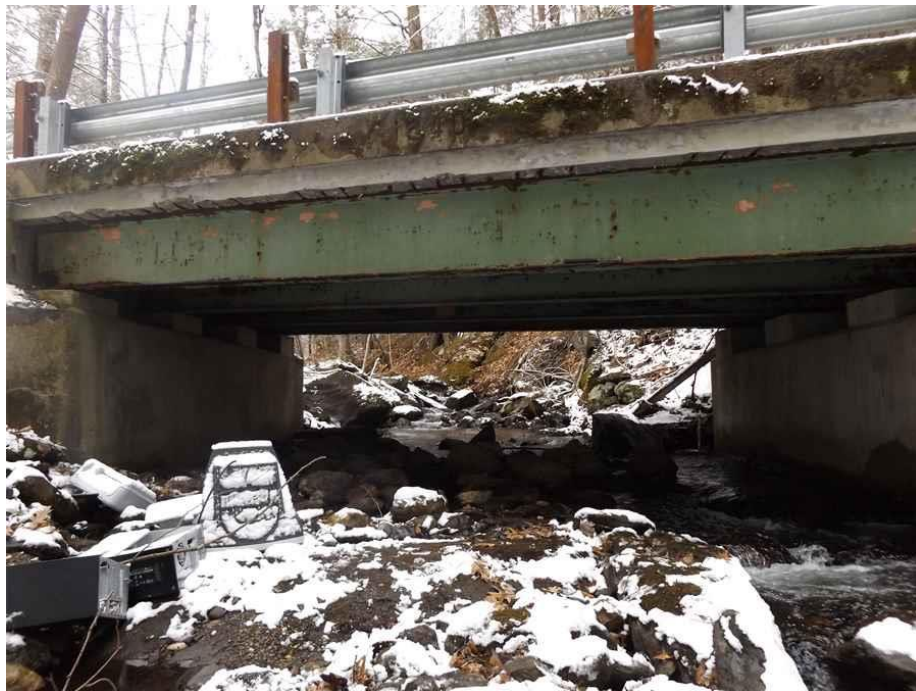
Figure 4.2 C-18-043 Elevation

To the south, the channel has debris and trash. The deck shows spalling and scaling approximately 2 inches in depth [see Figures 4.2-4.4]. The spalling is possibly caused by poor concrete quality and/or minimal rebar cover. Typically, reinforcement has a minimum cover of 2 inches to completely encapsulate the rebar within the concrete.

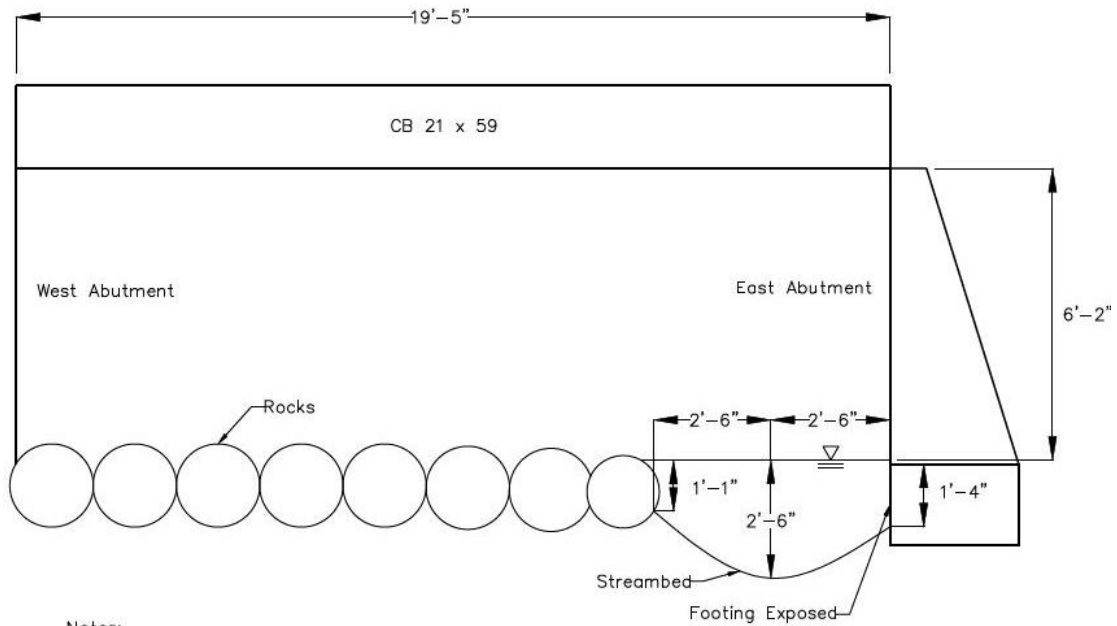
Figure 4.7 Scour Detail at East Abutment

The concrete abutments have some cracking [see Figure 4.6]. There is a scour pocket at the southeast corner approximately 5 feet in diameter [see Figure 4.7]. However, currently the scour has not undermined the abutment's footing.

1. Drawing not to scale.
2. All measurements taken at the fascia.
3. All measurements taken along the skewed span.
4. Channel Profile checked on 4/2/2018.
5. Water depth over the footing was 1" at the time of inspection; no undermining was found.
6. Rocks and soil above the waterline in the west side of the channel; no flow was observed in the channel at these locations.

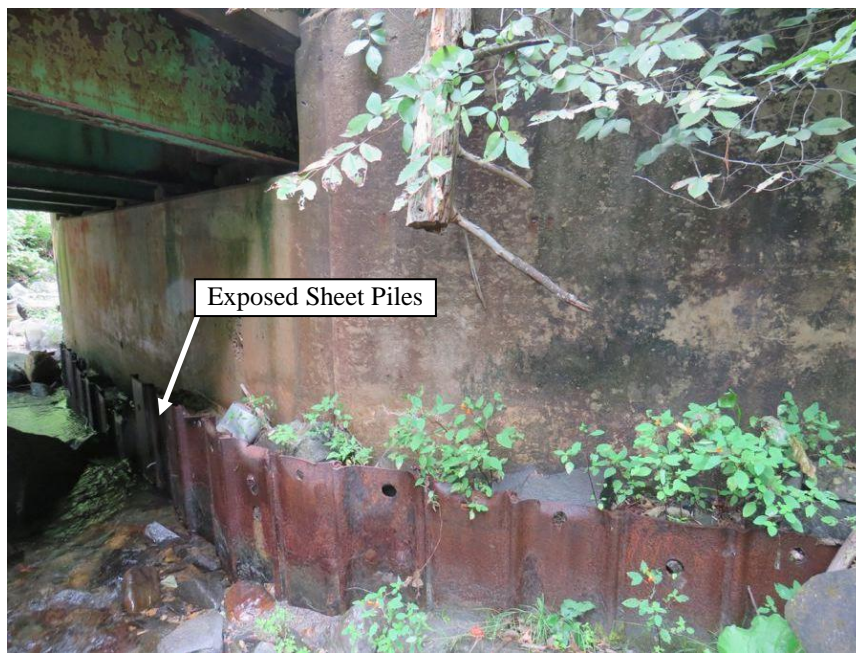
Figure 6.4 Sheet Piles at the East Abutment

The superstructure sits on bearing devices which are supported by concrete abutments. The abutments have an open bridge seat with bearings and exposed beam ends. This structure was built in 1939 and modifications have been made to prevent scour and erosion. Sheet piles have been installed in front of the east abutment footing [see Figure 6.4]. Also, gabion walls have been installed adjacent to the wingwalls to secure the roadway embankment.

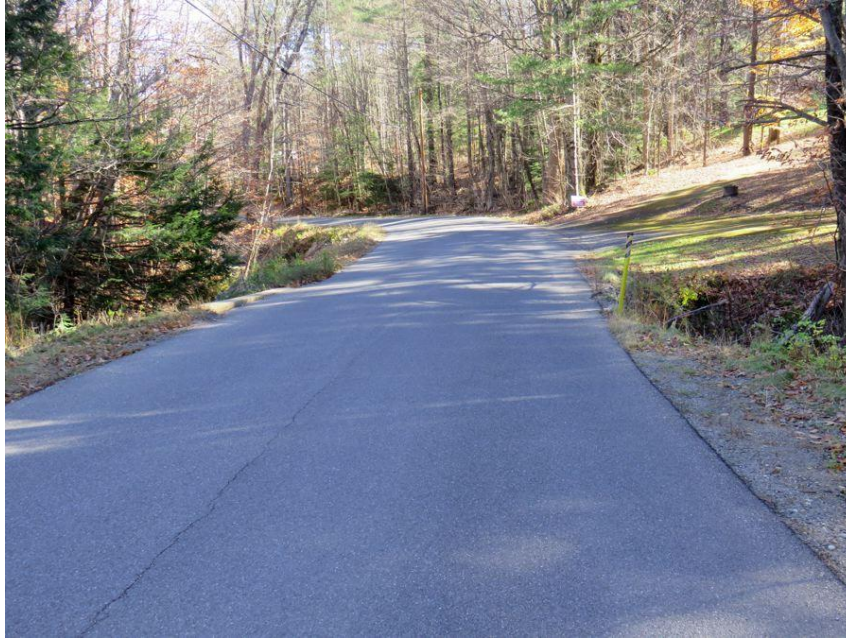
Figure 7.1 C-18-032 Roadway and Approach

The structure features two-way travel with a bituminous concrete (asphalt) wearing surface. To the north and south there are small curbs that are barely exposed, possibly from multiple roadway resurfacing. There is no bridge rail on this structure and no guardrail at either approach [see Figure 7.1].

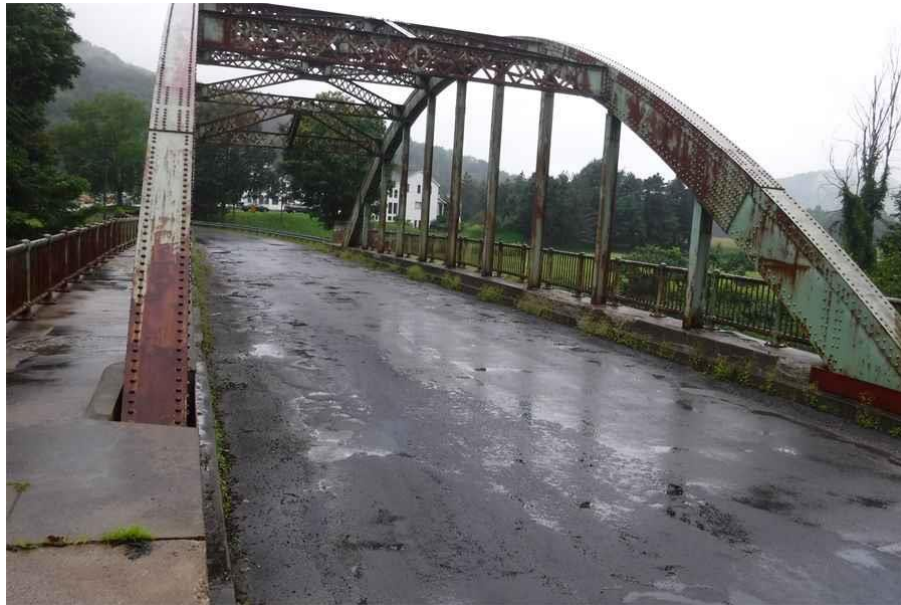
Figure 8.1 C-18-008 Roadway and Approach

There are extensive areas of paint failure including but not limited to: the overhead arches, vertical supports, bridge rail, and floor beams [see Figures 8.1, 8.4, 8.5, 8.8, 8.9 and 8.10].

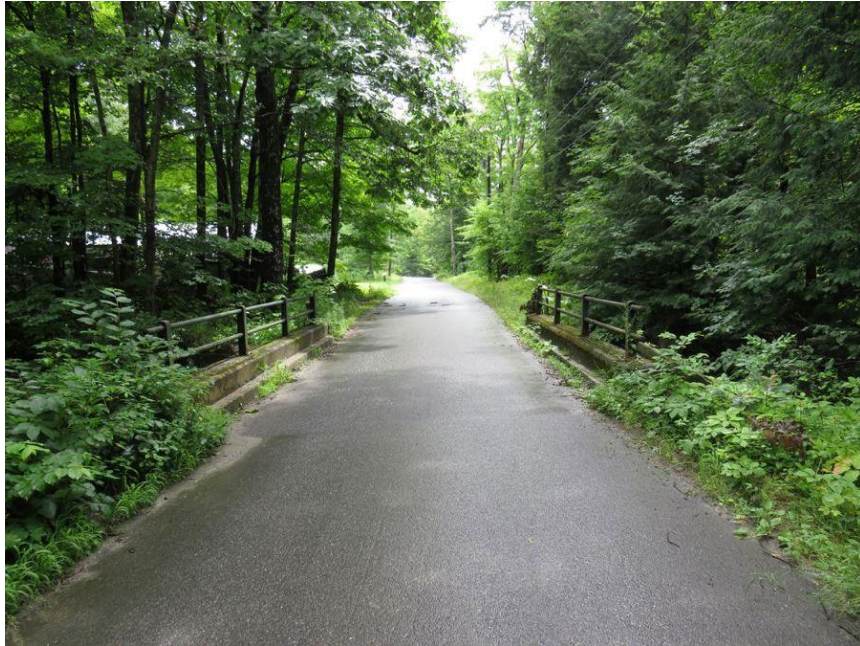
Figure 10.1 C-18-036 Roadway and Approach

Five steel beams support a non-composite concrete deck that is topped with bituminous concrete. The roadway has cast in place concrete curbs and steel pipe railings intermediately connected with steel posts [see Figure 10.1].

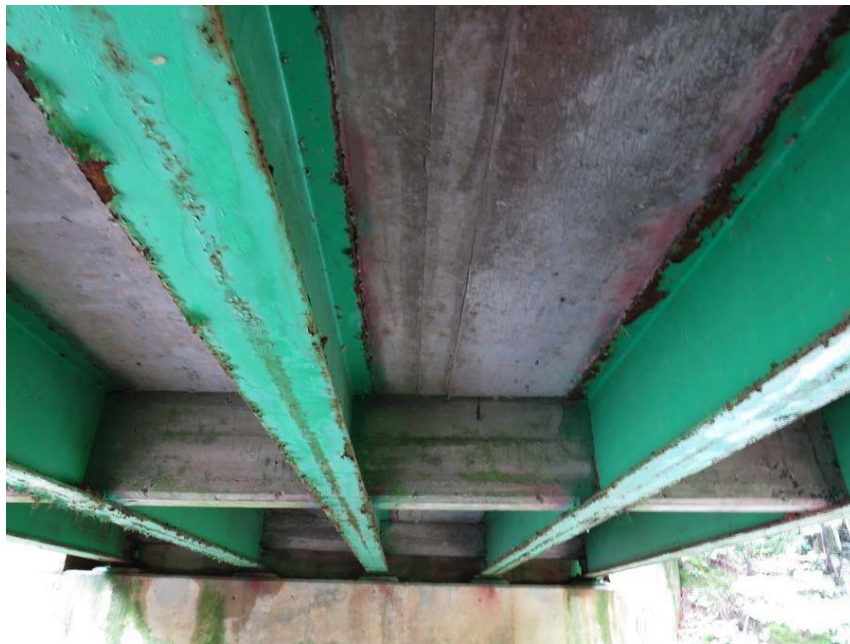
Figure 10.2 C-18-036 Typical Underside

The steel superstructure and bearing devices have various areas of moderate paint failure, rusting and pitting [see Figure 10.2]. One of the interior beam's anchor bolts has sheared off.
