**TECHNICAL REPORT**

**MOA MITIGATION SERVICES – ARCHAEOLOGICAL MONITORING  
COTLEY RIVER RESTORATION / BARSTOW'S POND DAM REMOVAL**

**Taunton, Massachusetts**

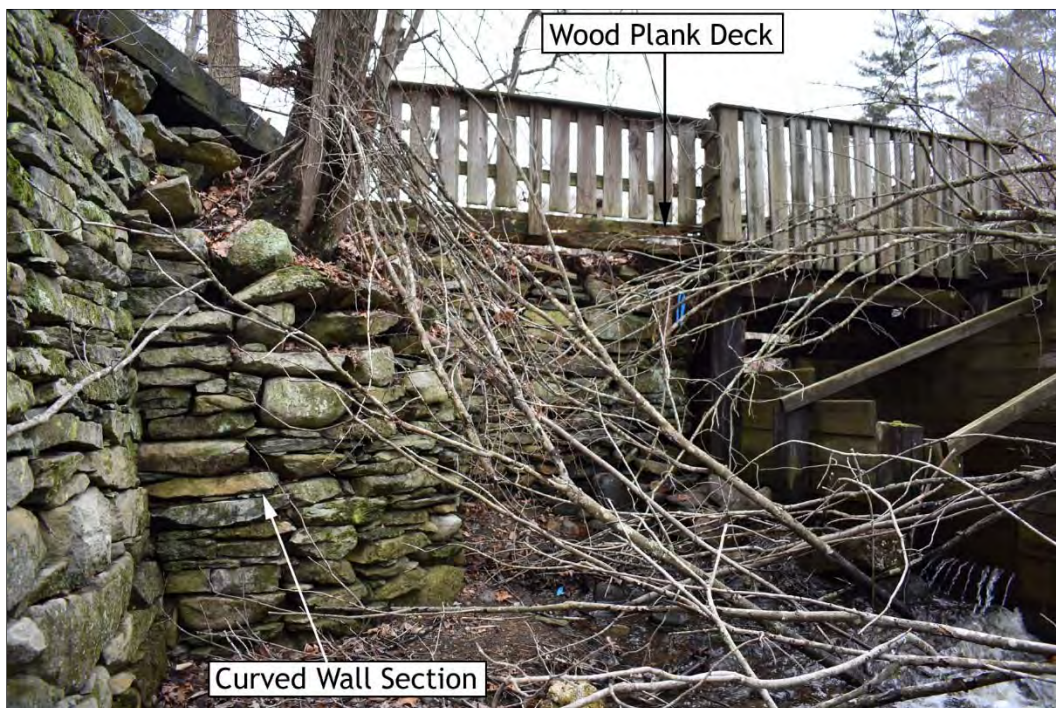
**Figure 11. Curved dry-laid fieldstone foundation wall section not documented during 2013 survey, view southwest.**

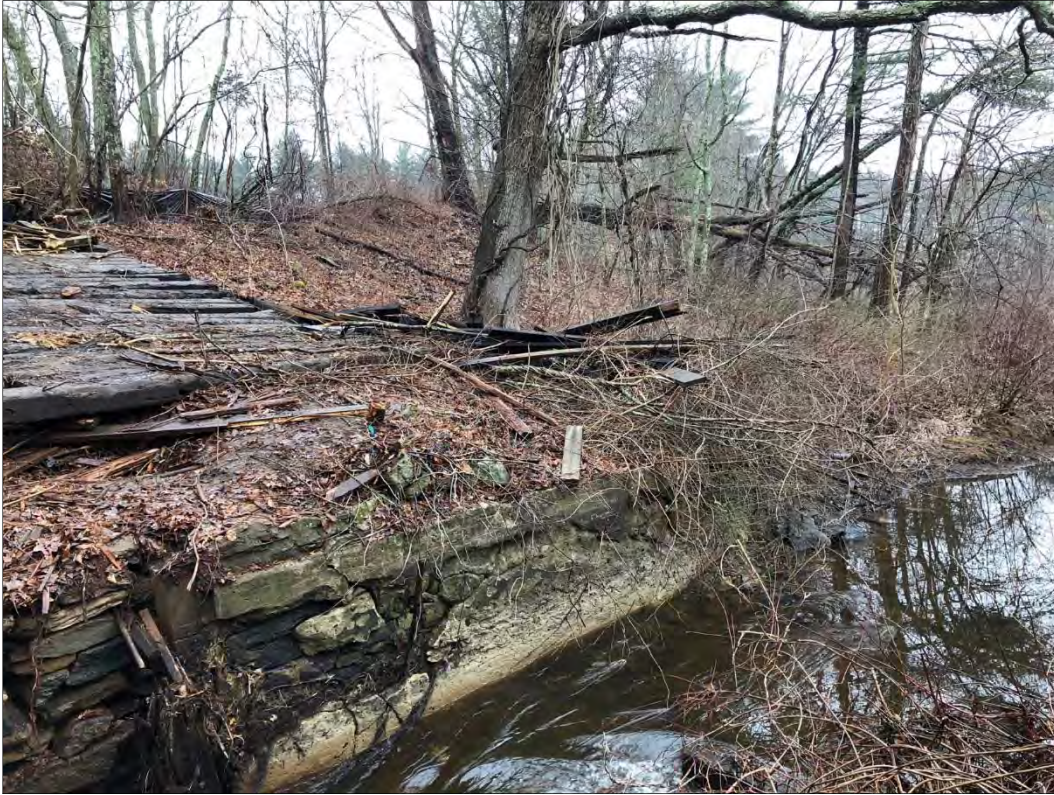
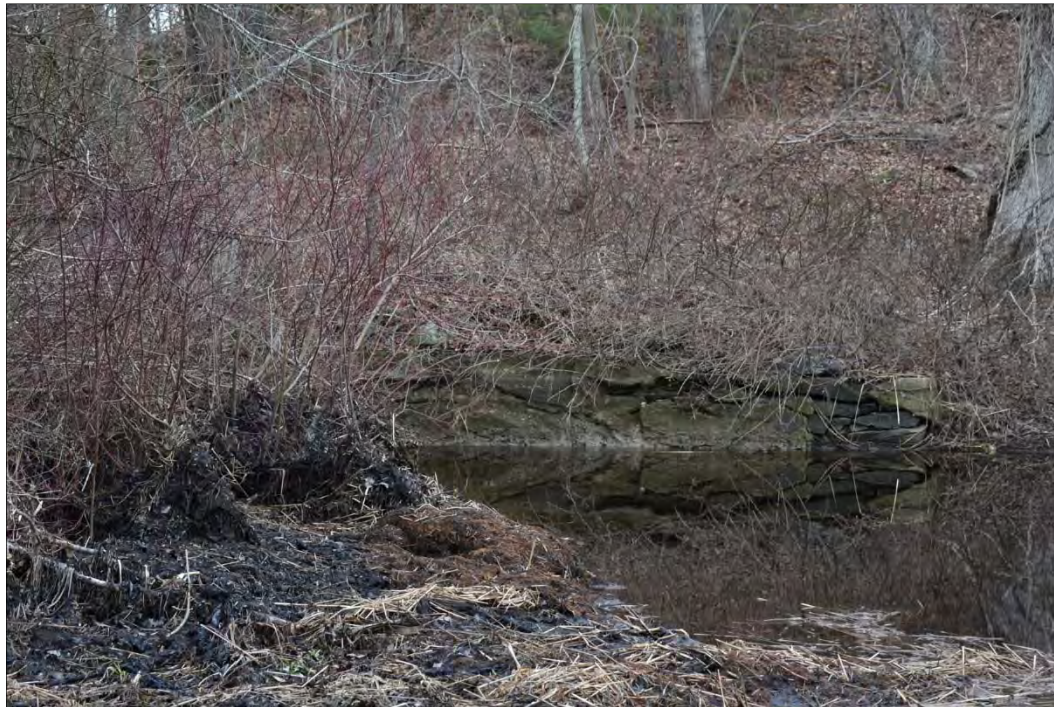
**Figure 12. Mill foundation wall sections composed of parged concrete over fieldstone foundation wall not documented during 2013 intensive survey, view south: a) wall section under former wood plank deck; and b) wall section lining upstream eastern channel (spillway) at west side of former wood plank deck.**

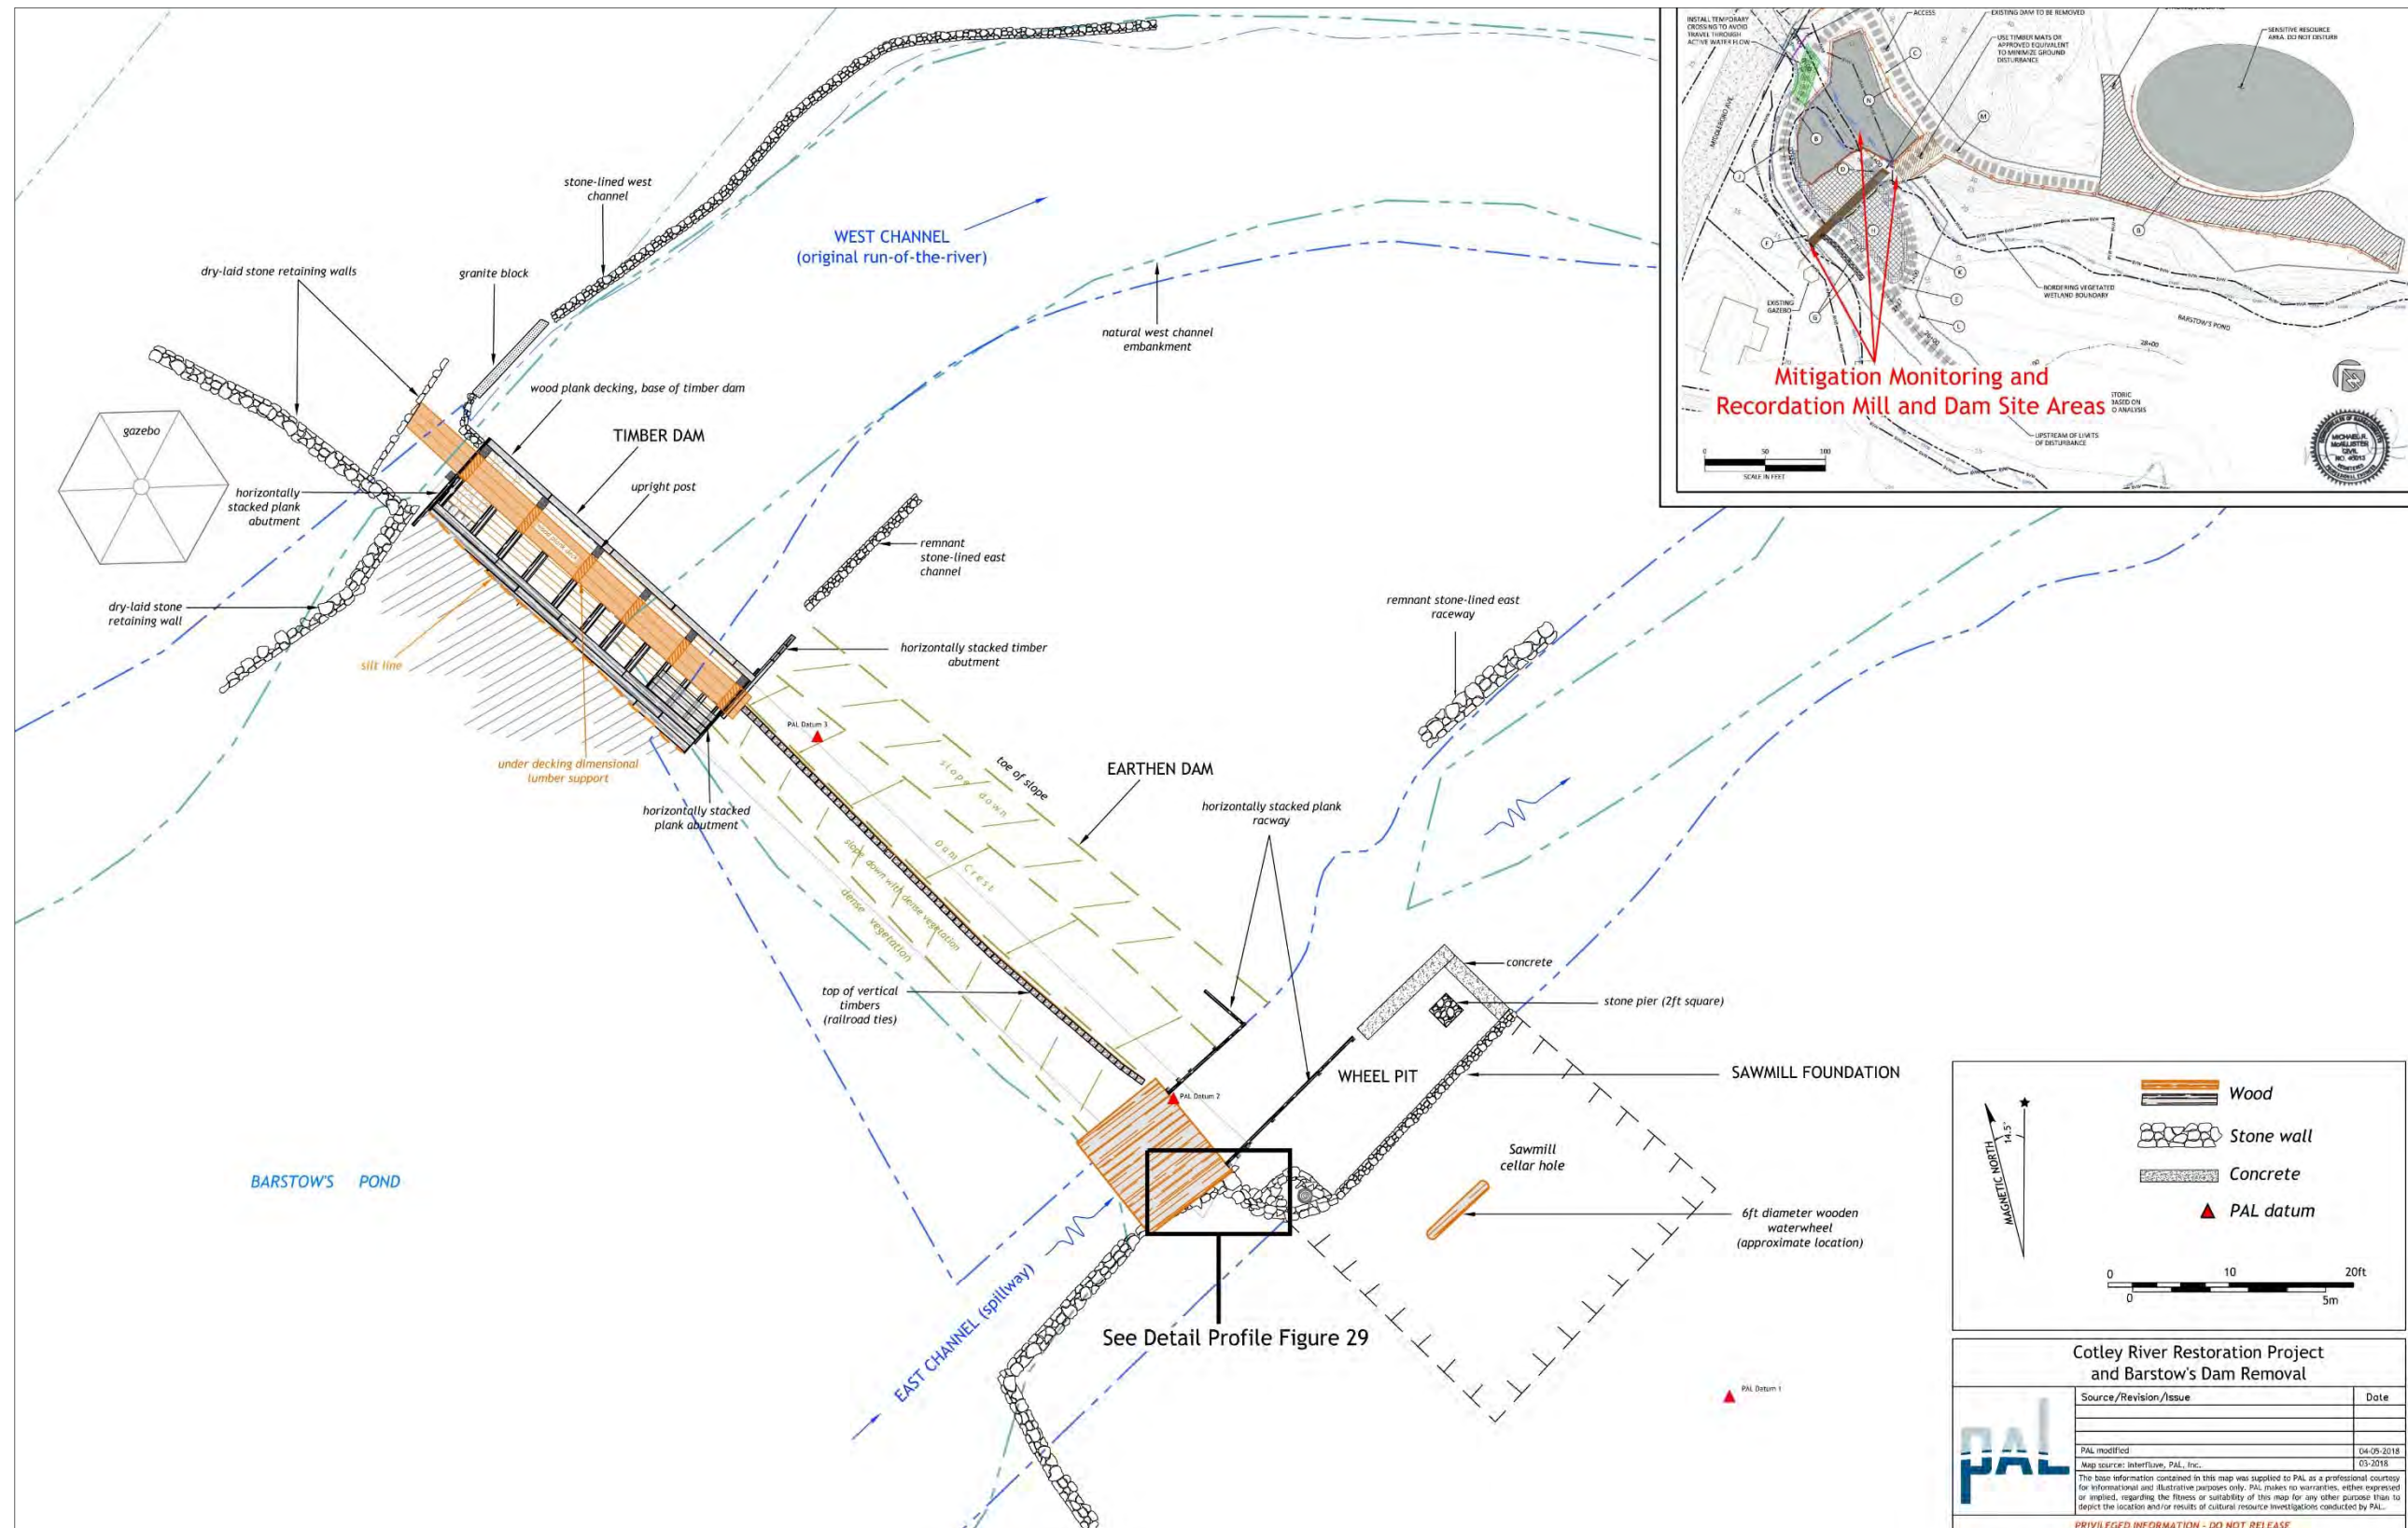
**Figure 18. Plan drawing of mapped earthen and timber dam elements, including wood plank deck across the east channel (spillway) and adjacent mill foundation remains.**

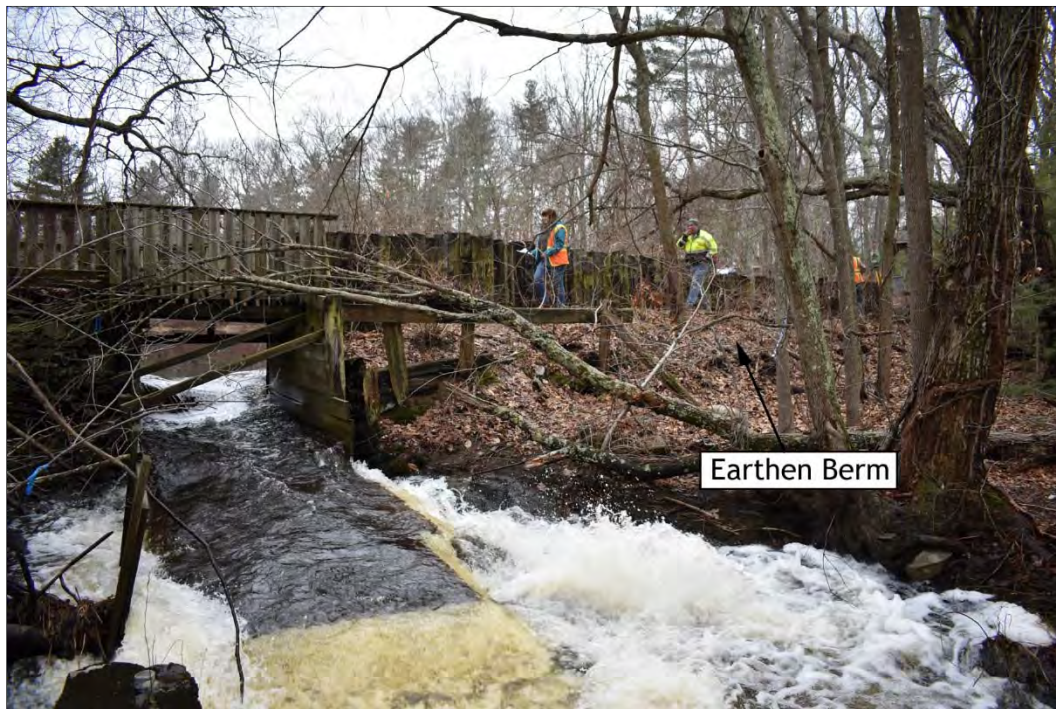
The earthen berm component of the Barstow's Pond Dam was approximately 48 ft (14.6 m) long and 4 ft (1.2 m) high with a flat crest approximately 6 ft (1.8 m) wide (Figure 18). The upstream side (southern edge) of the earthen berm was lined with vertical timbers that rose above the crest of the dam approximately 3 ft (0.9 m) (Figure 19). The timbers were set tightly abutting one another and were reinforced with horizontal wood boards nailed to the upstream (southern) sides (Figure 20; see Figure 19). The timbers were similar in size and shape to railroad ties, with creosote residue on the exterior surfaces and iron S-shaped pins embedded in the short ends to prevent rotting and splitting (Figure 21).

**Figure 19. Earthen berm component of Barstow's Pond Dam structure, view southwest.**

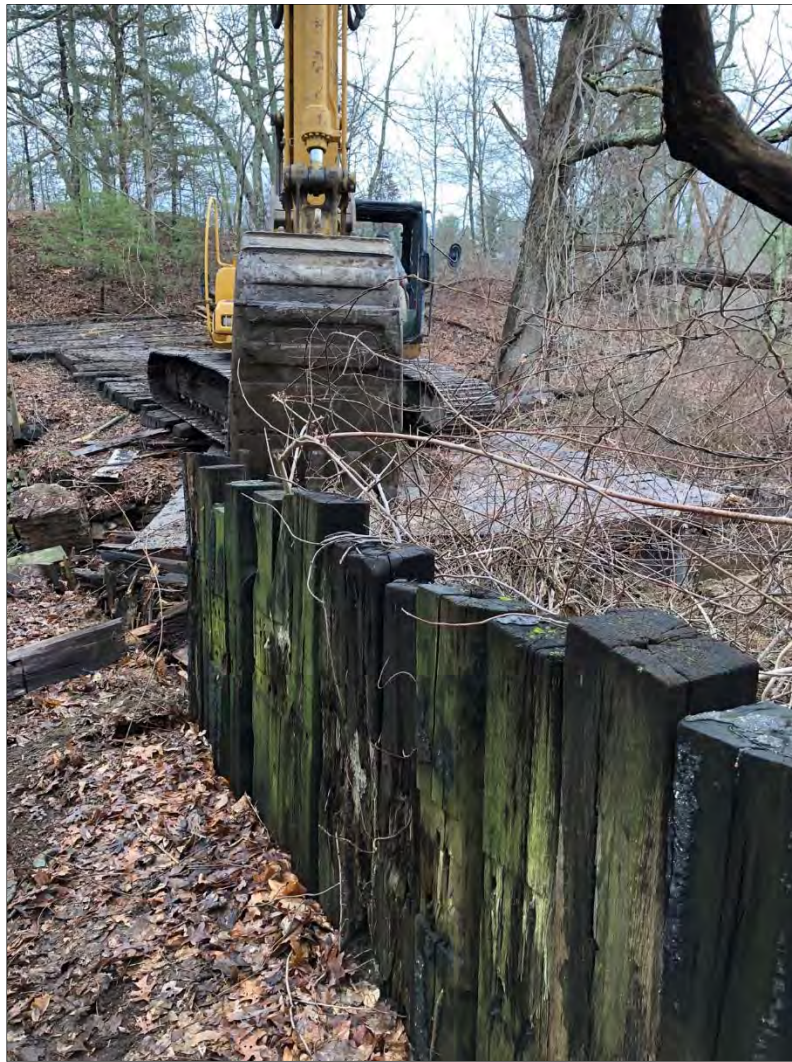
**Figure 20. Vertical wood timbers along upstream side of earthen berm component of the dam, view southeast.**

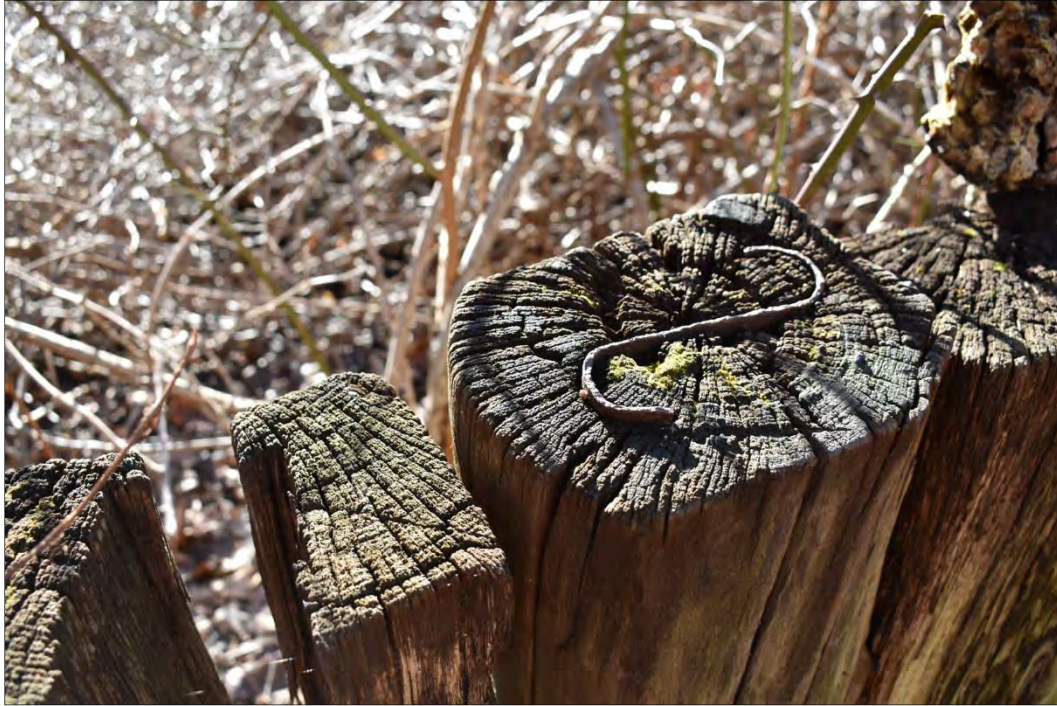
**Figure 21. Iron S-shaped pin embedded in short end of vertical wood timbers in earthen berm component of the dam.**

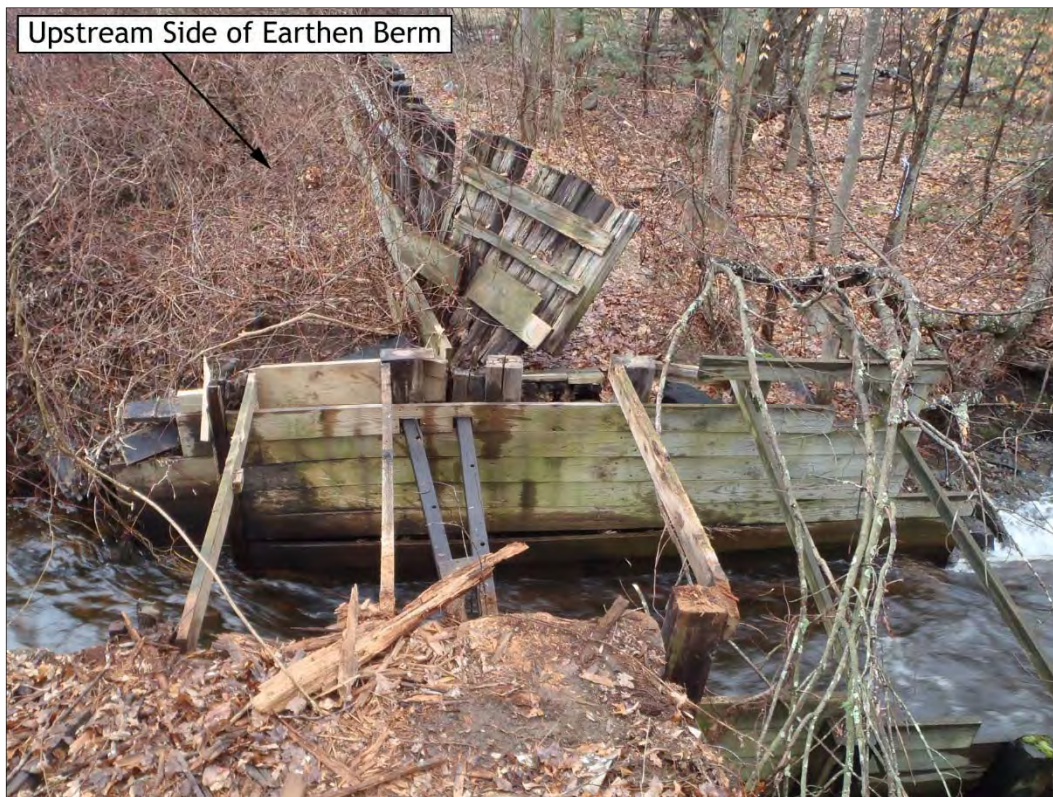
Machine excavation of the dam began with the removal of the modern wood deck and boards from the east channel (spillway) to facilitate drawdown of the impoundment (Figure 30). Removal of the wood deck, underlying support structures, and the wooden boards lining both sides of the spillway destabilized the mortared stones forming the right angle corner of the mill foundation remains closest to the east channel and southwest corner of the western wheel pit (Figures 31 and 32). The 5.2-ft (1.6-m) tall section of destabilized wall is composed of 8–10 courses of mortared narrow fieldstones topped with flat dry-laid fieldstones that formed a roughly 2.5-ft (0.8-m) square corner (Figure 33). The “cornerstone” section abuts the dry-laid fieldstone wall to the west and dry-laid fieldstone wall to the south that was underneath the wood plank deck across the spillway. The stonework rests on a horizontal wood timber set at the water line of the east channel. A rotting vertical wood post is present at the south side of the dry-laid stones where they abut a poured concrete section of mill foundation wall.

**Figure 30. Removal of modern wood decking and boards lining the east channel through spillway section, with earthen berm dam component in the background, view northwest.**

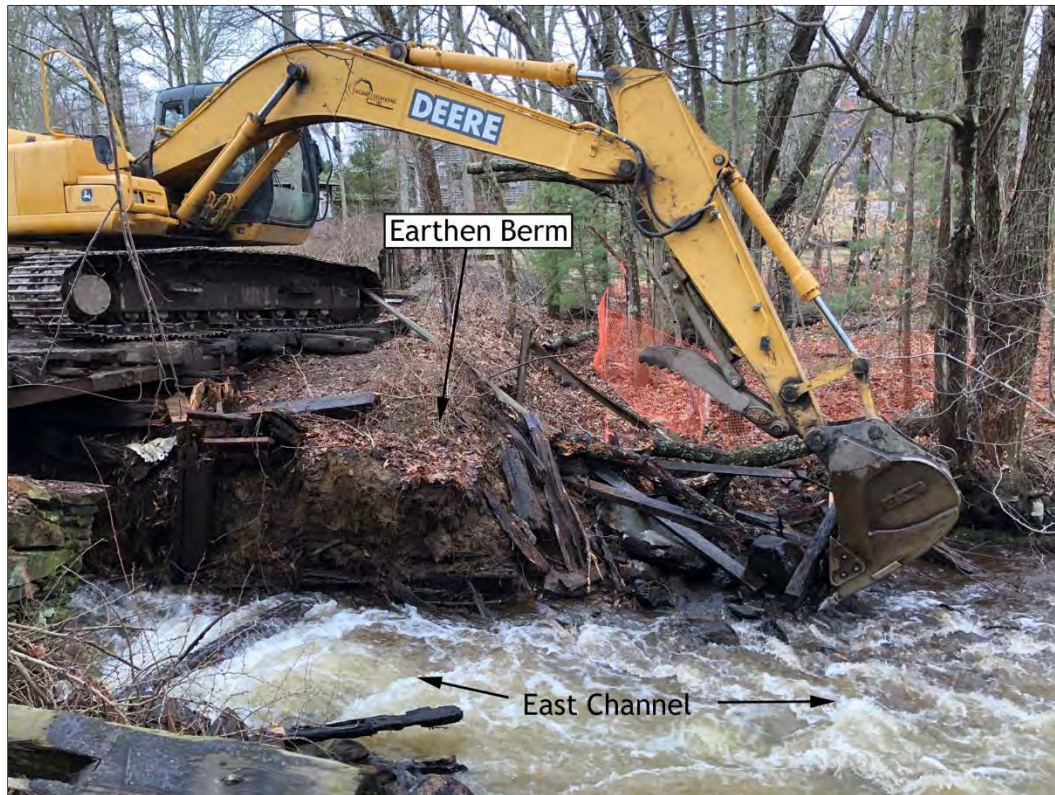
The contractor's machine excavations continued with the excavation of sediments in the east channel to further increase the drainage of the upstream pond and facilitate the dam removal work. Loose timbers and wood boards measuring 4–8 ft (1.2–2.4 m) in length were removed from the spillway and adjacent east bank of the earthen berm and in the east channel (Figure 36). The timbers and boards were not attached or anchored to the spillway sidewalls and most likely were remnants of flashboards and/or earlier spillway and sluiceway gate components.

**Figure 36. Contractor excavations in east channel (spillway) to facilitate upstream pond drainage, view east).**

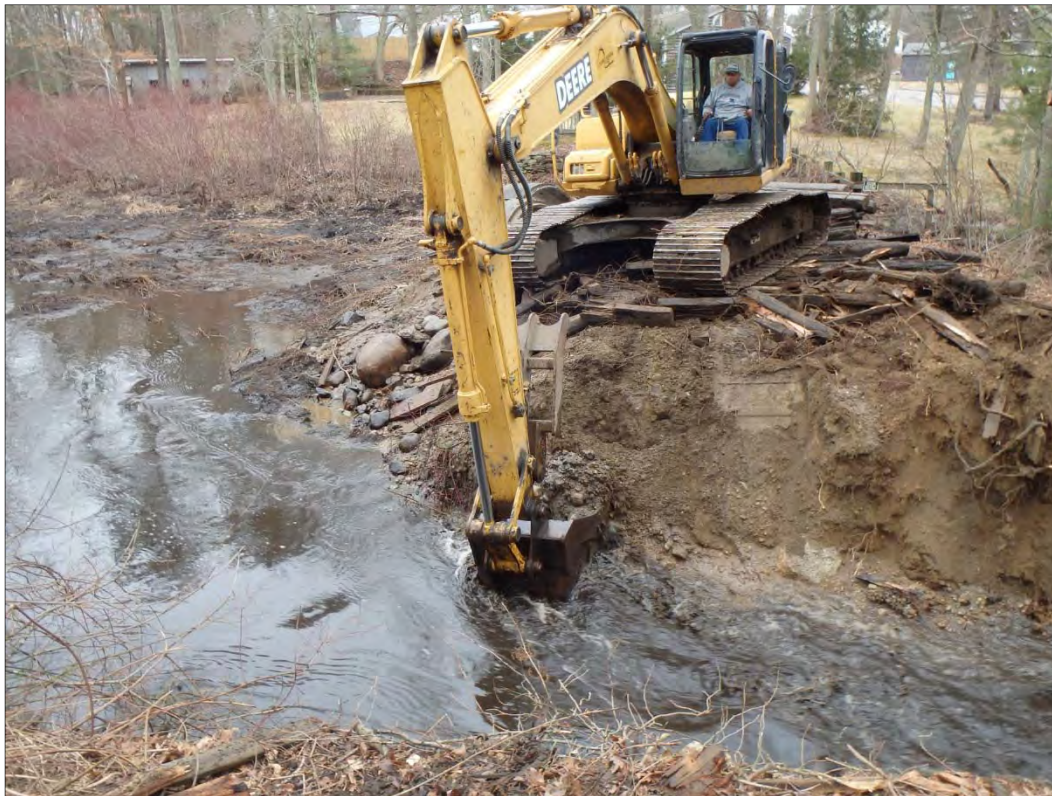
Once the water levels had receded, the contractor continued with the removal of the east portion of the earthen dam and the associated vertical timbers along the upstream side to facilitate the placement of the steel plates for vehicle access over the east channel<sup>5</sup> (Figure 39). Only the upper 3–4 ft of the earthen fill, consisting of brown (10YR 4/3) and light yellowish brown (10YR 6/3) silty medium sand with gravel, were removed. The lower fill levels were left in place to provide an upstream barrier to the "island" kept in place between the west and east channels.

**Figure 39. Contractor excavations in east end of earthen dam at east channel, view northwest.**

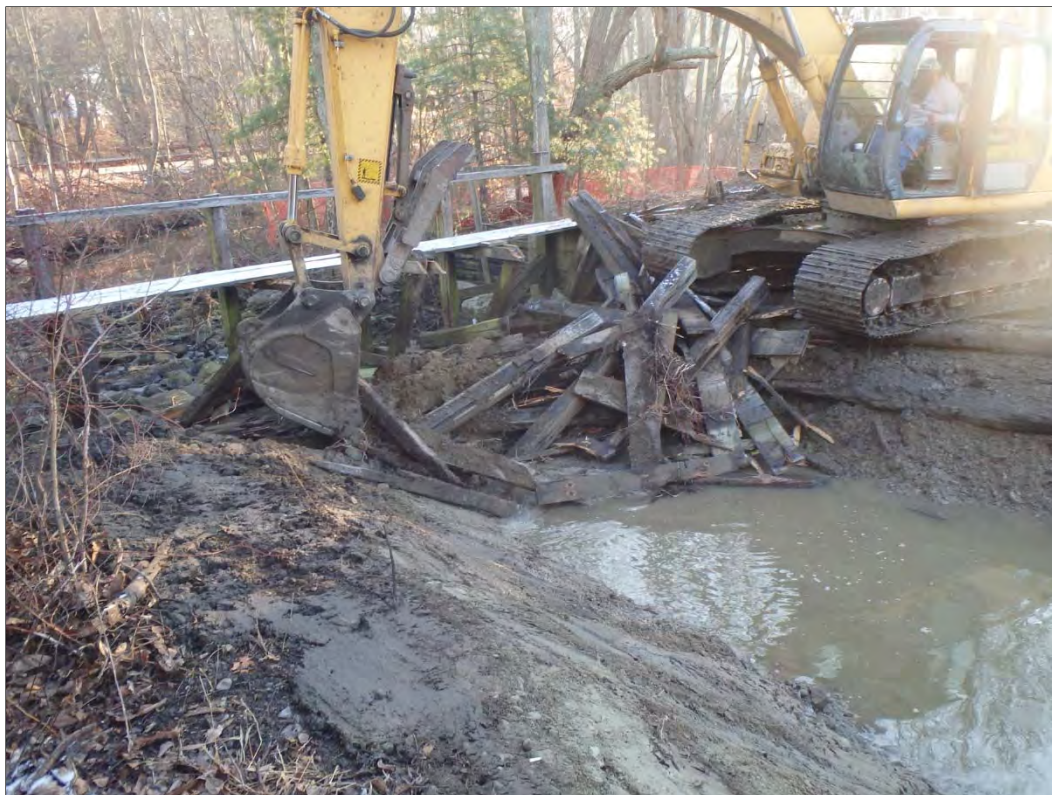
Work then continued to the west with the removal of the timber dam's wood planks and braces (Figure 40). Once the timber dam component was fully removed, the west channel was reconstructed away from the stone and wood plank abutments (Figure 41). Excavation of the remainder of the earthen dam to the desired grade (as noted above) then continued from west to east; the dam fill in this area was consistent with that observed in the east portion (Figure 42). Bank treatment along the west and east river channels was conducted concurrently with dam excavation and the construction of the east channel (Figures 43–45). The only cultural materials noted in the earthen berm fill soils were a few scattered bricks stamped "S & H" for

**Figure 40. Removal of timber dam from the east on remaining upstream portion of earthen dam fill, view east.**

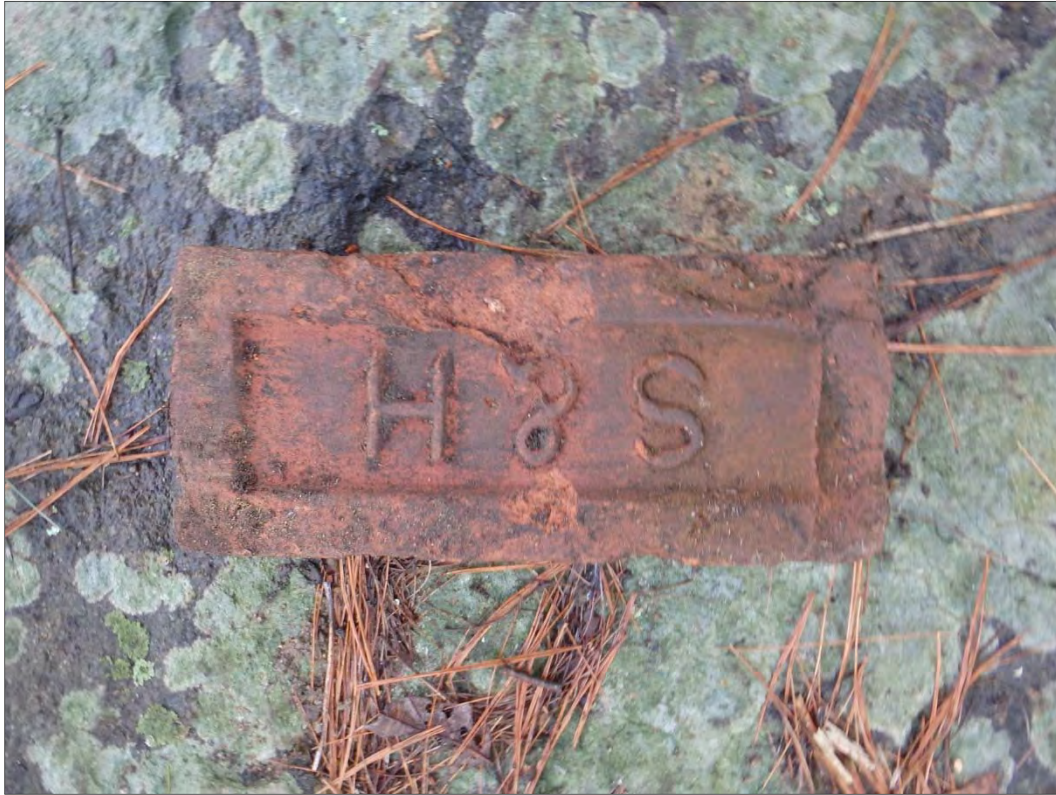
Stiles and Hart, a brick manufacturer established in 1886 in Bridgewater, Massachusetts (Figure 46; Stiles and Hart Brick Company 2018).

**Figure 46. “S & H” stamped brick noted in earthen dam fill.**

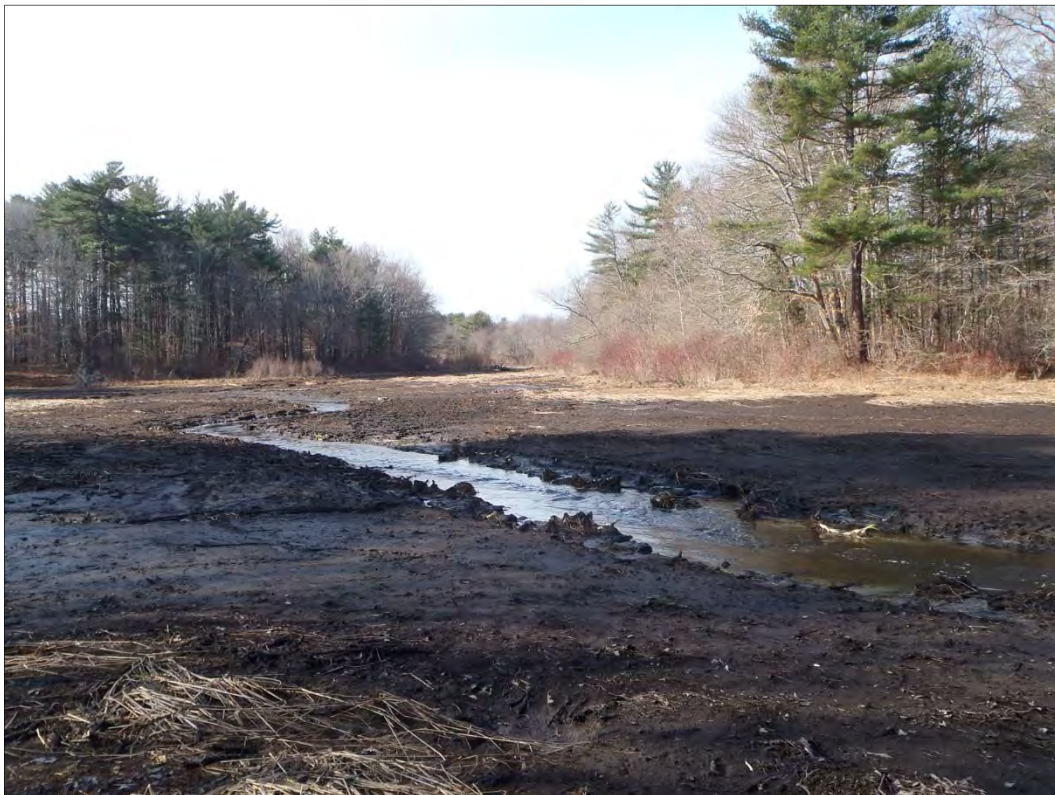
PAL conducted a walkover/reconnaissance survey with close ground surface inspection of the exposed areas of the upstream impoundment following the pond drawdown and dam removal work. The survey was conducted from the edge of the impoundment because the silt deposits were completely waterlogged (Figure 47). The impoundment shoreline sloped gently along the west side and was a steep embankment along the east side (Figure 48; see Figure 47). The impoundment contained soil and vegetation, particularly along the shorelines that was elevated enough to be intermittently dry during low water levels (Figure 49). The overlying silt deposits obscured the natural (pre-industrial) impoundment landforms and any cultural features that might have been present. No surface indications of any in situ pre-contact Native American or post-contact mill-related archaeological deposits were observed during the walkover/reconnaissance survey of the dewatered impoundment.

**Figure 47. Barstow's Pond impoundment after drawdown, view south.**

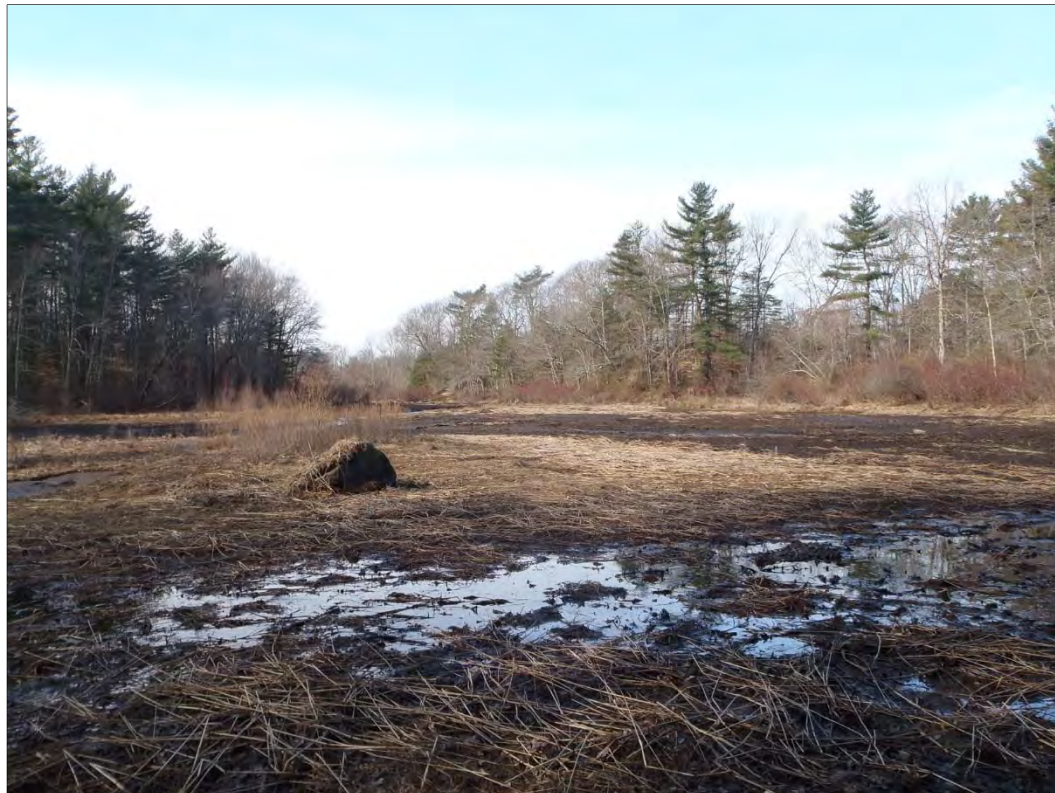
**Figure 48. Eastern bank of impoundment after drawdown, view southeast.**
