TECHNICAL MEMORANDUM

From: Keith Kantak; Mike McAllister, PE; Nick Nelson; Sarah Widing, PE

Date: August 31, 2018

Re: Cotley River Restoration Project, Post-Construction Monitoring, Taunton, MA

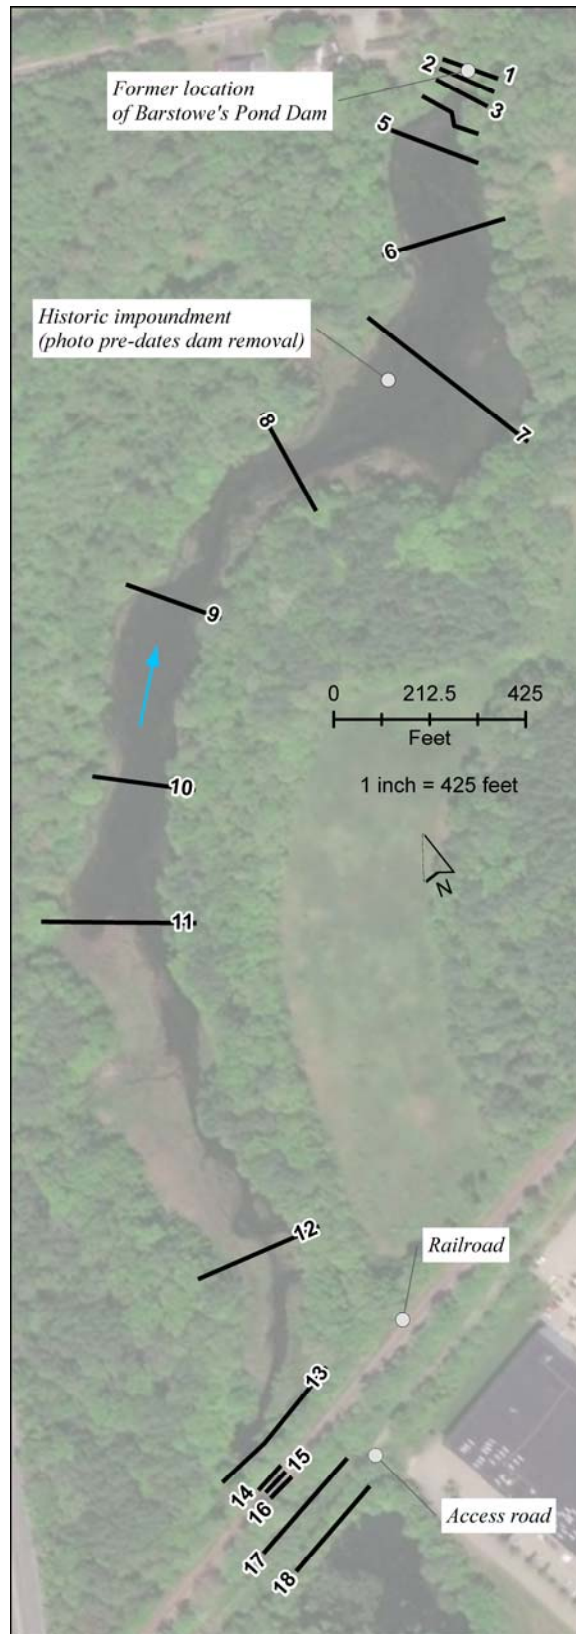
Figure 1. Cross-section locations.

In July and August of 2018, Inter-Fluve collected topographic survey data at 18 cross-sections of the Cotley River extending from the former dam upstream to approximately 100-feet past the railroad crossing (Figure 1). We collected the data with a Real-Time Kinematic (RTK) GPS and Total Station (TS) equipment.
