**Crossing Assessment for the Sandy Neck Barrier Beach System Area  
of Critical Environmental Concern (ACEC)**

**Suggested Citation:** Duffey, S.M. and A.L. Pappal. 2019. Crossing Assessment for the Sandy Neck Barrier Beach System Area of Critical Environmental Concern (ACEC). Massachusetts Office of Coastal Zone Management, Boston, MA.

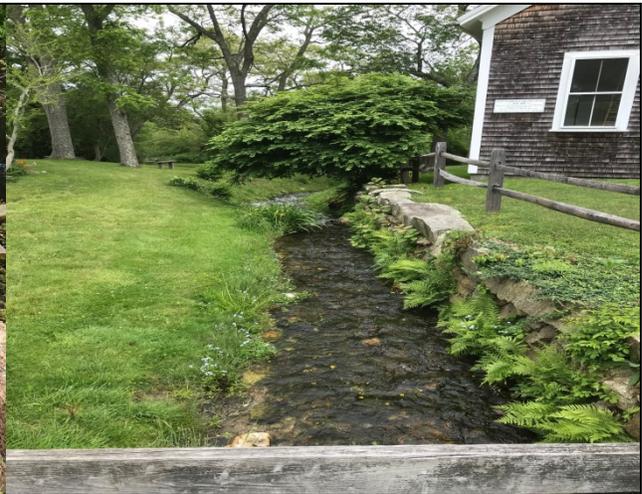
**Figure 4: The downstream area of site S4 which falls on the Nye Family of America Homestead and Museum property.**

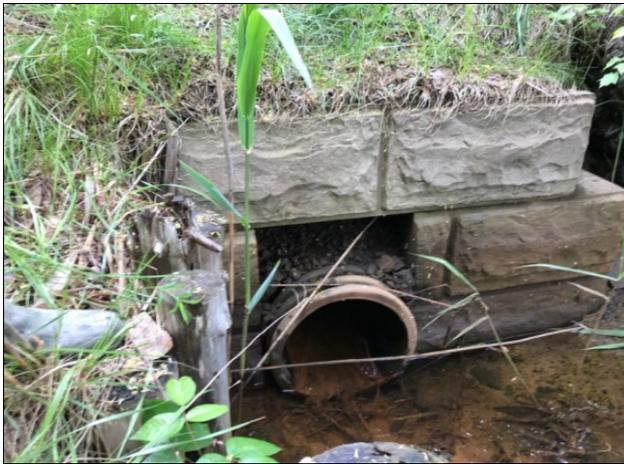
Located on the Game Farm Driveway in East Sandwich, this restriction is on a small unpaved road that leads to a parking lot owned by the Massachusetts Department of Fish and Game (DFG). The structure at S5 was reconstructed in 2012. Prior to replacement, the crossing was reported to be in poor condition with a broken corrugated metal pipe and clogged with debris (Justus et al. 2001). At the time of the current assessment, a plastic corrugated pipe with a metal tide gate within a stone headwall on the downstream side severely restricts flow to the upstream side. The structure is in new

condition. No visible utilities are present at the site. Crossing S8 (pg. 19) is located downstream and could be contributing to the restriction at this site by impairing flow and drainage, and therefore should be considered with any restoration efforts at S5. The property is currently owned by DFG and leased to the Thornton Burgess Society. The vegetation on the downstream and upstream sides is very different, with the downstream area consisting of *Spartina* spp., while the upstream area is dominated by the invasive common reed (*Phragmites australis*). It is unclear whether this channel or the area leading up to the tide gate serve as an anadromous fish run. A clear tidal restriction is present at this site; observations indicate the flap gate structure significantly restricts saltwater flow upstream of the crossing at all stages of the tide. Visual indicators of a restriction include the dominance of *P. australis* in the upstream affected area, ponded water and a scouring basin at the downstream tide gate, and slumping of the marsh surrounding the downstream structure.

**Figure 14: The upstream culvert at site S5 shown at high tide.**

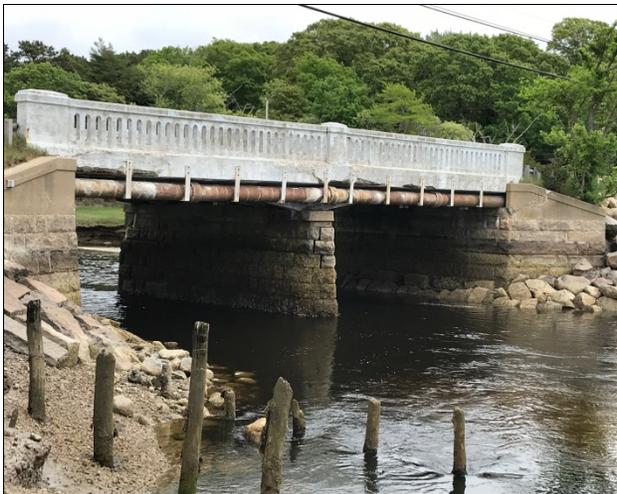
This crossing is located where Route 6A crosses Scorton Creek. It is a stone and concrete bridge with two cells separated by a center column and appears to be in OK condition. Visible utilities include overhead electrical wires and a water/sewer pipe in the ground. This bridge is the furthest downstream crossing of Scorton Creek, with crossings S4 (pg. 10), S7 (pg. 12), S19 (pg. 14), S5 (pg. 16), and S10 (pg. 21) all located upstream. Much of the immediate upstream marsh habitat is owned

by the Massachusetts Department of Fish and Game (DFG), and the downstream area is privately owned. In 2001, the Cape Cod Atlas of Tidally Restricted Salt Marshes noted visual indicators of a restriction including scouring and erosion on both the upstream and downstream sides, as well as significant marsh slumping and vegetation die-back seaward of the crossing (Justus et al. 2001). In the current assessment, the vegetation between the upstream and downstream areas was observed to be very similar, with *Spartina* spp. the dominant species. Significant marsh slumping, bank erosion, and vegetation die-back on the creek banks was noted on both sides of the crossing along with large scouring basins. These indicators are likely a result of high velocity water flow through the crossing caused by both tides and storm events. The Town of Sandwich has expressed interest in restoring the once active anadromous fish run up Scorton Creek and through Mill Creek to Nye Pond, which passes through this crossing as well as S4, S7, and S19. Based on observations from the current assessment, this crossing does not appear to inhibit aquatic organism passage.

**Figure 17: The upstream side of site S8 shown at low tide.**

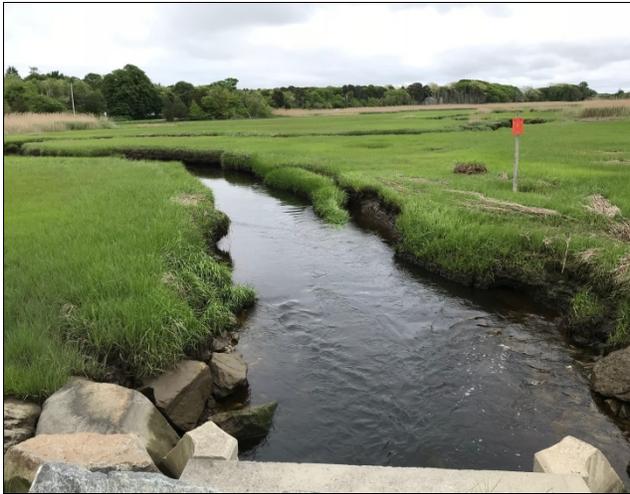
A concrete box culvert facilitates the flow of Scorton Creek under Jones Lane. The culvert was replaced and widened in 1998 and appears to be in OK condition. Overhead electrical wires are visible at the site. Crossing S8 (pg. 19) is located downstream and could be contributing to the restriction at this site by impairing flow and drainage, and therefore should be considered with any restoration efforts at S10. The downstream area is owned by the Town of Sandwich, with the upstream area split between the Sandwich Conservation Trust and private ownership. Upstream of

this crossing the waterway joins the portion of Scorton Creek that drains into Barnstable Harbor. Consequently, the upstream area of this crossing merges with the upstream area for B1 (pg. 25). In the Cape Cod Atlas of Tidally Restricted Salt Marshes, some visual indicators of a restriction were identified in 2001 including scouring, erosion, and marsh slumping on the downstream side of the crossing (Justus et al. 2001). In the current assessment, the vegetation between the upstream and downstream areas was observed to be very similar, with *Spartina* spp. the dominant species. Visual indicators of a restriction include marsh slumping and bank erosion occurring both upstream and downstream of the crossing. The invasive common reed (*Phragmites australis*) is present both upstream and downstream of the site, but far enough away that it is unlikely that its presence is related to this crossing. Scorton Creek has historically supported anadromous fish runs according to the Cape Cod Atlas of Tidally Restricted Salt Marshes (Justus et al. 2001), and this crossing does not appear to contain structures that would impede fish passage.

**Figure 20:** The salt marsh habitat immediately upstream of site S10. Stands of the invasive common reed (*Phragmites australis*) can be seen in the distance.

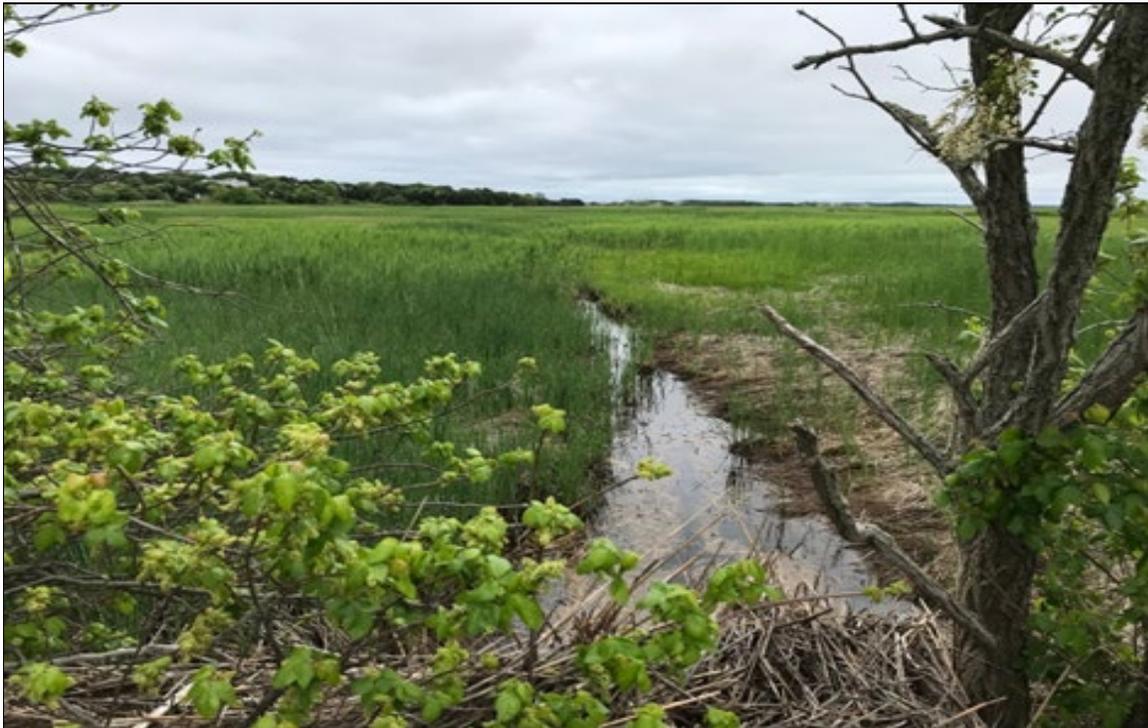
At this location, Scorton Creek flows underneath Route 6A and into Barnstable Harbor. The crossing consists of a concrete pipe that appears to be in poor condition. Overhead electrical wires are visible at the site. This site falls on the boundary between the Town of Sandwich and the Town of Barnstable, with the two towns splitting ownership of the downstream area. The upstream area is

split among multiple private landowners. Upstream of this crossing the waterway joins the portion of Scorton Creek that drains into Cape Cod Bay. Consequently, it is here that the upstream area of this crossing merges with the upstream area of S10 (pg. 21). In the Cape Cod Atlas of Tidally Restricted Salt Marshes, the pipe is identified as being in good condition and unclogged in 2001. Fringing invasive common reed (*Phragmites australis*) was also documented on the upstream side (Justus et al. 2001). In the current assessment, however, the structure was observed to be at least partially clogged, as evidenced by very little active water flow through the structure. The vegetation upstream is moderately different from downstream; both sides are indicative of a brackish to freshwater wetland, but *P. australis* is much more prevalent on the upstream side. Visual indicators of a restriction include ponded water, scouring basins, vegetation die-back on both sides, and bank erosion on the upstream side. The higher prevalence of *P. australis* on the upstream side may also be evidence of a restriction at the site, as it prefers less saline waters. Based on observations from the current assessment, the structure may need to be unclogged to allow better flow through the culvert.

Figure 29: The downstream area of site B1 is characterized by broadleaf cattail (*Typha latifolia*), invasive common reed (*Phragmites australis*), and other species indicative of a brackish wetland.

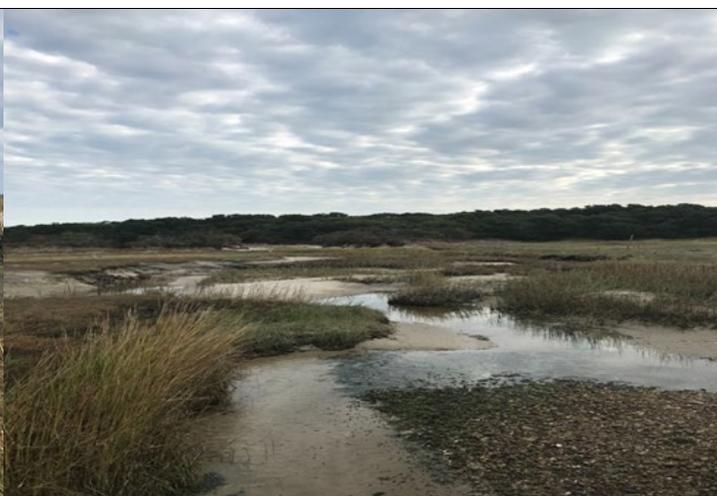
**Figure 42:** The upstream area of site B23 shows a transition from a salt marsh to a dune community, and the creek consists of predominantly sandy sediment.

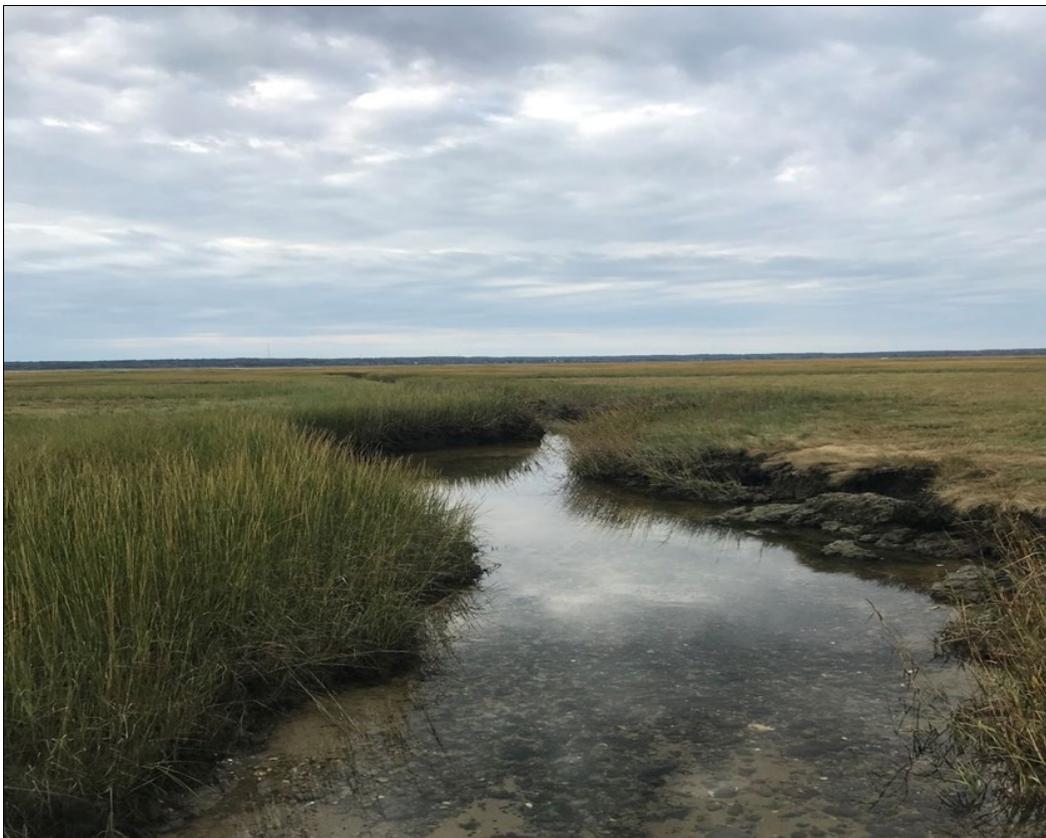
**Figure 43: The downstream area of site B23 is part of the expansive Barnstable Great Marsh.**

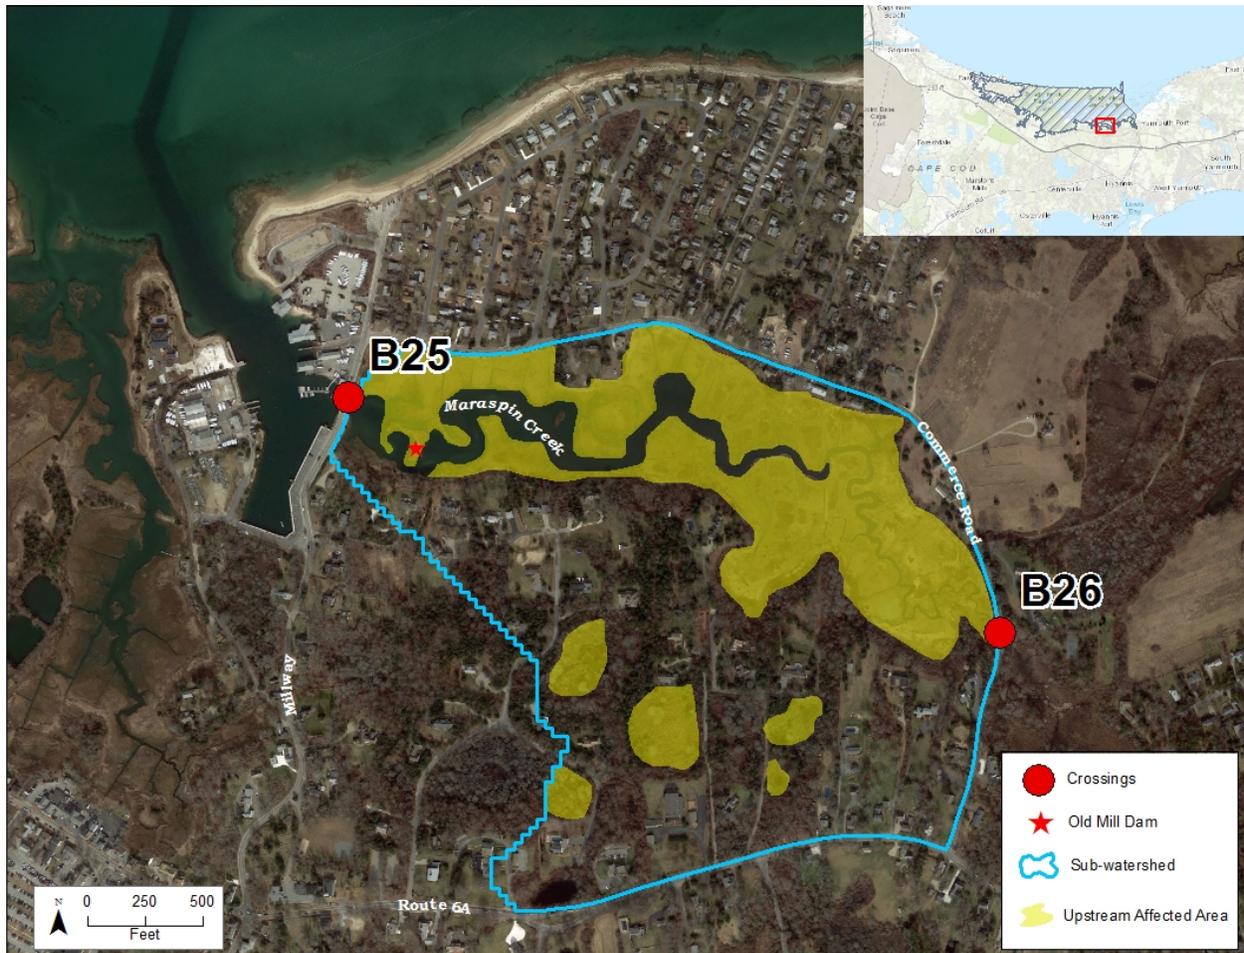
**Figure 44:** Site B25 is located at 41.7065°N 70.2984°W in Barnstable. Upstream Affected Area (as shown in the pea-green shaded area): Salt Marsh, 31.77 acres; Shallow Marsh, Meadow, or Fen, none; Shrub Swamp, 5.32 acres (based on the MassDEP Wetlands layer). Crossing B26 (pg. 41) is located upstream.

The concrete and stone bridge of Millway Road crosses Maraspin Creek at this site. The bridge appears to be in OK condition, and the upstream and downstream sides of the bridge are lined with large rocks for armoring. Overhead electrical wires are present at the site. This site is located downstream of crossing B26 (pg. 41). The upstream side of the crossing has a mix of ownership among private landowners, the Massachusetts Audubon Society (Mass Audubon), and the Barnstable Land Trust. The downstream side is owned by the Town of Barnstable and Millway

Marina, Inc. In the Cape Cod Atlas of Tidally Restricted Salt Marshes, a rise in elevation from the downstream to upstream side is noted. The remnants of an old mill dam on one of the many channels flowing through the upstream salt marsh were also observed (Justus et al. 2001). These characteristics were also observed in the current assessment, as well as rip rap on the upstream side of the crossing. The vegetation on the upstream side is very different from the downstream, as the upstream side is a salt marsh dominated by *Spartina* spp. while the downstream side is a public marina with no vegetation. Visual indicators of a restriction include marsh slumping, bank erosion, and ponded water on the upstream side of the crossing. There is no invasive common reed (*Phragmites australis*) at the bridge, but there are significant stands further upstream into Maraspin Creek. The perch created by the rip rap located in the creek may impede the movement of aquatic organisms at low tide. The elevation change, old mill dam, and rip rap should all be taken into account if this site is considered for restoration.

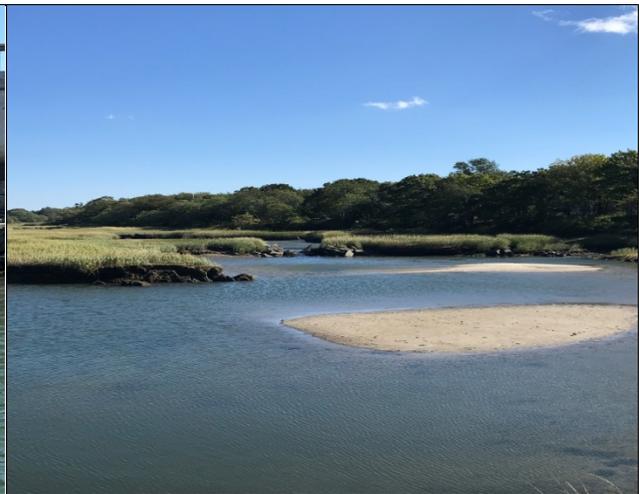
**Figure 46: The upstream area at site B25 is salt marsh habitat, where water must flow through multiple channels to move upstream, including through the site of an old mill dam.**

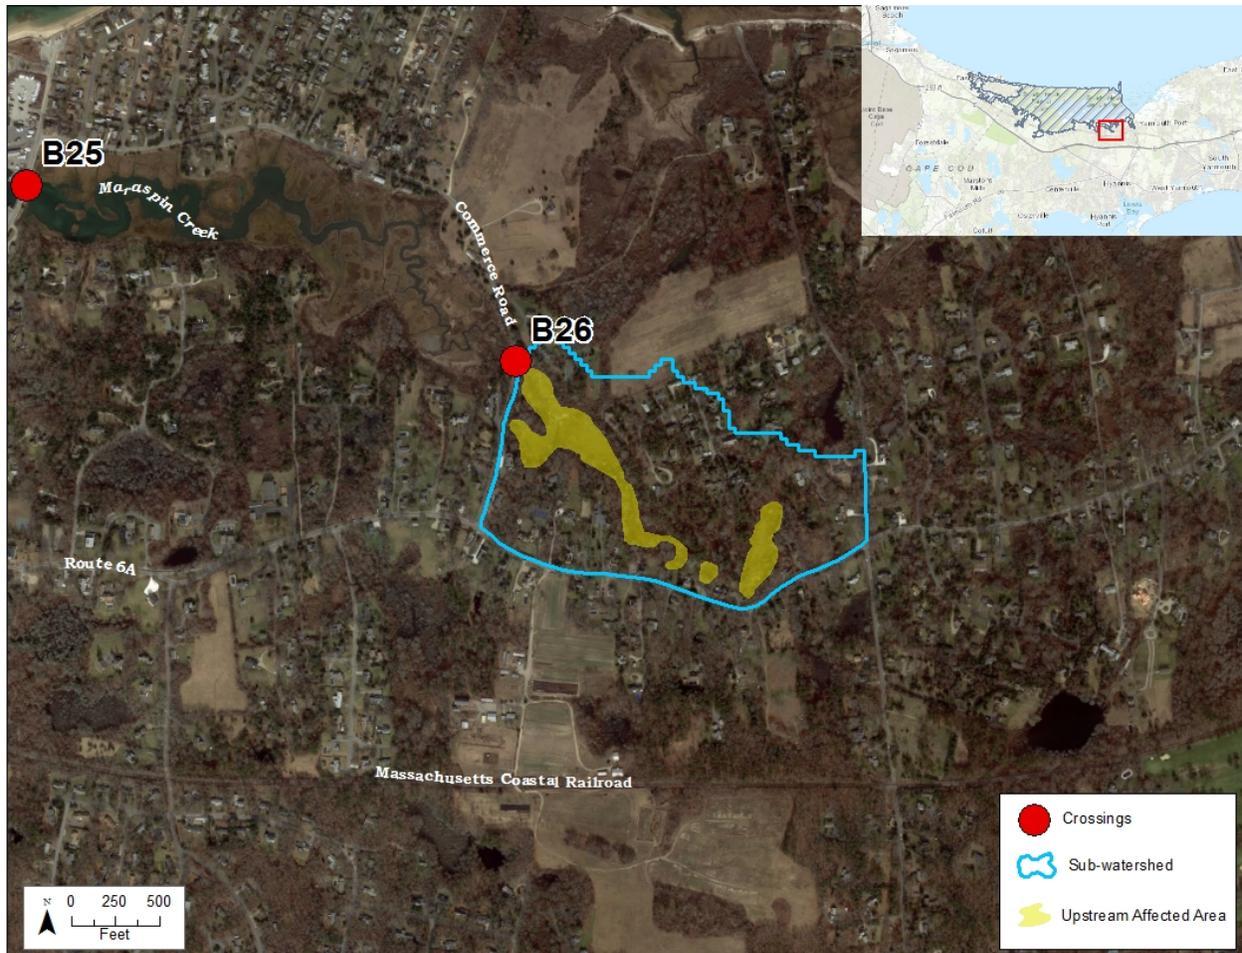
**Figure 47:** Site B26 is located at 41.7026°N 70.2882°W in Barnstable. Upstream Affected Area (as shown in the pea-green shaded area): Salt Marsh, none; Shallow Marsh, Meadow, or Fen, 1.57 acres; Shrub Swamp, 5.77 acres (based on the MassDEP Wetlands layer). Crossing B25 (pg. 39) is located downstream.

At this location, Maraspin Creek flows under Commerce Road through a corrugated metal pipe. The pipe appears to be in poor condition and is partially collapsed on both the upstream and downstream sides of the culvert. Visible utilities at the site include overhead electrical wires and underground water/sewer pipes. Crossing B25 (pg. 39) is located downstream and could be contributing to the restriction at this site by impairing flow and drainage, and therefore should be considered with any restoration efforts at B26. There is a mix of ownership on both the upstream

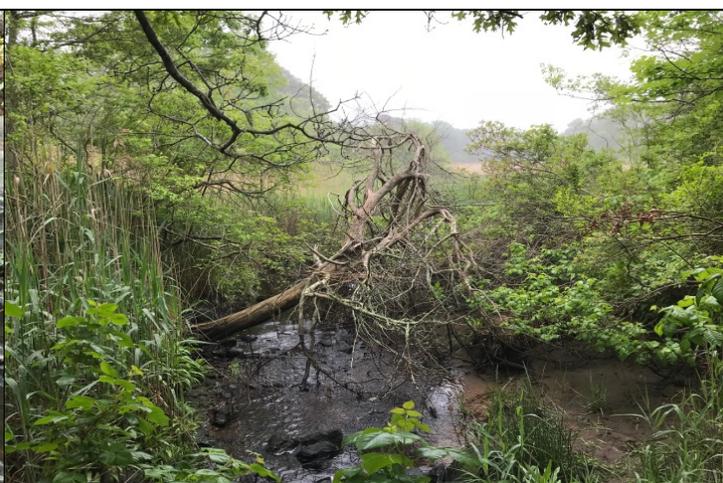
**Figure 49:** The upstream side of site B26 is a mix of freshwater wetland species, with a dead tree overhanging the creek. A stand of the invasive common reed (*Phragmites australis*) is observable on the left side of this photo, and is more prevalent further upstream.

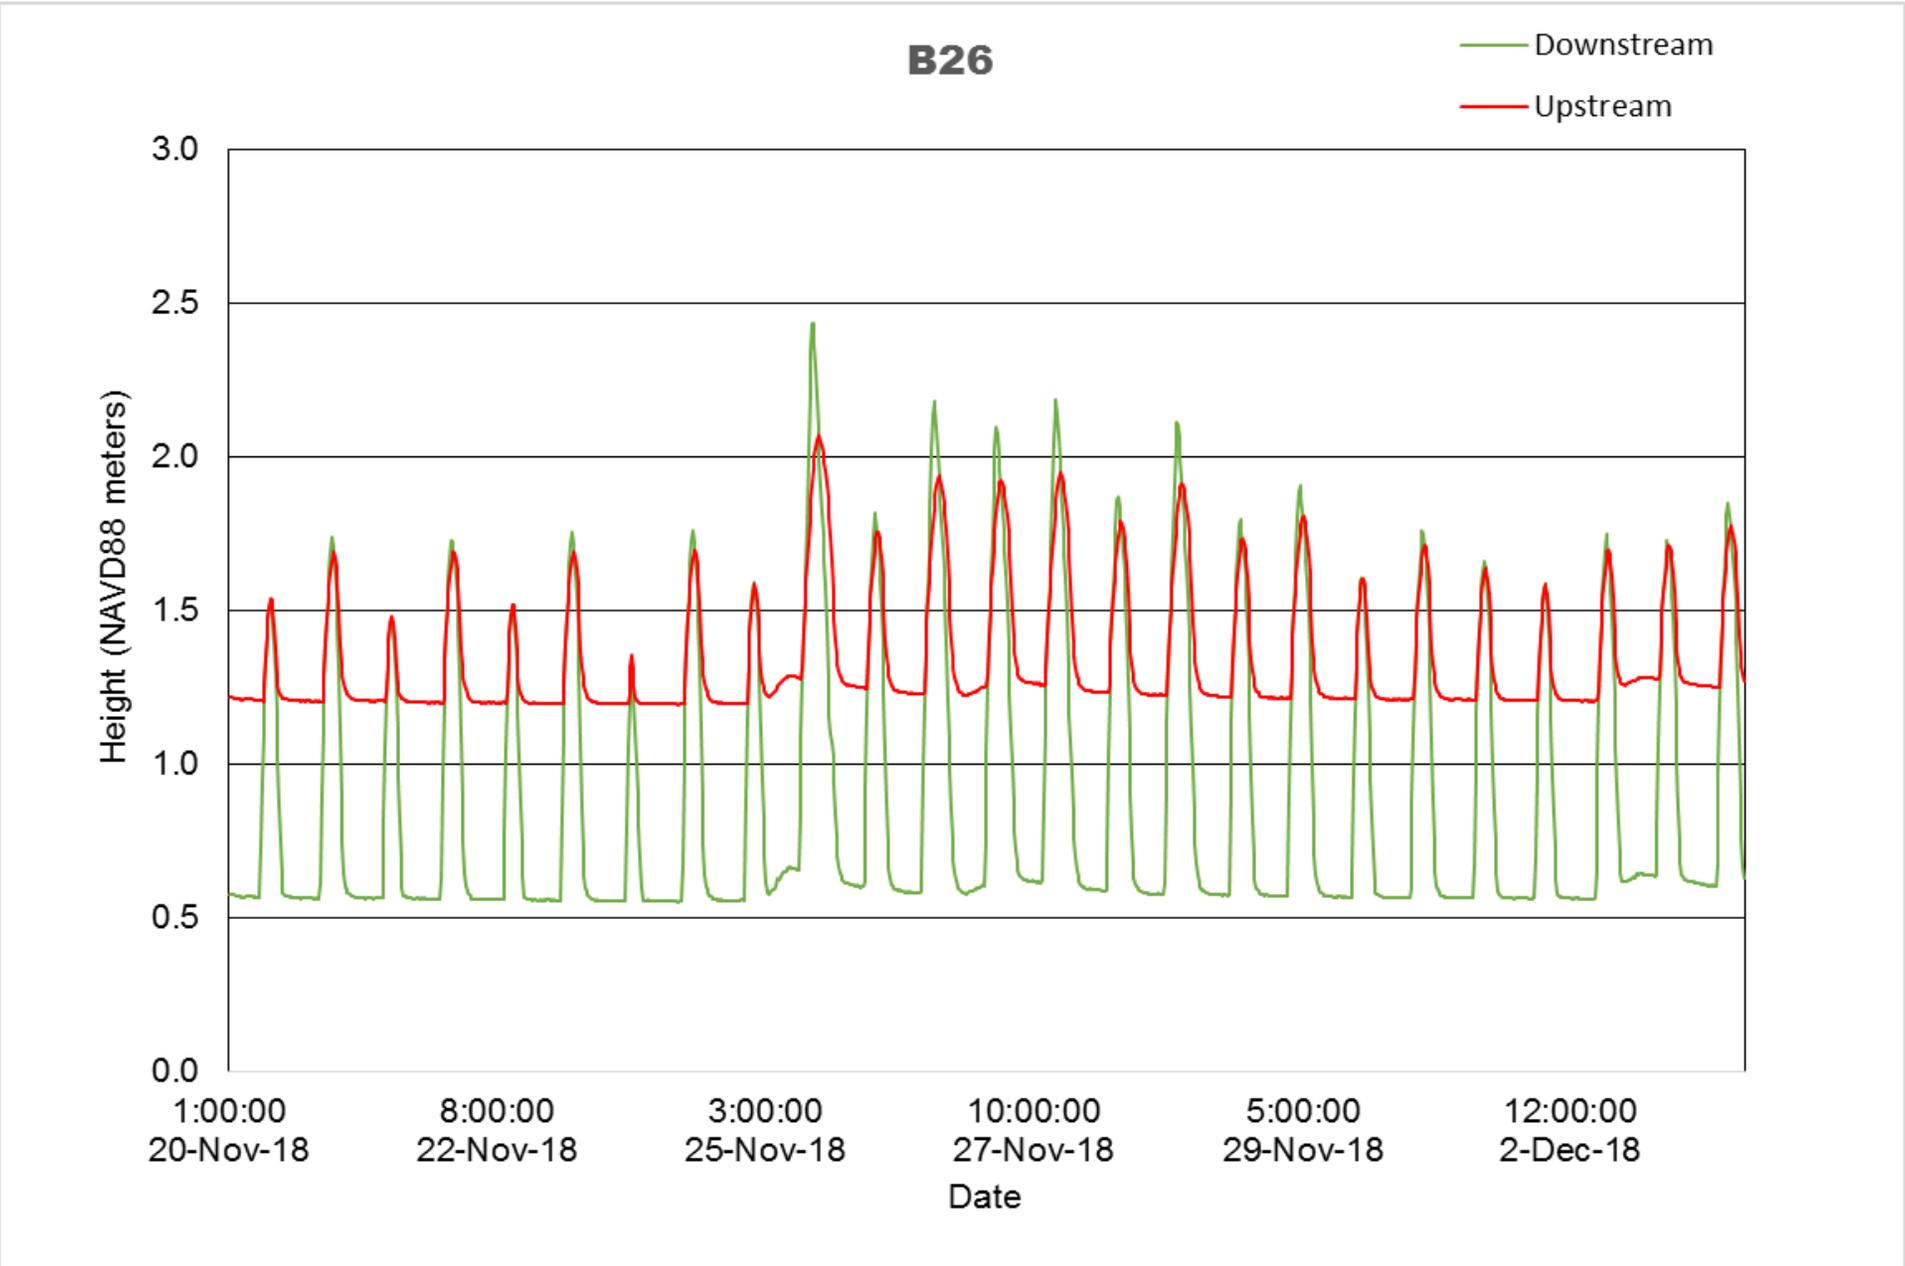
During this time period, the crossing at site B26 caused a restriction of the water level on the upstream side (Figure 52). The mean tidal range was 1.31 meters on the downstream side and 0.56 meters on the upstream side indicating that the upstream side of the crossing site receives, on average, 43% of the tidal flow compared to the downstream side. The highest tide recorded at the site occurred on November 25 with a height of 2.43 meters NAVD88 on the downstream side and 2.07 meters NAVD88 on the upstream side, with a delay of 1 hour between downstream and upstream (this was the largest delay of high tide during the deployment period; 12:45 p.m. on the downstream side and 1:45 p.m. on the upstream side). The maximum tidal restriction of 0.36 meters NAVD88 was also recorded at this time. Elevation of the downstream marsh surface and culvert were measured at 1.09 meters and 1.17 meters NAVD88 respectively. Based on the logger measurements and these elevations, the water level reached a height greater than the top of the culvert for some duration during every tidal cycle measured during this time period.

A precipitation event on November 25 resulted in 3.76 centimeters (about 1.5 inches) of rainfall in the Town of Barnstable (NOAA 2018). The high freshwater inflow from the precipitation event as well as tidal flow contributed to the high water levels observed on this date (Figure 52). Due to the restriction at site B26, the upstream side of the culvert may not efficiently drain these stormwater and tidal inputs. This could result in water backing up on the upstream side, which could ultimately lead to flooding. Expected climate change effects such as increased precipitation and sea level rise will exacerbate these impacts at this site and others that restrict water flow.

Figure 52: Hydrograph for Site B26 from 11/20/18 to 12/3/18. Data were measured with Onset HOBO data loggers. The green (downstream) and red (upstream) lines represent the fluctuation in water height (NAVD88 meters) during the measured time period. The pulse seen on November 25 is due to a precipitation event that resulted in 3.76 centimeters (about 1.5 inches) of rainfall (NOAA 2018).

The Town of Barnstable recently contracted with the Woods Hole Group (WHG) to conduct a Hydrologic and Hydraulic (H&H) assessment of Maraspin Creek, including modeled scenarios of impacts from flooding and sea level rise with the current culvert and a widened culvert at site B26. Water level data collected by WHG also indicate a tidal restriction exists between the downstream and upstream sides of the culvert at site B26 (Shultz et al. 2019). The results from the current assessment and the WHG study should be used to inform any restoration activity at this site as well as at site B25 (pg. 39).

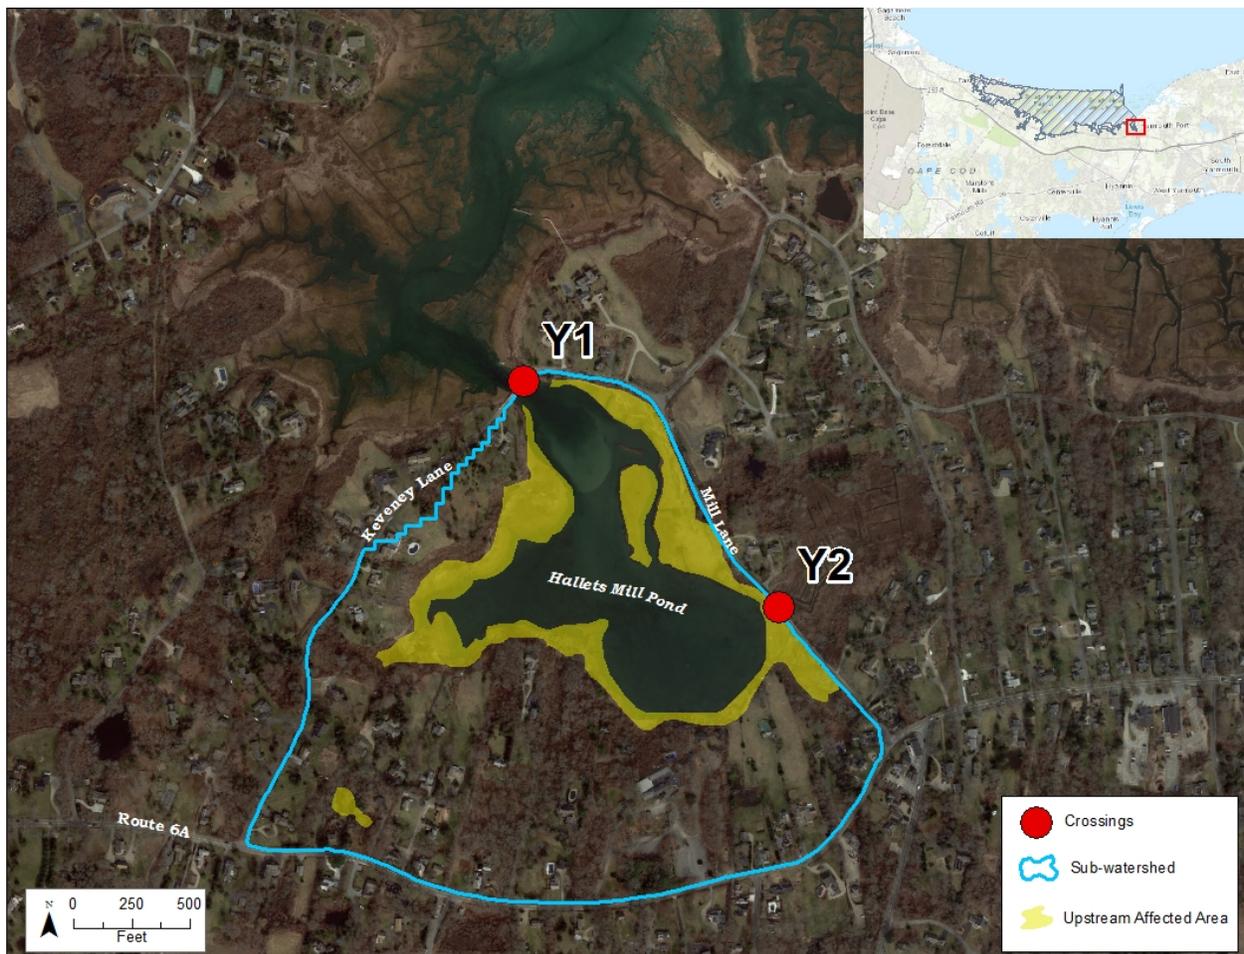
**Figure 53:** Site Y1 is located at 41.7074°N 70.2622°W in Yarmouth. Upstream Affected Area (as shown in the pea-green shaded area): Salt Marsh, 12.56 acres; Shallow Marsh, Meadow, or Fen, 0.57 acres; Shrub Swamp, 0.30 acres (based on the MassDEP Wetlands layer). Crossing Y2 (pg. 48) is located upstream.

The Keveney Lane/Mill Lane Bridge crosses Mill Creek where it intersects with Hallets Mill Pond. The bridge is made of stone and appears to be in OK condition. Both sides of the crossing are heavily armored with large stones. Underground water/sewer pipes are present at the site and overhead electrical wires are visible on either end but do not cross over the bridge. Crossing Y2 (pg.

48) is located upstream. This site falls on the boundary of the Towns of Barnstable and Yarmouth. The upstream area is owned by various private landowners, while the downstream area is owned in part by private landowners and the Barnstable Land Trust. In the Cape Cod Atlas of Tidally Restricted Salt Marshes, the bridge was reported in good condition, and a rise in elevation from the downstream to the upstream side due to rocks under the bridge was observed (and is still present) (Justus et al. 2001). In the current assessment, the vegetation between the upstream and downstream areas was observed to be very similar, with *Spartina* spp. the dominant species on both sides. Bank erosion, marsh slumping, and vegetation die-back were observed on both sides of the crossing. These indicators are likely a result of high velocity water flow through the crossing as a result of both tides and storm events. The invasive common reed (*Phragmites australis*) is present on both the upstream and downstream sides of the crossing. In the Tier 1 assessment, the presence of *P. australis* on both sides of the crossing is not considered an indicator of a tidal restriction (see Table B1 for the vegetation-based scoring matrix). The heavy armoring in the channel and elevation change between the upstream and downstream creek may inhibit the movement of aquatic organisms, especially at low tide. Ponded water on the upstream side is also indicative of water flow restriction.

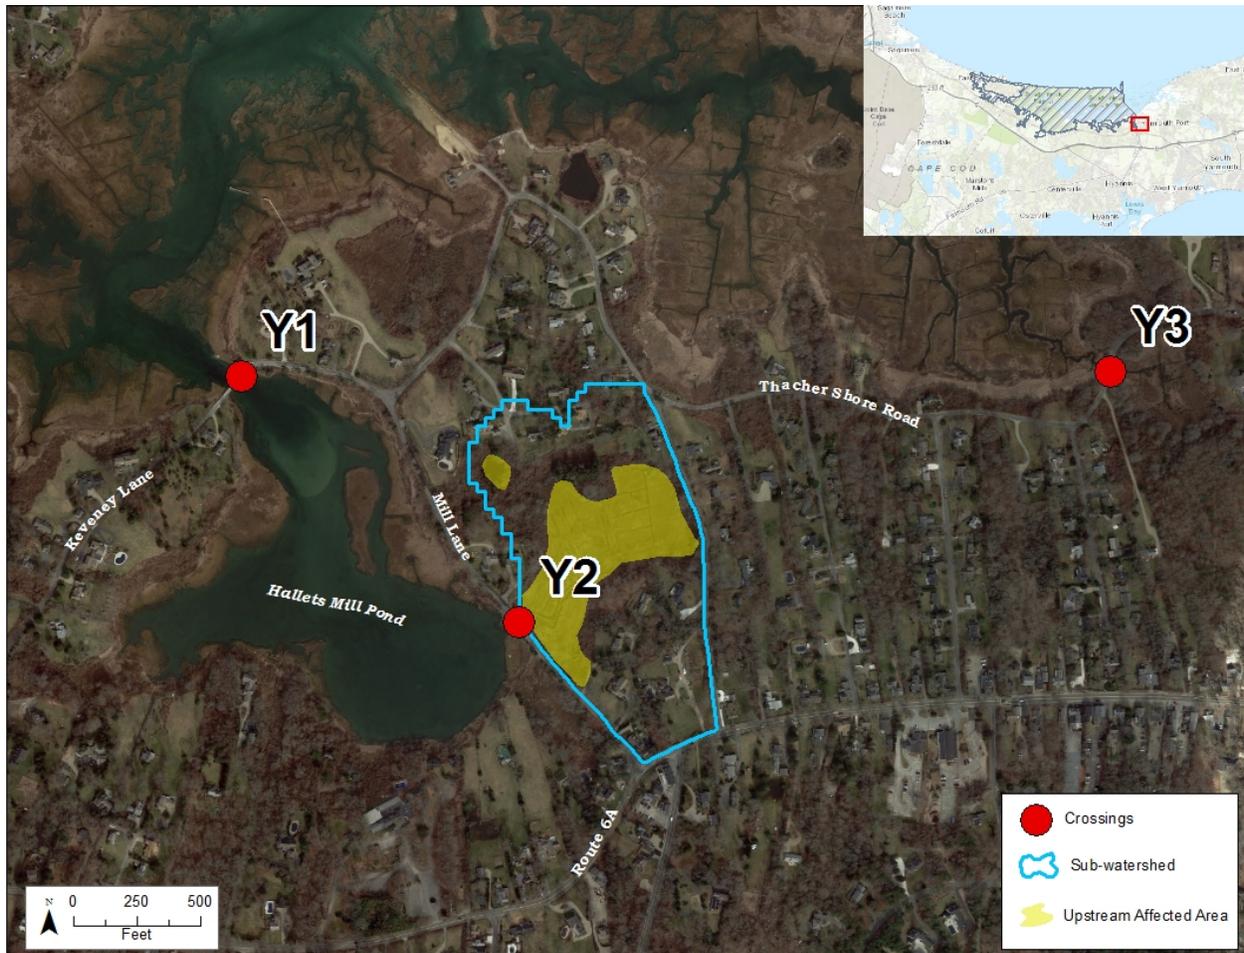
**Figure 56:** Site Y2 is located at 41.7047°N 70.2582°W in Yarmouth. Upstream Affected Area (as shown in the pea-green shaded area): Salt Marsh, 2.55 acres; Shallow Marsh, Meadow, or Fen, 3.53 acres; Shrub Swamp, 0.24 acres (based on the MassDEP Wetlands layer). Crossing Y1 (pg. 46) is located downstream.

A small creek connected to Hallets Mill Pond is restricted by Mill Lane at this site. The creek passes under Mill Lane through a round concrete culvert. Stones are placed on the lateral sides of both the upstream and downstream sides of the crossing to help prevent erosion and scouring around the structure. The upstream structure extends out from a concrete “sleeve,” and erosion was observed around this extended structure, likely from stormwater runoff from the road. The culvert appears to be in OK condition. Overhead electrical wires are visible at the site. Crossing Y1 (pg. 46) is located

downstream and could be contributing to the restriction at this site by impairing flow and drainage, and therefore should be considered with any restoration efforts at Y2. The downstream area is owned by multiple private landowners, while the upstream is owned by both the Town of Yarmouth and private landowners. In the Cape Cod Atlas of Tidally Restricted Salt Marshes, the downstream culvert was identified as perched one foot above the streambed, and scouring and erosion were observed on both the downstream and upstream sides of the crossing (Justus et al. 2001). In the current assessment, the vegetation between the upstream and downstream sides is moderately different. Both sides of the crossing are composed of *Spartina* spp., but the invasive common reed (*Phragmites australis*) is abundant in the upstream area. Visual indicators of a restriction include minor scouring and erosion on the downstream structure as well as marsh slumping on both sides of the crossing. There is also ponded water on the upstream side and evidence of submergence at high tide on both sides of the culvert. Water was observed flowing from an unknown source just north of the downstream culvert. The Town of Yarmouth has expressed interest in addressing the restriction present at this site, so further assessment may be warranted.

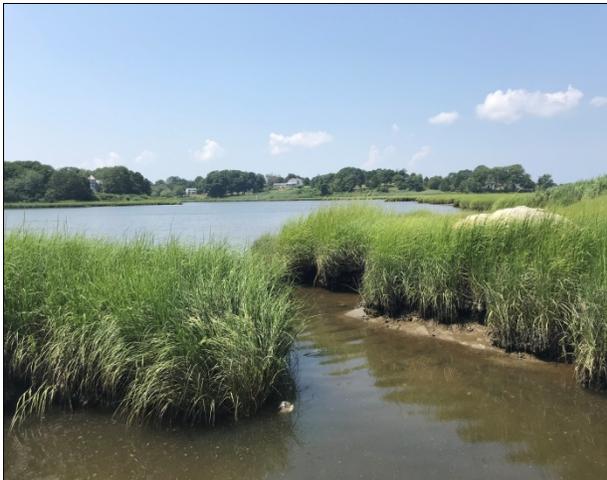
**Figure 59: The downstream area of site Y2 is predominantly Halletts Mill Pond, with an associated salt marsh dominated by *Spartina* spp.**

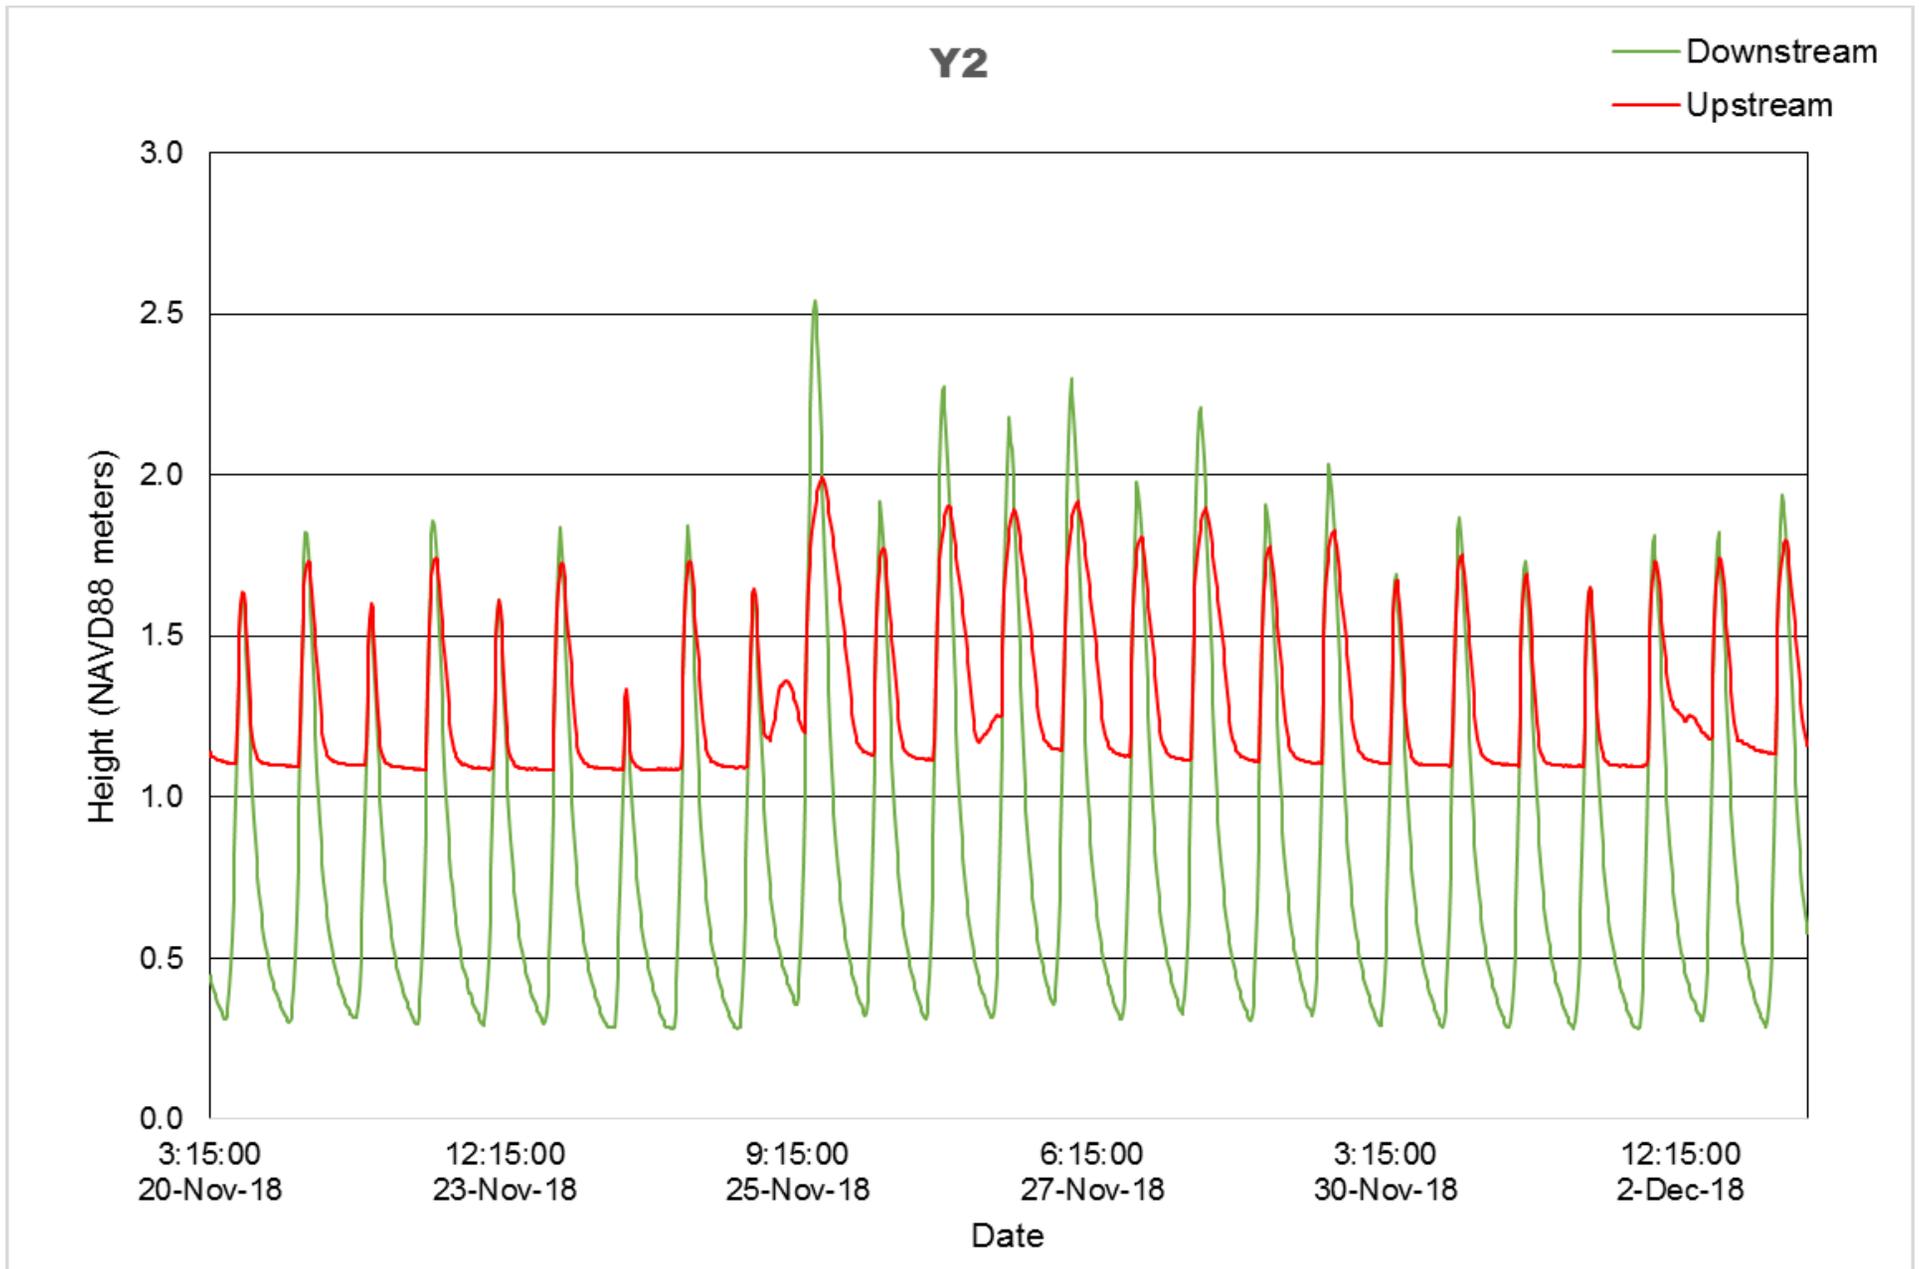
During this time period, the crossing at site Y2 caused a restriction of the water level on the upstream side (Figure 61). The mean tidal range was 1.68 meters on the downstream side and 0.69 meters on the upstream side, indicating that the upstream side of the crossing receives, on average, 41% of the tidal flow compared to the downstream side. The highest tide recorded at the site occurred on November 25 with a height of 2.54 meters NAVD88 on the downstream side and 1.99 meters NAVD88 on the upstream side, with a delay of 1 hour and 30 minutes (this was the largest delay of high tide during the deployment period; 12:30 p.m. on the downstream side and 2:00 p.m. on the upstream side). The maximum tidal restriction of 0.55 meters was also recorded at this time.

Elevation of the downstream side marsh surface and culvert were measured at 1.22 meters and 1.50 meters NAVD88 respectively. Based on the logger measurements and these elevations, the water level reached a height greater than the top of the culvert for some duration during all but one tidal cycle measured during this time period. The upstream marsh surface and culvert were measured at 1.29 meters and 1.83 meters NAVD88 respectively, with the water level reaching a height above the top of the upstream side of the culvert during five of the recorded tidal cycles.

A precipitation event on November 25 resulted in 3.76 centimeters (about 1.5 inches) of rainfall in the Town of Yarmouth (NOAA 2018). The high freshwater inflow from the precipitation event as well as tidal flow contributed to the high water levels observed on this date (Figure 61). Due to the restriction at site Y2, the upstream side of the culvert may not efficiently drain these stormwater and tidal inputs. This could result in water backing up on the upstream side, which could ultimately lead to flooding. Expected climate change effects such as increased precipitation and sea level rise will exacerbate these impacts at this site and others that restrict water flow.

Figure 61: Hydrograph for Site Y2 from 11/20/18 to 12/3/18. Data were measured with Onset HOBO data loggers. The green (downstream) and red (upstream) lines represent the fluctuation in water height (NAVD88 meters) during the measured time period. The pulse seen on November 25 is due to a precipitation event that resulted in 3.76 centimeters (about 1.5 inches) of rainfall (NOAA 2018).

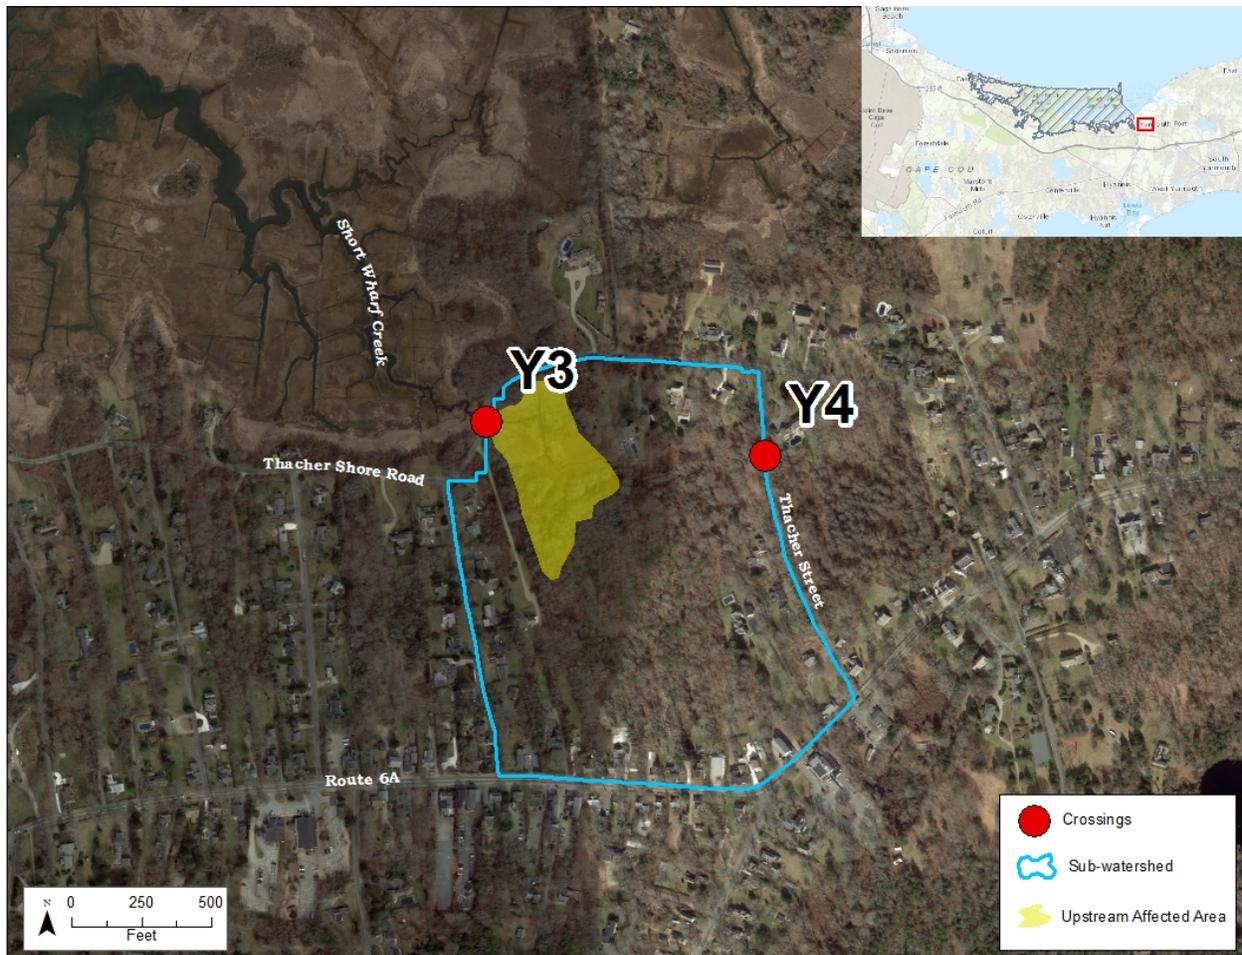
**Figure 62:** Site Y3 is located at 41.7073°N 70.2497°W in Yarmouth. Upstream Affected Area (as shown in the pea-green shaded area): Salt Marsh, 2.89 acres; Shallow Marsh, Meadow, or Fen, none; Shrub Swamp, 1.02 acres (based on the MassDEP Wetlands layer). Crossing Y4 (pg. 59) is located upstream.

Short Wharf Creek flows under Thacher Shore Road through a round concrete culvert that is in poor condition. Both the upstream and downstream culvert structures are damaged as scouring seems to have broken down portions of both sides of the culvert, evidenced by exposed rebar on the downstream side of the culvert. A rock headwall surrounds both the upstream and downstream structures. Utilities at the site include overhead electrical wires and a potential underground gas line (based on markings on the roadway). Crossing Y4 (pg. 59) is located upstream. The downstream

area is publicly owned by the Town of Yarmouth, while the immediate upstream area is held by private landowners. In the Cape Cod Atlas of Tidally Restricted Salt Marshes, scour, erosion, marsh slumping, and vegetation die-back were observed on the downstream side and identified as indicators of a water-flow restriction (Justus et al. 2001). In the current assessment, the vegetation between the downstream and upstream areas was observed to be moderately different. *Spartina* spp. are intermixed with brackish and freshwater species like broadleaf cattail (*Typha latifolia*) on the downstream side and a higher abundance of brackish and freshwater species on the upstream side. Marsh elder (*Iva frutescens*) is growing on the creek bank on the upstream side, which may be indicative of the deposition of sediment from mosquito ditching efforts in the creek. There is also a stand of the invasive common reed (*Phragmites australis*) a distance upstream from the crossing. Visual indicators of a restriction include evidence of structure submergence at higher high tides, scouring on the downstream side of the crossing, and marsh slumping on both the upstream and downstream sides. The stand of *P. australis* located upstream of the crossing may also be caused by restricted tidal flow at the crossing.

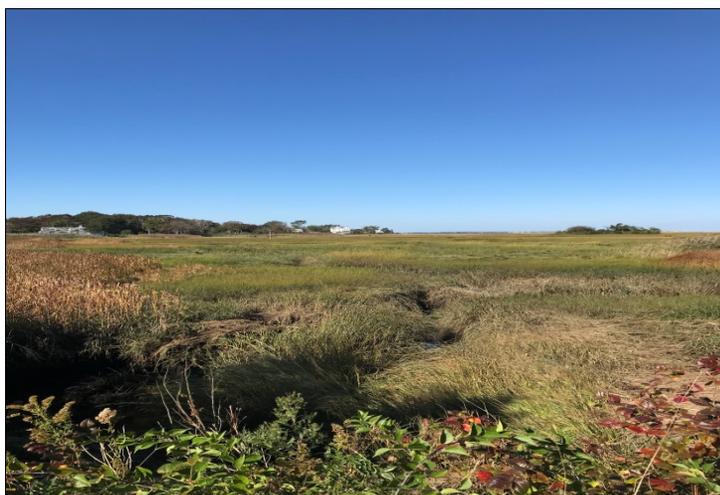
**Figure 63:** The downstream side of site Y3 is composed of *Spartina* spp. as well as broadleaf cattail (*Typha latifolia*) (shown on the left side of the image), giving way to salt marsh habitat further downstream.
