**Crossing Assessment for the Sandy Neck Barrier Beach System Area  
of Critical Environmental Concern (ACEC)**

**Suggested Citation:** Duffey, S.M. and A.L. Pappal. 2019. Crossing Assessment for the Sandy Neck Barrier Beach System Area of Critical Environmental Concern (ACEC). Massachusetts Office of Coastal Zone Management, Boston, MA.

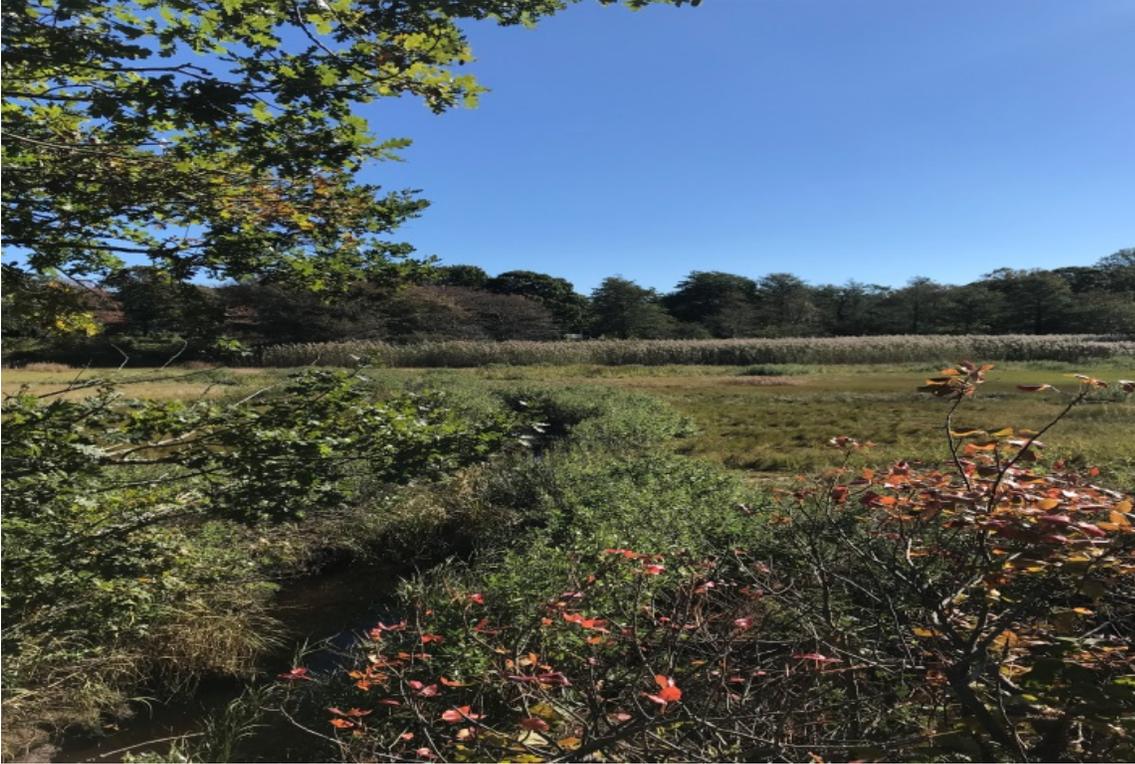
Figure 65: The creek on the upstream side of site Y3 has marsh elder (*Iva frutescens*) growing on the creek bank, which may be indicative of legacy mosquito ditching impacts. A stand of the invasive common reed (*Phragmites australis*) is also present upstream.

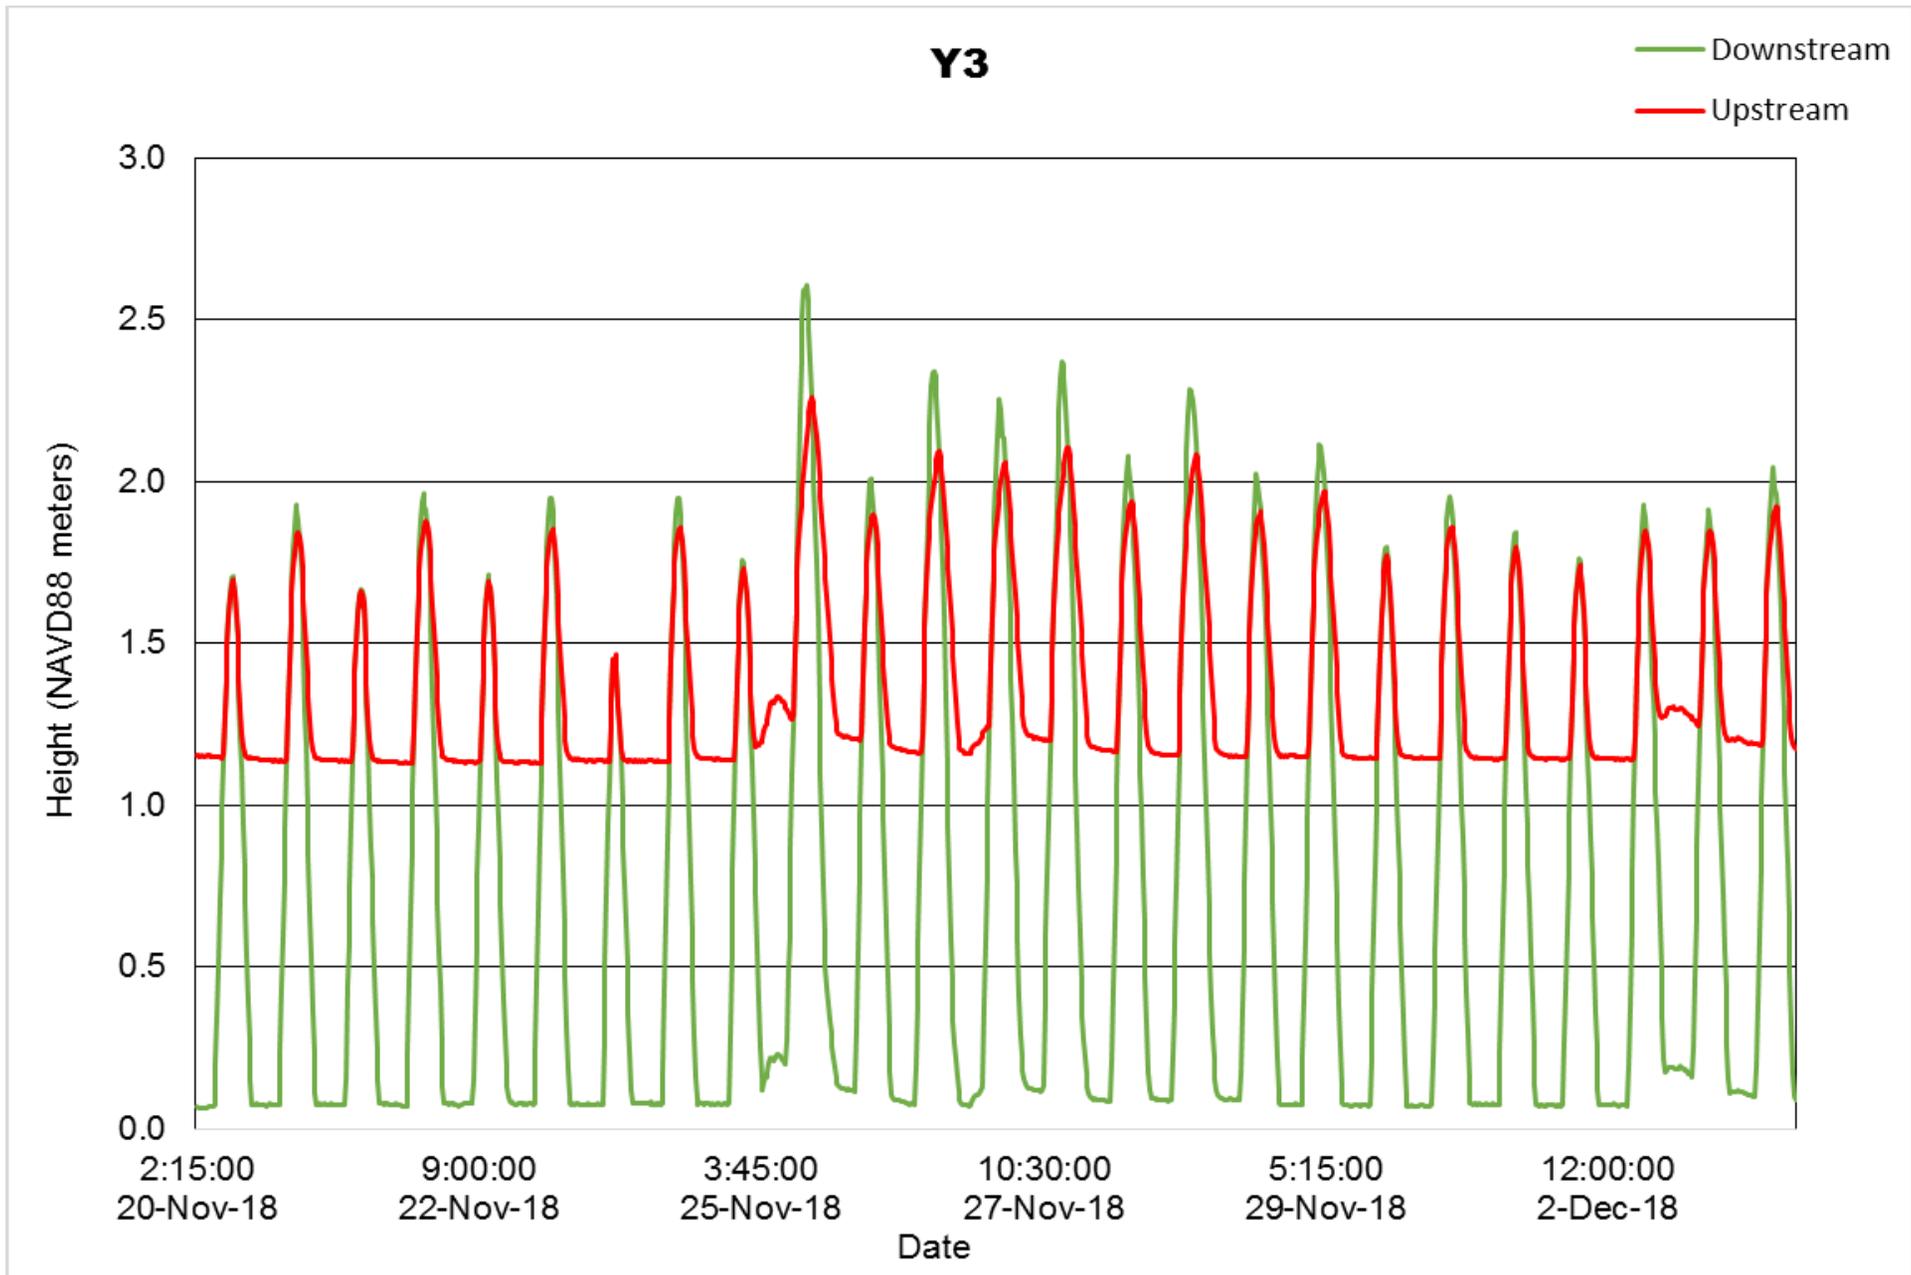
During this time period, the crossing at site Y3 caused a restriction of the water level on the upstream side (Figure 67). The mean tidal range was 1.99 meters on the downstream side and 0.79 meters on the upstream side, indicating that the upstream side of the crossing receives, on average, 39% of the tidal flow compared to the downstream side. The highest tide recorded at the site occurred on November 25 with a height of 2.61 meters NAVD88 on the downstream side and 2.26 meters NAVD88 on the upstream side, and a delay of 1 hour (12:30 p.m. on the downstream side and 1:30 p.m. on the upstream side). The maximum tidal restriction of 0.35 meters NAVD88 was recorded at this time. Elevation of the downstream side marsh surface and culvert were measured at 1.41 meters and 1.51 meters NAVD88 respectively. Based on the logger measurements and these elevations, the water level reached a height greater than the top of the culvert for some duration during all but one tidal cycle measured during this time period.

A precipitation event on November 25 resulted in 3.76 centimeters (about 1.5 inches) of rainfall in the Town of Yarmouth (NOAA 2018). The high freshwater inflow from the precipitation event as well as tidal flow contributed to the high water levels observed on this date (Figure 67). Due to the restriction at site Y3, the upstream side of the culvert may not efficiently drain these stormwater and tidal inputs. This could result in water backing up on the upstream side, which could ultimately lead to flooding. Expected climate change effects such as increased precipitation and sea level rise will exacerbate these impacts at this site and others that restrict water flow.

Figure 67: Hydrograph for Site Y3 from 11/20/18 to 12/3/18. Data were measured with Onset HOBO data loggers. The green (downstream) and red (upstream) lines represent the fluctuation in water height (NAVD88 meters) during the measured time period. The pulse seen on November 25 is due to a precipitation event that resulted in 3.76 centimeters (about 1.5 inches) of rainfall (NOAA 2018).

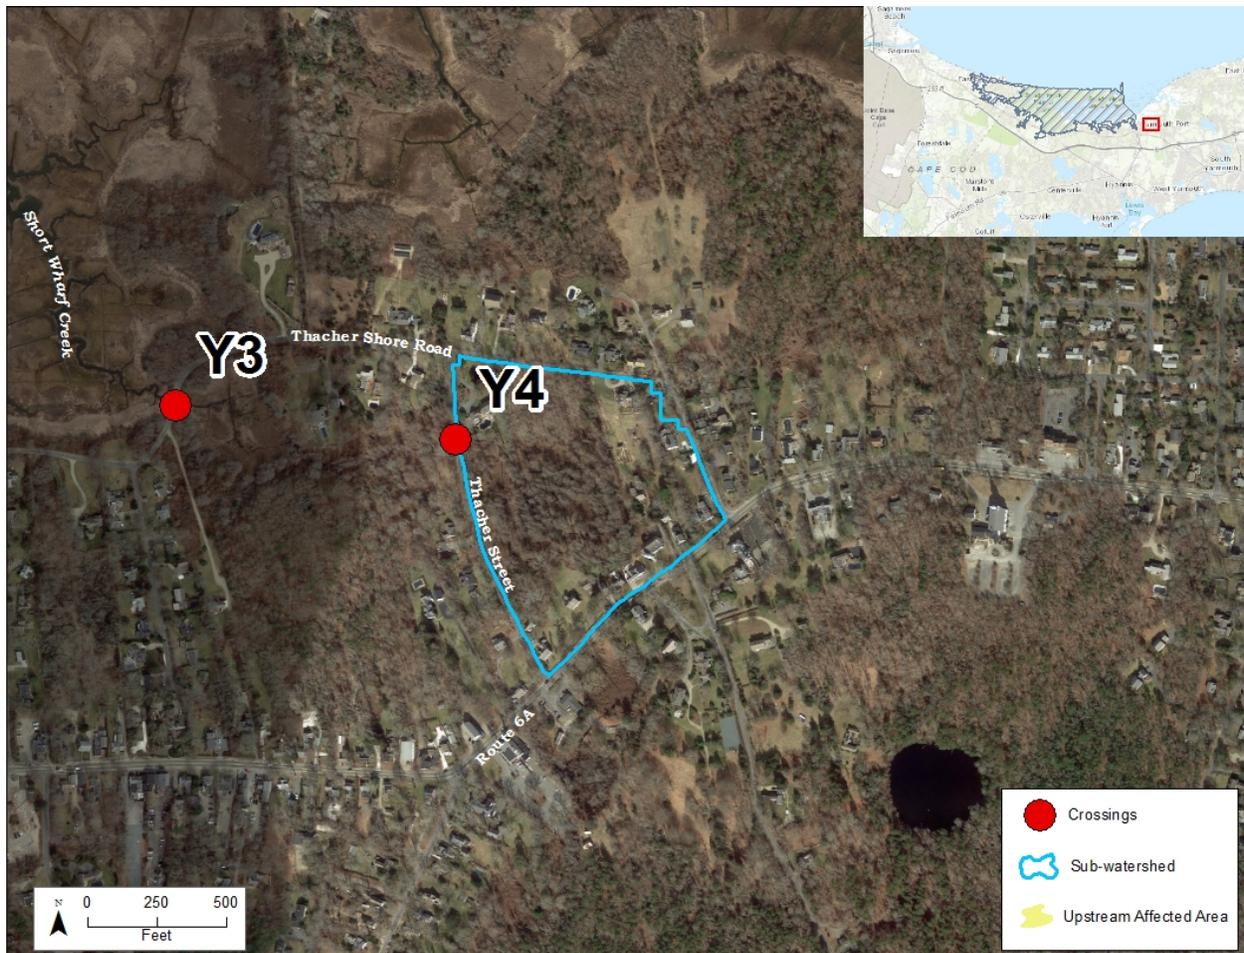
**Figure 68:** Site Y4 is located at 41.7069°N 70.246°W in Yarmouth. There is no Salt Marsh, Shallow Marsh, Meadow, or Fen, or Shrub Swamp in the upstream affected area. Crossing Y3 (pg. 53) is located downstream.

Thacher Street crosses Short Wharf Creek at this site. The type of crossing is unknown because it is covered by stone placed around both the upstream and downstream sides. It is possible that the structure is at least partially collapsed and failing, evidenced by the very minimal observed water flow through the structure. No visible utilities are present at the site. Crossing Y3 (pg. 53) is located downstream and could be contributing to the restriction at this site by impairing flow and drainage, and therefore should be considered with any restoration efforts at Y4. The area downstream is
