*Massachusetts Coastal Infrastructure
Inventory and Assessment Project
Coastal Hazards Commission*

South Coastal

Swansea
Somerset
Westport
Dartmouth

July 6, 2009

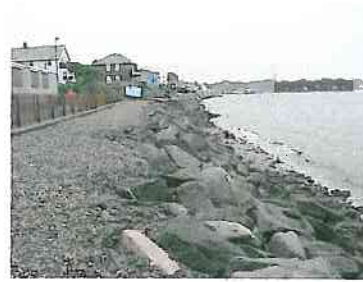
The dumped riprap has a slope of 1 on 1. The stones are approximately 3 feet by 2 feet by 2 feet in size. There is crushed stone at the crest. There is a building behind the revetment, and the town beach is adjacent and in front of the structure. There is moderate erosion at the top. There is some stone movement. No visible scour.

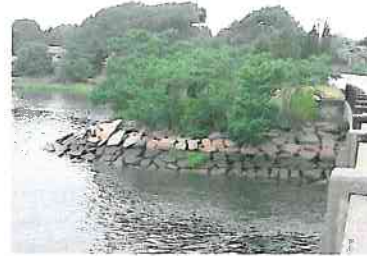
The placed riprap is at a 1 on 2 slope with stones that are approximately 4 feet by 2 feet by 2 feet in size. The stones are not placed tightly together. There is some signs of movement. The revetment is used to protect the Route 103 bridge abutments and adjacent banks. Mean high water reaches mid-height of the stones.

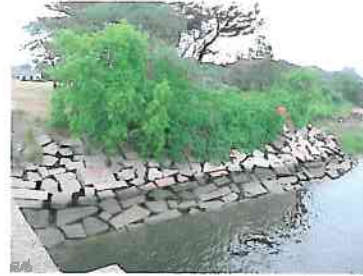
The placed riprap is at a slope of 1 on 2. The stones are approximately 4 feet by 2 feet by 2 feet. The stones are not placed tightly together. There is some sign of movement. The riprap protects the abutments for the Route 103 bridge and adjacent banks. Mean high water is at mid-height of the slope.

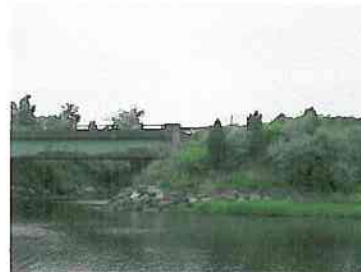
The structure is in front of the east bridge abutment for Route 195 is at a 1 on 1 slope with stones that are approximately 4 feet by 2 feet by 2 feet in size. There is no sign of erosion or stone movement.

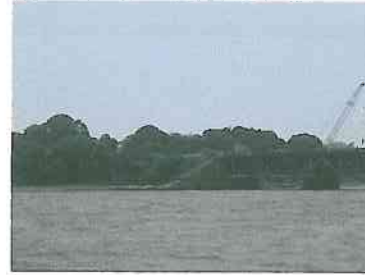
The dumped riprap has stones that are approximately 200 pounds. Behind and adjacent to the riprap is a bridge abutment. There is no sign of scour at the toe.

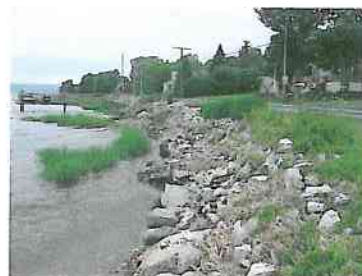
The dumped riprap is on a 1 on 1 to a 1 on 3 slope. Most stones are 1 foot diameter. There are some larger concrete slabs randomly placed throughout. There is minor scour at the toe. There is a road and houses behind the structure. There is a small boat ramp located in the middle of the structure.

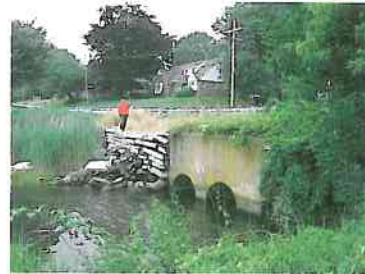
The stone block seawall is built in front of a road and adjacent to a concrete culvert. Some stones are 1 foot in diameter and are mortared. The remaining stones are 4 feet by 1 foot by 1 foot. There is some visible setting, shifting and rotating.

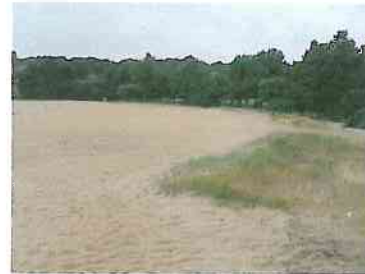
The small beach has a 1 on 15 slope with sand dunes behind it. The beach is filled and graded well. There is a park located behind the beach.

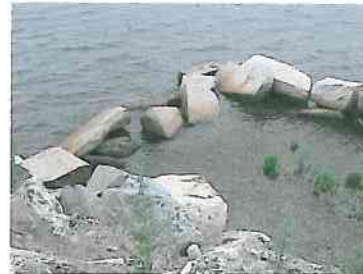
The dumped riprap is on a slope. The stones are approximately 300 to 400 pounds in size. Some section loss and stone movement are visible. In front of the slope is approximately 10 to 15 stones of the same size lined up. They are there possibly to protect the riprap toe behind them.

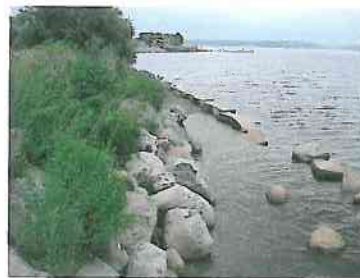
The sloped dumped riprap has stones that are approximately 300 to 400 pounds. There is some visible section loss and stone movement throughout. In front of the the slope there is approximately 10 to 15 stones lined up, possibly to protect the riprap toe behind them.

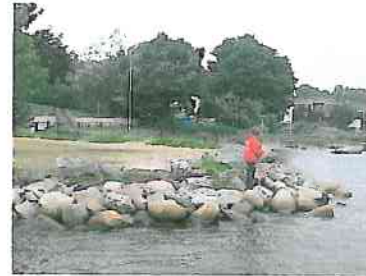
The dumped riprap is on a 1 on 1 slope with stones that are approximately 3 feet by 2 feet by 2 feet in size. The stones have signs of movement and settling.

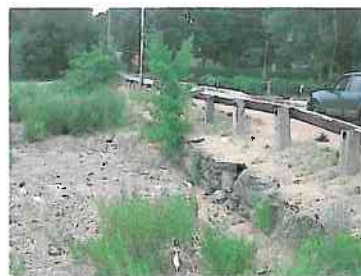
The stone bulkhead protects the street, walkway and houses behind it. The stones are approximately 3 feet by 2 feet in size. There is some stone heaving.

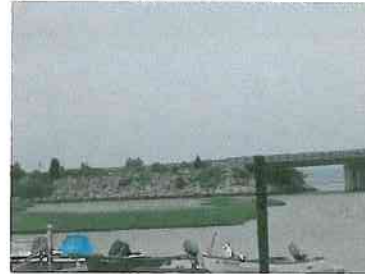
The placed riprap is on a 1 to 1 slope. The stones are approximately 4 feet by 2 feet by 2 feet in size. The riprap protects the bridge abutment and road leading to the bridge. The stones are well placed and interlocked. There is no sign of scour or movement.

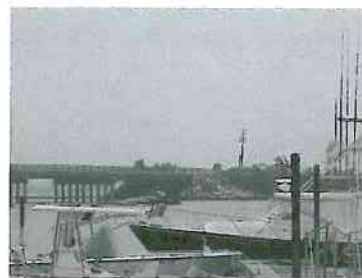
The placed riprap with stones of approximately 4 feet by 2 feet by 2 feet size is on a 1 to 1 slope. The riprap protects the bridge abutment and road leading to the bridge. The stones are well placed and interlocked with no sign of scour or movement.

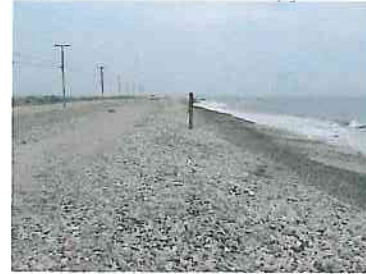
Coastal beach with cobble stones that are at a 1 on 5 slope. There is a road located behind the beach and a sandy beach located in front. The slope is not uniform and there are areas of low spots.

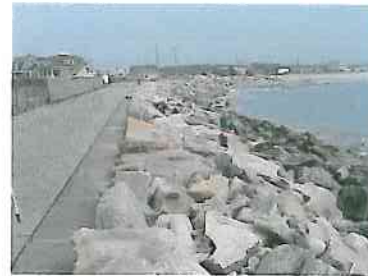
The placed riprap is at a 1 on 2 slope. The stones are approximately 4 feet by 2 feet by 2 feet in size. The toe is buried. There is no scour. There is minor stone movement and section loss. Behind the structure is the only road out to the point. High tide line is midway up the riprap.

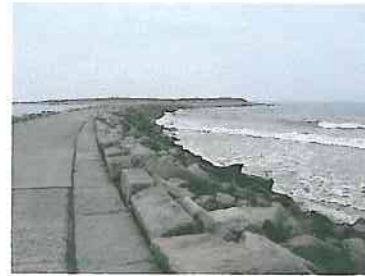
The placed riprap is at a 1 on 2 slope. The stones are approximately 4 feet by 2 feet by 2 feet in size. The toe is buried. There is no scour. There is minor stone movement and section loss. Behind the structure is the only road out to the point. High tide line is midway up the riprap.

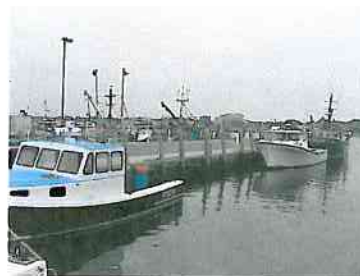
The stone block seawall is mortared together. The stones have settled. There is some movement and section loss. Asphalt and concrete on top of the stones. The structure is a pier.

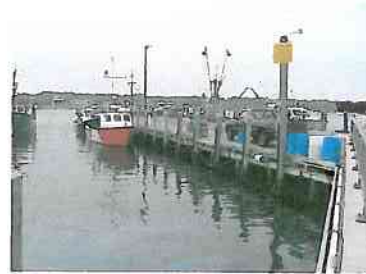
There are dumped stones with asphalt on top of them with a timber pier built around them. The stones are approximately 100 to 200 pounds.

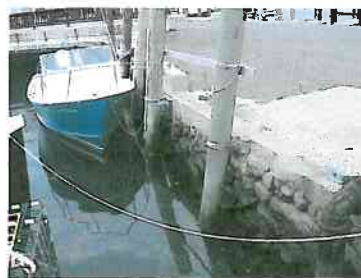
The stone block bulkhead has stones that are approximately 4 feet by 2 feet by 2 feet in size. There is an asphalt road above the stones connecting to the pier. There is no visible scour. There is some stone settling at the toe.

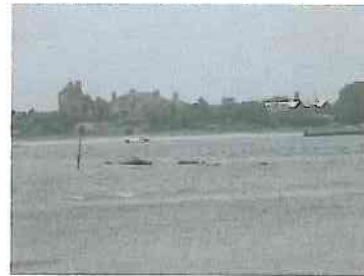
Dumped riprap groin. Stones are approximately 4 feet by 2 feet by 2 feet. Not all stones are visible. The structure is 90 percent buried by sand.

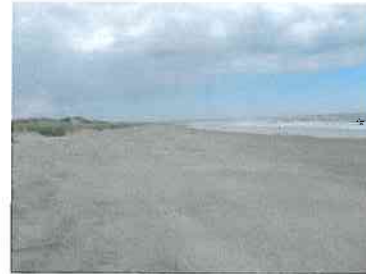
Sandy beach with high dunes behind. Beach is a popular habitat for nesting protected birds. The are west end of the beach show signs of recent nurishment.

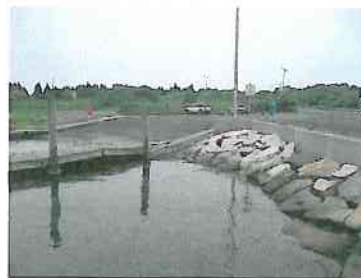
The cast in place seawall surrounds the town boat ramp. There is riprap coming off the seawall. The wall is 1 foot wide by 1 foot high inshore and by 5 feet high outshore. The riprap is placed at a 1 on 1 slope. The stones are approximately 4 feet by 2 feet by 2 feet. The toe is well buried. There is no sign of scour. There is a parking lot behind the structures, and a boat ramp and floats in the middle of them.

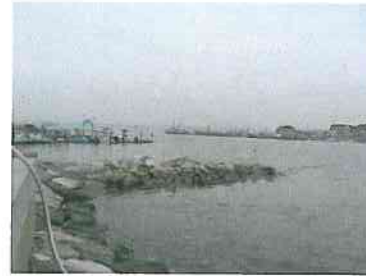
The dumped riprap groin has stones that are approximately 2 feet by 1 foot by 1 foot in size. There is no sign of movement or scour.

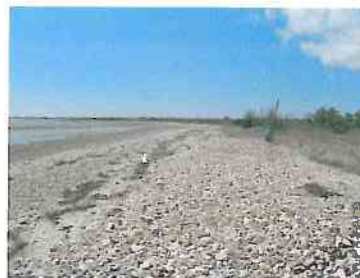
Beach mostly consisting of 4 inch to 6 inch diameter cobbles. One small area is sandy. Beach has an approximately 1 to 100 slope. There is a small berm and dunes behind the beach, then parking and picnic areas. Signs of erosion from strong currents.

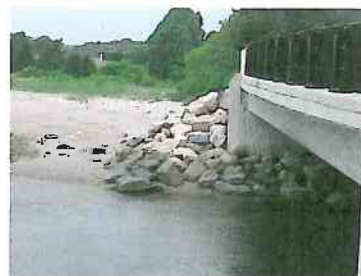
The dumped riprap with a 1 to 2 slope. The stones are approximately 3 feet by 2 feet by 2 feet in size. The filter fabric is visible. Stones have shifted and moved. There is some section loss. The toe is still intact; the stones are not buried.

*Condition***C***Rating***Fair***Level of Action***Moderate***Description*

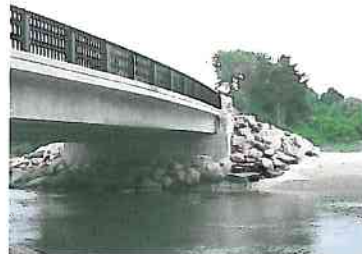
The dumped riprap has stones that are approximately 3 feet by 2 feet by feet in size and are on a 1 to 2 slope. The filter fabric is visible. Stones have shifted and moved. There is some section loss. The toe is still intact and the stones are buried.

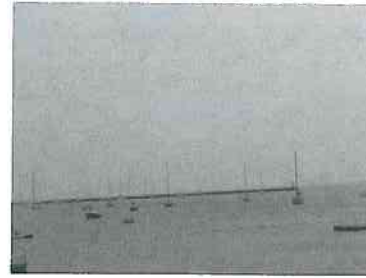
A detached stone breakwater that protects the mouth of Padanaram Harbor. The stones are approximately 5 feet by 2 feet by 2 feet. Some stone movement and settling.

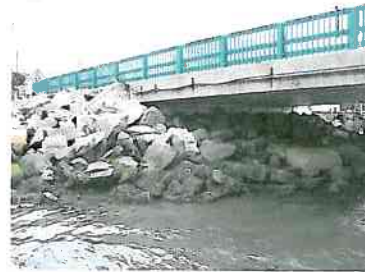
The dumped riprap has stones that are approximately 3 feet by 2 feet by 2 feet in size. The stones are at a 1 on 1 slope. The stones are dumped around the bridge abutment. The toe is intact and there is no visible movement.

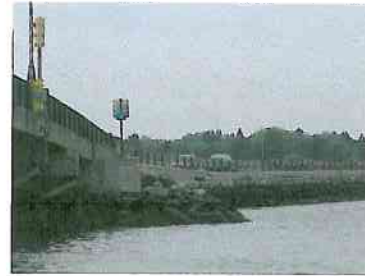
The placed riprap has stones that are approximately 3 feet by 2 feet by 2 feet in size. The stones are at a 1 on 1 slope. The stones are placed around the bridge abutment. The toe is intact and there is no visible movement.

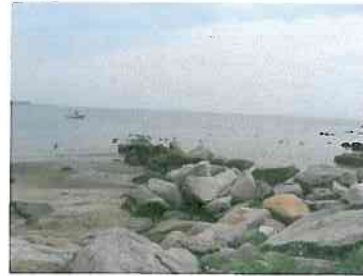
The dumped stone groin has stones of approximately 2 feet by 1 foot by 1 foot size. The groin protects a concrete drainage pipe from the street. Mean high water is approximately mid length of the groin.
