LINDEMANN MENTAL HEALTH CENTER

Programming & Renovation Feasibility Study
October 2023

Division of Capital Asset Management and Maintenance (DCAMM)
Department of Mental Health (DMH)

Prepared by **ICON Architecture**

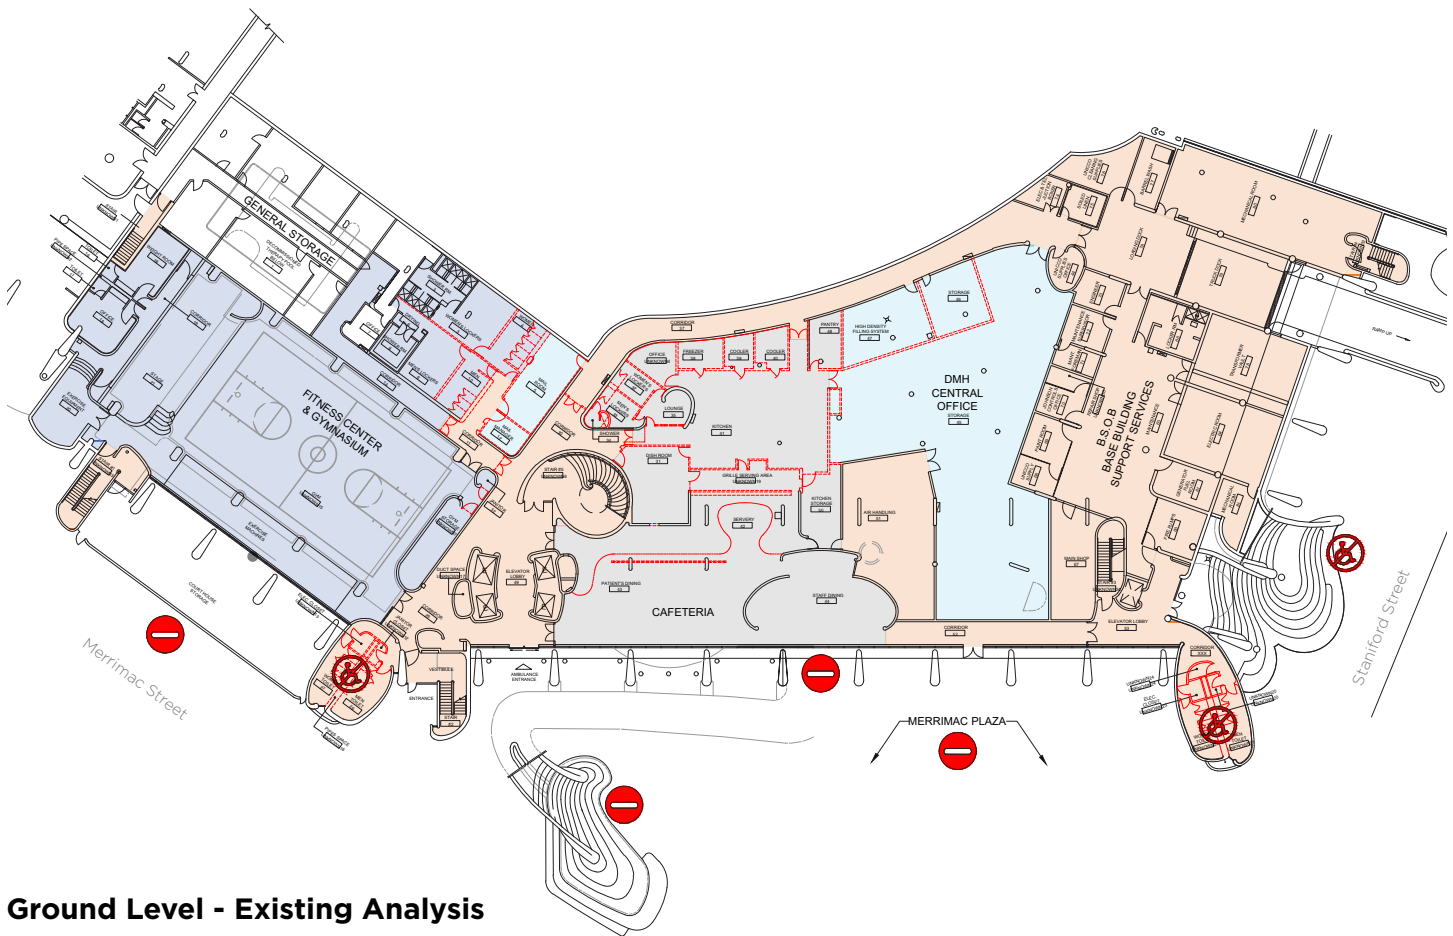
Figure 4.7. Ground Level Existing Analysis Plan

- A majority of the building's mechanical systems are housed on the ground floor.
- Lack of access throughout Merrimac Plaza and Staniford Street. No access to Cafeteria from the Plaza.
- Grand Stairs are not accessible due to structural concerns.
- Gym entrance is enclosed by a perimeter fence.
- Multiple restrooms lack accessibility including turning radius, fixture counts, doorknobs and light switches that do not meet ADA requirements.

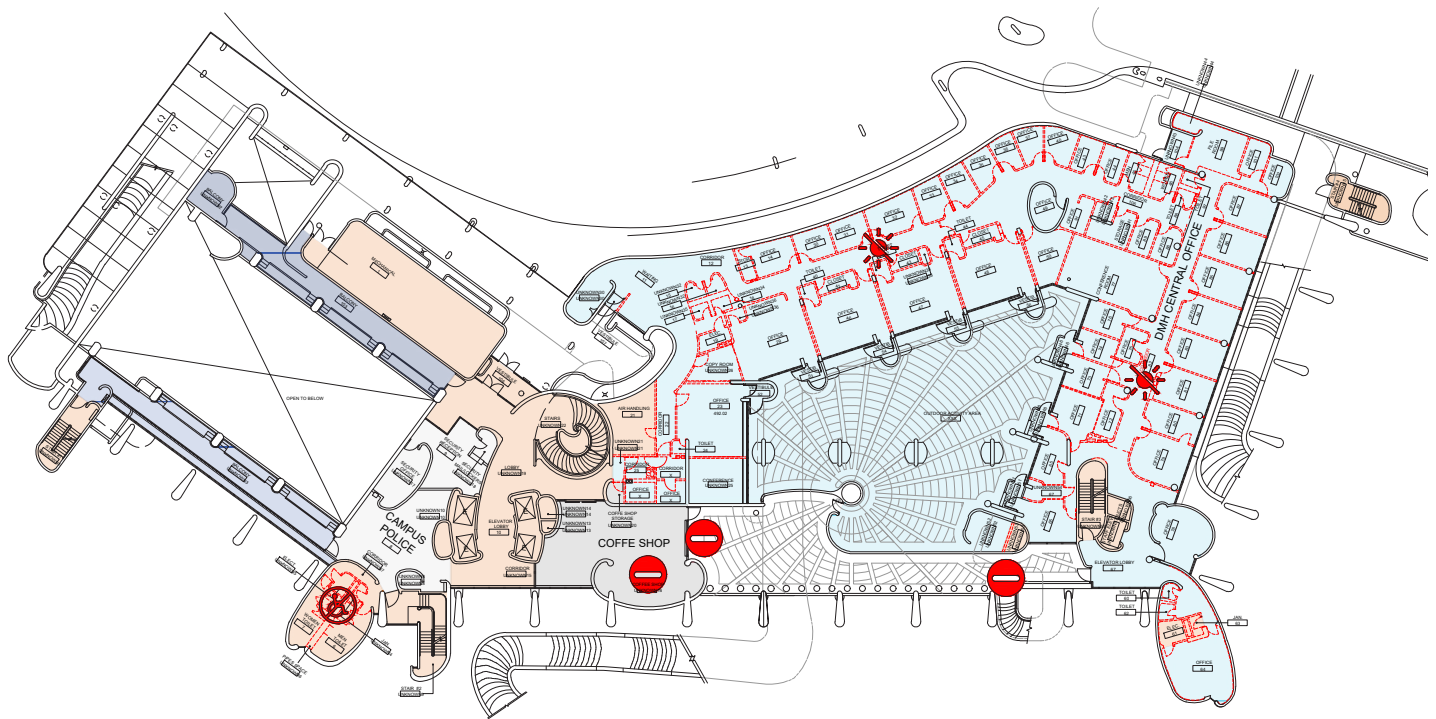
Figure 4.10. Mezzanine Level Existing Analysis Plan

- One training space (currently closed due to funding), the coffee shop is located adjacent to the DMH offices and outdoor space.
- Limited access to main outdoor space, only accessible through DMH Central Offices spaces.
- Little to no sunlight through hallways, multiple partitions result in small offices, difficult way-finding and limited access to outdoor space.
- The design team recognizes this level to provide a great opportunity for community building and implementing the DMH mission of integration of its clients to the community.

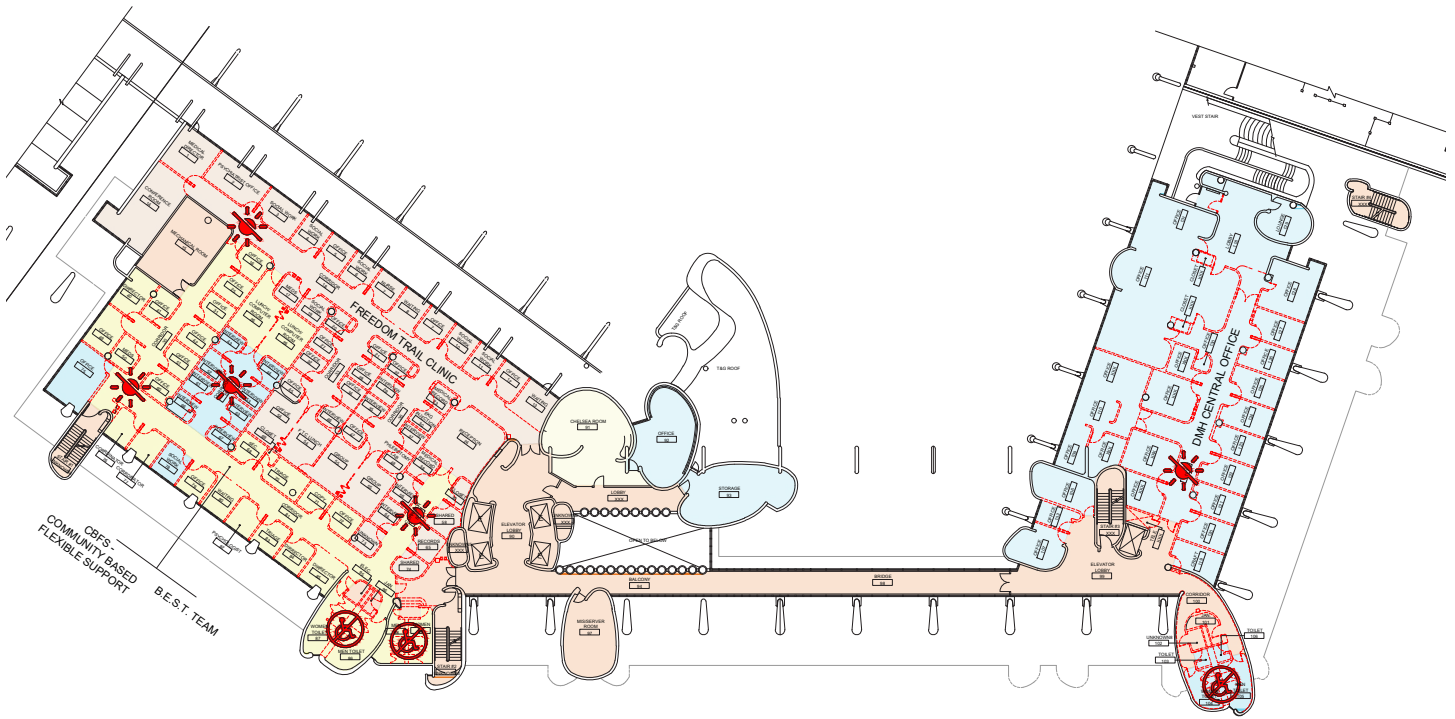
Figure 4.17. Level 02 Existing Analysis Plan

- A large number of partition walls divide the administrative service offices and DMH Central offices, resulting in small office spaces, inefficient conference room layouts and exam rooms with poor space for necessary equipment.
- Way-finding becomes confusing due to the dark corridors and office layout.
- Common restrooms are not accessible and there is little to no distinction between staff and client restrooms.

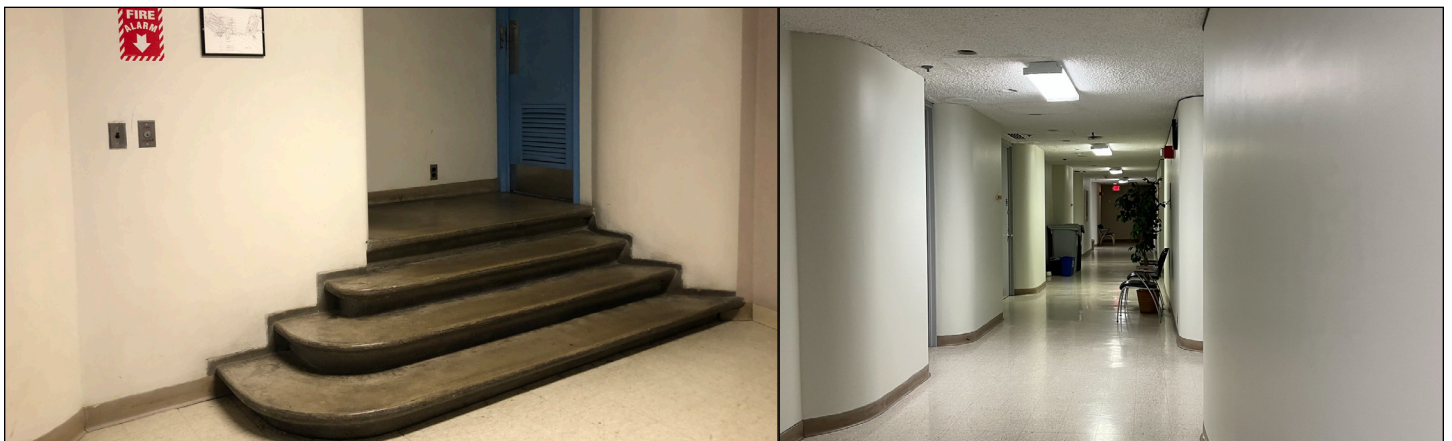
Figure 4.19. Existing Lindemann Building Spaces on Level 02 (From Left to Right): Steps leading up to Restrooms, Dark Corridor

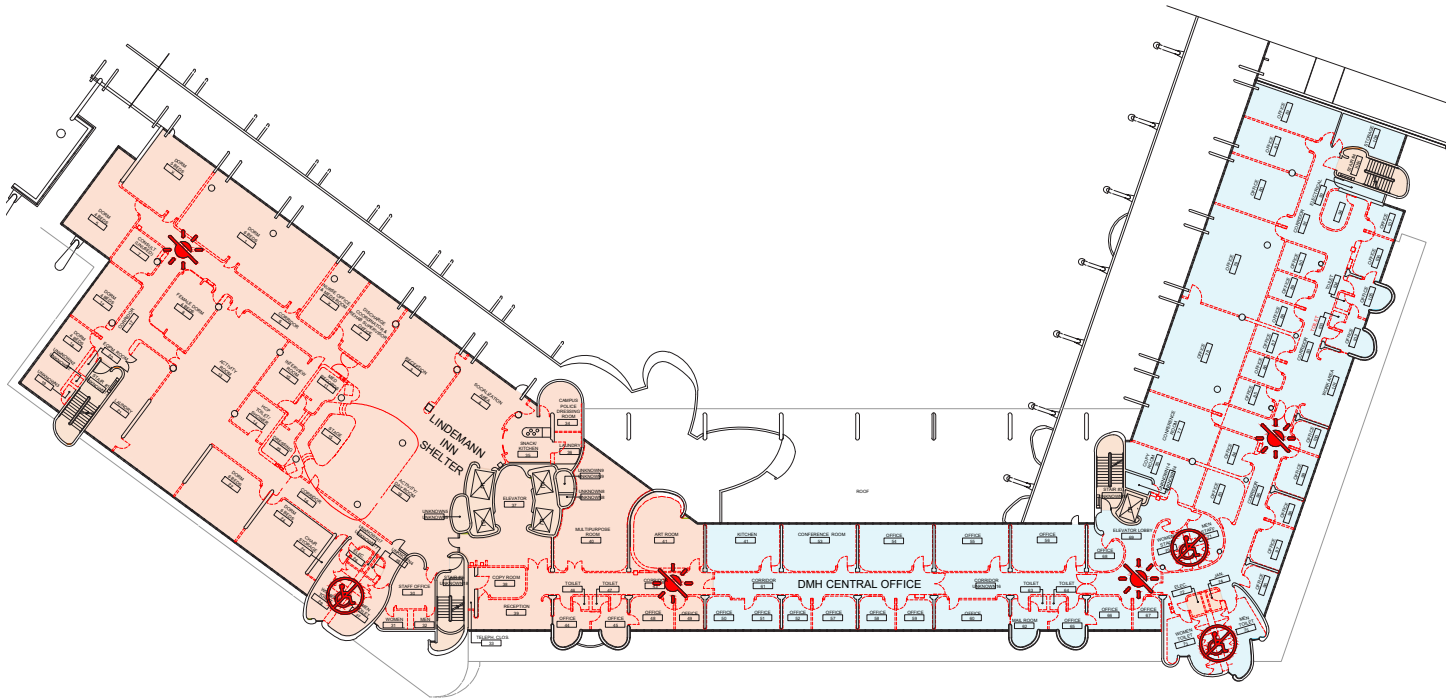
Figure 4.20. Level 03 Existing Analysis Plan

- In the shelter, there are underutilized and inefficient spaces, such as the large activity/day room, reception area housing the nurse's station and stage area.
- On the east side, the DMH Central offices are divided into large and small offices, multiple of these offices do not have access to sunlight.
- The existing windows along the DMH Central offices perimeter are not well utilized, these windows are used exclusively for the large office spaces.

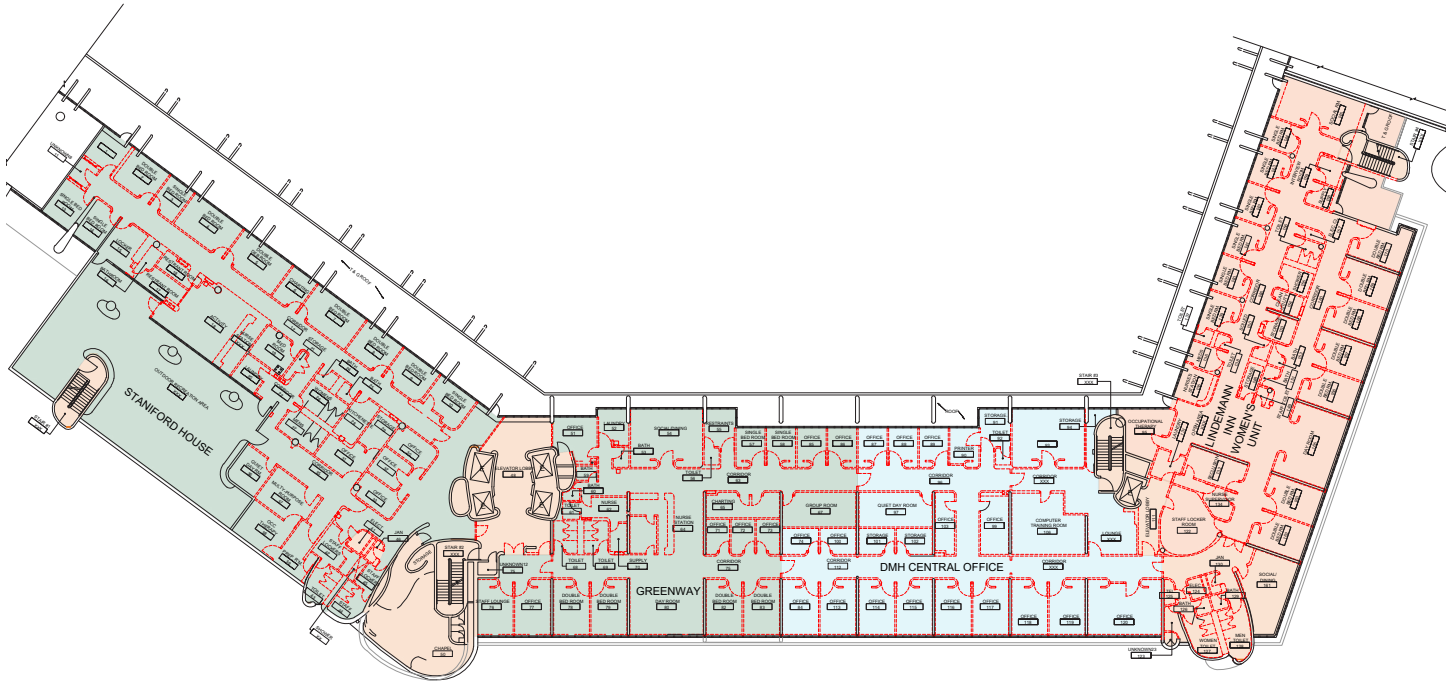
Figure 4.23. Level 04 Existing Analysis Plan

- The Chapel, on of the main common indoor space is located on this level, accessible through a series of steps.
- The third common outdoor space is only accessible through Stanford House, therefore the design team identified partition walls to be potentially removed to provide equal access to this amenity.
- A series of partition throughout the plan once again creates a lack of sunlight.

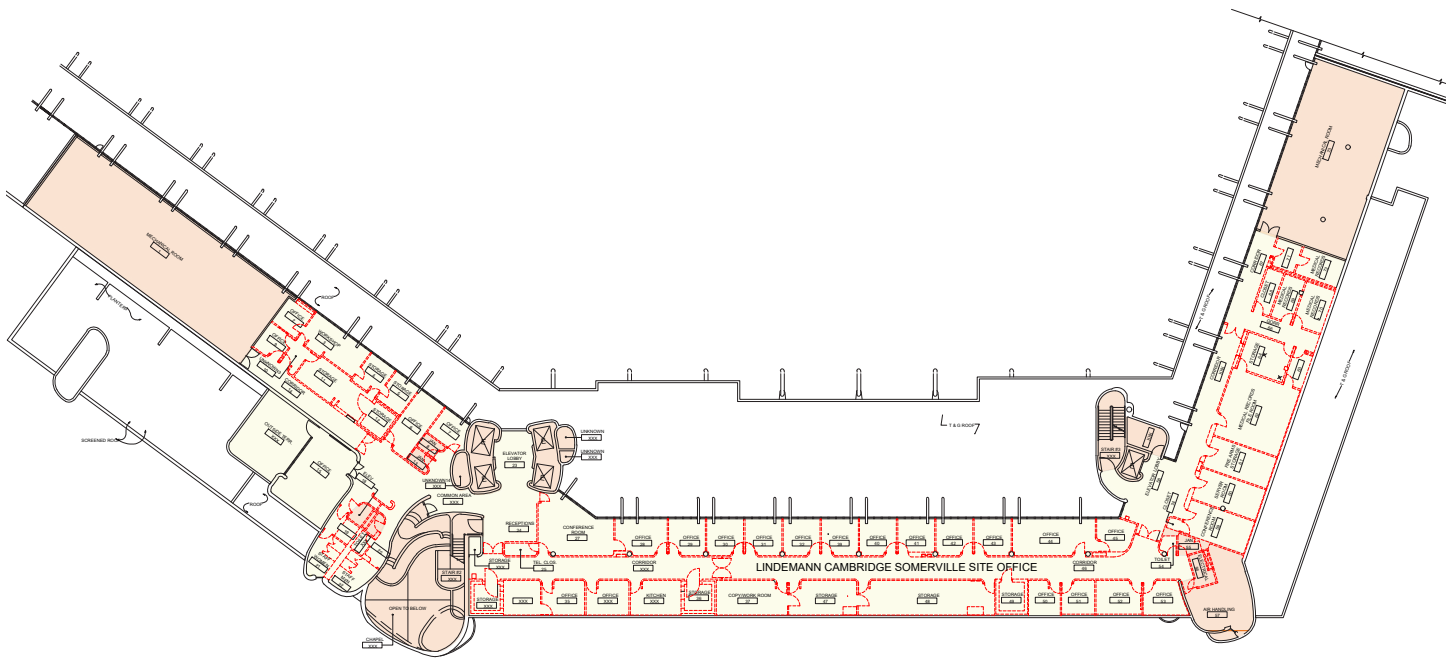
Figure 4.26. Level 05 Existing Analysis Plan

- The Site offices house an outdoor terrace area on the west wing of the plan.
- A series of mechanical and other building service spaces are located on the ends of each wing.
- The steps leading to the Chapel balcony are not fully accessible by all clients/guests, similar to the Boston Conference room this series of steps require an accessibility retrofit.

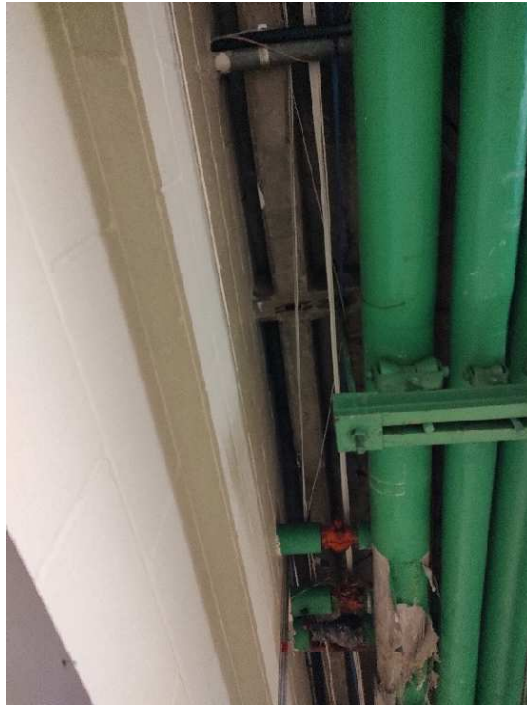
Figure 7 – Existing CMU walls are not clipped to the slab.

Diaphragm anchorage. Should the renovation be considered a level 3 alteration, diaphragm anchorage would be required for the entire building. Diaphragm anchorage would involve adding L8x8 angles @ 6'-0" OC on both sides of all CMU walls secured by epoxy anchors.
