*Massachusetts Coastal Infrastructure
Inventory and Assessment Project
Massachusetts Department of Conservation and Recreation
Office of Waterways*

Outer Cape Cod - North

July 6, 2009

MASSACHUSETTS COASTAL INFRASTRUCTURE INVENTORY AND ASSESSMENT PROJECT

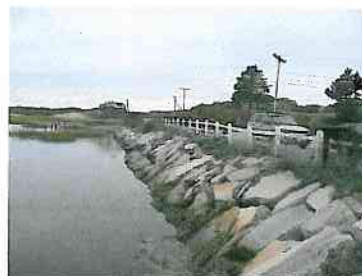
Placed stone riprap at a little slope. Stones are 3 feet by 2 feet by 2 feet on average. No visible scour or erosion. There is a road, a few houses, and a park behind.

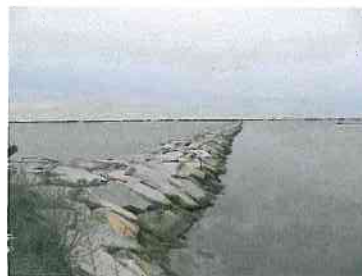
Placed stone dike with stones that are 3 feet by 2 feet by 2 feet on average. Minor stone movement and no visible scour. Provincetown Harbor is in front and there is marsh behind.

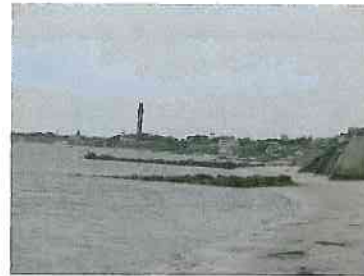
Set of dumped stone groins. The stones are coming unravelled. There are signs of stone movement and section loss. The groins are in front of houses.

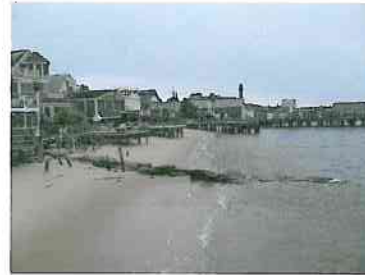
Set of 3 dumped stone groins. There is moderate stone movement and section loss. The stones are on average 4 feet by 3 feet by 3 feet in size. There appears to be relics of old groins along the coast also.

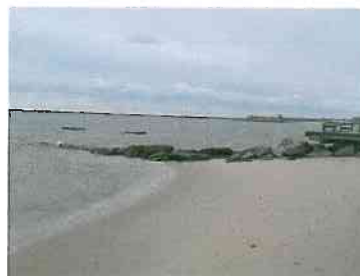
Set of 6 dumped stone groins. Moderate to heavy stone movement and section loss. Stones are 4 feet by 3 feet by 3 feet on average. There appears to be relics of old groins along the coast.

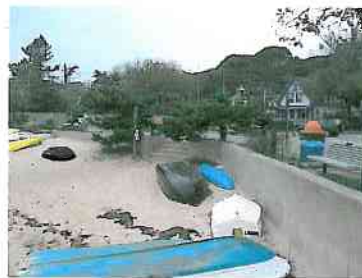
Concrete wall with sand beach in front. Parking lot and houses behind. No visible signs of erosion.

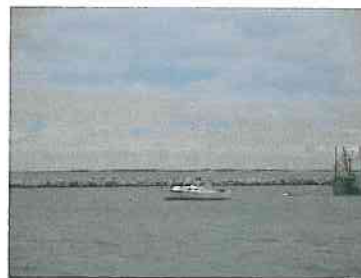
Detached dumped stone breakwater located in Provincetown Harbor. Stones are 6 feet by 3 feet by 3 feet on average. Minor to moderate stone movement.

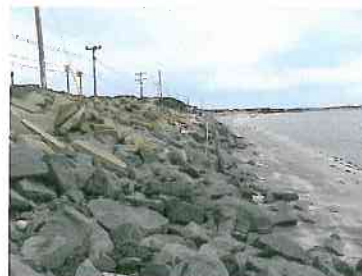
Dumped stone riprap. Stones are 3 feet by 2 feet by 1 foot on average. No visible scour. Moderate section loss and stone movement are visible. Behind is road into town and buildings

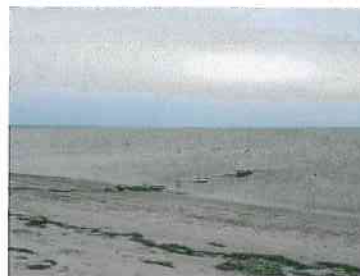
Set of 7 dumped stone groins. Stones are 3 feet by 2 feet by 2 feet on average. Stones have moderate stone movement and section loss. Behind there are many houses and a beach.

*Condition*C*Rating*Fair*Level of Action*Moderate*Description*

Structure is sound but may exhibit minor deterioration, section loss, cracking, spalling, undermining, and/or scour. Structure adequate to withstand major coastal storm with little to moderate damage. Actions taken to reinforce structure to provide full protection from major coastal storm and for extending life of structure. Moderate wind or wave damage to landform exists. Landform may not be sufficient to fully protect shoreline during a major coastal storm. Actions taken to provide addition material for full protection and extended life.

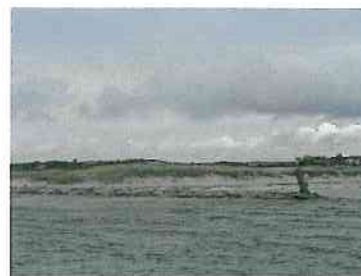
Placed stone jetty at the inlet of Pamet Harbor. Stones are 3 feet by 2 feet by 2 feet on average. There is moderate stone movement and section loss

Structure is sound but may exhibit minor deterioration, section loss, cracking, spalling, undermining, and/or scour. Structure adequate to withstand major coastal storm with little to moderate damage. Actions taken to reinforce structure to provide full protection from major coastal storm and for extending life of structure. Moderate wind or wave damage to landform exists. Landform may not be sufficient to fully protect shoreline during a major coastal storm. Actions taken to provide addition material for full protection and extended life.

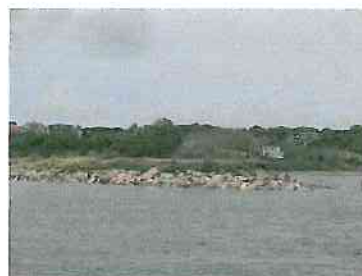
Dumped stone riprap at water line of old train tracks. Stones are 3 feet by 2 feet by 2 feet on average. Moderate stone movement.

*Condition***C***Rating***Fair***Level of Action***Moderate***Description*

Structure is sound but may exhibit minor deterioration, section loss, cracking, spalling, undermining, and/or scour. Structure adequate to withstand major coastal storm with little to moderate damage. Actions taken to reinforce structure to provide full protection from major coastal storm and for extending life of structure. Moderate wind or wave damage to landform exists. Landform may not be sufficient to fully protect shoreline during a major coastal storm. Actions taken to provide addition material for full protection and extended life.

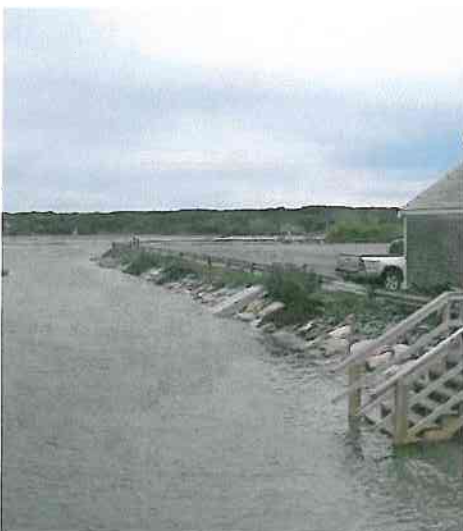
075-050-000-018-100-PHO1A

Placed stone riprap. Stones are 2 feet by 2 feet by 2 feet. There are many areas of concrete and asphalt repair. There are signs of stone movement, undermining and minor scour. There is a boat ramp in the middle of the structure.

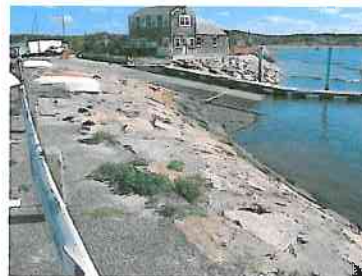
The placed stones are well placed. The slope is 1 on 4. It is currently being constructed to continue around the entire pier and replace structure 077-021-000-106-100. The Harbor Master's office and parking are located above it. The stones are on average 1 foot by 2 feet by 3 feet.

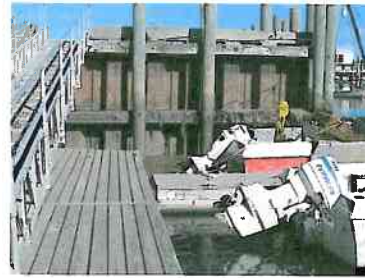
The steel bulkhead is stabilized by timber piles and wales in front of it. There is growth along the tidal zone. The steel is corroding along the top of the bulkhead. A gangway extends to the floats from the top of the cap. There is erosion behind the bulkhead in the parking lot. The timber cap is 1 foot by 1 foot.

*Condition***C***Rating***Fair***Level of Action***Moderate***Description*

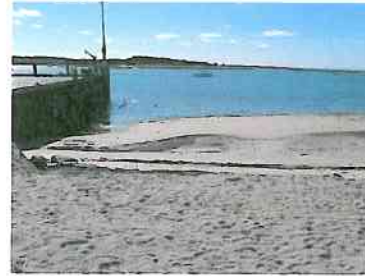
The beach is at a 1 on 5 slope out to mean high water where it slowly becomes a 1 on 20 grade. There are seashells and grass scattered throughout the beach. A parking lot and restaurant are inshore of the beach. Adjacent to the beach is the town pier.

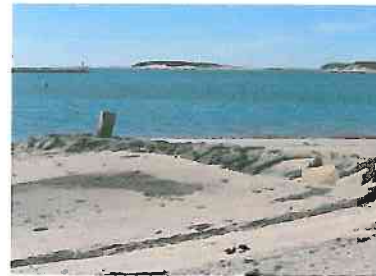
The single stone jetty is comprised of placed stones. The stones are on average 1 foot by 1 foot by 3 feet. The jetty extends from mean high water to mean low water. The stones are buried half way by the sand on either side of the jetty.

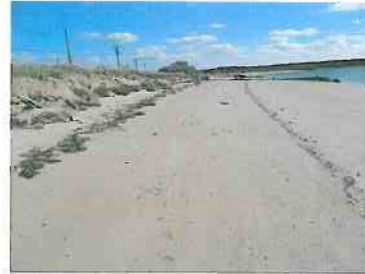
The well graded beach has fine brown sand. Sand dunes with debris are inshore. There is a road and houses located inshore also.

*Condition***B***Rating***Good***Level of Action***Minor***Description*

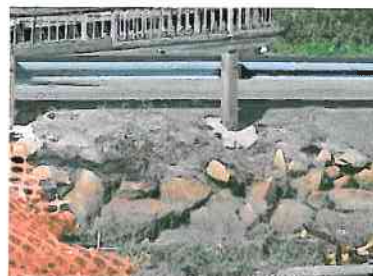
The dumped stone revetment has minor stone movement. The road located behind the revetment is paved into the top stones. There is a guardrail along the top. There are multiple drain pipes coming out of the stones. A restaurant is located across the road.

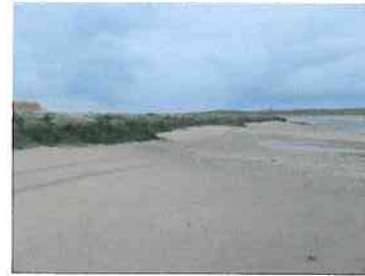
The breakwater consists of armor stones that vary from 4 to 8 tons. The structure is in good condition. There is no visible scour. There is sand build up against the armor, except at the head. Crest elevation is level.

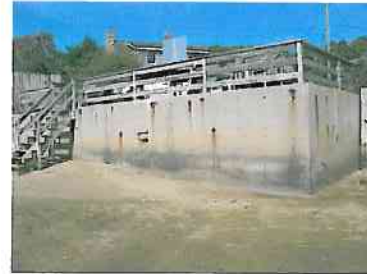
The cast in place wall has minor cracking throughout. There is a good amount of deterioration at places of rebar. Multiple PVC drains located at top of wall. A fence is on top of the wall with a staircase to the marsh outshore. The wall is located at the very end of the road. The adjacent houses have private bulkheads in front of them. The sand has drifted to one side of the wall, leaving the corner of the wall more exposed.

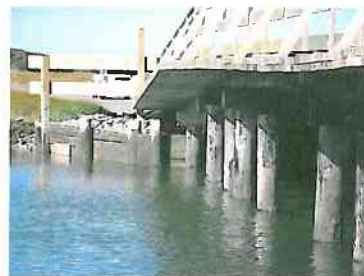
The timber bulkhead is in good condition. There is no visible scour. The riprap is 6 inches in diameter. The stones have been dumped under the timber bridge to stabilize the embankment. There is minor stone movement. The bridge is the only access road from the island to mainland.

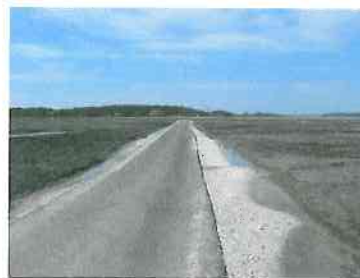
The causeway is the only access/egress on Lieutenant Island. The causeway is covered at high tide. The edges of the causeway have no slope to them.

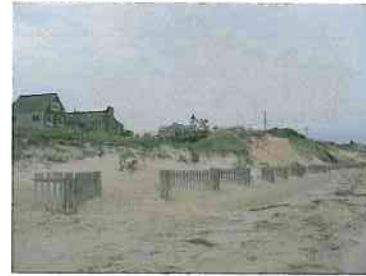
Coastal dune with retention fences in front of it. The dune is uniform and has minor erosion. There is dune grass on top and houses behind it.

*Condition***C***Rating***Fair***Level of Action***Moderate***Description*

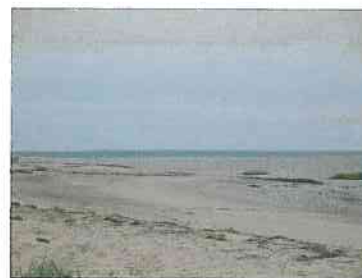
Set of three dumped stone groins. Stones are two feet by two feet by two feet on average.

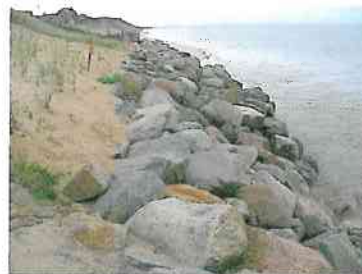
Dumped stone revetment at the end of a road. Stones are 3 feet by 2 feet by 1 foot on average. There are a few houses behind the structure and a sand beach in front.

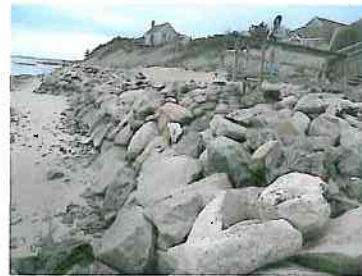
Dumped riprap. Stones are 3 feet by 2 feet by 2 feet on average. Structure has moderate to heavy undermining and erosion. There are voids in the stones in some sections.

*Condition***C***Rating***Fair***Level of Action***Moderate***Description*

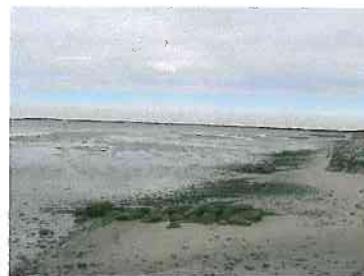
Set of dumped stone groins. Stones are 12 inches to 24 inches in diameter. Stones are scattered and show signs of heavy stone movement.

*Condition***D***Rating***Poor***Level of Action***Major***Description*

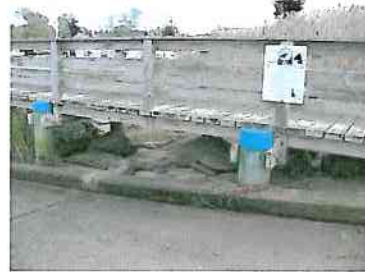
Dumped stone along the edge of a boat ramp. Stones had scattered. Stone size is 12 inches to 24 inches.

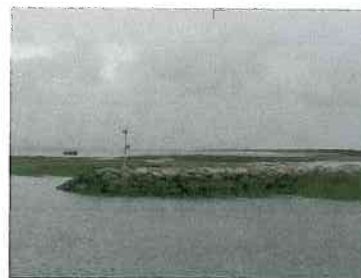
Placed stone mound jetty. Stones are 6 feet by 4 feet by 3 feet on average. Crest is one stone wide. No visible sign of stone movement.

Condition**B****Rating****Good****Level of Action****Minor****Description**

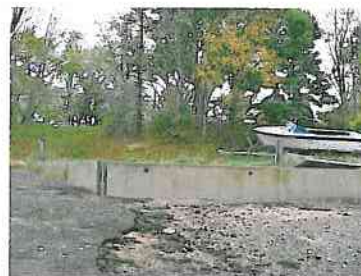
Cast in place concrete wall with parking lot behind and deteriorated boat ramp behind. Moderate cracking and spalling. No visible scour.
