EWING ASSOCIATES

September 7, 2022

Subj: Roof Moisture Survey
Roderick L. Ireland Courthouse
50 State St.
Springfield, MA

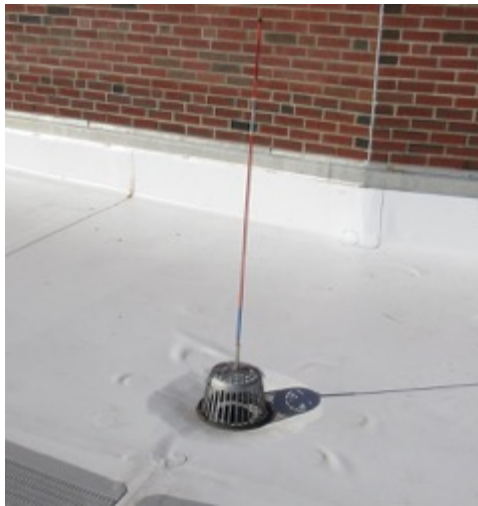
PHOTO 35

- Stair bottom bolted to 2x blocking setting on walkpad (Photo 34). Construction blocks drainage.
- Trench drain grating on main entrance plaza (before stairs) require cleaning. Most openings blocked (Photo 35).

Plaza drain grate openings clogged.
