Massachusetts Road-Stream Crossing Assessment Integrated Water Infrastructure Vulnerability Assessment and Climate Resiliency Plan – Town of Charlton and Town of Spencer May 2019

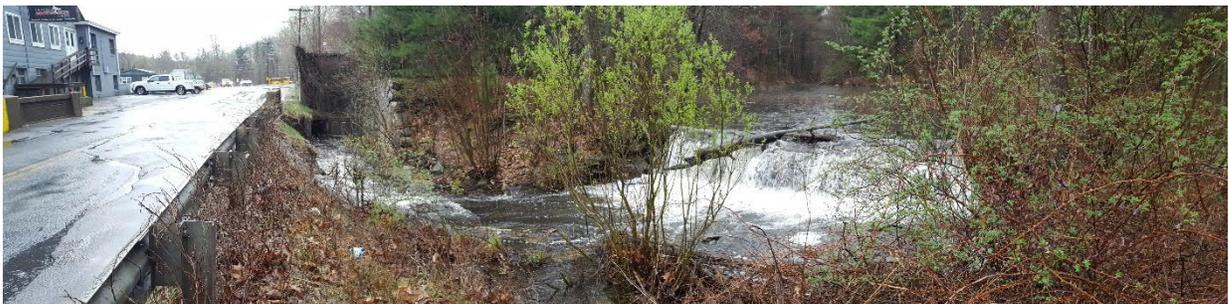
Panoramic view of Dam 4, including the spillway and a masonry wall to the right of the spillway. Route 31/City Depot Road is shown at the left but is actually parallel to the dam spillway (right).

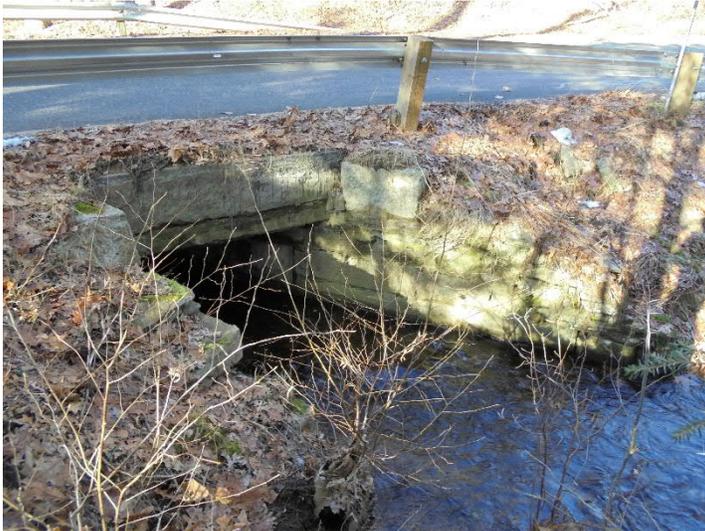
Outlet of the stone culvert under Cranberry Meadow Road, approximately 200 feet downstream of the Cranberry Meadow Pond Dam spillway.

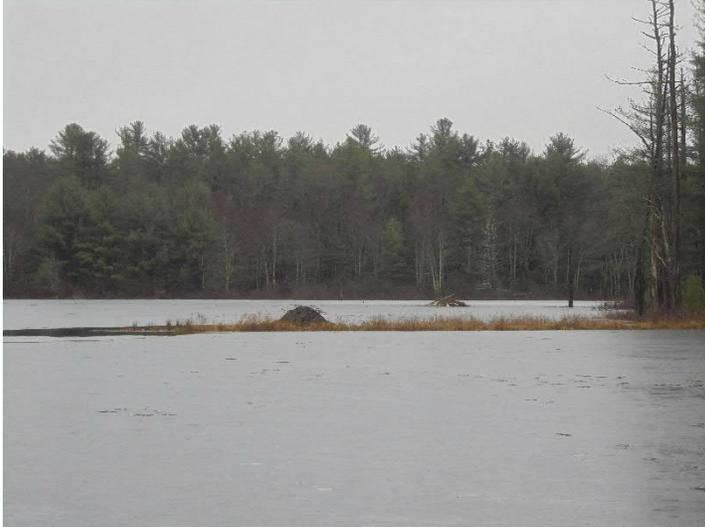
Beaver Lodges in Buck Hill Pond.

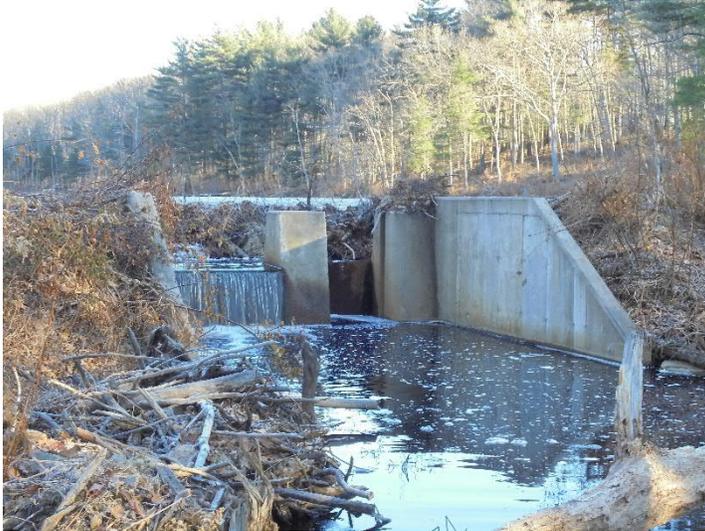
View of the Lambs Pond Dam Spillway and beaver dam from downstream.
