Wood-Pawcatuck Watershed Flood Resiliency Management Plan  
DAM INSPECTION FIELD ASSESSMENT

Charlton-Spencer Integrated Water Infrastructure Vulnerability Assessment and Climate Resiliency Plan  
VISUAL DAM ASSESSMENT

# Charlton-Spencer Integrated Water Infrastructure Vulnerability Assessment and Climate Resiliency Plan

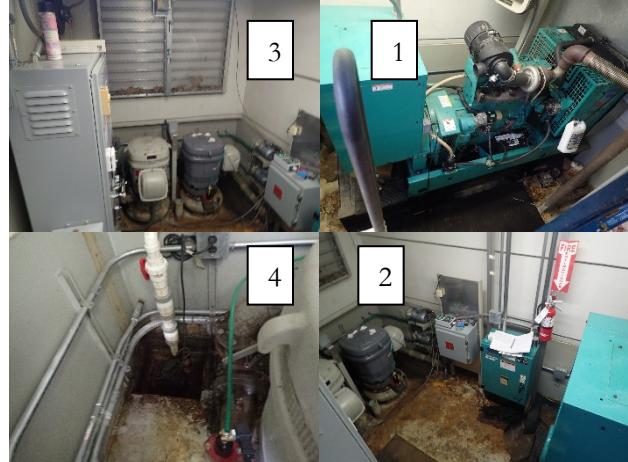
The facility accepts flow from the Muggett Hill Station just to the south and east of this station and pumps wastewater west to the North Main Street Station.

Barriers are recommended to protect the station and its critical components below grade against flooding. Further, the main service outside should be protected against flooding. This can be accomplished through walls around the facility or by upgrading the facility and elevating critical components above grade in a new structure.

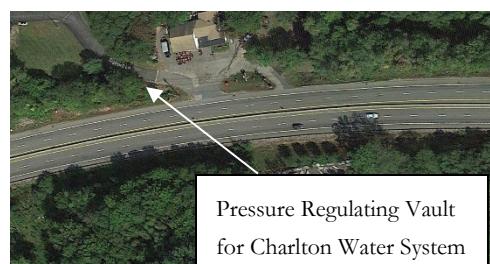
A Pressure Regulating Vault (PRV) for the water system on the north side of Route 20 that floods occasionally due to surface runoff and high groundwater levels. The vault is in front of commercial buildings just west of Stafford Lane and adjacent to a grass swale along Route 20.

Runoff should be redirected around the facility and the vault should be modified with a watertight cover to reduce the potential for flooding and water entering the structure.

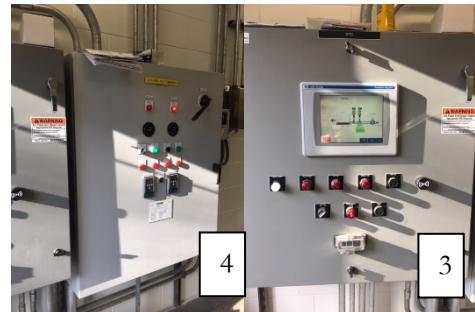
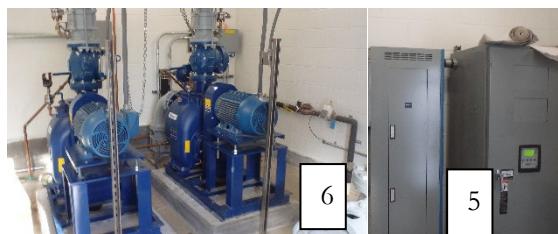
This facility is on Meadow Road just south of Fourth Avenue. It lies on the west side of the road and is adjacent to the 100 year flood zone and regulatory floodway associated with the Seven Mile River. The elevation of the pump station is 635.0 +/- based on LIDAR elevations. This very close to the 100 year flood elevation in the area of 634.5 (See Photo 1). The station entrance is flush with the ground elevation in the area and there is critical equipment very close to the ground elevation. This includes the backup generator (6 inches off the

ground on a housekeeping pad) and the liquid propane storage tank (also on a concrete pad just 6 inches off the ground). See Photo 2.

- SCADA Control Panel (3 feet off the floor - Photo 3)
- Pump Control Panel (3 feet off the floor - Photo 4)
- Three Phase Panel (19 in. off floor - Photo 5)
- Auto. Transfer Switch (ATS) (17 in. off floor - Photo 5)
- Centrifugal Pumps (30 in. off floor - Photo 6)

Because the elevations of critical components of the pump station are very close to the 100 year flood elevation, fortification of the critical equipment including the backup generator, and propane storage tank as well as the items less than 3 feet off the floor should be considered. This would require the electrical cabinets, the ATS and the pumps be raised at least 3 feet above the floor.

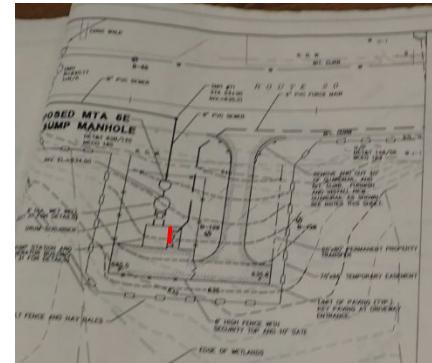
This facility is just off Route 20 and adjacent to a 100 year flood zone associated with Sibley's Pond to the west and draining towards Cady Brook which runs south.

Resiliency recommendations for this facility would include:

- Providing a protective barrier for the main entrance to minimize water entering the building
- Install a watertight hatch over the access entrance to the level of the facility
- Seal penetrations between main level and lower level (conduits and ventilation)

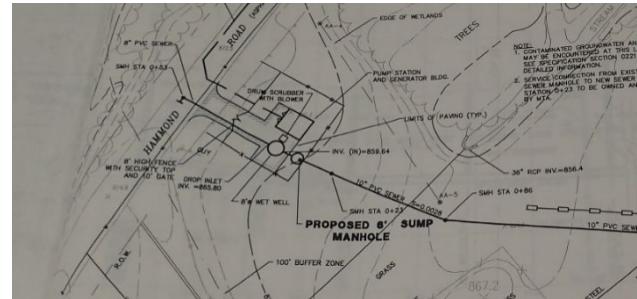
This station is located just north of the Massachusetts Turnpike (Route 90) adjacent to one of the service areas. The facility is just south of a 500 year flood zone and is adjacent to a small stream which flows by the facility.

The building has three stories with the upper level housing the generator, transfer switch, power and control panels and a transformer for single phase equipment. Most electrical panels are above the floor ( $>3$  feet) and conduit and receptacles are watertight.

The middle level has piping from the groundwater well that feeds a hydropneumatic tank to maintain pressure for water being provided to the pumps for seal water. This level has conduits that extend to the lower level as well as a 16 inch PVC pipe used for ventilation for the lower level.

The lowest level (20 feet below grade) includes piping, pumps, a dehumidifier, unit heater, sump and pump and piping for the seal water for the pumps. All conduit and receptacles in this area are watertight.

Resiliency recommendations for this facility would include:

- Providing a protective barrier for the main entrance to minimize water entering the building
- Install a watertight hatch over the access entrance to the lower levels of the facility
- Seal penetrations between main level and lower levels (conduits and ventilation)
