Fitchburg District Court Fitchburg, MA

HVAC SYSTEM EVALUATIONS COVID-19

Office of Court Management

August 4, 2021

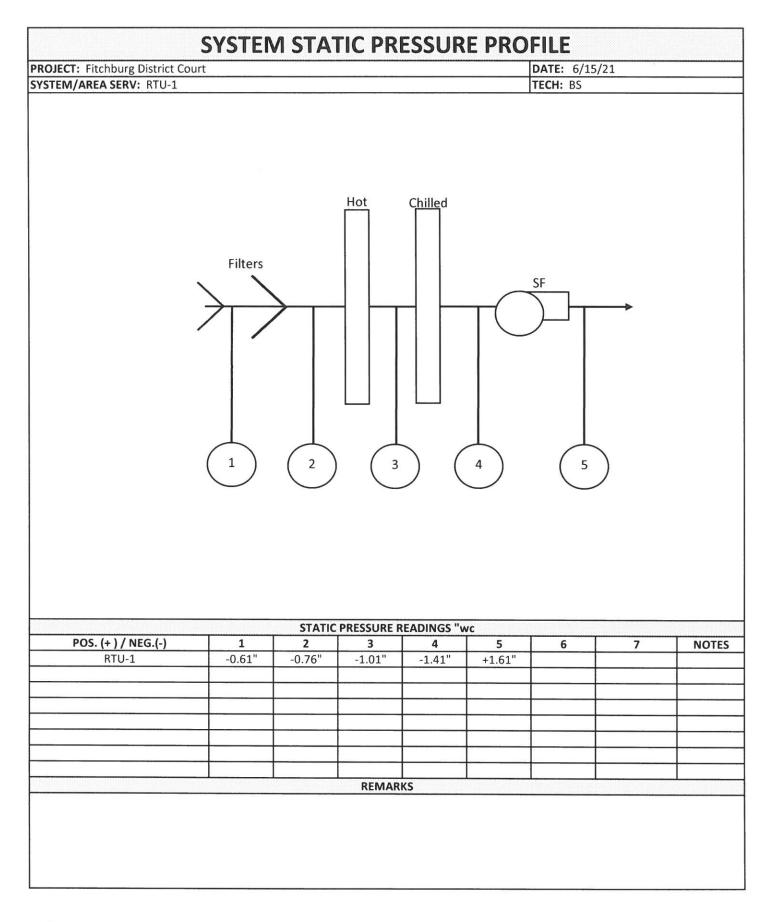
ROJECT: Fitchburg District Court							DATE: 6/15/21			
AREA SERVED: Various							TECH: BS TEST NO			
TRAVERSE LOCATIONS	DUCT SIZE "	AREA SQ.FT.	DESIGN FPM CFM		CENTERLINE STATIC PRES."	FPM	NOTES			
	JILL		TEINI	Crivi	STATIC PRES.		CFM			
RTU-1 Total	118" x 40"	32.8		24,000	w/velgrid	675	22,140			
RTU-1 OA	118" x 40"	32.8		3200	w/velgrid	88	2860			
RTU-1 Return				20,800	calc		19,280			
RF-1 Total	72" x 24"	12.0		20,800	w/velgrid	1622	19,464			
AHU-1 South Ret	16" x 12"	1.33		ND	-0.08	469	625			
AHU-1 North Ret	24" x 8"	1.33		ND	-0.08	497	<u>663</u>			
							1288
