# MassDEP Field Assessment and Support Team (FAST)

After Incident Report

DEP RTN 4-22,693

Foxboro Jet Fuel Tanker Spill

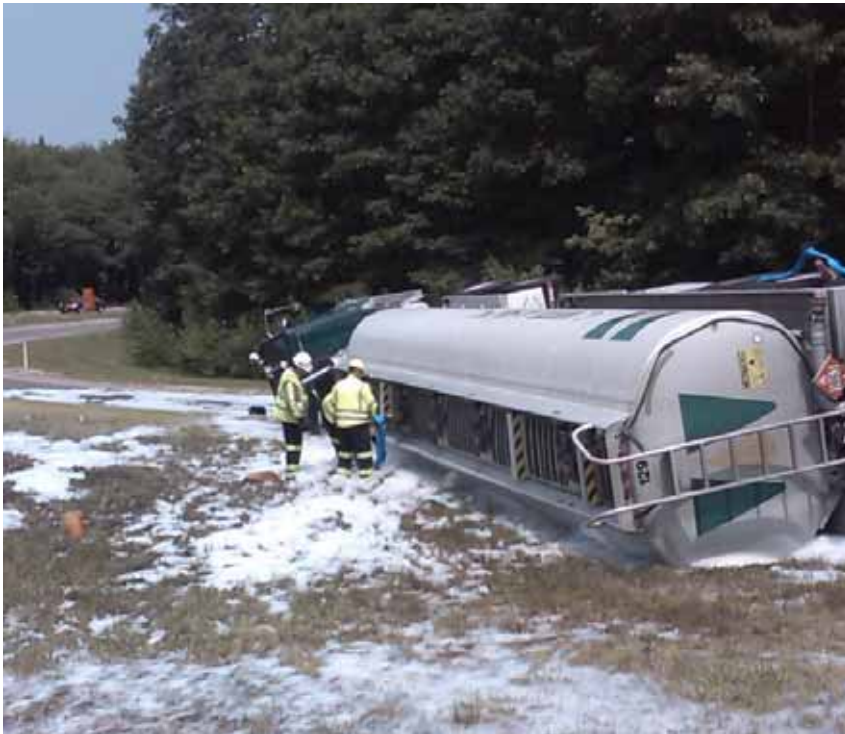
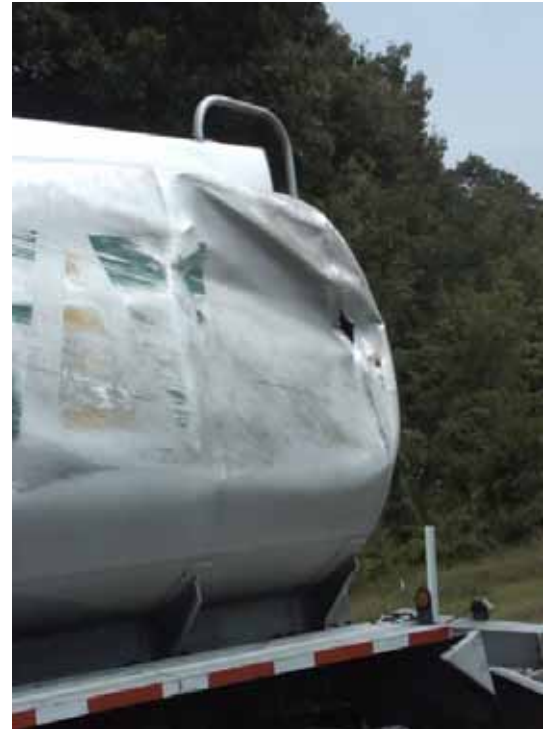
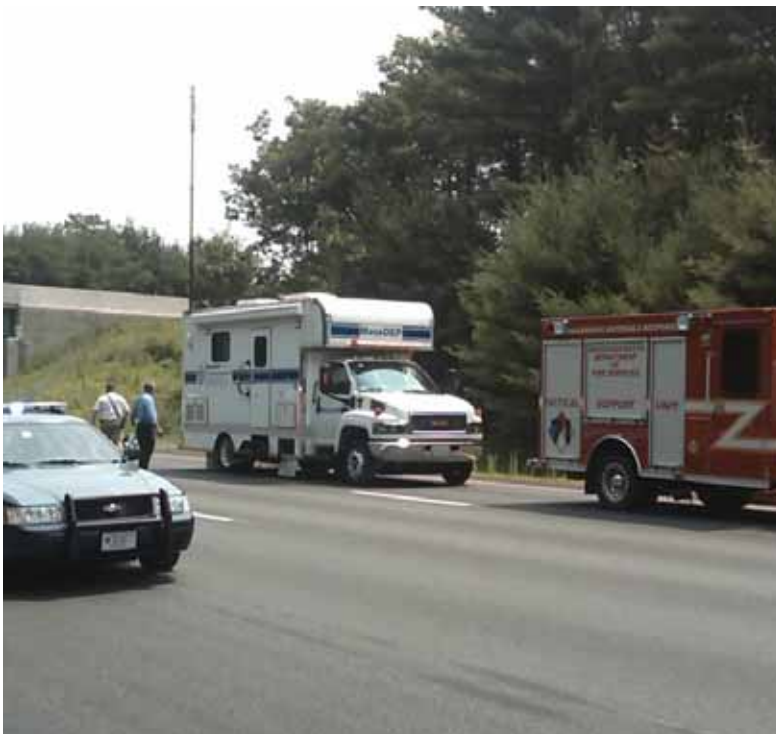
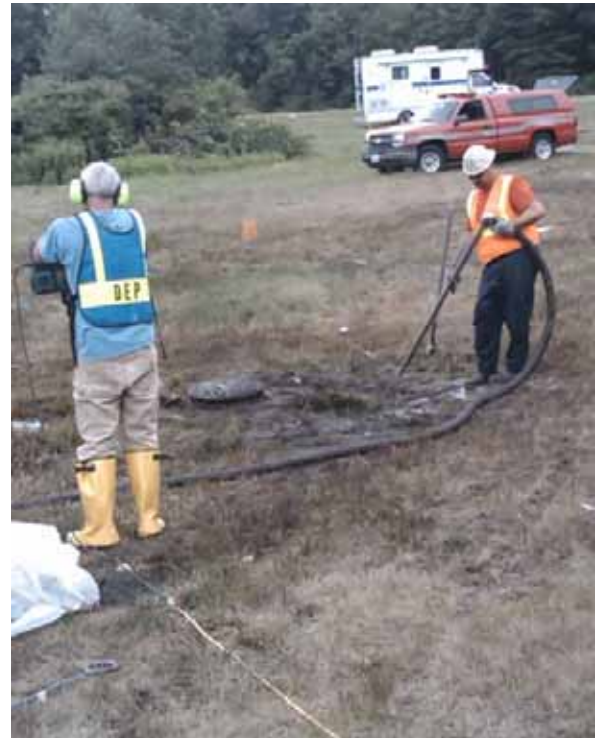
The tanker landed on its side, in a grassy area just off (southwest of) the ramp (see cover). Later in the morning, it was ascertained that all 11,000 gallons of fuel had spilled from the tanker. The fuel had discharged onto the ground, and flowed into a nearby catch basin. The catch basin discharged to a nearby manhole, which flowed into a culvert that discharged to a drainage ditch on the north side of the ramp (See Figure 1).
