**REPORT#:** 22MA058

**REPORT DATE:** May 29, 2025

## Freight Mover Struck by Backing Dumpster Truck at Freight Transfer Facility— Massachusetts

At 6:32 a.m. on December 16, 2022, a 31-year-old Hispanic Black laborer for a transportation company was struck and killed by a backing waste haul dumpster truck at a freight transfer facility. [READ THE FULL REPORT>](#) (p.3)

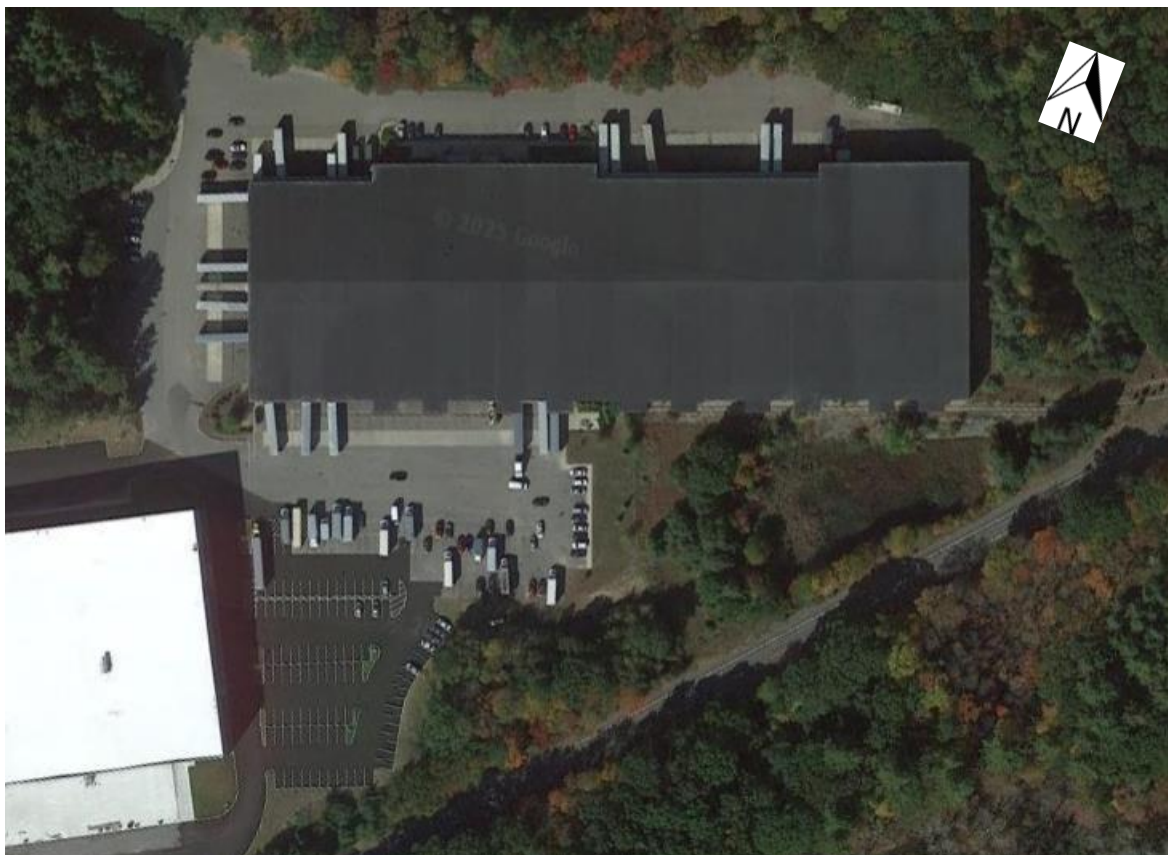
**Image 3. Aerial view of the freight transfer facility. (Photo courtesy of Google Earth.)**

The main parking lot was located on the south side of the building. Personal vehicles and inactive trucks were parked in the lot. The overall layout had an area for vehicles and trucks to pass between the parking spaces and the building, with enough room for trucks to back up to the loading docks. There was a raised sidewalk on the east perimeter of the parking lot that led to exterior steps and an entrance to the building. On the west side of the lot, there were two faded white lines painted on the pavement that led from the first row of parking spots to an entrance on the southwest corner of the building. The two white lines were from a prior parking lot configuration, when the lot was larger and had more parking spaces and hashed no-parking zones that extended west of the lines. No other pedestrian walkways or painted zones were around the parking lot or near the docks. A dumpster was consistently located at a specific dock door on the south side of the building.

Discussion: First responders at the scene noted that lighting in the area of incident was lacking. The rainy weather and the darkness before sunrise highlighted the issue of inadequate lighting in the loading dock area and the parking lot area. With those external factors, employees, both drivers of vehicles and pedestrians, are affected by poor visibility which increases their risk of struck-by incidents, similar to this case.

Discussion: The victim was struck as he walked near the landing pad area that ran along the warehouse. The configuration of the parking lot and entry doors suggests that any freight truck drivers who back up to a loading dock would gain access to the building by walking in this area. This exposes workers to the hazard of vehicles backing up to

park and also vehicles pulling forward to realign with a dock or to depart. The designated walkways for pedestrian workers were inadequate and unclear.

### ***Recommendation #1: Employers should ensure adequate outdoor lighting for areas with moving vehicles and pedestrians walking.***

### ***Recommendation #2: Employers should ensure there is a clear designated walkway for pedestrians to get between the parking lot and buildings. Conspicuous signs for moving vehicles and pedestrians should be placed near walkways.***
