*Massachusetts Coastal Infrastructure
Inventory and Assessment Project
Massachusetts Department of Conservation and Recreation
Office of Waterways*

Cape Ann

July 6, 2009

**Bourne Consulting Engineering
Franklin, Massachusetts**

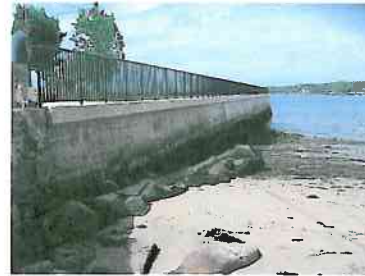
Seawall is cast in place. Construction appears new. Behind the wall there is a playground and park. Riprap in front of the wall is approximately 25 feet wide. Stones are 6 feet by 2 feet by 3 feet, varying to 100 pound stone dumped riprap. No signs of scour or undermine. The top of the wall has drainage scuppers. The wall is 2 feet higher than grade at the back of the wall.

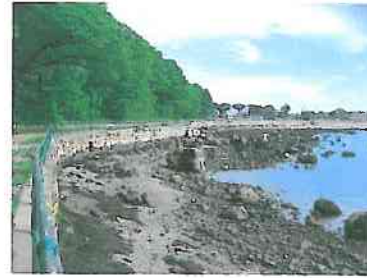
Stone mortared seawall with boardwalk, monuments, houses and road behind. There are areas with stone loss about every 100 feet with 5 feet width holes behind the top of the wall that are exposing the wall to the bottom. Small (100 to 200 pound) riprap has been placed in front of these areas.

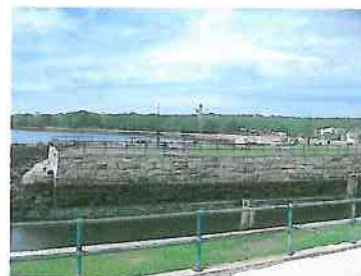
The newly constructed seawall is stone mortarted. The seawall is adjacent to a bridge over the channel to the Annisquam River. There is a roadway behind the structure.

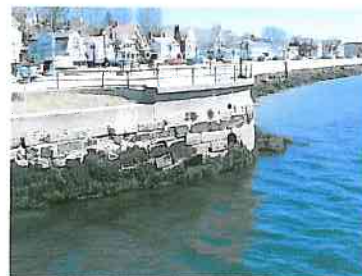
The seawall is comprised of two parts. The bottom of the wall is five to six stones high with a cast in place wall on top of it. The stones are approximately 5 feet by 2 feet. There is settling of the boardwalk behind the wall and undermining holes visible.

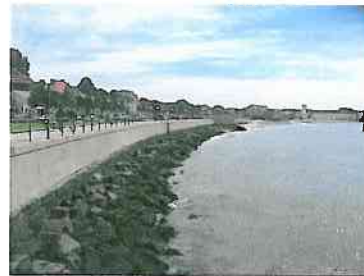
Monuments, boardwalk, houses and road are behind the stone block seawall. Five to six stones high (5 feet by 2 feet) for about half the wall then cast in place at the top of the wall. No scour visible. Riprap is approximately 5 feet by 5 feet by 5 feet dumped and stops about 2 feet below the cast in place wall.

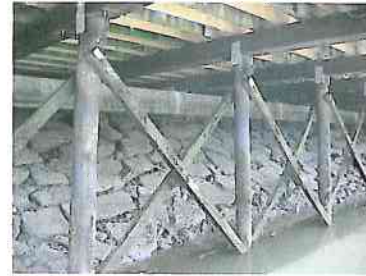
Riprap is below timber pier. Concrete cap above the riprap. The stones are approximately 2 feet by 2 feet by 5 feet. No signs of movement or shifting.

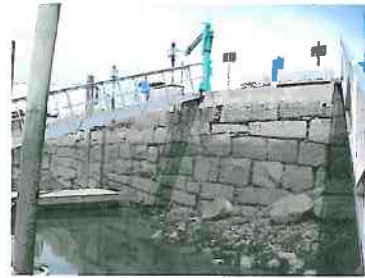
Stone block seawall is comprised of 2 feet by 2 feet stones. Toe of the wall is exposed at low tide. Stones are shifted and settled. Half of the wall is cast in place wall with wave return face, and half has a concrete cap. Gangway to the town landing floats is connected.

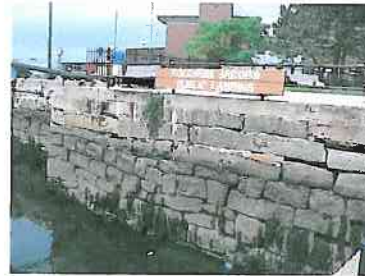
Top is concrete walkway and park. The dry set stone seawall is comprised of stones that are on average 2 feet by 2 feet by 6 feet. There is stone movement, shifting, and bowing out.

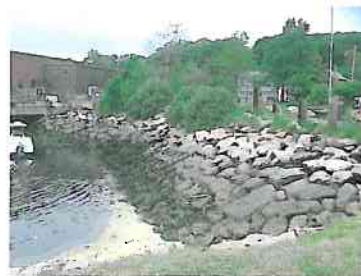
Placed riprap with stones that are on average between 0.5 to 1 ton. 1 on 1 slope. There are no signs of movement or shifting. The stones are placed and locked in well. Park behind revetment.

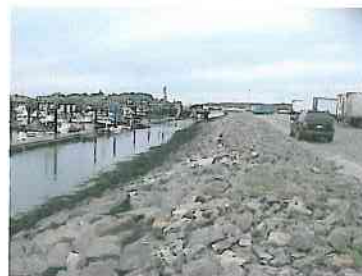
Dumped riprap revetment circling the state pier. Unable to see materials under or behind wall. The slope is 1 on 2 to 1 on 1. Stones are 50 to 100 pounds. Riprap comes to grade level. Parking lot, building, and storage area behind. The timber pier off of it.

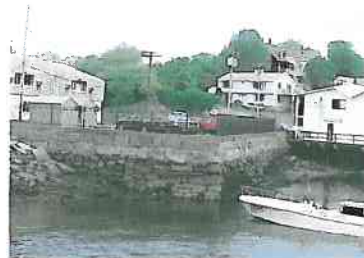
Stone bulkhead with 2 feet by 2 feet stones with a concrete cap. Behind the wall is a parking lot and the Environmental Policy Organization Building. Some movement of stones. Chinking is still in place.

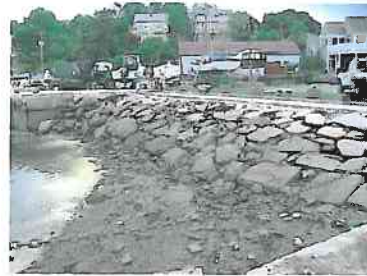
Placed riprap with stones approximately 4 feet by 2 feet by 2 feet. The toe is exposed at low tide. On the top of the revetment is a walkway and park. No scour or movement visible.

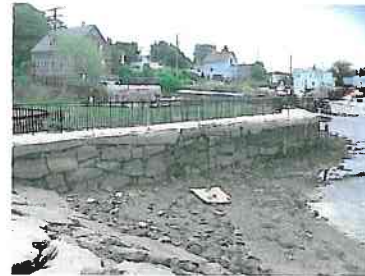
Stone bulkhead with stone approximately 6 feet by 3 feet by 2 feet. The top of the wall is mortared. Some mortar is lost. Behind the wall is a playground, and in front is the gangway for a public landing. Some riprap at the toe. No scour visible.

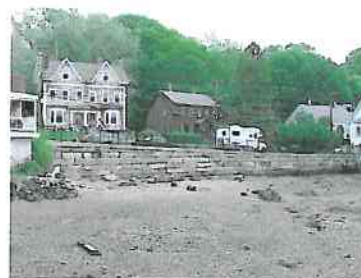
Stone block mortared seawall. The stones are approximately 1.5 feet in length by 1 foot in height. A sidewalk, road and houses are behind the wall. A sandy beach is in front of the wall. There is no sign of scour or undermine.

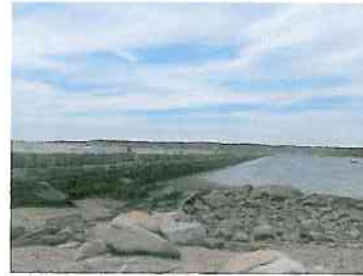
The breakwater is at the mouth of the Gloucester Harbor. The stones are 9 feet by 3 feet by 3 feet and rectangular. The riprap on the ocean side is placed and is 9 feet by 4 feet by 5 feet with a 1 on 1 slope. Five of the riprap stones have been pushed out of place by storm action.

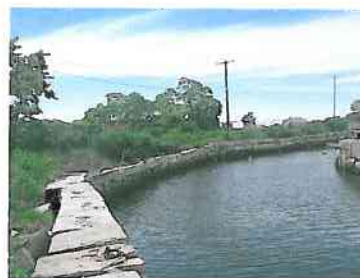
Stone block bulkhead with stones averaging 7 feet by 2 feet by 2 feet. Erosion behind wall and stones have shifted and settled. Slope is 1 on 1 to 1 on 0.5.

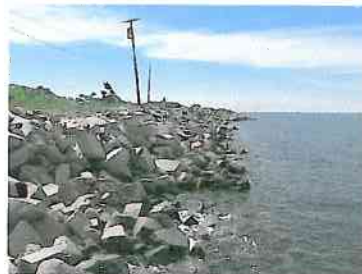
Dumped riprap with stones of varying size. The average stone size is 3 feet by 3 feet by 3 feet. The stones have unraveled, shifted and settled in many parts.

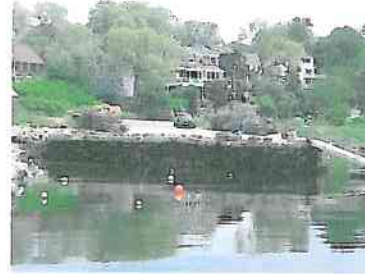
Stones are undermining, settling, shifting and rotating. They are approximately 4 feet by 2 feet by 2 feet. A storage area for fishing equipment and a parking lot are located above the middle structure in the cove.

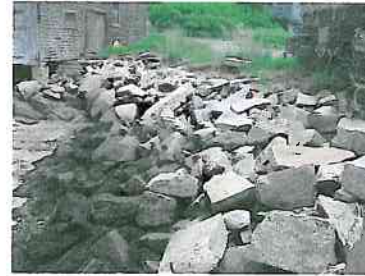
Dumped riprap is approximately 200 pounds. Some erosion along the top. The toe is still intact.

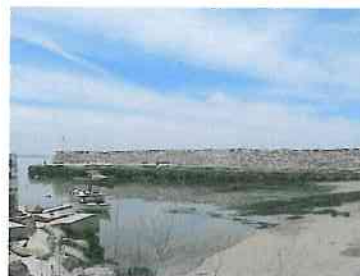
The stone breakwater is approximately 4 feet by 3 feet by 1 foot. There is some visible stone heave and bowing out, along with some settling and unraveling. The breakwater protects the cove and channel. Adjacent to the breakwater is a 20 foot wall connected to a 20 foot landing which is connected to a 15 foot wall. There is erosion along the inshore base. There is approximately 100 feet of dumped riprap.

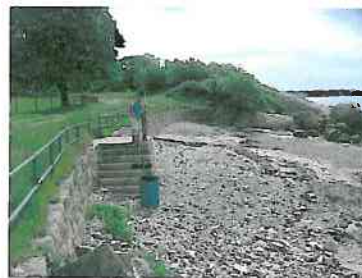
The stone riprap revetment has stones of approximately 5 feet by 3 feet by 2 feet size. The slope is 1 on 1.5. There is a good amount of erosion at the top. Some sections of understone have washed out leaving large gaps in the understone exposing geotextile. The toe is intact. There is a cobble beach in front of the revetment.

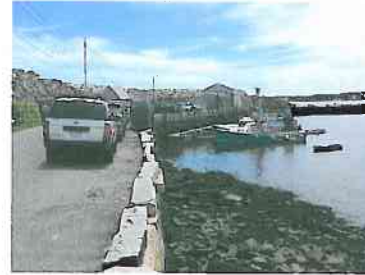
The stone block bulkhead is approximately 5 feet by 2 feet by 2 feet. Some settling of stones. The top is used for storage of fishing equipment and parking. No sign of scour throughout.

*Condition***B***Rating***Good***Level of Action***Minor***Description*

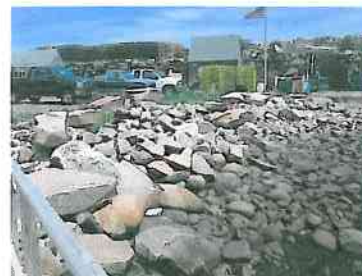
Dumped riprap; approximately 200 pound stones. In between is a boat railway. The stones are unraveled and settled.

*Condition***D***Rating***Poor***Level of Action***Major***Description*

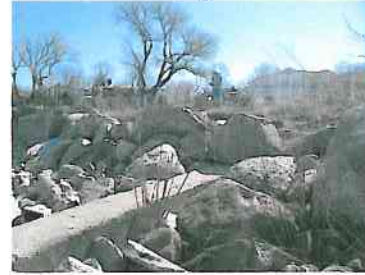
Dumped stone approximately 4 feet in diameter in front of a pumping station. Stones are scattered creating many voids. There is heavy erosion in the coastal bank behind the revetment.

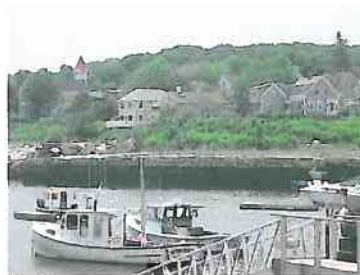
Stone bulkhead with parking lot and building behind. Stones are approximately 9 feet by 3 feet by 2 feet. Some movement of stones and sink holes behind walk and at the corners of the wall. No sign of scour. Some stone movement at jetty.

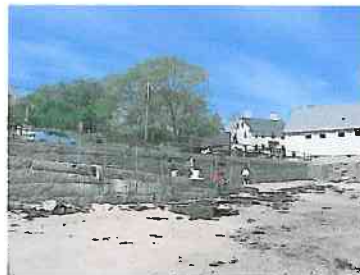
The stone wall is mortared with stones approximately 7 feet by 2 feet by 2 feet in size. There is a ramp that goes to the beach. The wall is protecting the road behind and there is a sandy beach in front. No scour or erosion is visible.

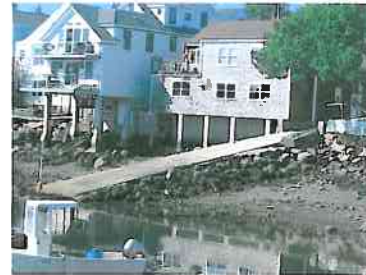
Riprap against a cast in place concrete boat ramp. Stone size is approximately 100 to 200 pounds. Section loss and stones are unraveled in a few sections. The boatramp is undermined and cracking halfway up.

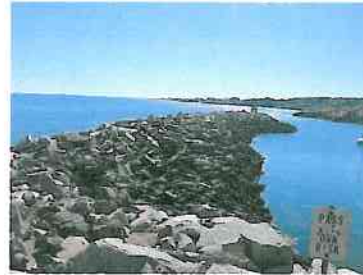
The breakwater is located at the mouth of Rockport Harbor. The stones are approximately 5 feet by 5 feet by 3 feet on average. Some movement has occurred among the stones, along with some section loss.

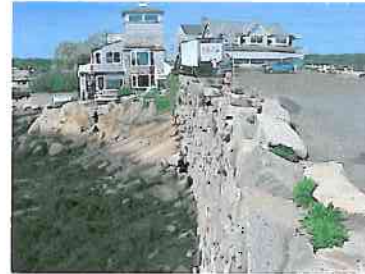
Stone bulkhead with stones that are approximately 5 feet by 2 feet by 2 feet. No sign of movement or settling. Above is a parking lot and small park. The bulkhead is attached to a breakwater. There is no visible scour. The bulkhead is built on a ledge.
