*Massachusetts Coastal Infrastructure
Inventory and Assessment Project
Massachusetts Department of Conservation and Recreation
Office of Waterways*

Outer Cape Cod - South

Orleans
Brewster
Harwich
Chatham

July 6, 2009

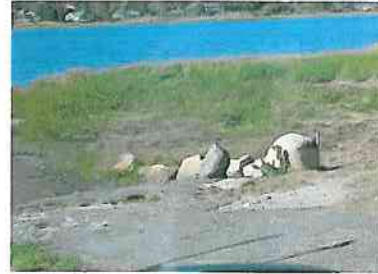
Placed single line of stones adjacent to the town landing. The stones are on average 2 feet by 1 foot by 1 foot in size.

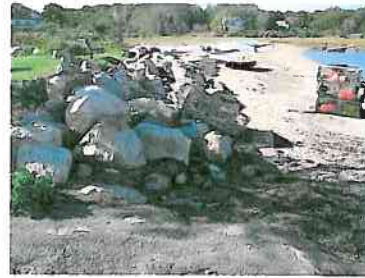
The dumped stones vary in size, averaging 2 feet by 1 foot by 1 foot. The slope is 1 on 5. There is erosion inshore of the revetment. There is understone visible and unraveling at the toe. Debris, grass, and branches are scattered throughout the structure. There is a parking lot behind, beach in front and boat ramp adjacent to the revetment.

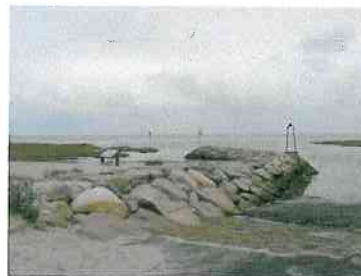
The stone groin is at the mouth of Rock Harbor, adjacent to the boat ramp. The stones are approximately 2 feet by 2 feet at a 1 on 1 slope. The crest is 1 stone wide. The stones are well placed with no visible movement.

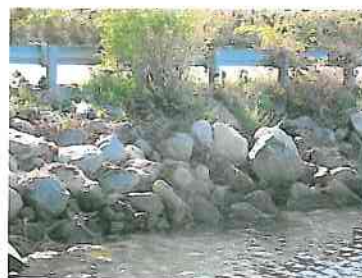
The dumped stone revetment has stones that vary in size. On average, the stones are 3 feet by 2 feet by 1 foot in size. The slope is 1 on 3. There is visible stone movement. The understone is visible. Behind the revetment is a road and houses.

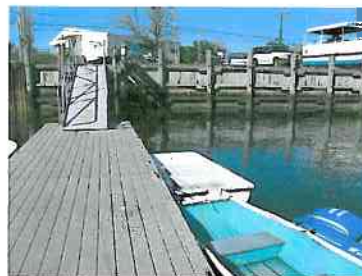
The timber bulkhead is stabilized by timber piles and wales. There is minor growth at the tidal zone. A gangway and floats come off the middle of the bulkhead. Behind is a parking lot. Adjacent is a boat ramp.

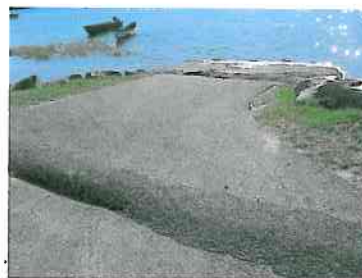
The dumped stone revetment consists of stones that are approximately 2 feet by 1 foot by 1 foot in size. The stones are dumped along the boat ramp.

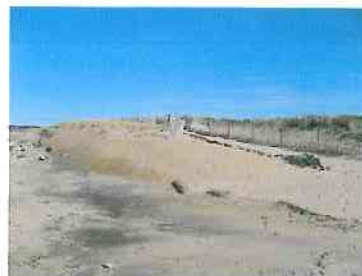
The dunes are at a 1 on 3 slope. The high tide line comes up to the toe of the dunes. Outshore is a beach with some debris. Behind are houses.

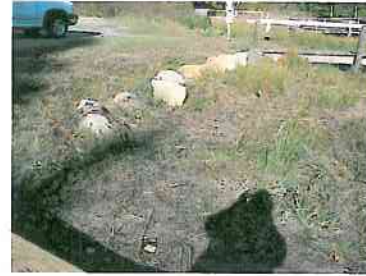
A single line of placed stones lines the side of a boat ramp. The stones are approximately 1 foot by 1 foot by 1 foot in size. The stones have been overgrown. There is a parking area behind the revetment and a boat ramp and pier adjacent.

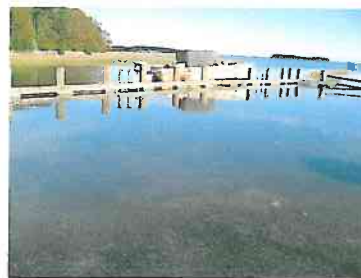
The timber bulkhead is fully emerged at high tide. The cap and tops of piles are still visible. The bulkhead does not retain the water. The parking area behind the bulkhead is under water also. The bulkhead would not protect any of the houses located behind it. Boats tie off the bulkhead. The stone revetment is adjacent to the bulkhead and boat ramp. There is minor stone movement.

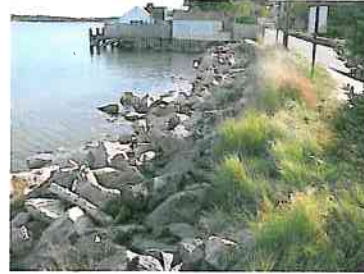
The dumped stone revetment is at a 1 on 3 slope. The stones are approximately 1 foot by 1 foot by 2 feet. There is stone movement and unraveling throughout. Route 28 is directly behind the revetment. There are houses adjacent to the structure and across the street.

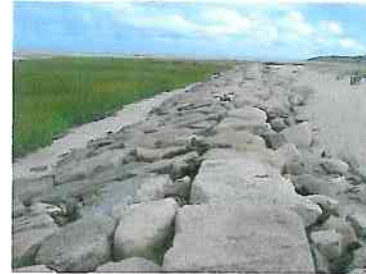
This structure is the revetment fronting the parking lot at Paines Creek Beach. There is some slumping of the crest and erosion is evident behind the structure.

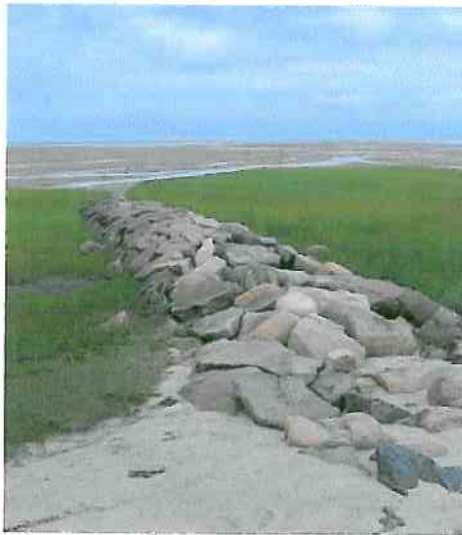
009-038-000-701-200-PHO2A

These structures are the two groins at Paines Creek Beach. The side slopes and crest are in fair condition. Some loss of fill stone is evident.

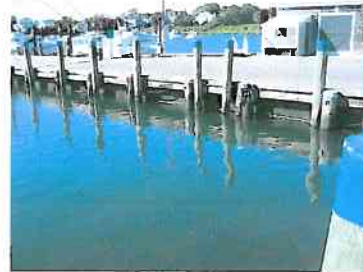
This structure is a bulkhead at the Wychmere Harbor town pier. The structure fronts a parking lot and is adjacent to town dockage. It is weathered but solid.

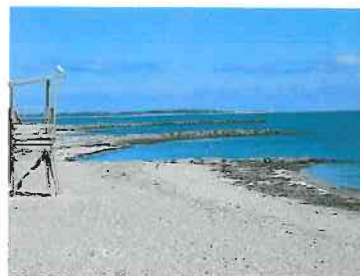
These structures are the groin field at Red River Beach. There are 9 groins recorded. The western 8 groins alternate in length with one short groin between 2 longer ones. There is a terminal groin at the eastern end of the field which is approximately twice the length of the longer groins. The armor stones on these structures are becoming unraveled.

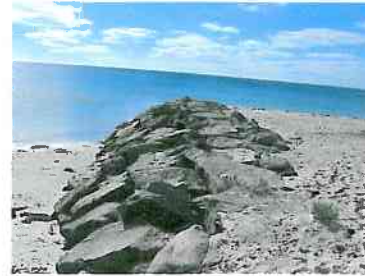
This structure is the groin at Pleasant Road beach. There is some minor slumping of the armor stone evident. The beach is impounded to the crest on the updrift (west) side while the downdrift side is exposed to the toe.

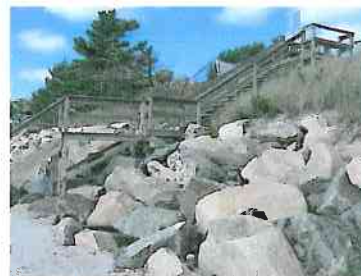
This structure is a stone revetment at the foot of the dune at Grey Neck Beach. The armor east of the stairs is slumped with erosion evident behind it. The revetment toe is buried and the dune above is vegetated.

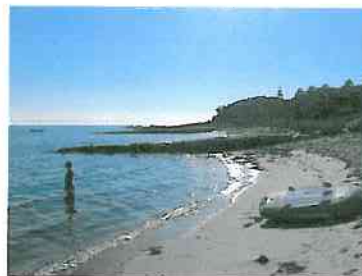
This structure is the terminal groin on the west side of Mill Creek. The landward section of the structure is partially buried by the beach. Armor stones on the structure have become unraveled.

*Condition***D***Rating***Poor***Level of Action***Major***Description*

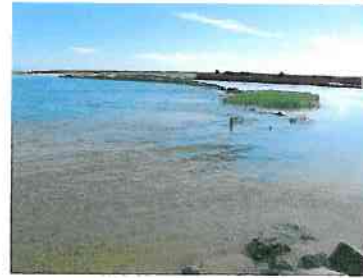
This structure is a stone jetty on the east side of Mill Creek. The section nearest the shoreline is unraveled and mostly submerged. The armor on the unraveled portion near the shoreline is being flanked. The outer section is also unraveled but sits higher in the water.

*Condition***D***Rating***Poor***Level of Action***Major***Description*

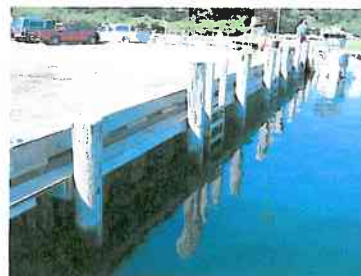
This structure is a bulkhead at Barn Hill Road boat ramp. It is a steel sheetpile with timber caps. Both components show aging.

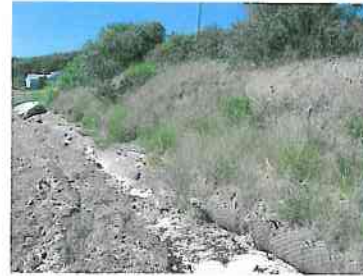
This structure is a sheetpile at the bend in Champlain Road that is fronted by earth/dune. The cap of the sheetpile is visible while the rest of the wall is buried in the bank and covered in vegetation. There are fiber rolls at the base that are becoming exposed.

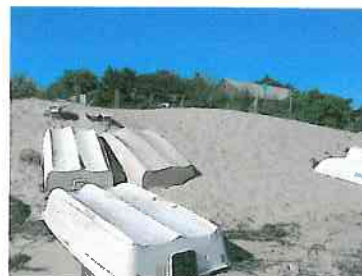
This structure is a nourishment located at the end of Strong Island Road. The dune is fronting a small parking lot and functioning well. There is no evidence of the fiber roll reported beneath dune.

*Condition*C*Rating*Fair*Level of Action*Moderate*Description*

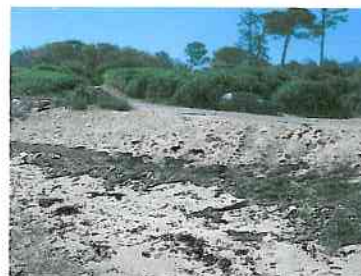
This structure is a nourishment located at the end of Cotchpinicut Road. The dune elevation is becoming depleted. The beach is showing a typical profile shape.

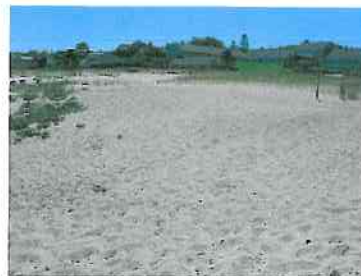
This structure is a nourishment at Claffin Landing. The beach and dune elevation are somewhat depressed. There is no beach grass on dune area. A typical beach profile is evident.

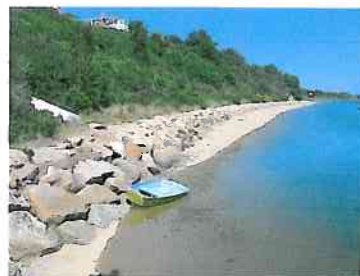
This structure is a stone revetment running north of the Fish Pier. The crest and sideslopes are level. The toe is starting to become unraveled at the southern end. Some armor stones have become displaced.

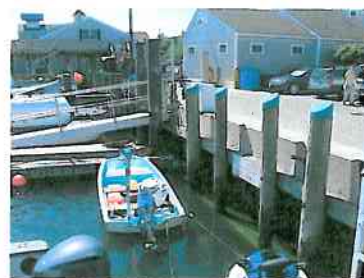
This structure is a bulkhead fronting the Fish Pier. The bulkhead is a steel sheetpile with concrete cap and fronted by timber whaling. It was installed in 1998.

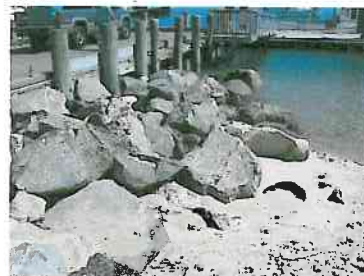
This structure is a stone revetment at the south end of the Fish Pier. It is composed of dumped armor stone which lies along the south side of the bulkhead. There is no appreciable interlocking between stones.

Structure is sound but may exhibit minor deterioration, section loss, cracking, spalling, undermining, and/or scour. Structure adequate to withstand major coastal storm with little to moderate damage. Actions taken to reinforce structure to provide full protection from major coastal storm and for extending life of structure. Moderate wind or wave damage to landform exists. Landform may not be sufficient to fully protect shoreline during a major coastal storm. Actions taken to provide addition material for full protection and extended life.

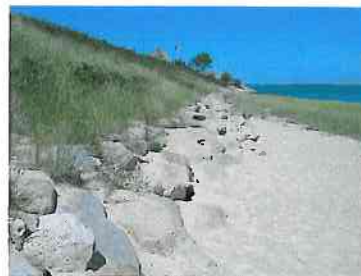
This structure is a revetment fronting the parking lot at the Chatham Lighthouse. There is a moderate dune in front of the majority of the structure. The dune fronting and backing the revetment is heavily vegetated with beach grass. The armor stone in the center section is mostly unraveled.

Structure exhibits advanced levels of deterioration, section loss, cracking, spalling, undermining, and/or scour. Structure has strong risk of significant damage and possible failure during a major coastal storm. Structure should be monitored until repairs/reconstruction can be initiated. Actions taken to reconstruct structure to regain full capacity to resist a major coastal storm. Landform eroded, stability threatened. Landform not adequate to provide protection during major coastal storm. Actions taken to recreate landform to adequate limits for full protection from a major coastal storm.

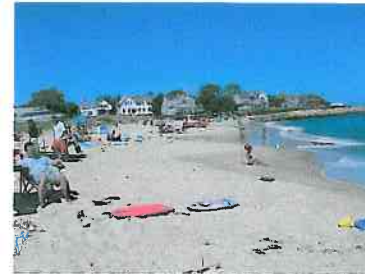
This structure is a beach nourishment at the end of Andrew Harding Lane. The beach and dune are in good condition. There is a small scarp at the toe of the dune. A normal beach profile has developed.

*Condition***C***Rating***Fair***Level of Action***Moderate***Description*

Structure is sound but may exhibit minor deterioration, section loss, cracking, spalling, undermining, and/or scour. Structure adequate to withstand major coastal storm with little to moderate damage. Actions taken to reinforce structure to provide full protection from major coastal storm and for extending life of structure. Moderate wind or wave damage to landform exists. Landform may not be sufficient to fully protect shoreline during a major coastal storm. Actions taken to provide addition material for full protection and extended life.

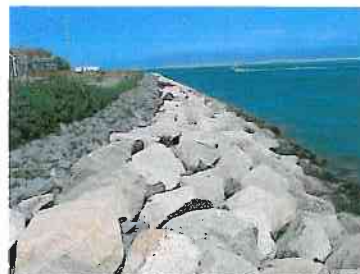
This structure is a stone revetment from the end of Holway Street south to Andrew Harding Beach. The crest and side slope are in good shape. There is some shifting of armor at the face and loss of crest elevation.

Structure observed to exhibit very minor problems, superficial in nature. Minor erosion to landform is present. Structure / landform adequate to provide protection from a major coastal storm with no damage. Actions taken to prevent / limit future deterioration and extend life of structure.

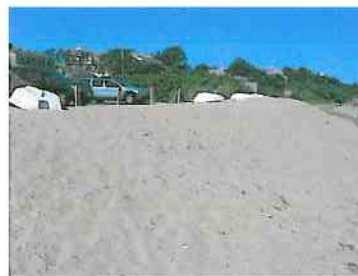
This structure is a nourishment located at Scatteree Beach. The dune is in good condition. There is no evidence of the Jersey Barriers that are reported beneath the dune. The beach is showing a standard profile shape.

Structure is sound but may exhibit minor deterioration, section loss, cracking, spalling, undermining, and/or scour. Structure adequate to withstand major coastal storm with little to moderate damage. Actions taken to reinforce structure to provide full protection from major coastal storm and for extending life of structure. Moderate wind or wave damage to landform exists. Landform may not be sufficient to fully protect shoreline during a major coastal storm. Actions taken to provide addition material for full protection and extended life.

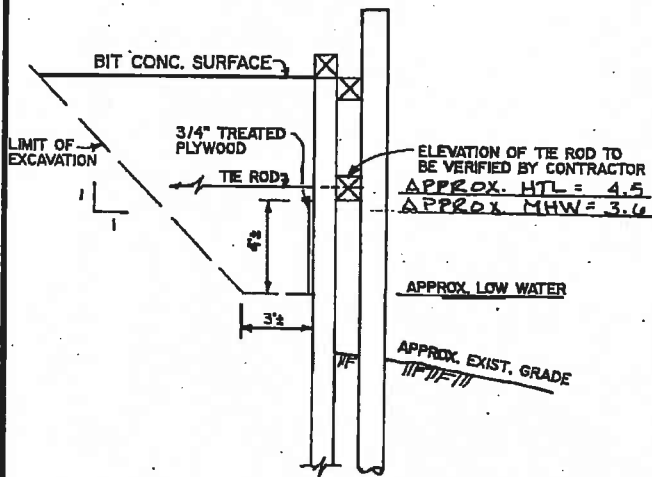
REPAIR DETAIL
SCALE 1/8" = 1'-0"

TREATED PLYWOOD SHALL BE PLACED BEHIND ANY PERFORATION IN BULKHEAD AND SECURED,
