***South Shore Coastal Infrastructure Inventory  
and Assessment Demonstration Project  
Coastal Hazards Commission***

**Town of Hingham**

**Prepared for:  
Office of Coastal Zone Management  
Boston, MA**

**Presented by:  
Bourne Consulting Engineering  
Franklin, Massachusetts**

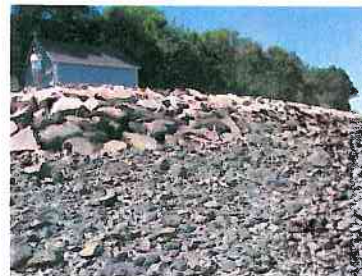
Placed rip rap slope along steep earth bank. 45 degree slope toed into cobble beach. 5 feet wide crest. Stone size is 1 to 3 ton.

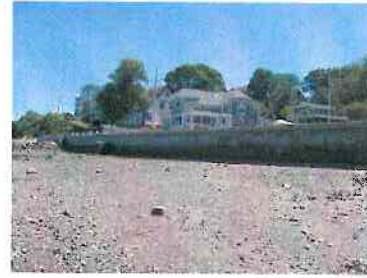
Placed rip rap slope (1 vertical to 2 horizontal) using 1000 to 2000 lb stones. Toed into cobble beach. Earth slope continues up inshore of revetment.

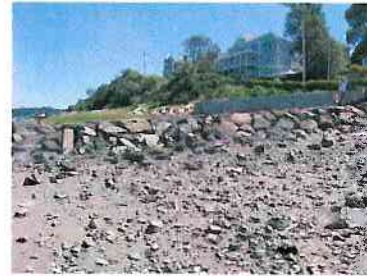
Placed rip rap groin with 1 to 2 high side slopes. Crest about 5 feet wide. Approximately 1000 lb stones.

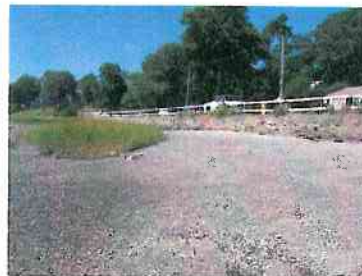
Stone seawall mortared with concrete. Base of wall has concrete mortar washed out (approximately mean high water). Patching of asphalt behind seawall where fill loss has occurred. Road located approximately 5 feet behind and multiple houses beyond road.

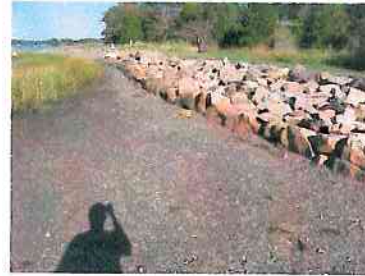
Low revetment slope with 200 to 1000 lb. stones. Located at mean high water.

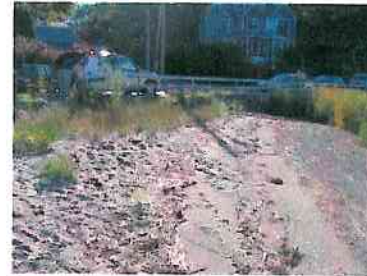
Mortared stone block seawall with wetlands outshore and town road inshore. Horizontal movement of top stones near south end (overhaul lower portion of wall). Fill loss along inshore face of wall.

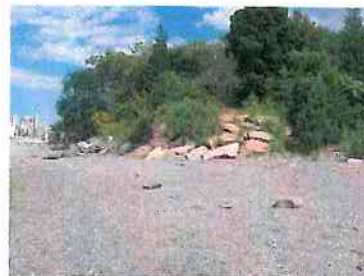
Dumped rip rap scattered across earth slope at mean high water. Stone size 50 to 300 lb.

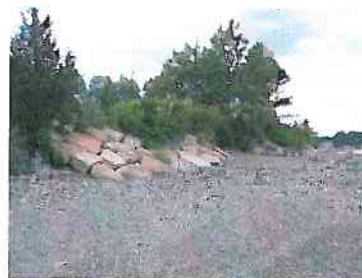
Placed rip rap slope (1 vertical by 2 horizontal) at top of coastal beach. Portions are toed in (about half of length). No evidence of scour.

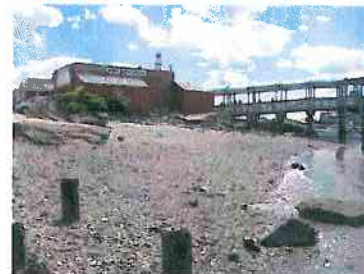
Dumped rip rap slope along bank. Stone size 100 to 1000 lbs.

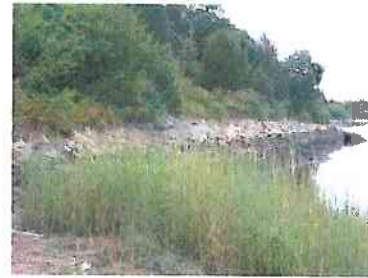
Dumped rip rap slope (1 vertical by 3 horizontal) with stone size from 100 to 2000 lb. Minor erosion at top of revetment.

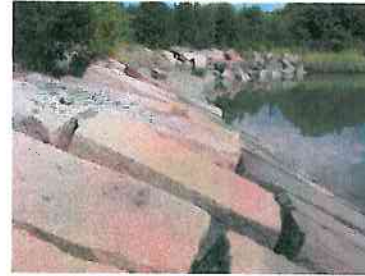
Placed stone block slope (2 to 3 ton) on earth and crushed stone slope. Gaps between stones and some erosion above top of revetment. Portions are dumped stones.

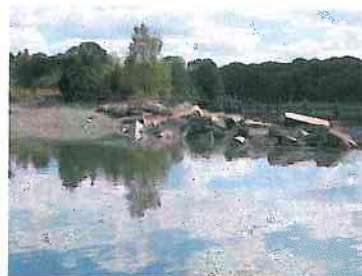
Dumped stone blocks piled about 4 feet above mean high water.

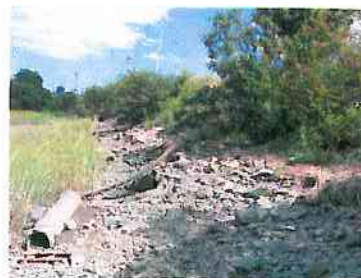
Earth slope (near vertical) with small stones at base of slope. Stone size 4 inches to 12 inches and dumped poorly.

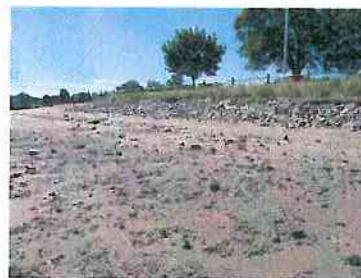
Dumped rip rap along coastal bank. Coastal beach outshore. Stone size varied from 4 inches diameter to 8 inches diameter.

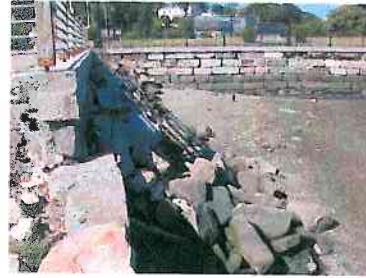
Stone block seawall (dryset) with 30 inch wide concrete cap and railing. Minor fill loss inshore of seawall.

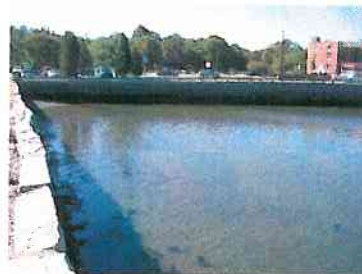
Stone block seawall (dryset) with route 3A rotary directly inshore. 2 feet wide by 1 foot high concrete cap. Some fill loss behind seawall in median strip. (1 foot wide by 1 to 2 foot diameter)

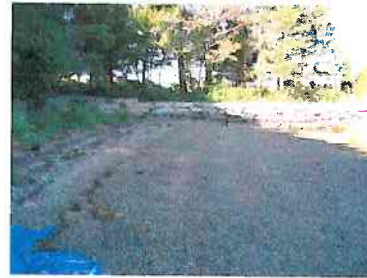
Stone block seawall (dry set) around park area. Major fill loss behind seawall (4 feet wide by 1 to 2 foot deep). Many voids (typical 6 inches by 2 to 4 feet long)
