***South Shore Coastal Infrastructure Inventory  
and Assessment Demonstration Project  
Coastal Hazards Commission***

**Town of Hull**

**February 28, 2007**

**Presented by:  
Bourne Consulting Engineering  
Franklin, Massachusetts**

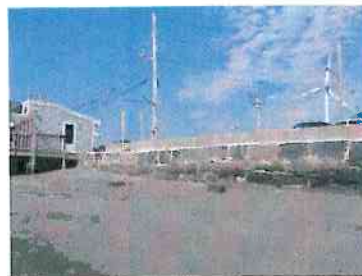
Stone masonry seawall with coastal beach outshore. Mean high water at mid height of stone wall and mortar washed out below mean high water. 2 feet high concrete wall (12 inches wide) along top of stone wall (located 3 feet behind face). Concrete sidewalk behind concrete wall. A few minor voids at stone wall base with fill loss behind.

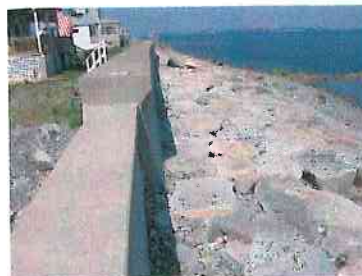
5 foot wide concrete seawall with wave break face and placed rip rap outshore. Revetment approximately 25 feet wide by 5 feet high. Average stone size is 1000 to 2000 lbs. Concrete poured along rip rap/wall interface for some sections. Concrete footing for wall exposed about 1 foot in some areas (about 400 feet long).

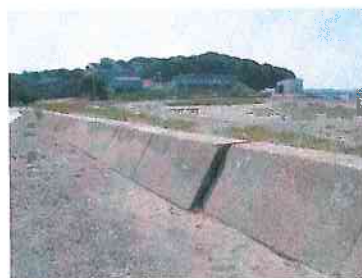
Precast concrete wall along road. Coastal beach / dune outshore with sand up to top of wall in places. Top of 18 inch wide with tapered back to 30 inch wide.

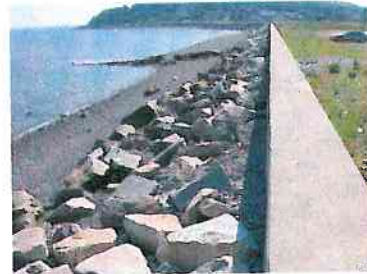
Stones tumbled with gaps in groyne. Average stone size is 500 to 1000 lbs.

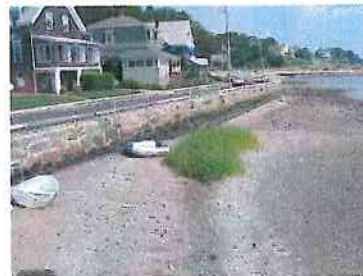
3 foot wide stone block seawall with mortared base buried under sand road directly behind. Timber railing on wall (insufficient for pedestrians or vehicles loading). Inshore face of wall is concrete curb for road.

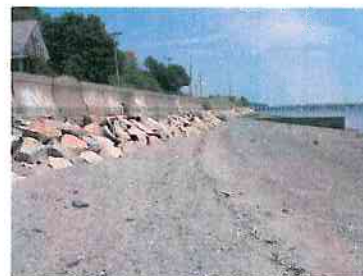
Placed stone revetment forms base of structure. 1 to 1 slope. 1 ton to 2 ton stones. 5 foot long precast concrete sections on 6 inch concrete slab form top of structure. Paved slope behind concrete at 1 to 1 slope to road edge.

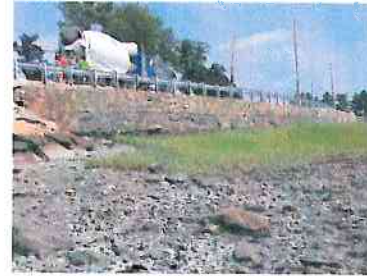
30 foot wide stone masonry block seawall with sidewalk and road behind. Cemetery also. Mortar washed out below mean high water (about mid height of wall).

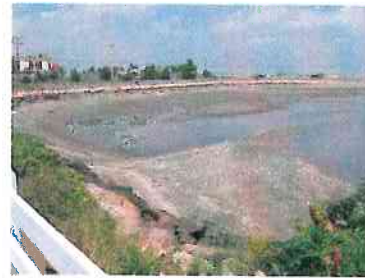
Treatment facility inshore. Average stone 1 ton. Placed at 1 to 1 slope. Road directly inshore. Top is flat (3 foot wide)

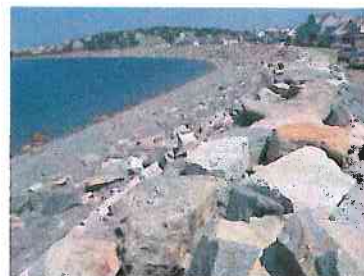
Revetment seawall with 6 foot flat top and 45 degree front face. Placed stone toed into beach. Road behind approximately 5 feet below top of wall. Western third of structure has moved stones and voids. Eastern 2/3 of structure is satisfactory.

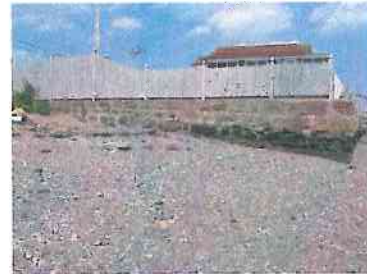
Road inshore. Stone masonry seawall. Voids along wall base (about 2 feet wide and 20 feet high inshore of mean high water). Fill loss inshore of wall.

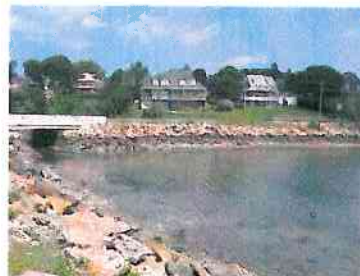
Stone block seawall outshore of concrete abutments for road bridge over channel from salt water pond to harbor. Bridge spans approximately 20 feet and built in 2003. Loss of fill material at wall ends near pond because no return on wall.

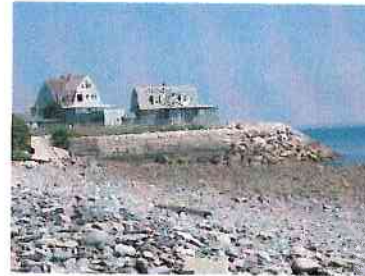
Approximately 30 foot high revetment slope with 10 foot flat top. Stones on top are mortared. Slope varies from 45 degree and steeper. Stone size is 1 to 3 ton. First 100 feet (plus or minus) is stone seawall (vertical) with revetment (10 feet wide) in front. Large voids and arching of stones existed.

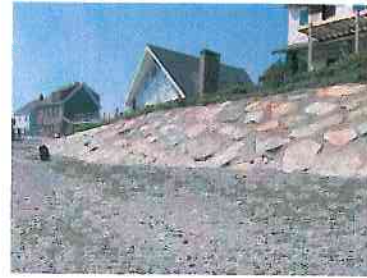
Revetment slope (steeper than 1 to 1 about 3/4 to 1) with 1 to 2 ton stones concreted together.

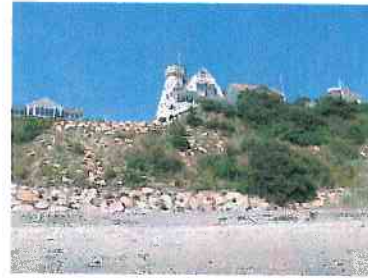
Revetment slope for entire height of cliff (75 +/- feet) at slope about 1 to 1. Average stone size is 2 ton. Lower portion of revetment is continuation of adjacent structure.

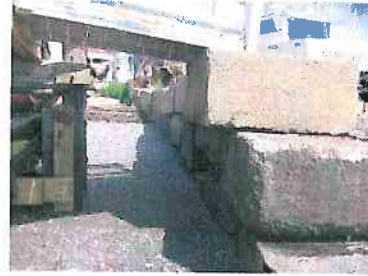
30 inch wide precast concrete blocks stacked as seawall. No signs of movement. Some fill loss inshore.

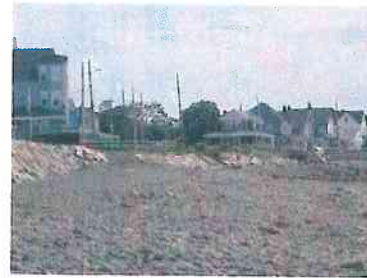
Dumped rip rap covered with asphalt covering. Eroding slope with road directly behind it.

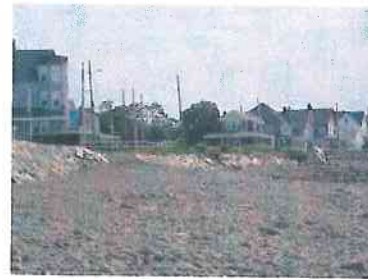
Placed rip rap slope (at 45 degrees) with road directly inshore. Toed into beach.

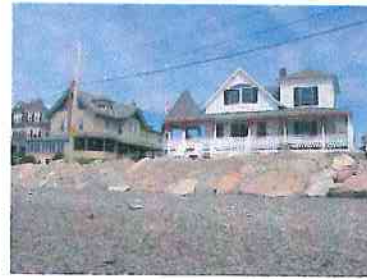
Placed rip rap 1 to 2 ton stone 45 degree slope concreted in place. Void at start of structure. Toed into slope of beach.

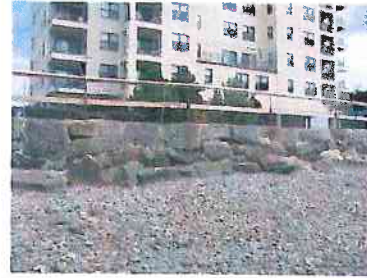
Stone block seawall (mortared) with dumped rip rap outshore (1 to 3) mound. 1000 to 2000 lb. stones. Loss of mortar for wall height. Revetment toed in well. Road directly inshore of wall.

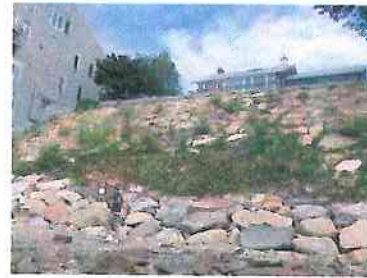
Placed rip rap slope (45 degree) up earth bank (over 40 feet high). 1000 to 3000 lb. stone with some vegetation growing in slope. Toed into beach.

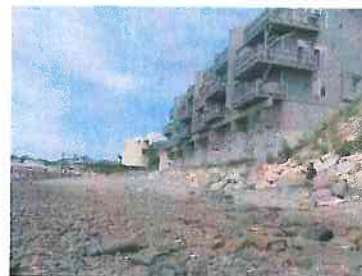
Placed rip rap slope (45 degree) with 1 to 2 ton stones. Toed into beach wall.

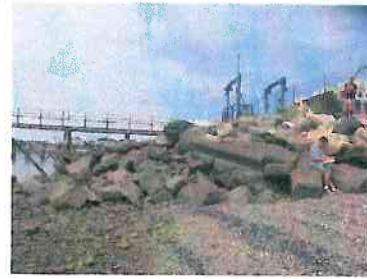
Dumped rip rap (1 ton size) and concrete slabs. Between revetment is a private travel lift made of concrete walls. Approximately 45 degree revetment slope.

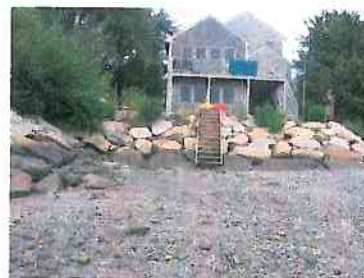
Placed stone revetment with 1 to 2 slope. Rip rap is 1 to 2 ton stone. Toe scoured out at some locations.

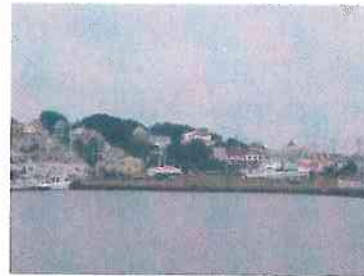
Stone block seawall (mortared) around filled wharf parking lot. 20 feet section moved outward with fill loss inshore.

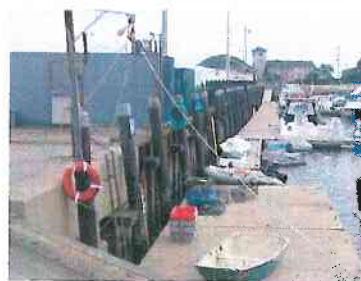
Steel sheet pile bulkhead with steel cap for south face and north face. Outshore (west) end has concrete cap. Some scalling at mean high water and splash zone. Timber fender piles along face. Timber pier on outshore face. Some fill loss behind wall.

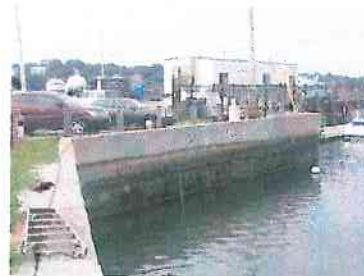
Stone block seawall (mortared) with gravel parking lot inshore. Loss of mortar below mean high water. Minor fill loss inshore of wall.

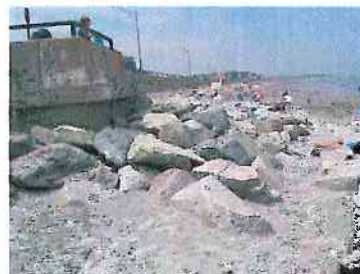
2 foot wide concrete seawall with revetment outshore (10 feet to 20 feet wide X 5 feet high). Average stone size 1 to 2 ton. Weep drains at 25 feet on center (at sidewalk height at about 2 feet below top of wall) Rip rap slope at 1 vertical to 3 or 4 horizontal.

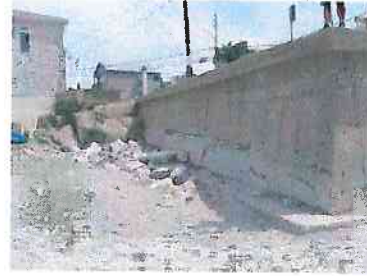
Concrete seawall (4 foot wide cap) on concrete base (partly exposed). Front face tapered with wave return at top. Some washing out of cement 6 inches above base. Several patches about 2 foot long washing out.

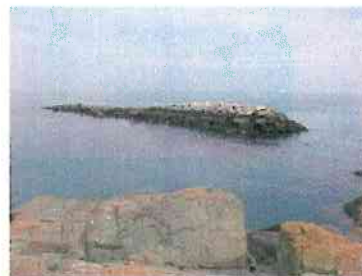
Breakwater (offshore). Average stone size is 1 to 3 tons. Northern half of structure toppled and lower than mean high water.

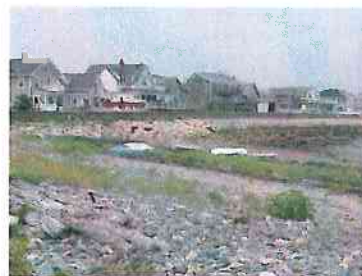
3' wide concrete seawall in satisfactory condition. Placed rip rap slope @ 1 on 1 in front. Average stone size is 1-2 ton. Toe of rip rap has minor movement. Rip rap was grouted, although grout is cracking and breaking rip rap top about 3' below top of wall. The seawall has cracks in the construction joints. There is also overwash problems with landward ballast during nor-easters.

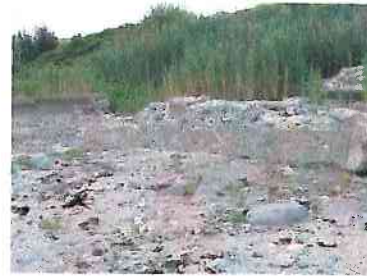
30" wide concrete seawall in poor condition. Broken for approximately half of length with severe spalling. Concrete seawall ends at ledge. Material loss behind wall. There is some areas above the wall where the slopes have failed.

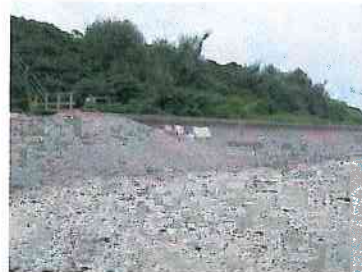
30" wide concrete seawall in satisfactory condition with wave break face. Severe deterioration at joints. Some vertical cracks. There is some areas above the seawall where the slopes have failed.

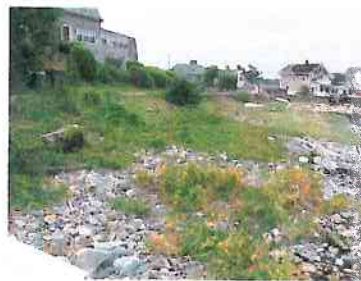
Concrete seawall less than 5' high located at base of earth slope. 3' to 0" wide at cap and in satisfactory condition. No revetment found as part of this structure.

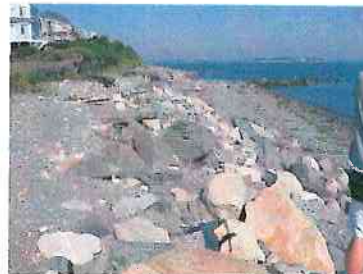
Revetment seawall in fair condition. Many loose and dislodged stones. Wall is not fit tightly together and some toppling of structure.

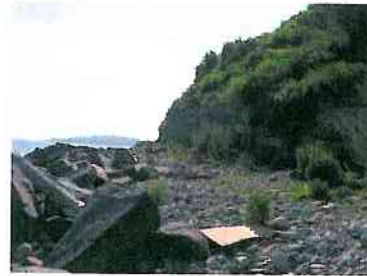
Stone block seawall (dryset) with coastal beach oushore. Eastern slope (vegetated) inshore of wall extending more than 20 feet higher at 1 on 2 slope. Wall appeared to lean outshore slightly. Revetment is in poor condition. 15 foot failed section (about 3rd stone) wall 2nd half is satisfactory condition. Revetment is fair condition.

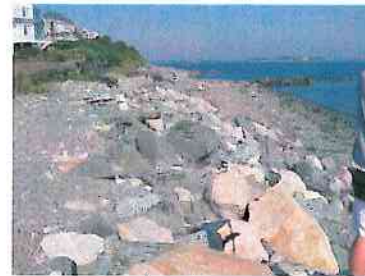
Stones toppled and some small gaps in groin. Stone size is 500 to 1000 lbs.

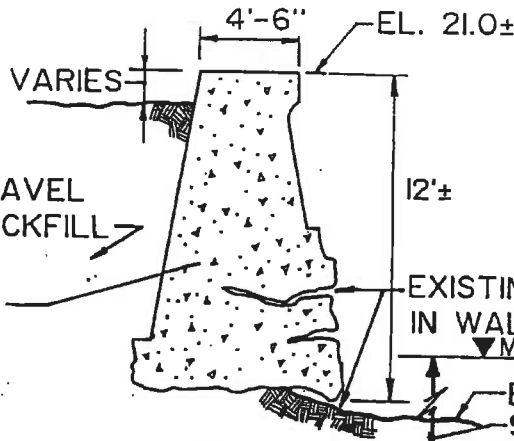
EXISTING CONC. SEAWALL

EXISTING VOIDS IN WALL (TYPICAL)
