**September 2021**

**Report No. 21-024**

# Improved Load Rating Procedures for Deteriorated Steel Beam Ends with Deteriorated Stiffeners

**University of Massachusetts Amherst**

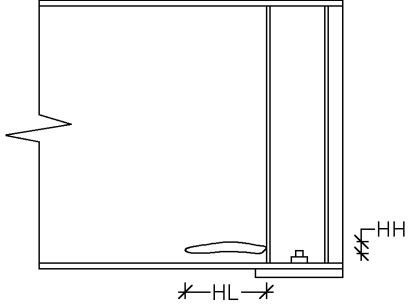
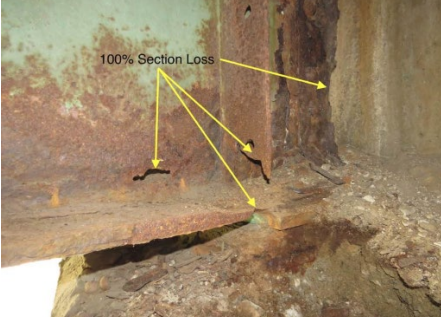
**Table 2.18: Web hole pattern H3 for C2 configuration**

<p>Adopted from W-44-063-1LA-DOT-NBI (District 5, City of Worcester)</p>
<p><b>Short description:</b> H3 is a case where the hole appears in front of the inner bearing stiffener and expands along the longitudinal beam axis. <math>HH</math> is the height of the hole, and <math>HL</math> is the length of the hole. Both parameters are expressed with respect to the web depth (<math>d_w</math>). The photograph on the right shows a typical case of H3.</p>

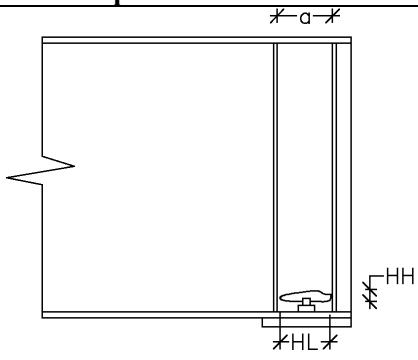
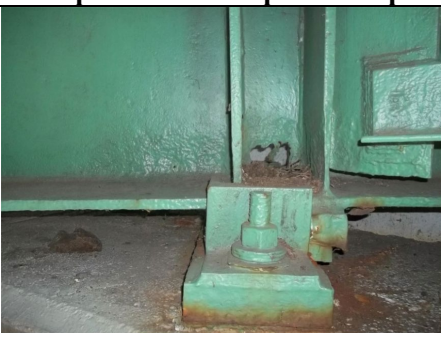
Table 2.19: Web hole pattern H4 for C2 configuration

<p>Adopted from F-02-071-3MJ-DOT-NBI (District 5, Town of Fall River)</p>
	<p><b>Short description:</b> H4 pattern describes a hole at the lower part of the web, located between the bearing stiffeners. HH is the height of the hole, and HL its length. HH is expressed with respect to web depth (<math>d_w</math>), and HL is normalized to <math>\alpha</math>, where <math>\alpha</math> is the distance between the stiffeners. The photograph on the right shows a typical case of H4.</p>

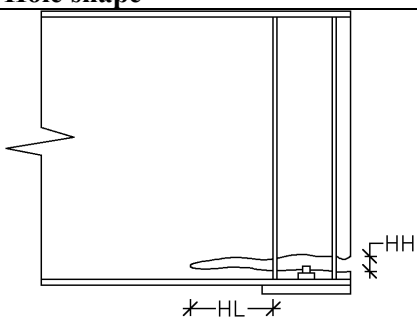
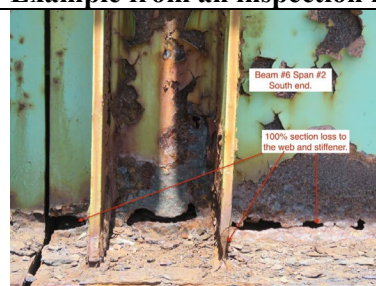
Table 2.20: Web hole pattern H5 for C2 configuration

<p>Adopted from B-06-022-2AR-DOT-NBI (District 3, Town of Bellingham)</p>
	<p><b>Short description:</b> H3 is a case where a hole appears at the bottom of the beam. The hole initiates from the outer web edge and expands with similar height beyond the bearing stiffeners. HH is the height of the hole, and HL is the length of the hole beyond the inner bearing. Both parameters are expressed with respect to the web depth (<math>d_w</math>). The photograph on the right shows a typical case of H3.</p>

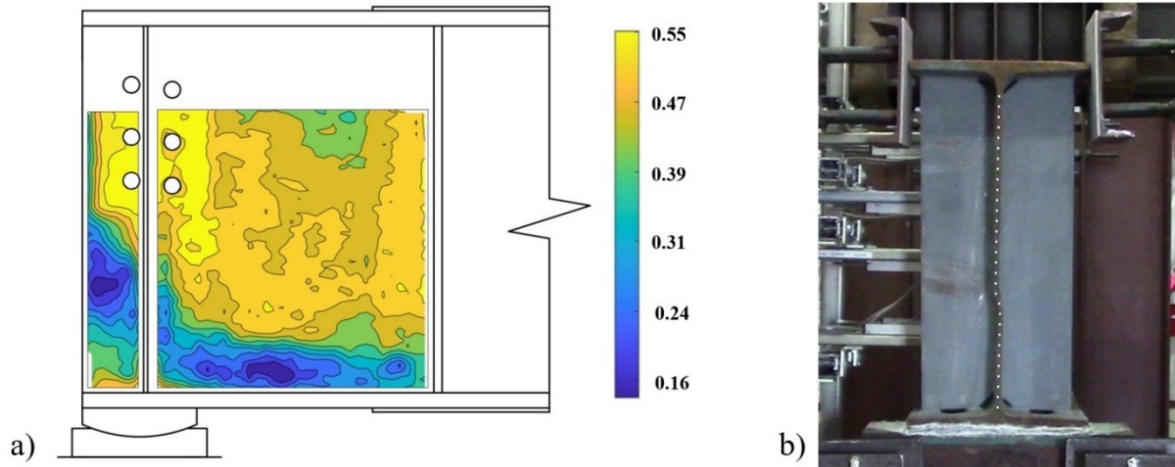
To quantify the remaining material along the deteriorated beam end, the team scanned the beams using a Riegl VZ-2000 laser scanner. Scans were performed from both sides of the specimen, and the acquired point clouds were registered to one unique coordinate system making use of reflective targets placed in the laboratory and on the specimen surface. Following a methodology previously developed by the authors (17), contour maps capturing the remaining material along the web were created and are shown in Fig. 3.8a. A diagonal area with extensive section loss extended above the bearing, which later propagated in parallel to the bottom flange, while initial web deviation was observed at the outer part of the web, with a maximum magnitude of 0.5 inch (Fig. 3.8b).

**Figure 3.8: a) Contour maps depicting remaining thickness of Specimen A; and b) initial web imperfection for same girder**

Point B corresponds to the bearing capacity of Specimen A, and the failure mode is characterized by lateral deformations mainly developed at the web region toward the end of the beam and the bearing stiffener, governed by the initial web deviation from straightness at this area. In addition, the failure seemed to propagate diagonally following the region of the extensive section loss presented in Fig. 3.8a.

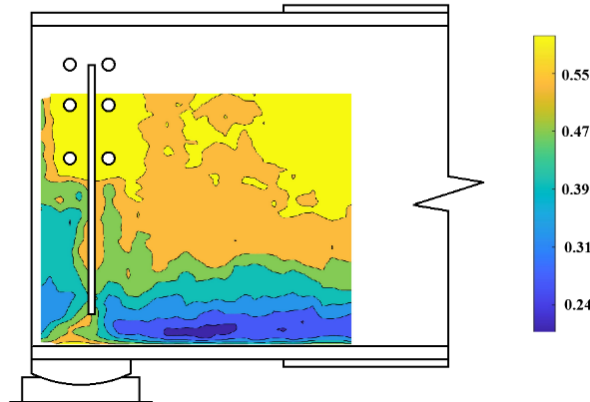
To quantify the remaining material along Specimen B, the Riegl VZ-2000 laser scanner was used and scans were performed capturing both web faces. After registering the obtained point cloud data to a unique coordinate system, contour maps depicting the remaining material along the tested end were developed and are presented in Fig. 3.13. Overall, the observed corrosion topology is very similar to the deterioration condition of Specimen B, strengthening the findings from (14) that beams belonging to the same bridge exhibit similar corrosion-induced damage, governed by the in-service configuration of the support area.

For the two specimens examined in the framework of this study (Fig. 3.8 and 3.13), the existence of the riveted plates above the supports prevented the water flow from deteriorating the web below (yellow areas surrounding the upper part of the bearing stiffeners). Furthermore, for both cases, section loss with progressively reduced height was observed directly below this region, which eventually propagated in parallel to the bottom flange. For Specimen B, the region with the minimum remaining thickness (around 50% of the intact web thickness) was located approximately 4 inches beyond the bearing. Finally, visual observation as well as post-processing of the point cloud data did not reveal significant web deviation from straightness.

**Figure 3.13: Contour maps of remaining thickness along tested end of Specimen B**

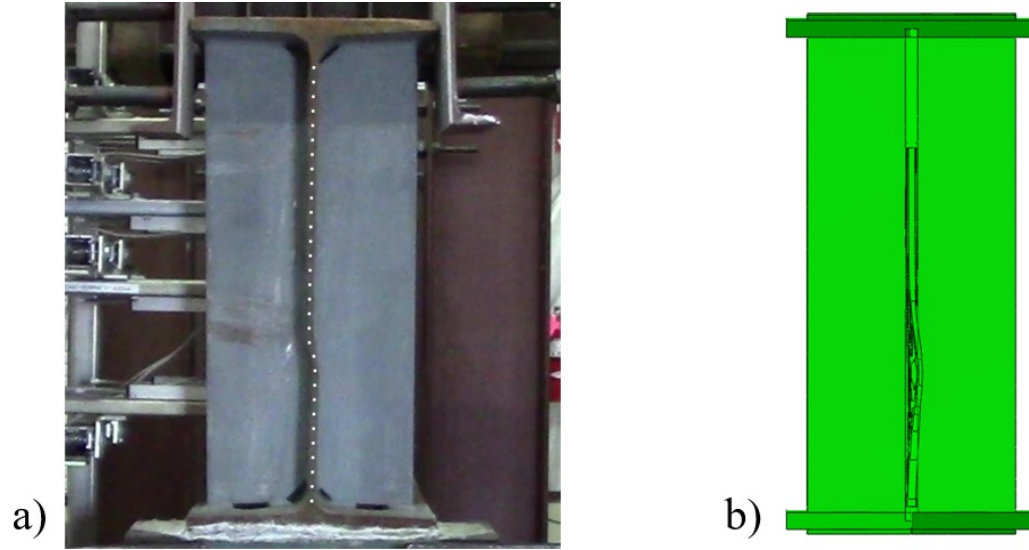
For Specimen A, the maximum initial web lateral displacement was observed at mid-height and equalled 0.5 inches (Fig. 4.3a). The selected eigenmode managed to represent satisfactorily the initial out-of-plane web displacement, as shown in Fig. 4.3b.

**Figure 4.3: a) Front view of Specimen A; b) initial geometric imperfection as imported to FEM**

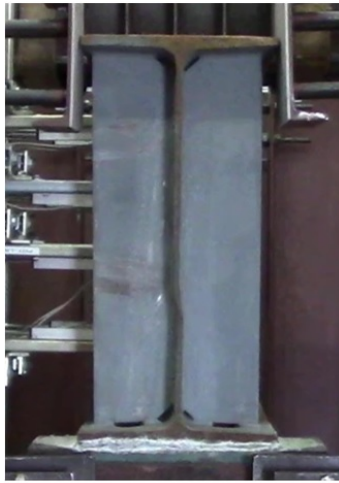
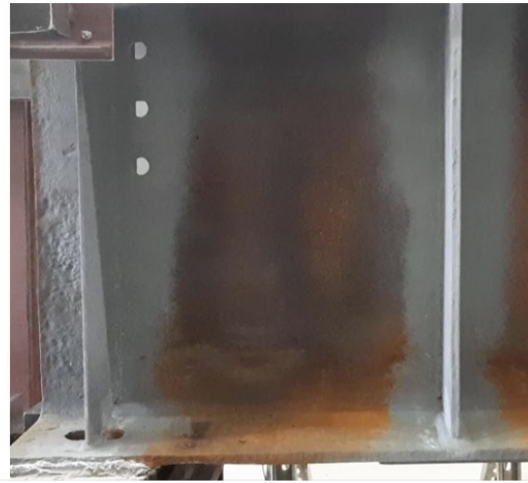
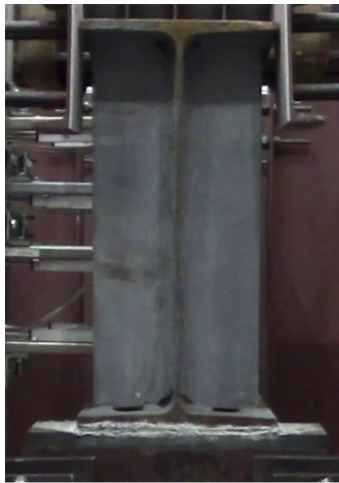
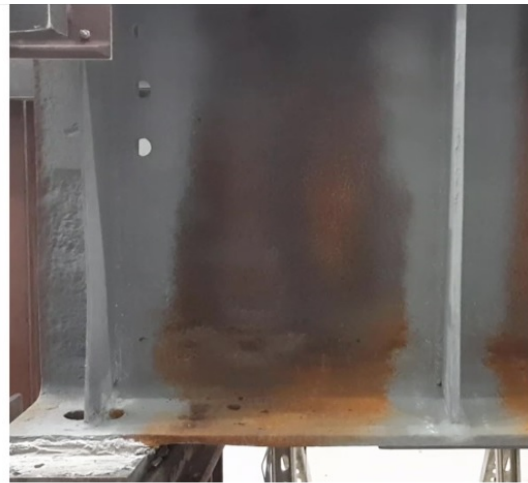
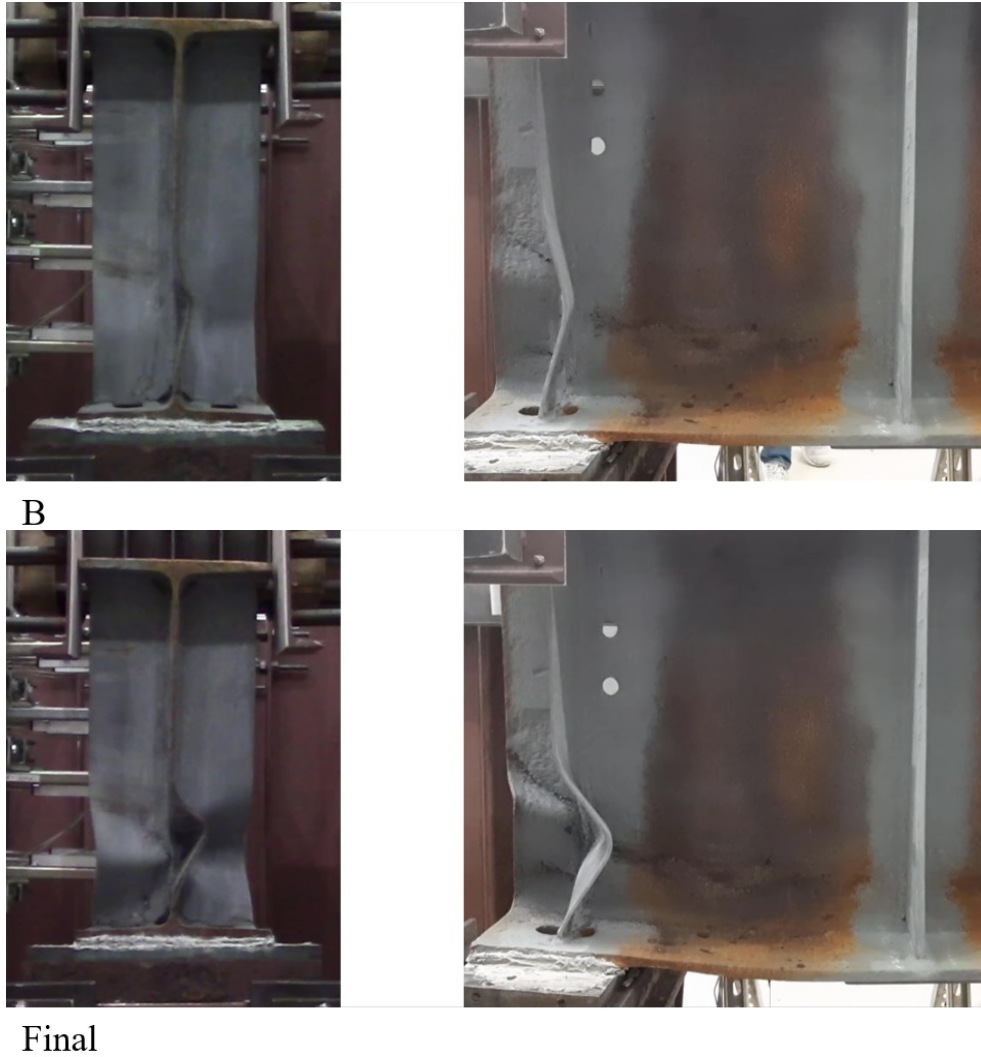
Furthermore, Fig. 6.1a illustrates a relatively linear response of the specimen until failure, where a sudden capacity drop occurred. This behavior is consistent with the macroscopic observation of the specimen, where no large deformations were noticed prior to the sudden failure. The whole experimental process was captured by two cameras (Figure 6.2). The first camera recorded the plane of the web (side view of the beam), while the second camera recorded the beam profile. These photos illustrate the girder's deformation at the initial condition before loading, followed by deformations observed at different steps of the experimental procedure (points from A and B, Fig. 6.1a).

**Figure 6.2: Side-by-side images showing side view of web and profile view of beam during experiment (A and B correspond to Fig. 6.1a)**

From the initial condition pictures, web deviation from straightness was observed at the lower half of the depth. In addition, perforations also existed at the upper web half, due to the riveted plate removal. At Point A, which corresponds to applied load equal to 88% of the failure load, a slight out-of-plane bending of the bearing stiffener was captured.

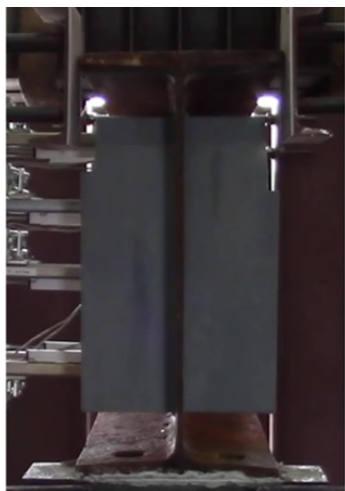
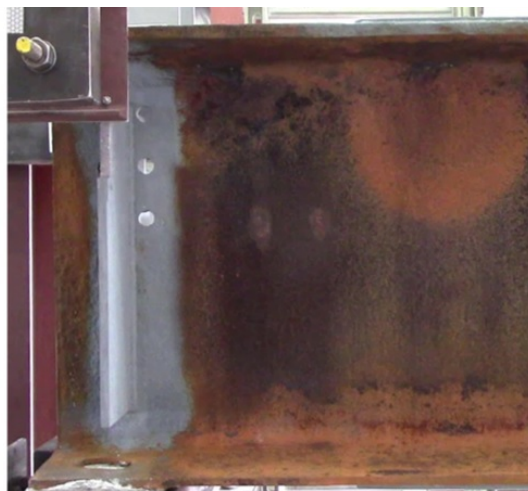
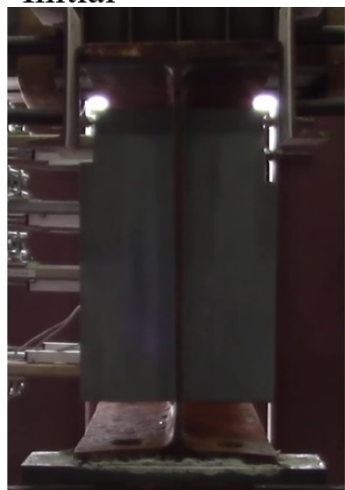
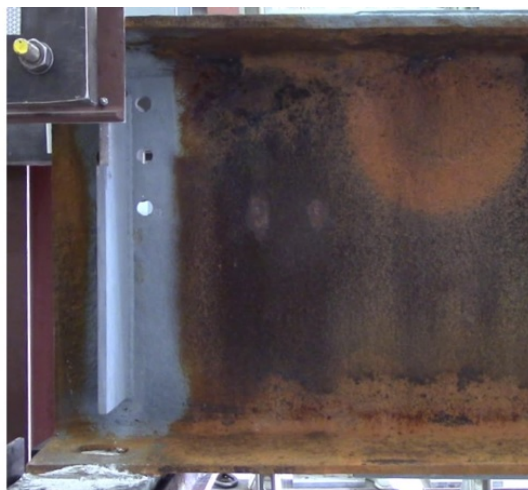
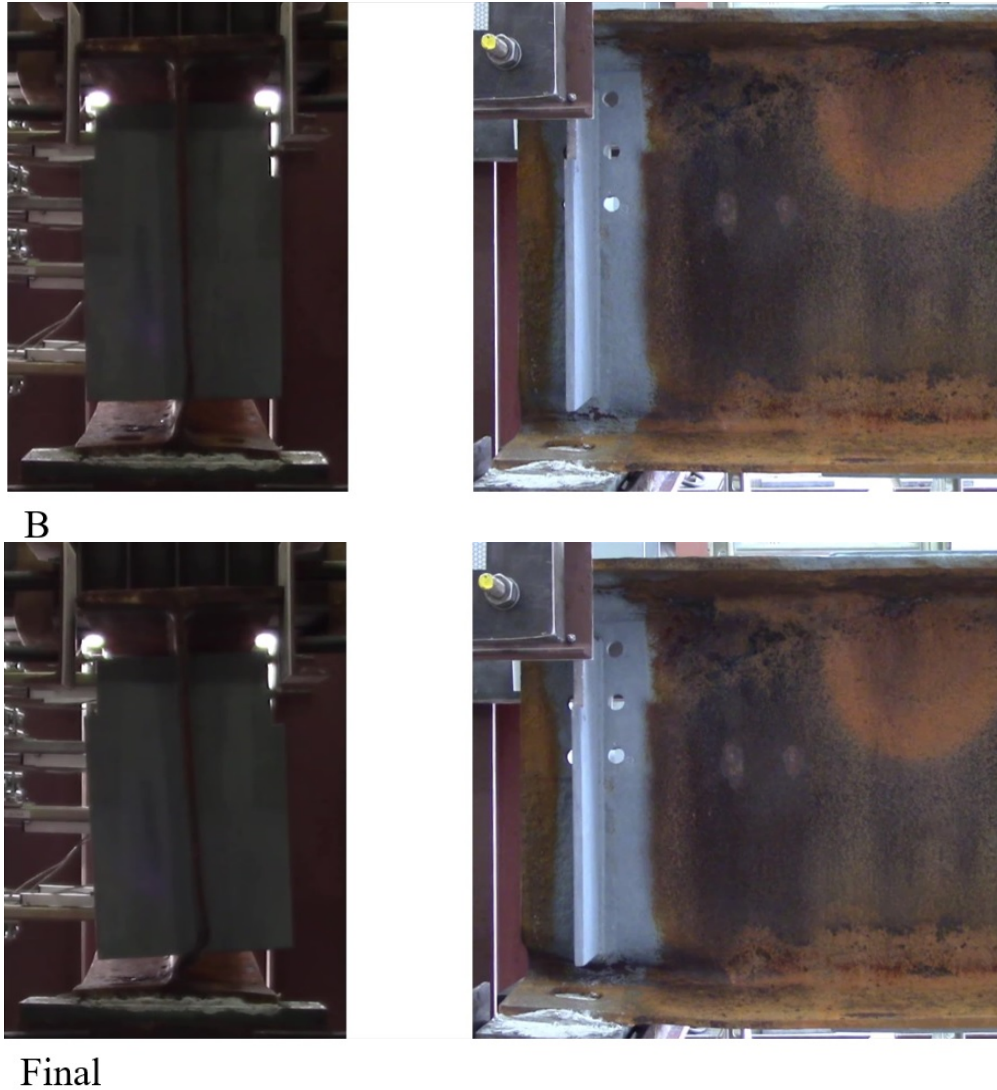
The riveted plate in Fig. 3.3 was removed prior to the partial stiffener welding, revealing perforations at the upper part of the web (Fig. 6.5). Other than that, visual observation did not reveal significant deficiencies or deformations, before loading initiation. At Point A, which corresponded to 90% of the maximum applied load, the cameras' captures did not depict any significant variation in specimen's geometry, strengthening the linear response presented in Fig. 6.4a.

At Point B, where the undertaken load reached the magnitude of 172.3 kip, the whole web seemed to translate laterally along the same direction, with peak displacements concentrated at the bottom unstiffened part of the web. It is worth noting that, according to the remaining thickness profile derived from point clouds (Fig. 6.5b) capturing both web surfaces, the bottom web part coincided with a region of section loss.

**Figure 6.5: Side-by-side images showing side view of web and profile view of beam during experiment (A and B correspond to Fig. 6.4a)**
