The Commonwealth of Massachusetts  
Office of the Inspector General

May 6, 2011

**The Cost of the Project at 21-27 Temple Place and the Permit Fees Paid to ISD**

## **The Examination of the Project Plans by ISD**

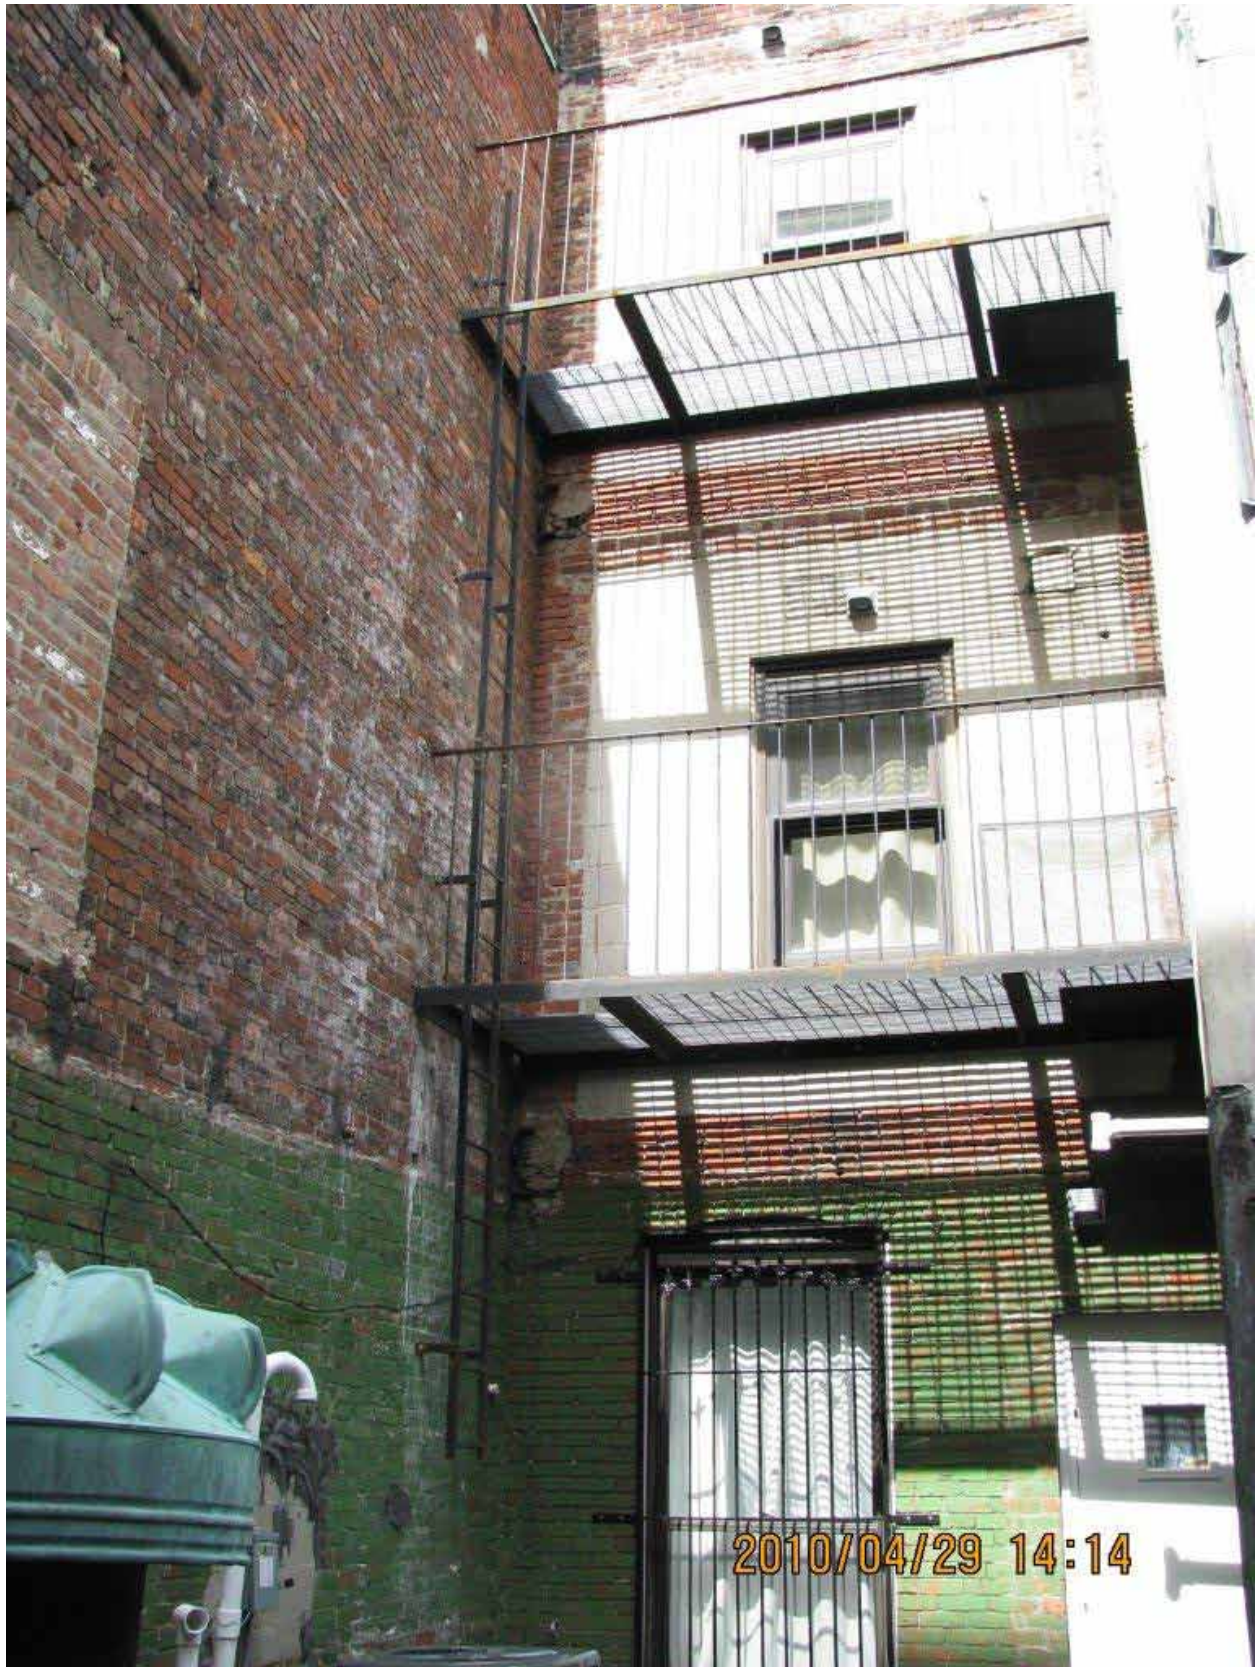
2010/04/29 14:14

During the inspection, the ISD Building Inspector discovered that the ladder egress situation may be problematical. He subsequently learned that the ladder egress was a deviation from the plans approved by the Plans Examiner and he issued a violation which the owner initially ignored. I am aware of the fact that ISD has now taken the owner to court on this matter and the owner is finally taking appropriate steps to resolve the matter. However the fact remains that between April 17, 2009 when the ISD Plans Examiner informed the owner that ladder egress was not allowed and April

29, 2010 when the above inspection disclosed that egress from the rear by ladder still existed, the tenants were improperly exposed to a public safety issue. The truth is that but for the April 29, 2010 inspection of the rear of 21-27 Temple Place, this fire safety problem would still exist.
