Main Street, Hampden Flooding Assessment Report

Prepared for Town of Hampden, Massachusetts

Prepared by Howard Stein Hudson

June 2021

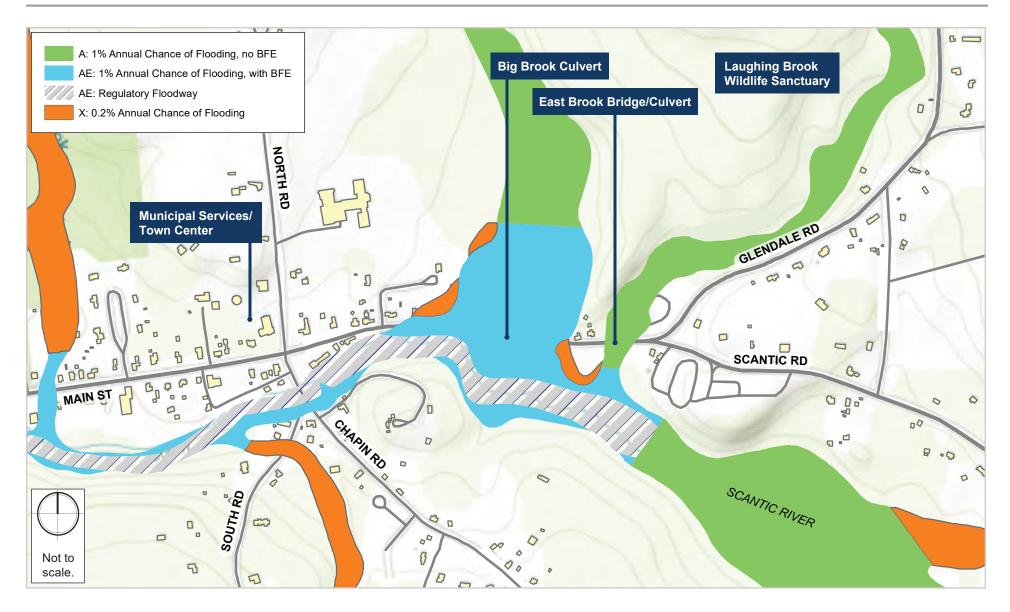
Figure 1. Main Street Flooding Study Area / Culvert Locations

Main Street road-stream crossings included in the assessment include the two highest priority locations identified in the Town of Hampden's 2015 *Hazard Mitigation Plan*: the culvert crossing at Big Brook, and the bridge/culvert crossing at East Brook (see **Figure 1**). The assessments consisted of field surveys of individual stream crossing structures using established road-stream crossing assessment protocols to determine structural condition, geomorphic risk, opening suitability with respect to the Massachusetts stream crossing standards, transportation and emergency services, other flooding impacts, and climate change considerations. The results of the stream crossing assessments will inform the selection of grey infrastructure alternatives including natural system solutions to increase flood resilience at each crossing.

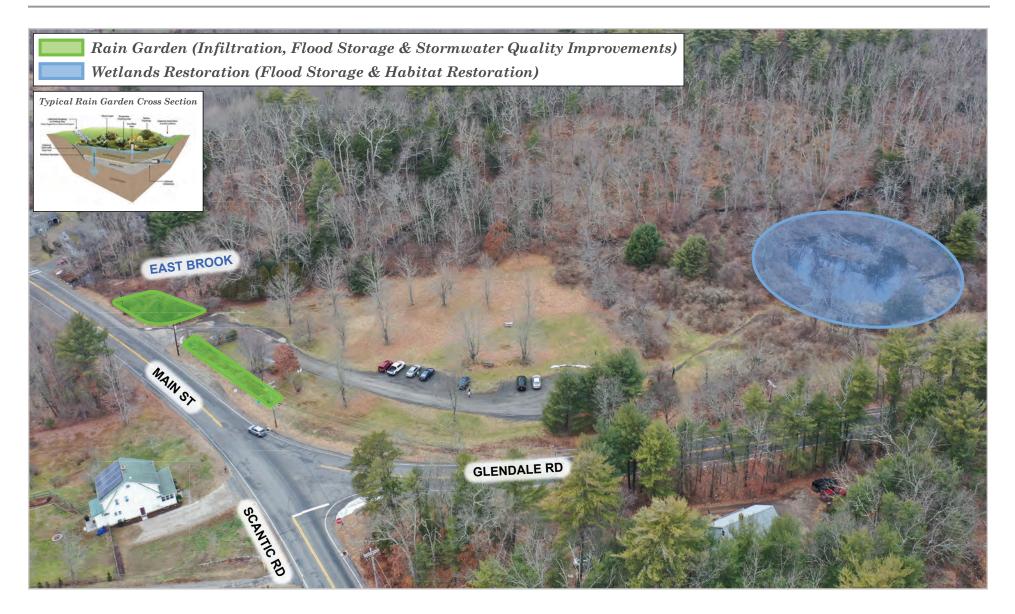
Figure 2. Green Infrastructure Main Street Flood Mitigation Strategies

- Construct a vegetated "rain garden" that also serves as a stormwater quality and infiltration swale along the roadway right-of-way bordering on the Laughing Brook Wildlife Sanctuary parking area. This nature-based green solution would accumulate stormwater from the roadway including the existing catch basin and treat, store and infiltrate stormwater, thereby, improving flood storage, water quality and groundwater infiltration within the project area.

- Construct a vegetated "rain garden" treats stormwater runoff from the Laughing Brook Wildlife Sanctuary parking areas, as well as Main Street roadway stormwater runoff and/or provide secondary treatment from the above-described rain garden swale prior to discharge into East Brook. This solution would also treat, store and infiltrate stormwater, thereby improving flood storage, water quality and groundwater infiltration within the project area. In addition, both first 2 "rain garden" solutions also provide an exceptional stormwater quality improvement benefit and could be credited for as a betterment measure in the town's NPDES Stormwater permit.

- Implement a wetlands habitat restoration project consisting of removing the existing manmade pond and nature-made dam structure, converting the entire area a more natural wetland riverine flood plain area like it once was. Removing the man-made pond and restoring natural stream morphology flood flow conditions utilizes the available flood plain rather than creating channels. These channels cause further erosion as well as preventing

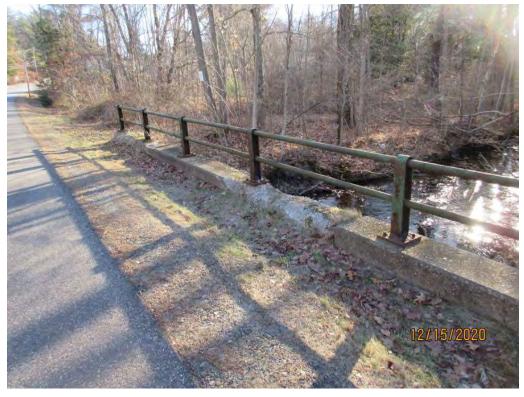
Photo 3: North Railing has a bend in the top rail at mid-span

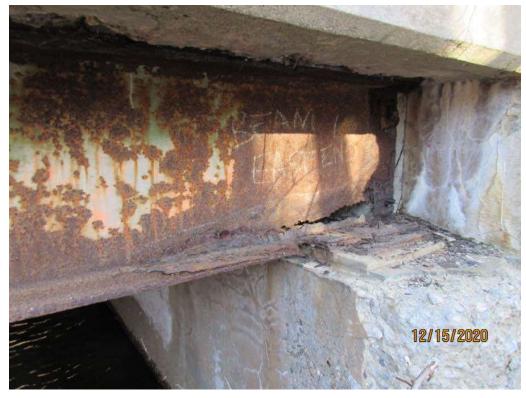
Beam 1 has severe rust and holes through the beam at both ends. See Sketch 4 and Photos 5 & 6.

Beam 1, at both abutments the anchor bolts and nuts have rusted away and the plate is heavily rusted. **See Photos 5 & 6.**

Photo 5: Beam 1, west end, has a large hole in the web & bottom flange.

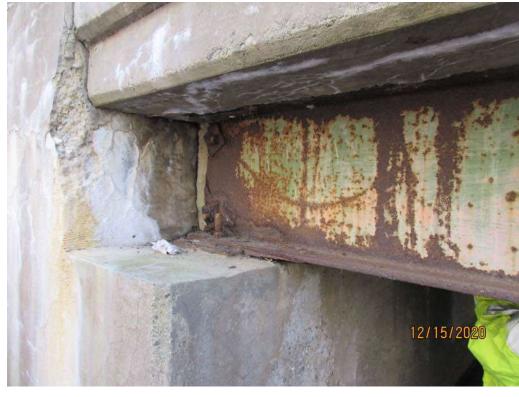
- West end has severe rust and a through hole. See Sketch 5 and Photo 7.
- East end has severe rust and delamination. See Photo 8.

- West Abutment anchor bolts and nuts have rusted away and the plate is severely rusted. **See Photo 7.**
- East Abutment anchor bolts nuts have rusted away and the plate is severely rusted. See Photo 8.

- Exposed portion of the rods have heavy rust and section loss. See Photos 7 & 8.
- Lower rod at the West Abutment has lost all section where it was exposed and is now nonfunctional.

Photo 7: Beam 10, west end, has a large hole in the web & bottom flange.
