*Massachusetts Coastal Infrastructure
Inventory and Assessment Project
Massachusetts Department of Conservation and Recreation
Office of Waterways*

North Shore - North

Manchester
Beverly
Salem

July 6, 2009

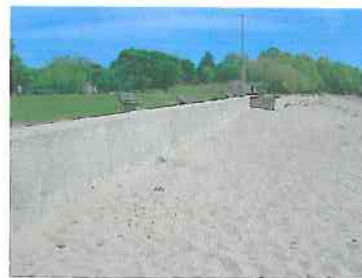
A reported beach nourishment with sand typically in place, but no sand and exposed toe stone revetment at the western end.

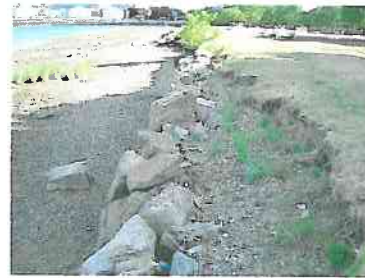
A dumped stone revetment in front of a park lawn, with over topping erosion typical. There is significant erosion.

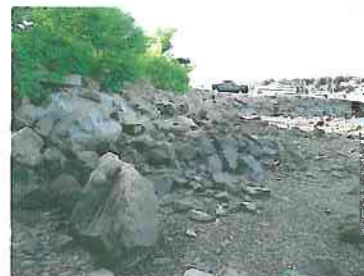
A dumped rubble stone and concrete debris revetment and a dumped rubble stone and debris revetment also alongside boat ramp and edge of parking lot. There is some localized unravelling of revetments.

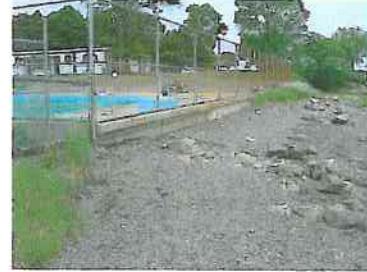
A cast in place concrete seawall along the municipal pool wall with previously broken areas and patched in several locations. There is exposed electrical conduit at base of the wall in one location.

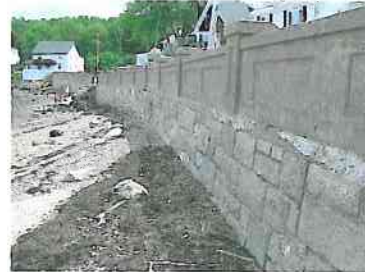
A stone seawall with concrete cap wall in fair condition. The cap has minor hairline cracking and typical scaling. There is missing mortar from lower face stones and the stone steps are severely damaged. The street is adjacent with houses in the vicinity.

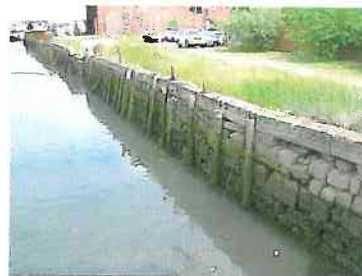
A granite block seawall with missing stones, misalignment and bulges; in poor condition. One sinkhole 2 feet long by 6 feet wide and 4 feet deep. Remnants of steel sheet pile toe wall with corrosion holes through the sheets. Located on a vacant lot.

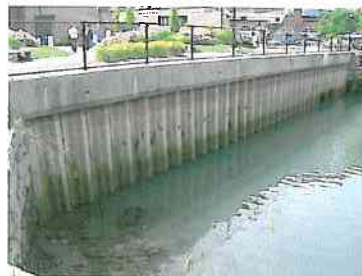
A steel U sheetpile bulkhead with cast in place concrete cap in fair condition. There are high water corrosion holes in webs and flanges at the tie rod elevation.

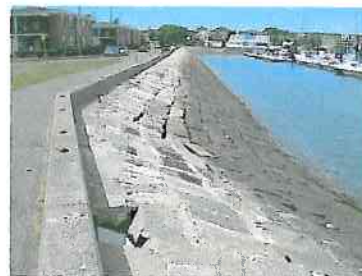
A granite block revetment with concrete cap wall. A longitudinal buckle in revetment slope paving is apparent mid slope, along with joint mortar loss on the lower half of the slope. There is some pavement subsidence behind cap wall, approximately 1 inch, and a few localized areas of cap wall spalling. Adjacent to a street and in satisfactory condition.

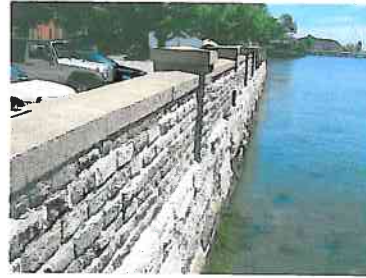
A mortared granite block seawall with parapet wall at a street end. Some lower blocks dislodged and patching repairs are apparent. There is a parking lot behind wall and some mortar cracks in parapet wall. The condition is satisfactory.

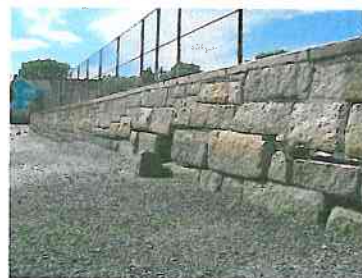
A mortared granite block wall with concrete cap. The mortar is cracked, some mortar is missing and toe concrete is exposed. One stone has fallen out near east end. There is a lawn behind wall.

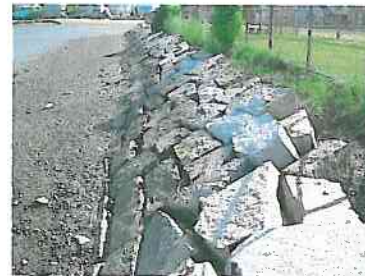
A granite block revetment in front of a park baseball field. Crest stones have rotated, and there is some loss of joint fill stones with localized crest subsidence. It is in fair condition.

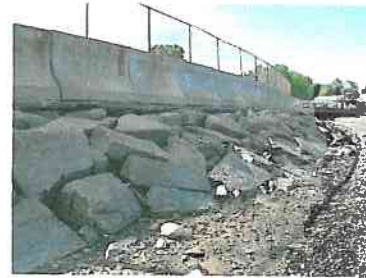
A precast wave return concrete seawall with rubble stone toe protection that has unravelled in some areas. There are some voids under the concrete wall. It is at a park, and in fair condition.

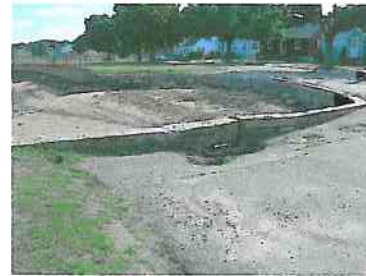
A mortared rubble stone wall with missing mortar, with a sinkhole 20 feet by 4 feet, also a sinkhole in street patched, and a sinkhole in pavement 8 feet by 3 feet. It is in fair condition. Located at a street end park.

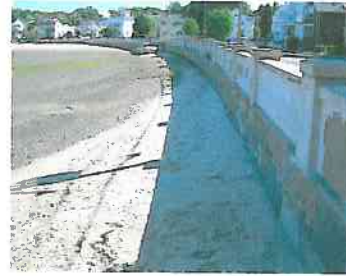
A mortared rubble stone wall with 4 foot high concrete cap with some mortar loss. There is some cap cracking and spalling. It is in fair condition with some damage to the stairs. The street is located behind the wall.

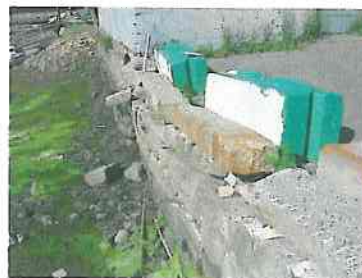
A mortared granite block wall that is failing, leaning offshore and stones are falling out with sinkholes behind. The building on top of wall immediately adjacent to the north end has cracks in concrete block joints at building corner over wall.

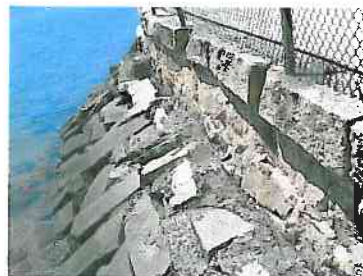
A mortared granite block wall with granite block revetment, in satisfactory condition. Some revetment stones may have rotated. The revetment is in fair condition.

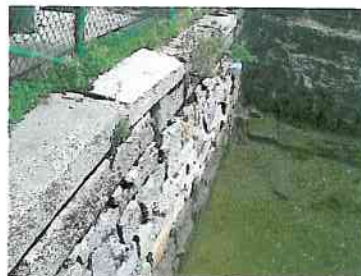
A dry set granite block wall at a street end, in satisfactory condition with a few chinking stones missing.

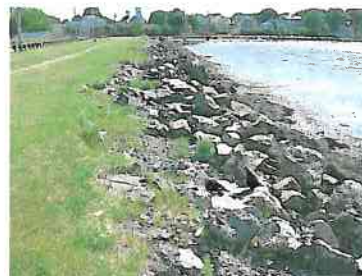
A dumped stone rubble revetment with unravelled areas. It has crest over topping erosion and a lawn and path behind.

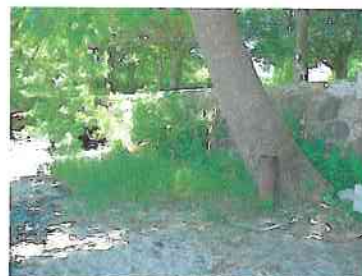
A mortared stone seawall with concrete cap. There is some mortar deterioration, efflorescence and vegetation. There is also some concrete cap deterioration/spalls. It is in a park and in satisfactory condition.

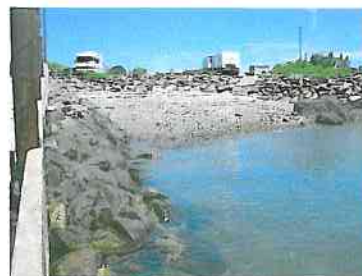
A placed stone revetment along park shore and boat ramp, in good condition.

*Condition***B***Rating***Good***Level of Action***Minor***Description*

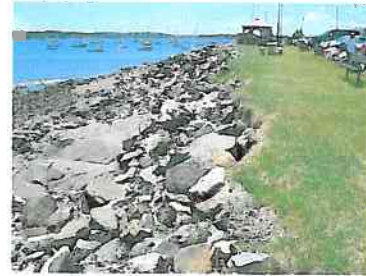
A dumped rubble stone revetment with a lawn area behind. There is some soil erosion along crest and dislodged stones. It is in fair condition.

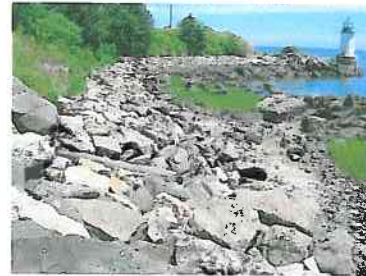
A small stone placed revetment in fair condition. There is a park lawn behind with some toe unravelling. Some overtopping erosion with two localized unravelled areas, approximately 10 feet by 15 feet each.

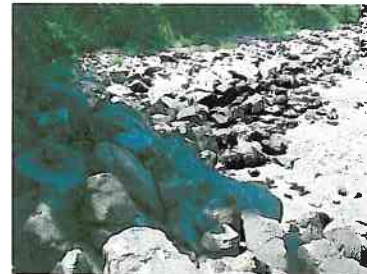
A placed stone revetment with toe typically unravelled and crest unravelled with over-topping erosion. There is a park shrub area behind and the revetment is in fair condition.

*Condition***C***Rating***Fair***Level of Action***Moderate***Description*

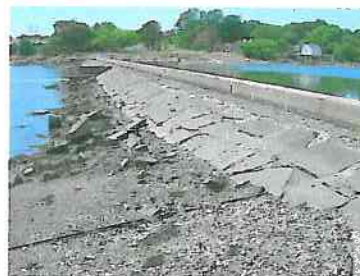
A tidal dam at Cat Cove. A stone dike with concrete cap and with some steel sheet pile at the weir structure. It is missing some revetment joint concrete between stones and there is some scaling on concrete, and one spill. In fair condition.

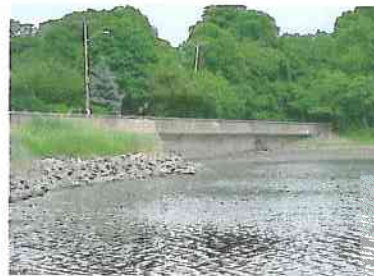
A cast in place concrete seawall with cantilever sidewalk in satisfactory condition. There are a few cracks and scaling. The wall cap has some spalls and delamination with rebar exposed. The wall is adjacent to the road.

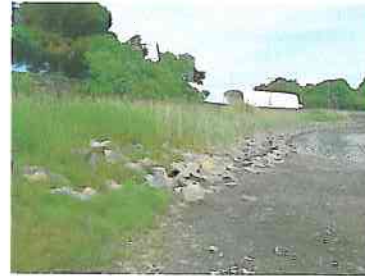
A mortared stone seawall with concrete cap, cracks in cap, and a sidewalk subsidence behind the wall. The wall continues inland away from water along the road and is not mapped. It has a toe stone revetment. Both are in satisfactory condition.

*Condition***B***Rating***Good***Level of Action***Minor***Description*

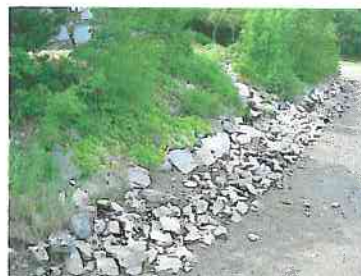
A stone revetment with smaller toe stone and possible a repair overlay of smaller stone. It is near a driveway and lab buildings. It is in satisfactory condition.

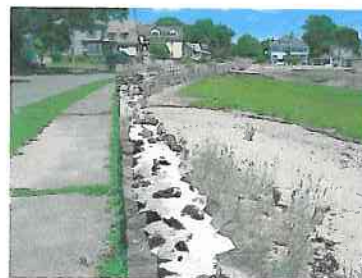
A mortared rubble stone wall with some cracked mortar; in satisfactory condition. There are 6 small sinkholes in the bituminous walk, approximately 6 inches in diameter. There is a walk and grass strip, then road behind.

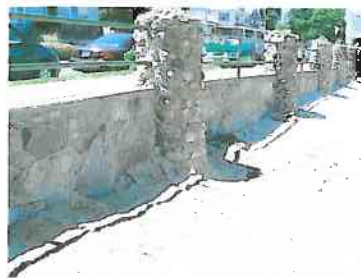
A mortared stone seawall with concrete cap in good condition. A sidewalk and street are behind with one cap spall and some mortar cracking.

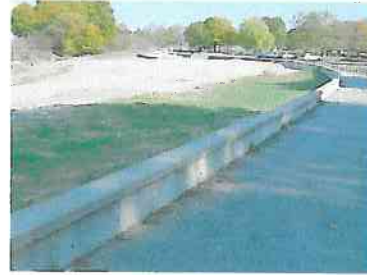
A cast in place concrete seawall at top of beach in good condition. The sidewalk and street are behind. There is one vertical crack with a few minor spalls.

*Condition***B***Rating***Good***Level of Action***Minor***Description*

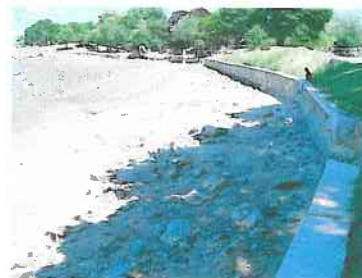
A mortared stone rubble seawall with concrete and granite cap. It is under repair. There are sinkholes and it is leaning offshore. There are some stones displaced and it is in poor condition.

Structure exhibits advanced levels of deterioration, section loss, cracking, spalling, undermining, and/or scour. Structure has strong risk of significant damage and possible failure during a major coastal storm. Structure should be monitored until repairs/reconstruction can be initiated. Actions taken to reconstruct structure to regain full capacity to resist a major coastal storm. Landform eroded, stability threatened. Landform not adequate to provide protection during major coastal storm. Actions taken to recreate landform to adequate limits for full protection from a major coastal storm.

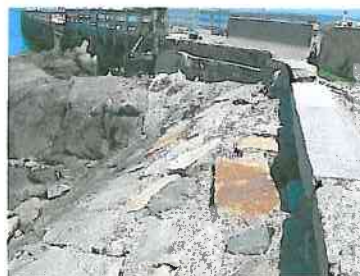
A granite block seawall with granite block placed stone revetment with concrete infill. It is in satisfactory condition and includes the pier abutment.

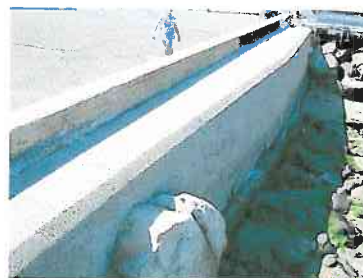
A cast in place concrete seawall with repair mass concrete in front of the original spalled concrete. It is in a park area and is in satisfactory condition.

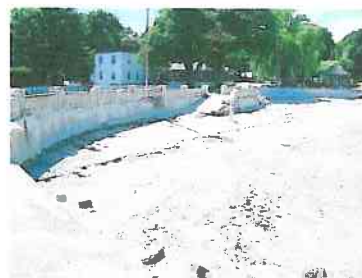
A cast in place concrete seawall with park road behind. It has weathered concrete, with some cracks and toe exposed at south end. It is in satisfactory condition.

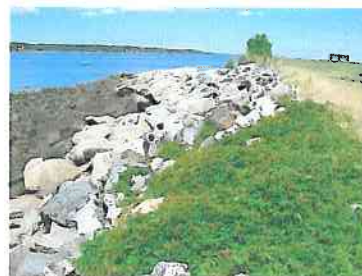
A rubble stone revetment in front of park lawn area in satisfactory condition.
