***South Shore Coastal Infrastructure Inventory
and Assessment Demonstration Project
Coastal Hazards Commission***

Town of Marshfield

Prepared for:
Office of Coastal Zone Management
Boston, MA

Presented by:
Bourne Consulting Engineering
Franklin, Massachusetts

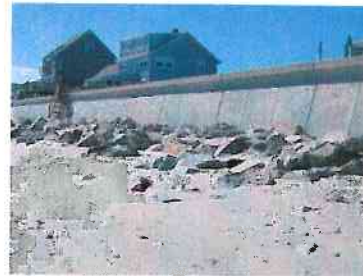
This is a concrete seawall with random placed stone along the toe. Small amounts of physical erosion of the wall is evident along the toe of the wall, presumably due to abrasion from the armor stones. The crest and face of the wall appear almost as new.

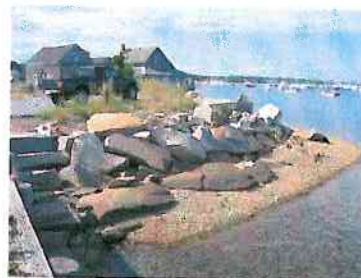
This structure is a small stone revetment. The armor stone has shifted and become unraveled.

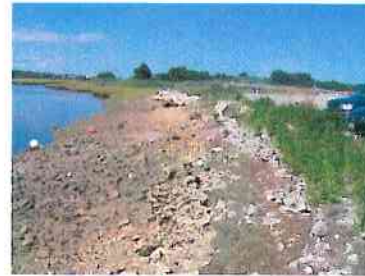
This structure is a small stone revetment alongside a marsh. This fronts the north end of the parking lot for the town boat ramp. The stone in the revetment is severely weathered and the structure has come unraveled for most of its length.

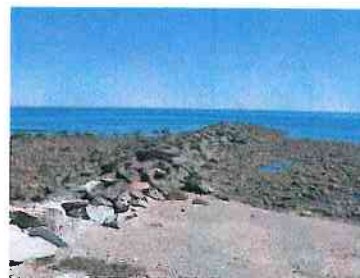
This is a stone groin. The sideslopes and crest are unraveled for a majority of the length of the structure. The head of the groin is completely unraveled.

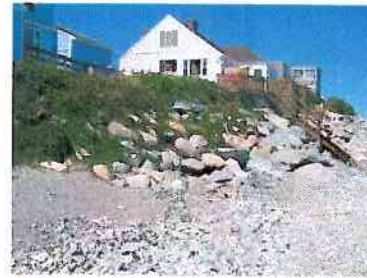
This structure is a stone revetment fronted by a groin and cobble beach. The sideslopes are mostly intact while the armor stone exhibits strong weathering.

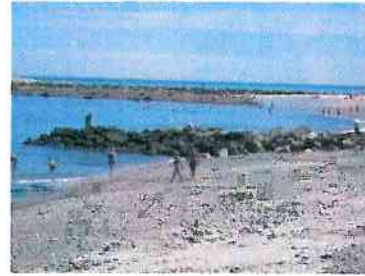
This structure is a short stone groin. The sideslopes and crest are mostly unraveled.

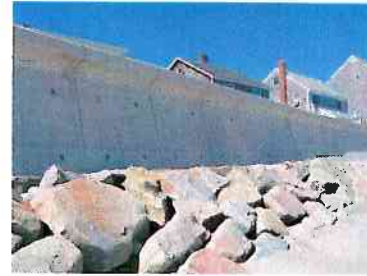
This is a concrete seawall with a wave return face and stone revetment along the toe. The wall and revetment at toe appear recently constructed. There has been backfill placed behind the crest which appears stable. There is minor erosion along the toe of the wall presumably due to impact from shifting armor stones at toe.

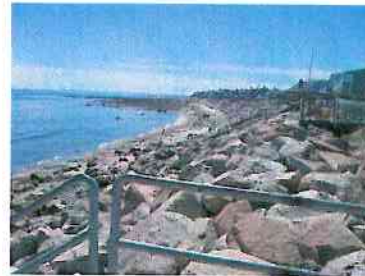
This structure is a stone revetment. There is significant movement of the armor stone evident. Some armor stones are displaced and there are voids evident within the armor layer.

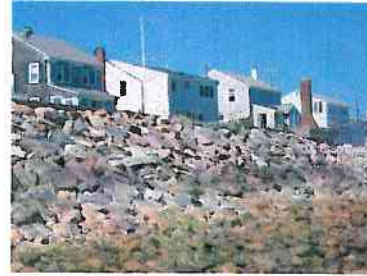
This is a stone revetment. There is some movement of the armor layer and displaced armor stones.
