**Massachusetts Probation Service  
Training and Operations Center  
Clinton, MA**

**HVAC SYSTEM  
EVALUATIONS  
COVID-19**

Office of Court Management  
June 14, 2022

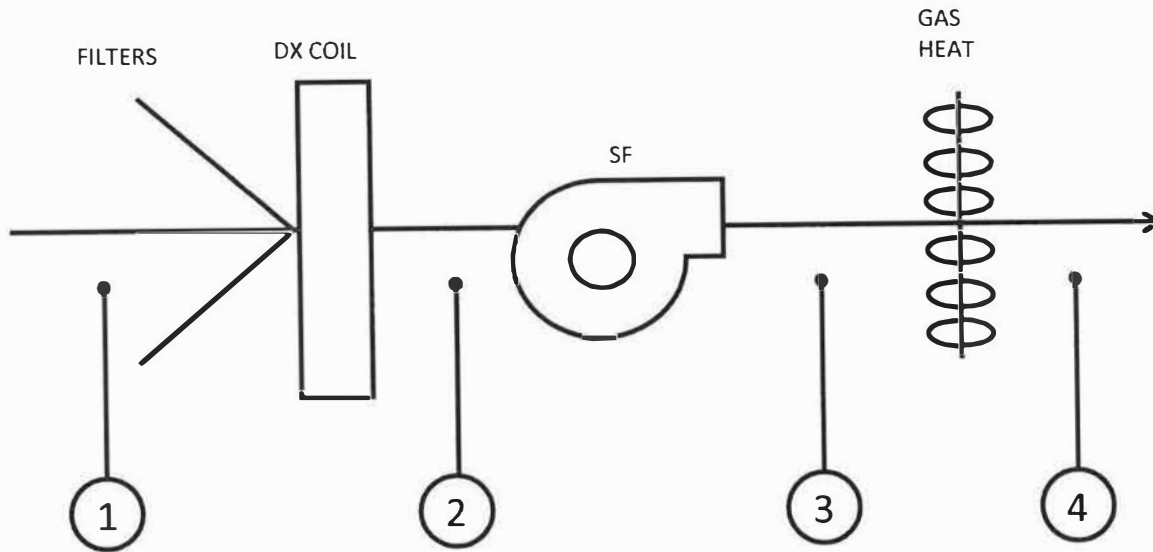
**SYSTEM STATIC PRESSURE PROFILE****PROJECT:** Massachusetts Probation Services Training and Operations Center**DATE:** 3/14/22**SYSTEM/AREA:** RTUs**TECH:** BS

UNIT	1	2	3	4	5	6	7	8	NOTES
RTU-1	-0.35"	-0.75"	+0.30"	+0.28"					
RTU-2	-0.76"	-1.21"	+0.48"	+0.45"					
RTU-3	-0.15"	-0.33"	+0.73"	+0.70"					
RTU-4	-0.43"	-0.78"	+0.32"	+0.30"					
RTU-6	-0.29"	-0.67"	+0.47"	+0.44"					
RTU-7	-0.59"	-1.14"	+0.68"	+0.65"					
RTU-8	-0.48"	-0.95"	+0.94"	+0.91"					
RTU-10	-0.24"	-0.42"	+0.17"	+0.15"
