APPENDIX C:
BUILDING CONDITIONS SURVEY

DCR Building Conditions Survey & Assessment for: Gate Lodge at Maudslay State Park Newburyport, MA

DCR BUILDING CONDITIONS SURVEY & ASSESSMENT
for
Gate Lodge at Maudslay State Park
Newburyport, MA

January, 2016

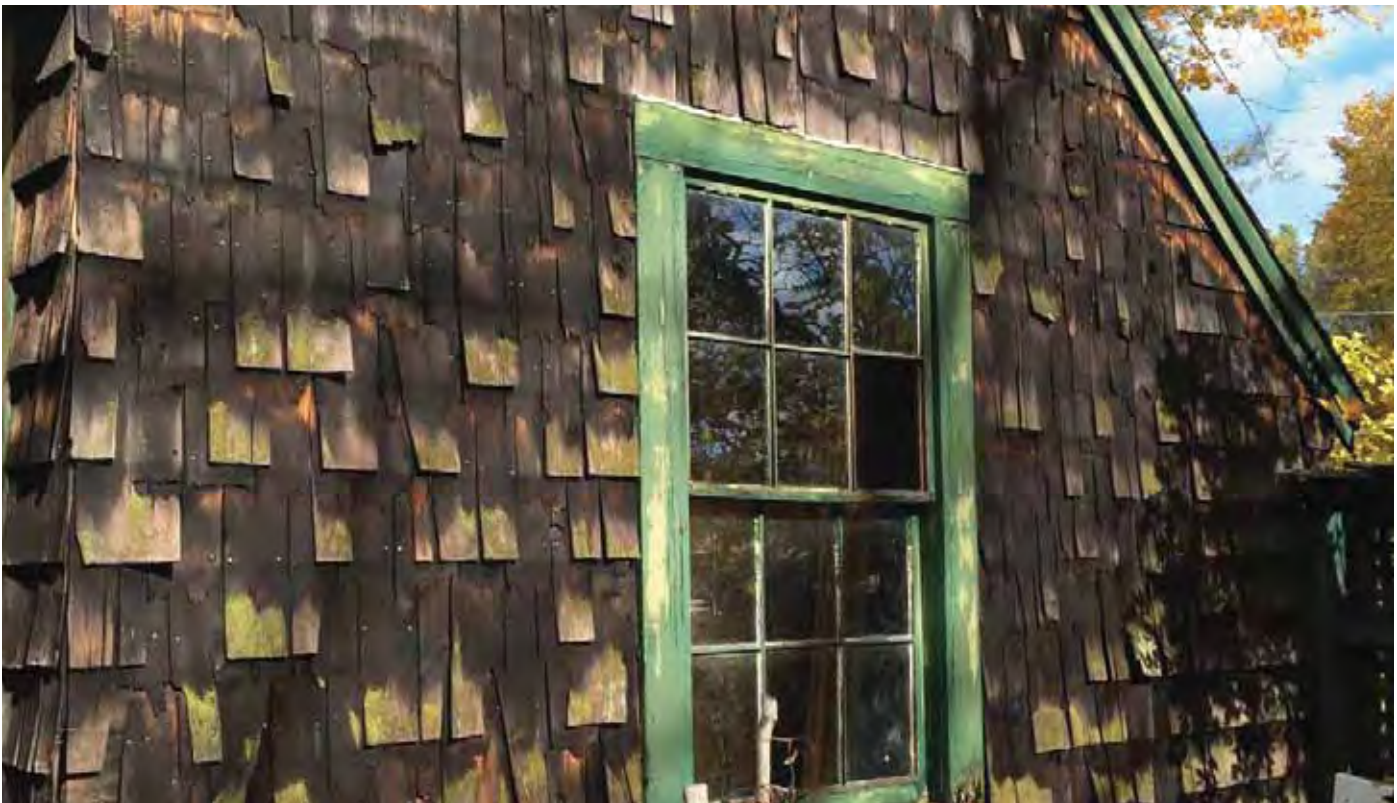
Image #16: Cedar shingles on detached garage

The exterior wall framing of the detached garage are 2x4 stud walls with horizontal sheathing boards (nominal dimensions). The framing appears to be in good condition. The exterior cedar shingle finish is in poor condition and should be replaced (#16). The shingles are curled, discolored and falling off.

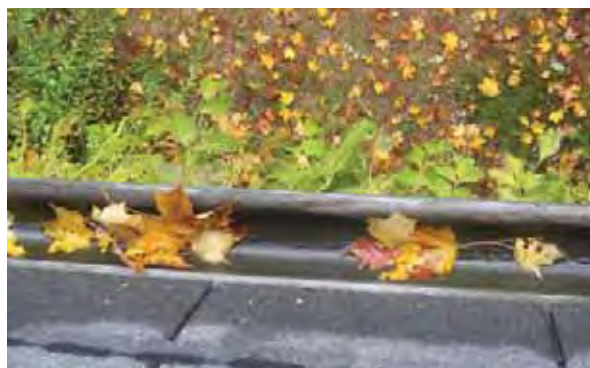
The house's gutters are wood. In 2011 the permittee restored the one remaining historic cedar gutter and installed new cedar gutters along with new, historically accurate downspouts. Those gutters which are visible from a second story window on the east side of the house appear to be unlined (#19). Other gutters should be checked for linings. All the wood gutters should be cleaned and lined with membrane roofing material or copper to improve their longevity. Gutters should be added to the eave at the eastern wall of the shed.

Image #19: Existing wood gutter with no lining

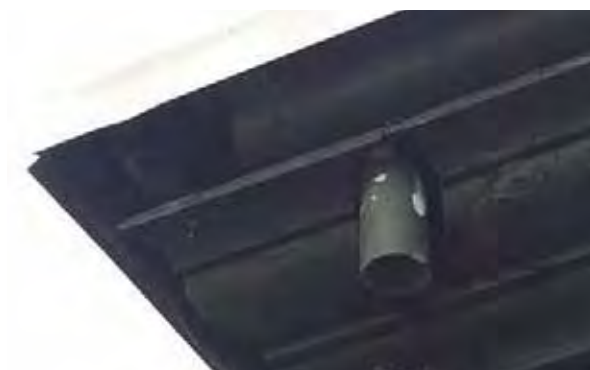
Image #20: Wood gutters on the porch

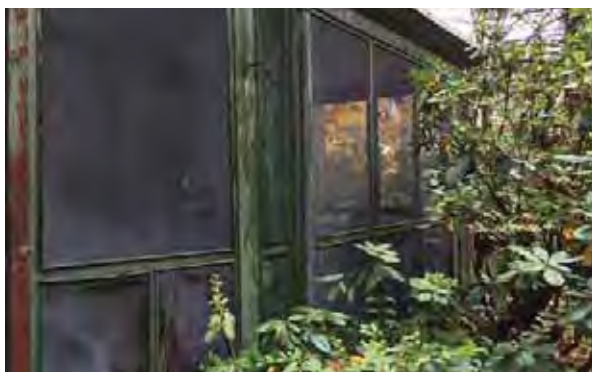
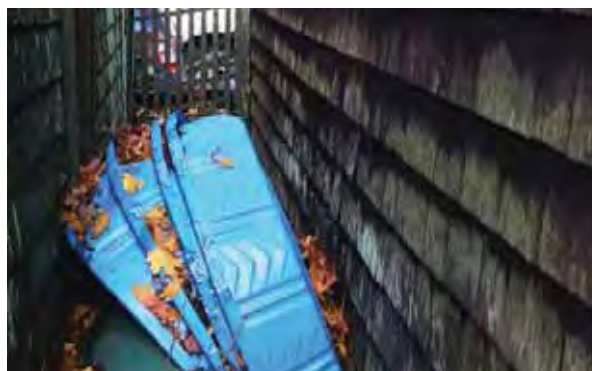
Image #24: Debris between shed and detached garage

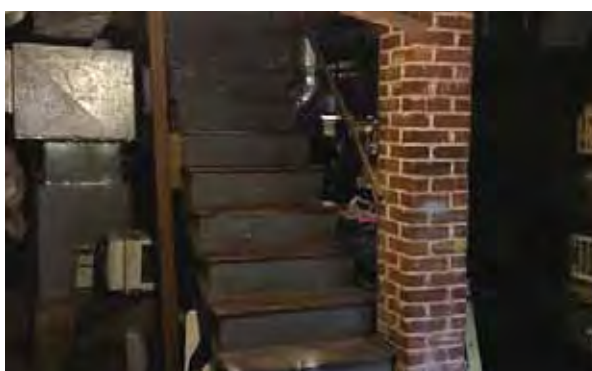
Image #30: Basement stairs

The wood stairs from the first floor to the basement are in fair condition. A railing should be added to the west side of the stair for safety (#30, 50).

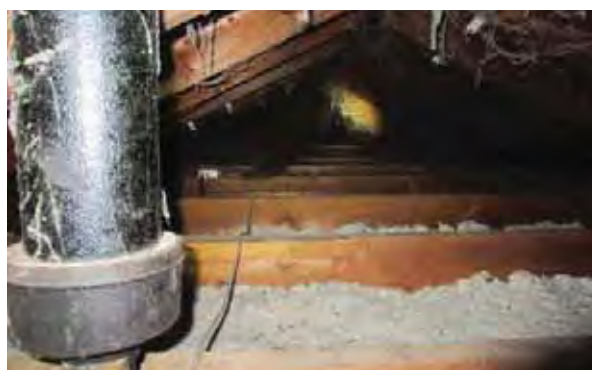
Image #32: Insulation in attic

in cellulose insulation should be added in those areas to improve the energy efficiency of the house and increase inhabitant comfort.

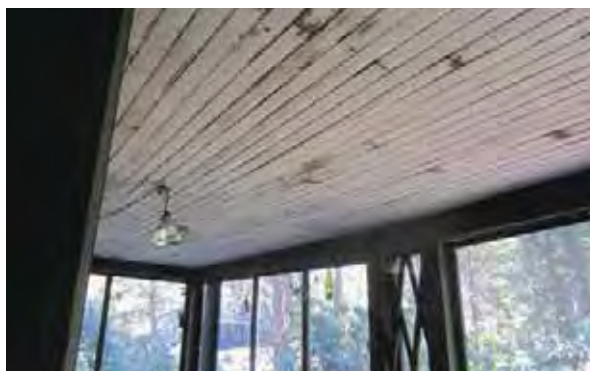
As noted above, the condition of the screen porch is poor. The framing of the floor and roof have deteriorated from water damage. The most notable damage is to the floor framing at the front step which has completely disintegrated (#28, 38). The wall panels no longer meet the floor at this location. In addition to the structural damage to the porch, the paint on all the porch woodwork contains lead (#37). Given this combination of conditions, replacement of the entire porch, in the same size, style & detail of the original, is

Image #38: Screen porch step

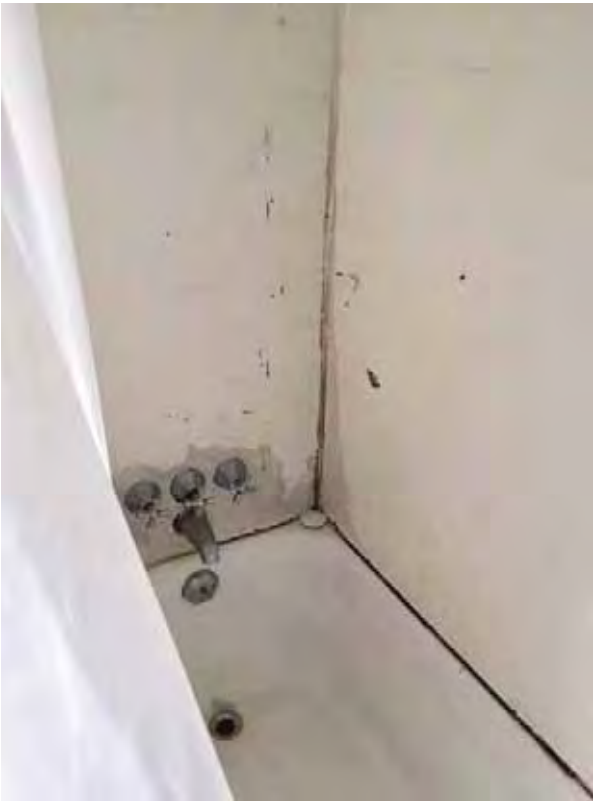
Image #39b: Simulated tile wallboard in 2nd floor bath

The wall tile in the newly renovated first floor bathroom is in good condition (#47). The simulated tile wallboard which surrounds the second floor tub is in poor condition and should be replaced (#39b).

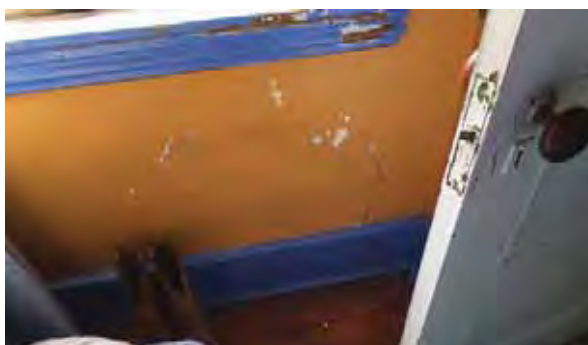
The interior walls and ceilings are painted plaster and are in generally good condition (#48, 49). There is an area of bulging and cracking on the south wall of the eastern bedroom from previous water damage prior to exterior repairs on the house in that location (#43). The plaster in this area should be repaired and repainted. The ceiling of the office is also peeling and needs to be repainted (#44).

Image #43: Plaster in east bedroom

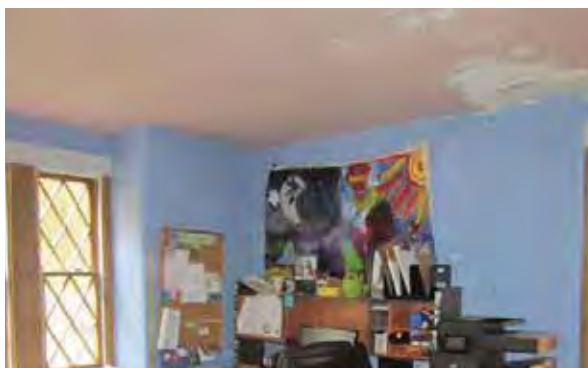
Image #44: Office ceiling

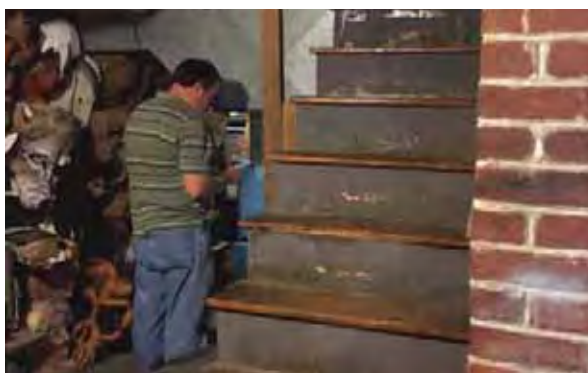
Image #50: Basement stair with no handrail

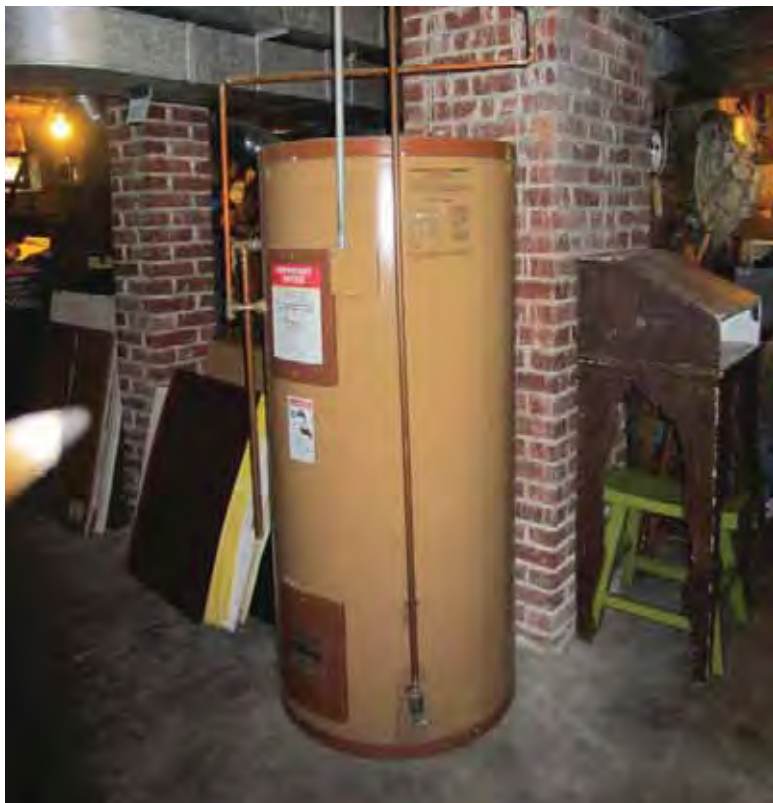
Image #52a: Hot water heater

The plumbing system components are at or near their end of their useful lives or are inefficient and should be replaced. This includes the plumbing fixtures on the 1st and 2nd floors, the hot water heater (#52a) and hose bibs. All existing piping to remain requires new pipe hangers, insulation and valves.

1. Replace existing main panel.
2. Replace all receptacles & switches. Rewire & provide grounding type and coverplates.
3. Install new surface mounted LED light fixtures (quantity = 20)
4. Install new exterior LED lighting at entrances (quantity = 5)
5. Hard-wire smoke detectors
6. Install 2 carbon monoxide detectors

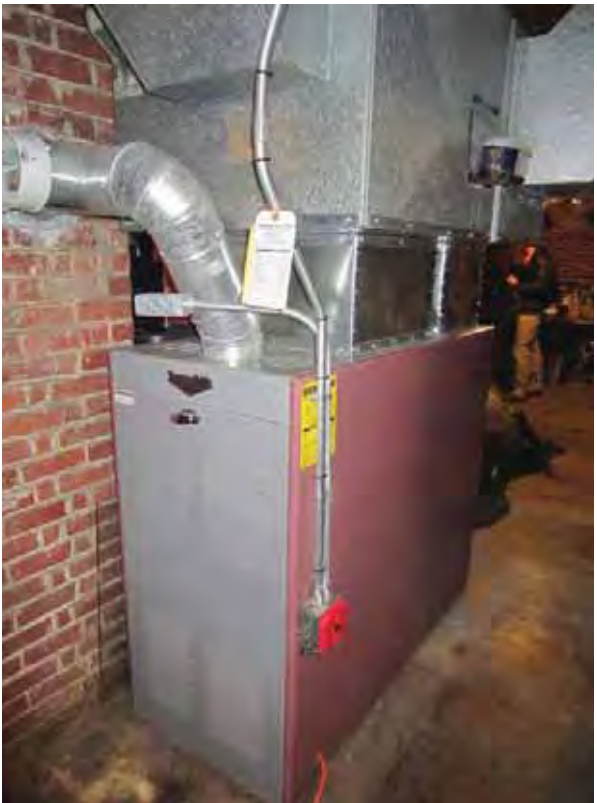
Image #52b: Furnace

The gate house's furnace was replaced in 2009 and is in good condition (#52b). There is no central air conditioning in the house and it is not expected to be added. There are no exhaust fans in the bathrooms, which should be added.

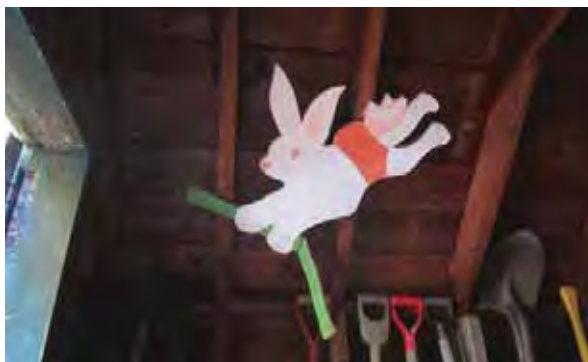
The structural components of the garage are in generally good condition (#53).

Image #53: Garage structure

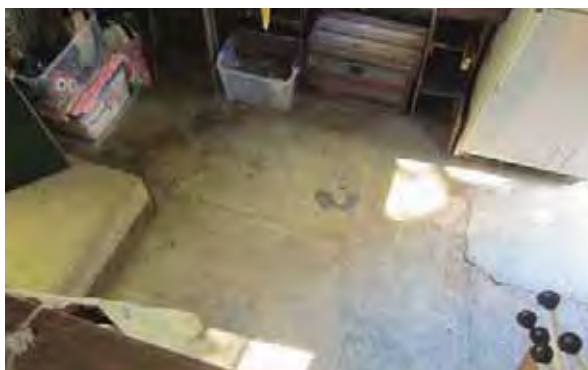
The structural components of the attached shed have deteriorated in several locations and require rehabilitation, including the concrete slab and entire east wall (#51, 54).

Image #54: Shed concrete slab

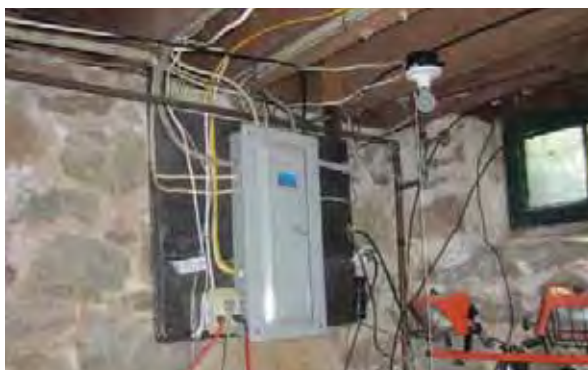
The electrical system components are antiquated and should be replaced. This includes replacing the main distribution panel (#56), all receptacles and switches (#55), and light fixtures.

Image #56: Electrical panel

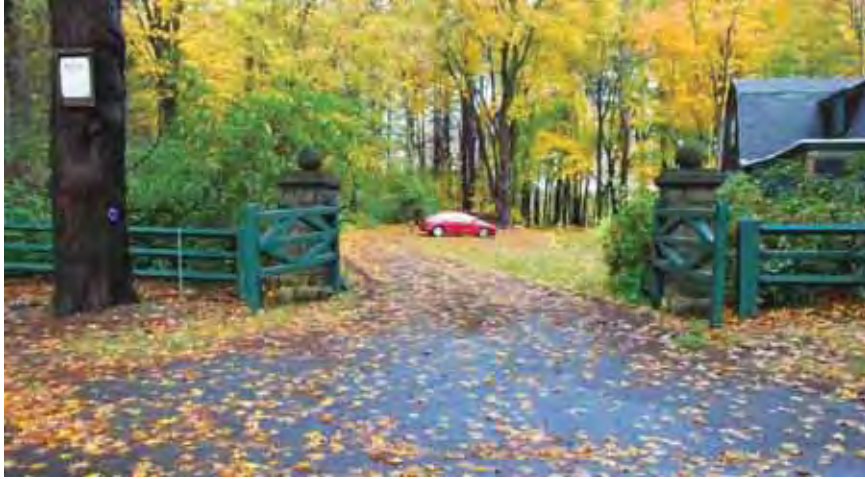
Image 1: Entrance along Pine Hill Road

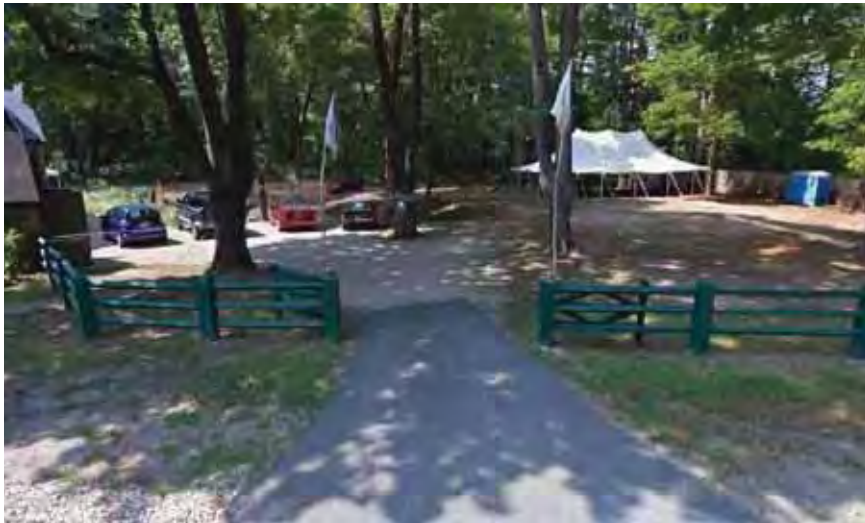
The main living building is situated on relatively flat ground at the corner of Pine Hill Road and Spring Lane with detached storage shed to the east of the building. There are two entrances to the property: one at Spring Lane and one on Pine Hill Road. The property along those streets is lined with a painted rail fence and gates at entrances. Rail fence returns to the storage shed on the east side. The gates and fences looked in good condition.

Image 2: Entrance along Spring Lane (Image by Google) and rail fence returning to the shed

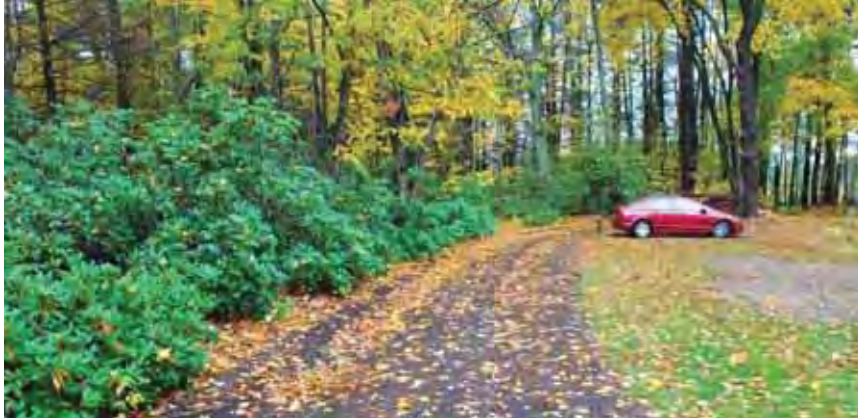
A short asphalt drive leads from Spring Lane entrance to an informal gravel parking area in front of the shed which can accommodate approximately 4-5 cars. (Image 3) The asphalt appears to be in good condition. The gravel parking area does not appear to have a defined edge. There is a large pit on the north side of the house which appears to contain the septic system. A manhole cover and a metal pipe protrude from the bottom. (Image 5) A dirt drive leads from Pine Hill Road, around the large pit and connects to Spring Lane Drive. (Image 4) We were informed by the house tenants that the dirt drive is used by parents as drop off loop during the summer open air theatre camp. There are approximately 12 informal parking spots along the septic pit and dirt drive. There is a decaying wood post along the drive.

Image 3: Dirt drive past Pine Hill Road entrance

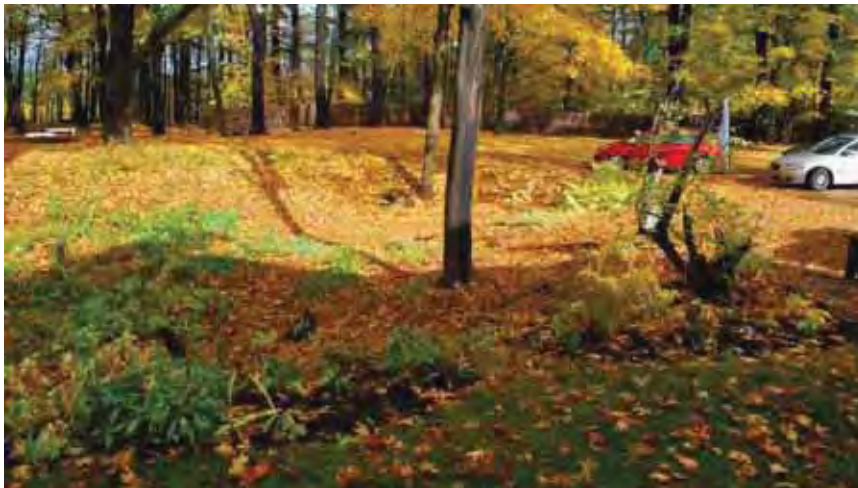
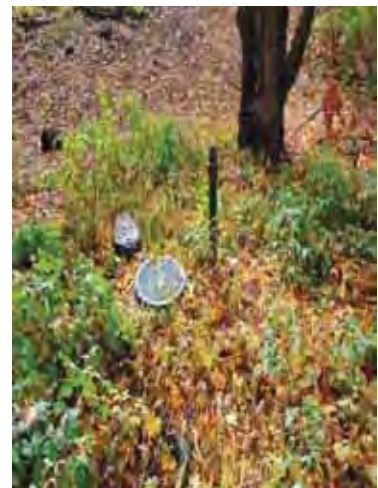
Image 5: Septic pit to the north of the main house and metal pipe at the bottom

Four mature Norway Maple trees are growing inside the septic pit, two of which appear to be in poor condition. Edge of the pit is planted with isolated ornamental plants including ferns, hosta, and daylilies. A few small tree stumps are present. There are isolated invasive plants growing at the bottom of the pit (see invasive plant image board in this document for reference).

3. Remove small tree stumps along the edge of the septic pit. Grind stumps 12" below grade, finish grade to blend with existing. (quantity = 6)
4. Remove two failing trees growing within septic pit.

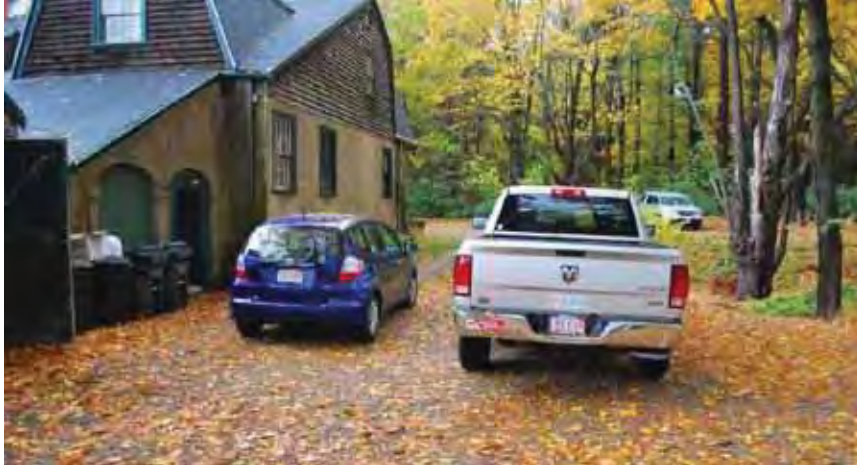
Image 6: Informal gravel parking area in front of the shed

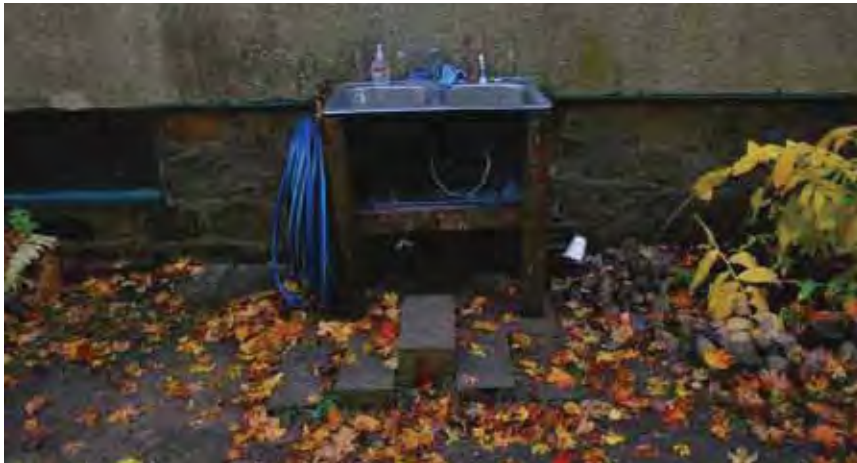
There are four residential trash receptacles located against the shed at the edge of grave parking area. There are two small brick plant beds against the north wall of the house with sparse ferns and hosta plants. The edge of plant beds was in poor condition. Small wisteria vine is climbing the building stucco wall. Small outdoor sink is placed between the two planters.

Image 7: Outdoor sink

1. Restore landscape plantings (see planting recommendations in landscape report in Appendix B)
2. Provide new outdoor garden sink & stable step-up for children.
3. Remove isolated understory invasive plants from area between stage and dirt drive.
4. Remove 8 failing trees along the edge of the property.
5. Prune trees along the property edge as needed to maintain good health.
6. Install 6" raised granite curb vegetable beds; same dimension and location as existing wood to be removed.

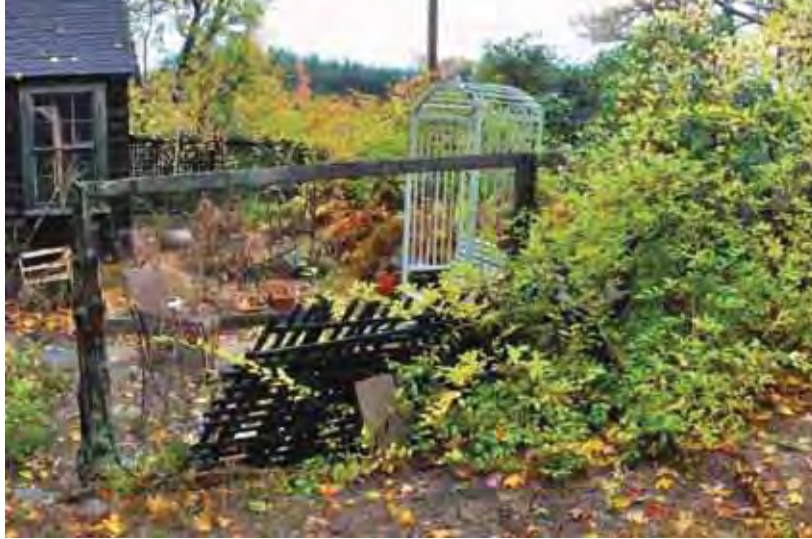
Along the rail fence the property is lined with dense mature Rhododendron shrubs in various stages of decline that act as privacy screen. A small private garden abuts the house on the south side (*Image 8*). Part of the garden is delineated with low, crumbling retaining walls. A cinderblock serves as a step between upper and lower level of the garden. Several fallen screen fences that appear to have been part of the garden are leaning against Rhododendron and Forsythia shrubs. Three low wood vegetable beds and a bench with pergola are located within the lower section of the garden, both with signs of wood decay. The upper part of the garden is overgrown with blackberry vines and ferns. A small wisteria vine is climbing the building stucco wall (*Image 10*).

Image 8: Private garden

8. Provide paved pathway from the drives to the house entrances. (approx 30 ft)
9. All garden structures, except retaining walls, to be removed from private garden. Clear garden of overgrown plant material. Remove failing Maple tree at corner of property at edge of garden. Repair retaining walls and rebuild step with natural stone. Build new privacy screen to match existing. (privacy screen = ornate painted wood lattice, approx. 30 ft)

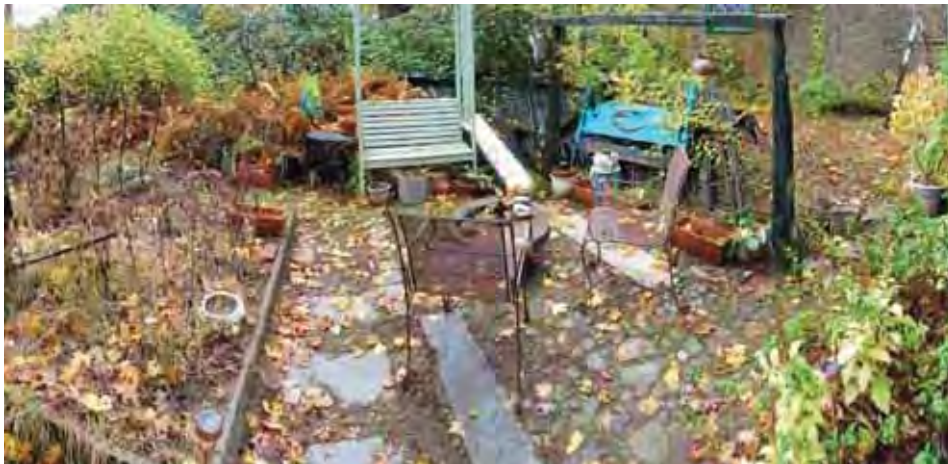
Image 9: Vegetable bed and bench in private garden

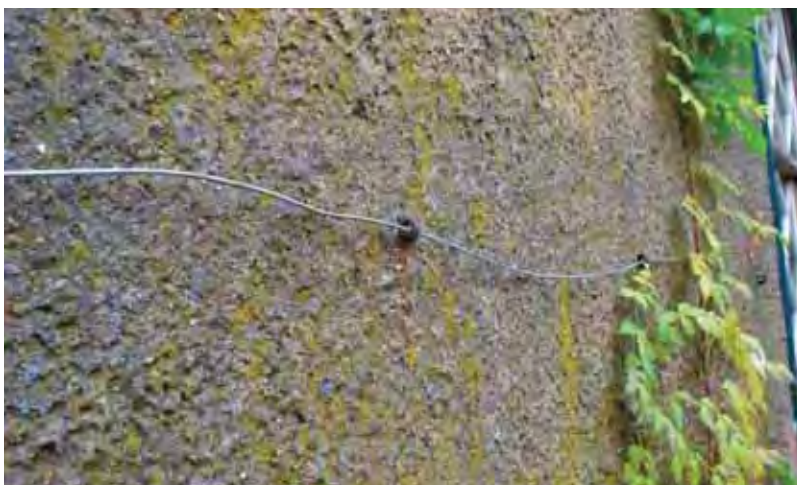
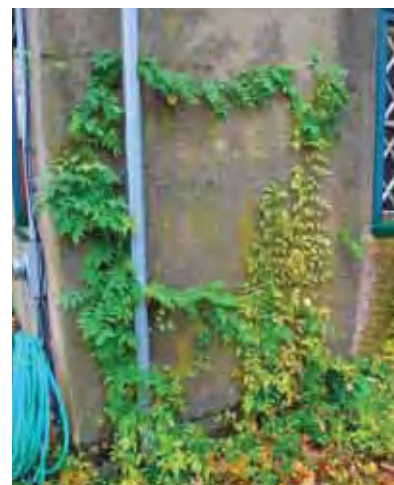
Image 10: Wisteria vine climbing building stucco wall

12. Preserve historic vine support on building structure and maintain Wisteria vines to prevent building damage.

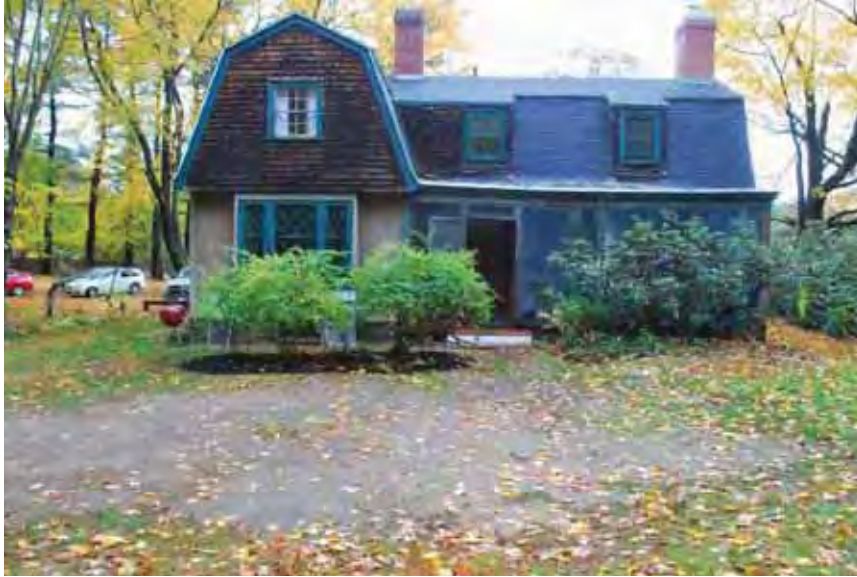
Image 11: West side of the house

The main entrance of the house is located on the west side of the building. There is no paved path leading to the door and entrance is not ADA accessible. Landscape on the west side of the building consists of two declining shrubs and barren soil (*Image 11*).

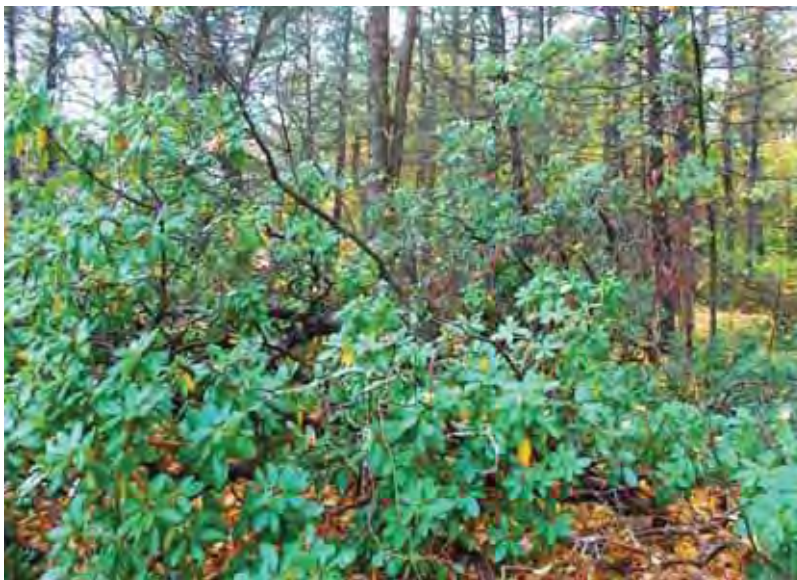
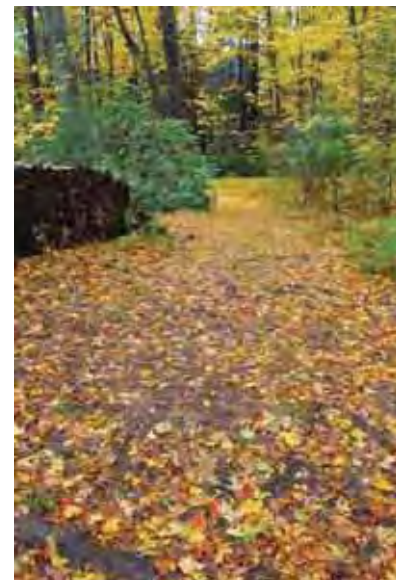
There is no fence along southwest property line, but a section of it is lined with dense mature Rhododendron shrubs in various stages of decline (*Image 12*). An approximately 5' wide dirt path enters the property at the edge of Rhododendron screen and connects with dirt drive near the septic pit. The dirt path leads to the rest of the Maudslay State Park. There is no gate on this path at property line. To the left of the drive chopped wood is being stored in a pile (*Image 13*).

Image 12 and 13: Rhododendrons along west property line and dirt path entering property

- P1. Save and protect existing mature rhododendrons, approximately 200 LF of large shrubs. Prune to maintain good health. Add new rhododendron as needed to match existing and create continuous planting screen.
- P2. Install new plant material: 4 fruit trees, 40 medium shrubs, 200 SF of ornamental grasses and perennials at 12" o.c.

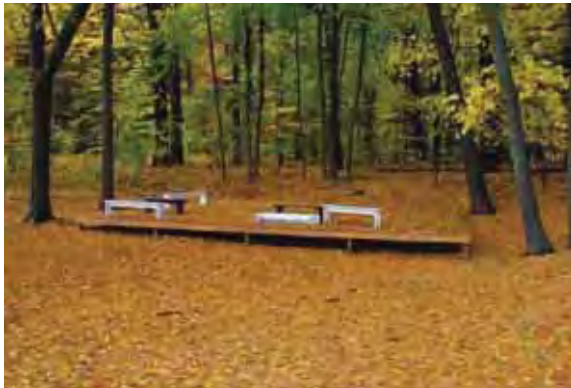
The stage of the summer outdoor theatre is located in a depression in the northwest corner of the property (*Image 14*). The area is mostly clear of understory plantings with isolated invasive Norway Maple saplings and bittersweet vines. There are several mature tree stumps in proximity of the stage.

Image 14: Stage area in northwest corner of property

1. Clear fallen tree trunks lining north property line & repair wire & slat fence, Repair leaning posts in solid wood fence.
2. Grind tree stumps in stage area 12" below grade, finish grade to blend with existing. (quantity = 6)

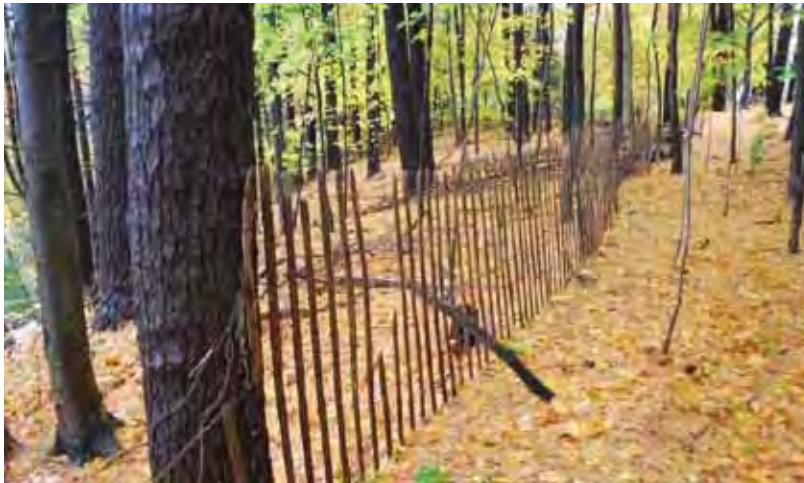
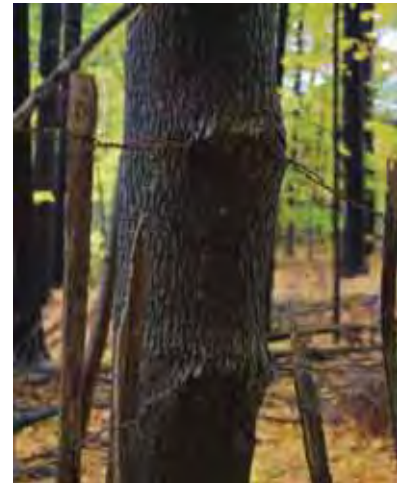
The north property line is delineated partially by solid wood fence shared with the abutter, fallen tree trunks, and broken wire and slat fence. Sections of the wire fence are growing into adjacent trees. Some posts in the solid wood fence are leaning (*Image 15 and 16*).

Image 15: Wire and slat fence.

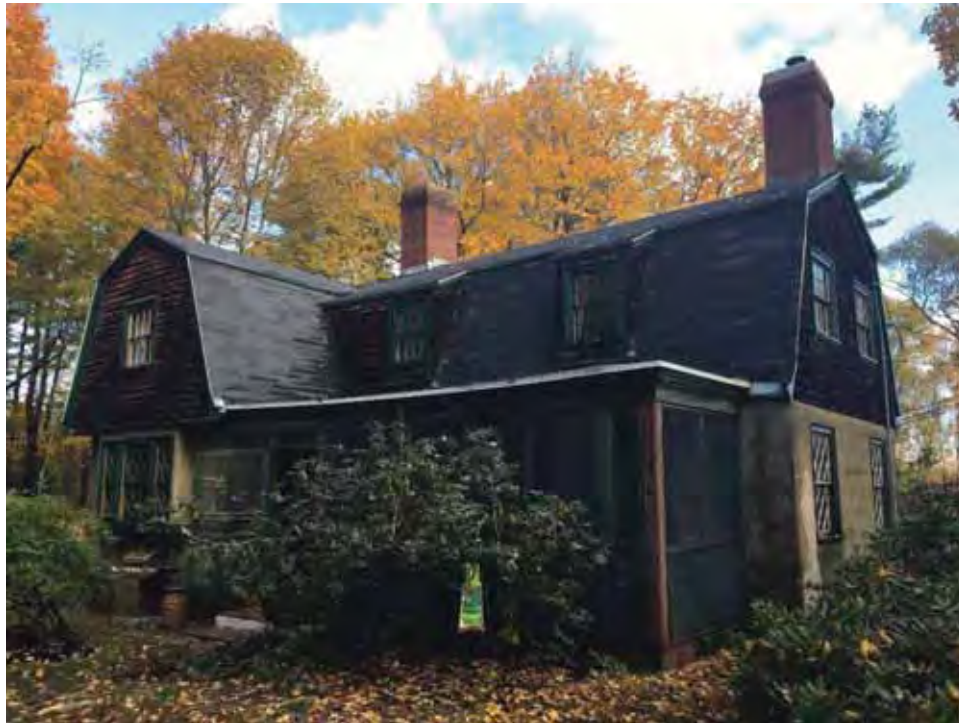
As requested, Dan Foiles of RSE Associates visited the Gate Lodge at Maudslay State Park on October 29, 2015 to observe the existing condition of the structure. The building is a single-family home constructed in the early 1900's (photo 1). The main structure consists of granite stone foundations with brick piers supporting light wood frame construction. Both the attached and detached sheds on the east side of the building consist of concrete foundations supporting light wood frame construction.

Photo 1 – Gate Lodge viewed from the south west.

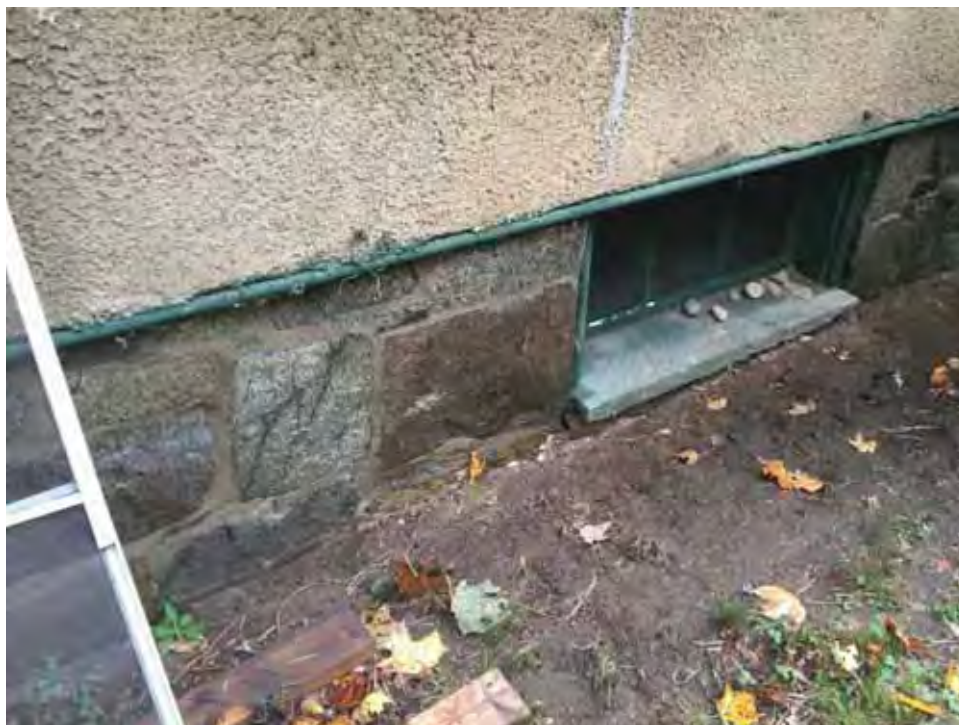
The main building foundations consist of granite stone masonry walls (photo 2-3) around the perimeter of the building and several brick piers (photo 4) in the interior. The granite masonry walls are in good condition with no obvious sign of cracking or water infiltration. The brick piers are in good condition with only minor cracking. The basement floor is a concrete slab on grade that is in good condition. A report prepared by the current resident in 2012 suggests that the slab on grade is not original and replaced the original dirt floor. According to the resident's report, in 2012, the resident replaced the last portion of the dirt floor with slab on grade.

Photo 2 – Granite foundation wall exterior face at the north elevation.

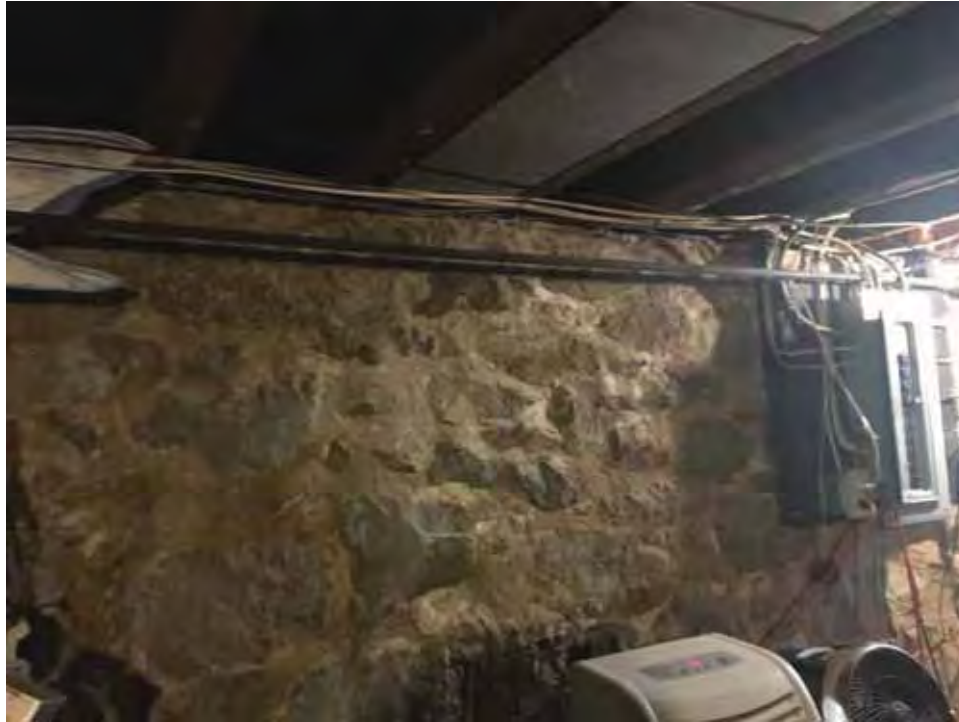
Photo 3 – Granite foundation wall viewed in the basement.

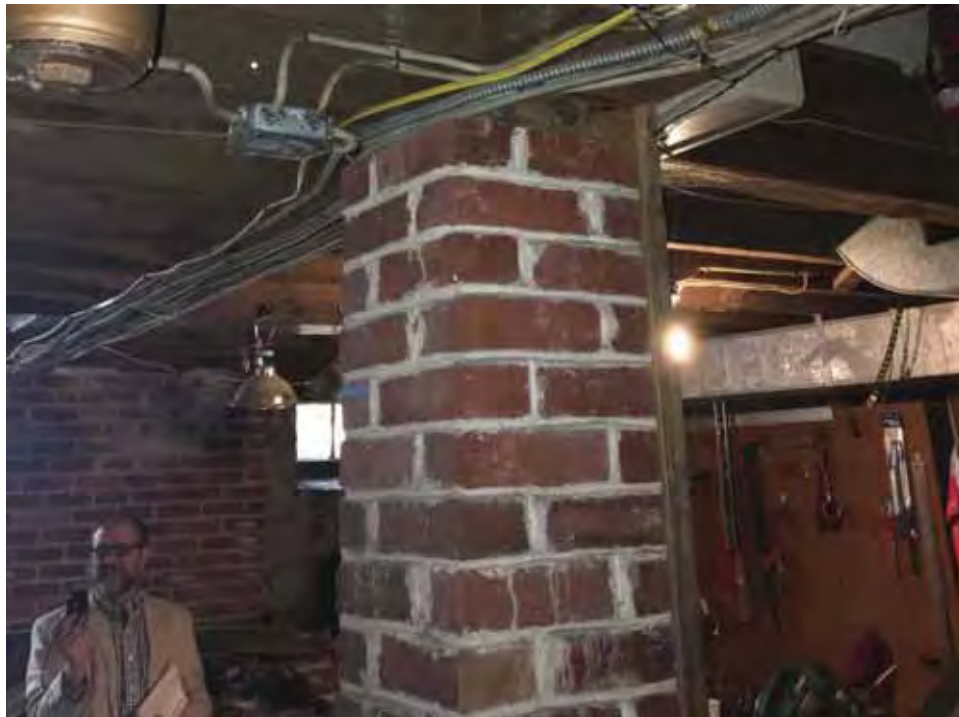
Photo 4 – Interior brick pier in the basement.

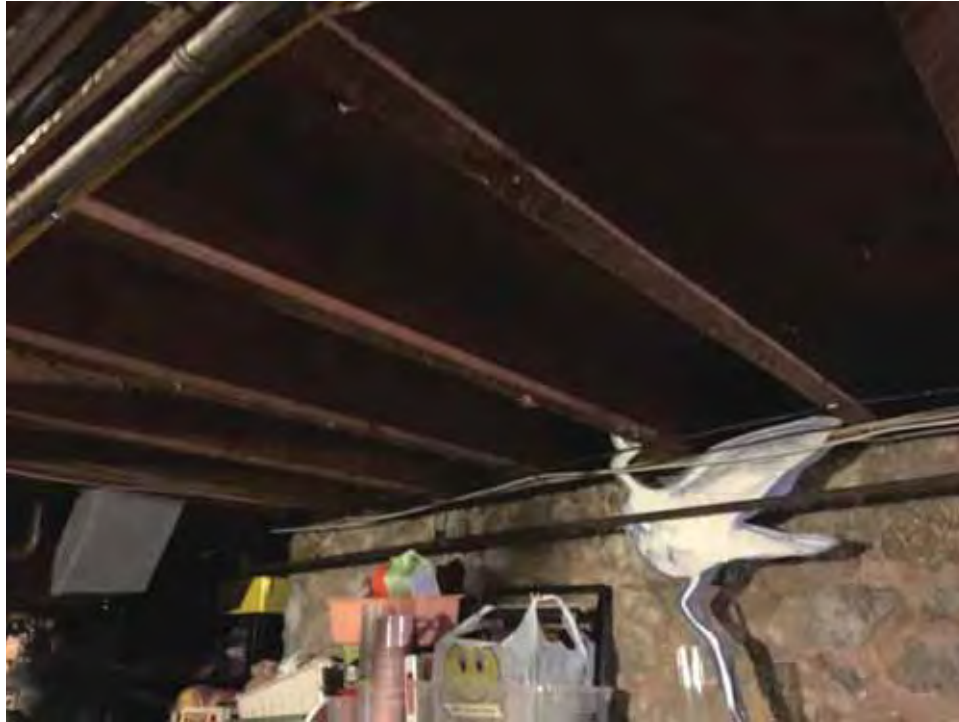
The first floor framing consists of 2x10 joists at roughly 16 in. on center and 6x10 beams (photo 5). The 2x10 joist widths are a true 2 in wide. The joists either bear directly on the granite foundation walls at the perimeter (photo 6) or frame into the 6x10 beams at interior locations (photo 7). The 6x10 beams bear either on the granite foundation walls or on the interior brick

Photo 5 – First floor framing.

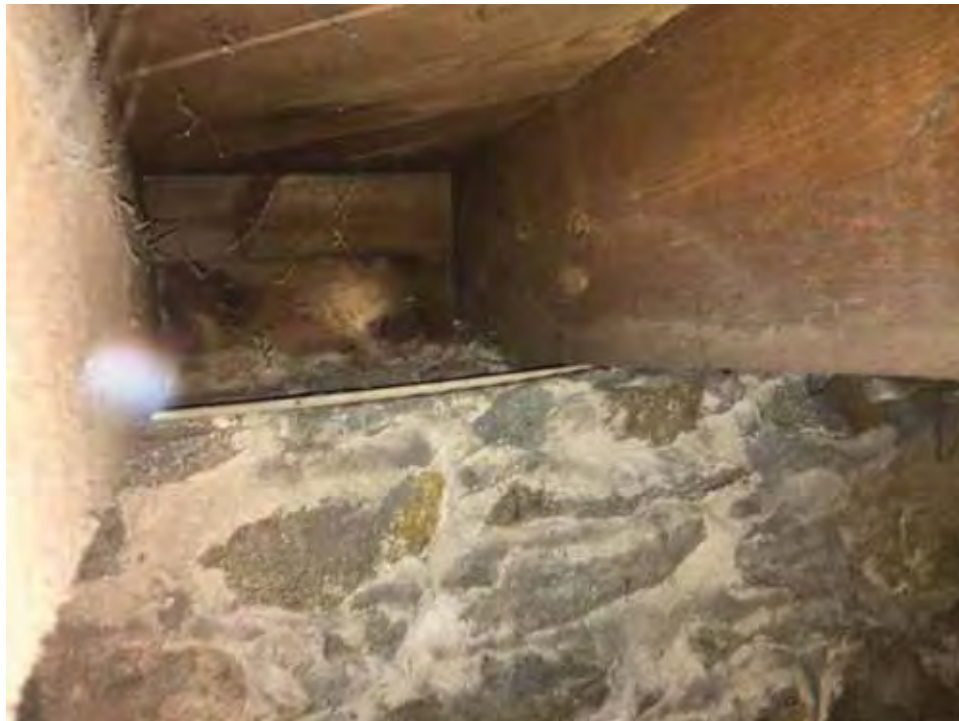
Photo 6 – First floor joists bearing on the granite foundation walls.

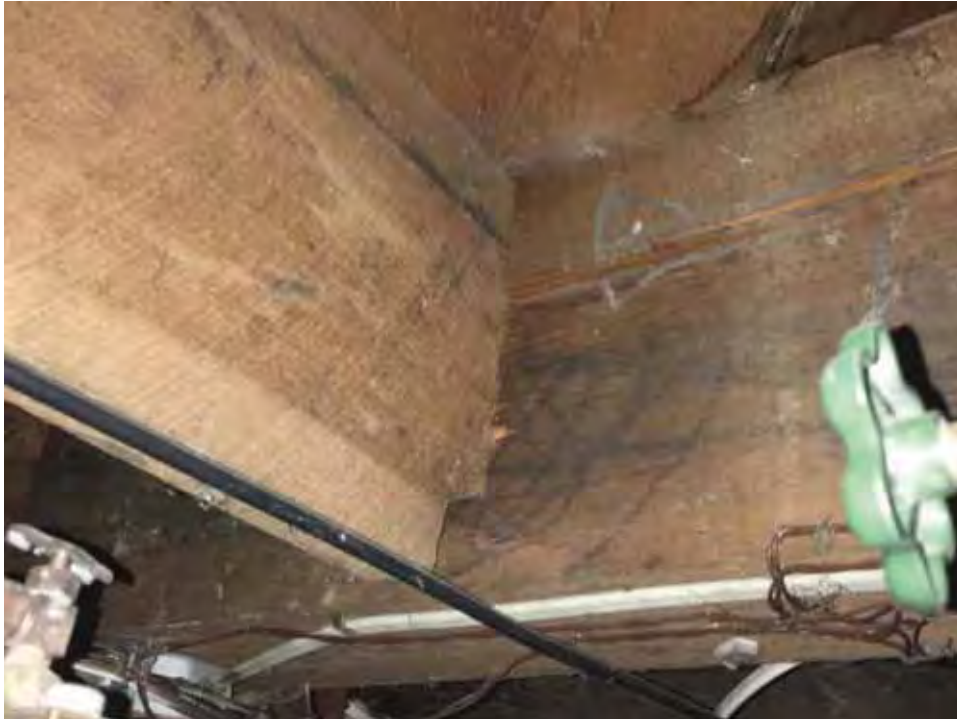
Photo 7 – First floor framing joist-to-beam connection

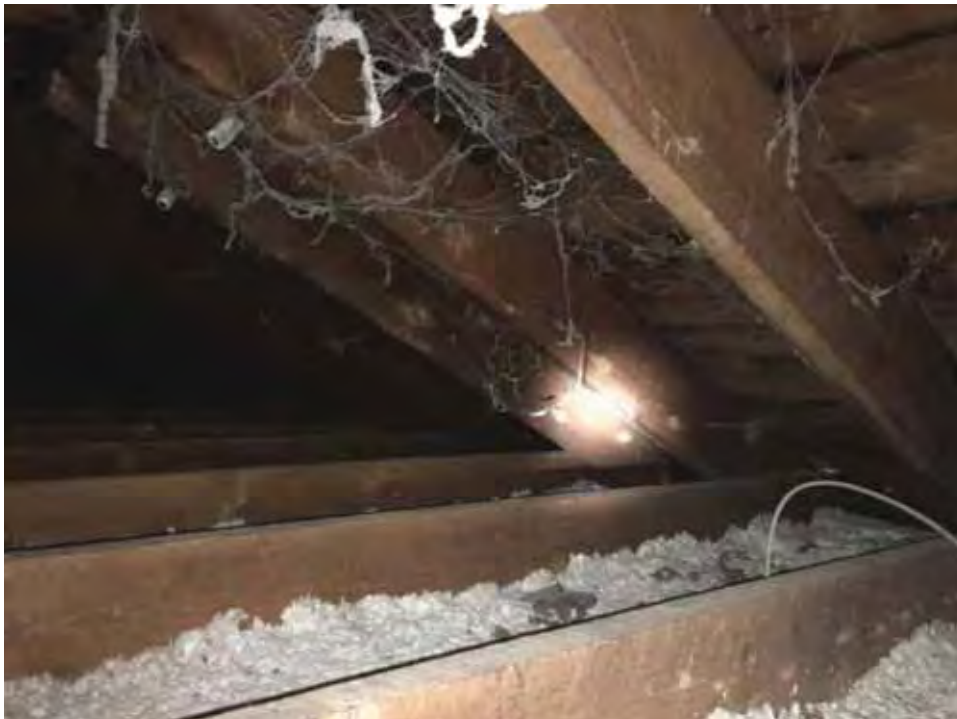
Access to observe the roof framing is limited to one hatch into the attic near the north chimney. The attic is too small to move around in so we could only observe the roof framing from this one location. The roof framing consists of 2x8 (true 2 in. width) rafters at 16 in. on center with 3/4 in. wood decking (photo 8). From this location, the roof framing appeared to be in generally good condition. Near the north chimney, we observed water staining on the rafters (photo 9), but the staining appeared to be old and the wood did not appear to be rotting.

Photo 8 – Main building roof framing.

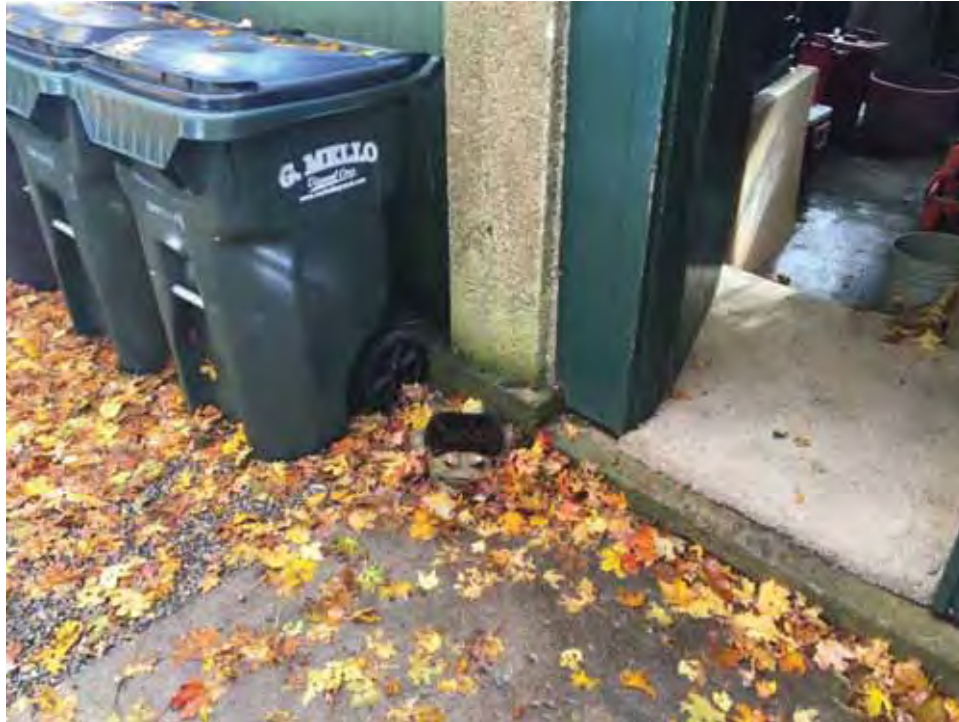
The north side of the shed bears on a concrete foundation that extends roughly 6 in. above grade (photo 13). The south wall of the shed appears to bear on the floor slab except for a small portion on the east end of the wall that appears to be directly on grade (photo 14). The east wall also appears to be directly on grade.

Photo 13 – Concrete foundation supporting the attached porch north wall.

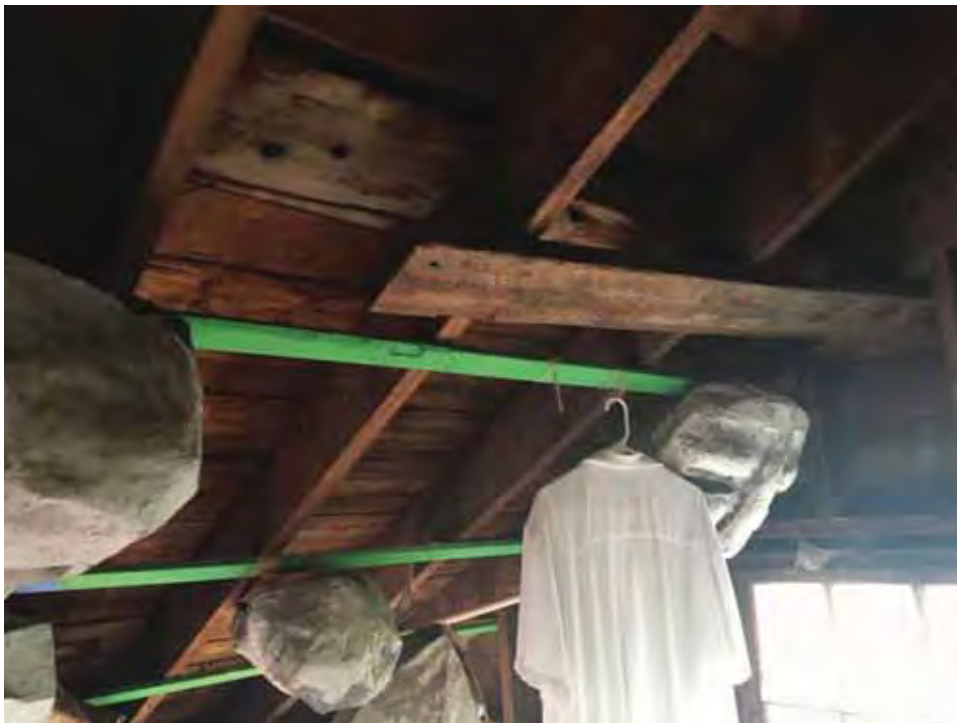
The shed has a monoslope roof and the framing is similar to the main house and consists of 2x8 rafters (true 2 in. width) and wood decking (photo 16). The roof framing is in good condition and we did not observe any significant deterioration.

Photo 16 – Attached shed roof framing.
