APPENDIX C:
BUILDING CONDITIONS SURVEY

DCR Building Conditions Survey & Assessment for: Gate Lodge at Maudslay State Park Newburyport, MA

DCR BUILDING CONDITIONS SURVEY & ASSESSMENT
for
Gate Lodge at Maudslay State Park
Newburyport, MA

January, 2016

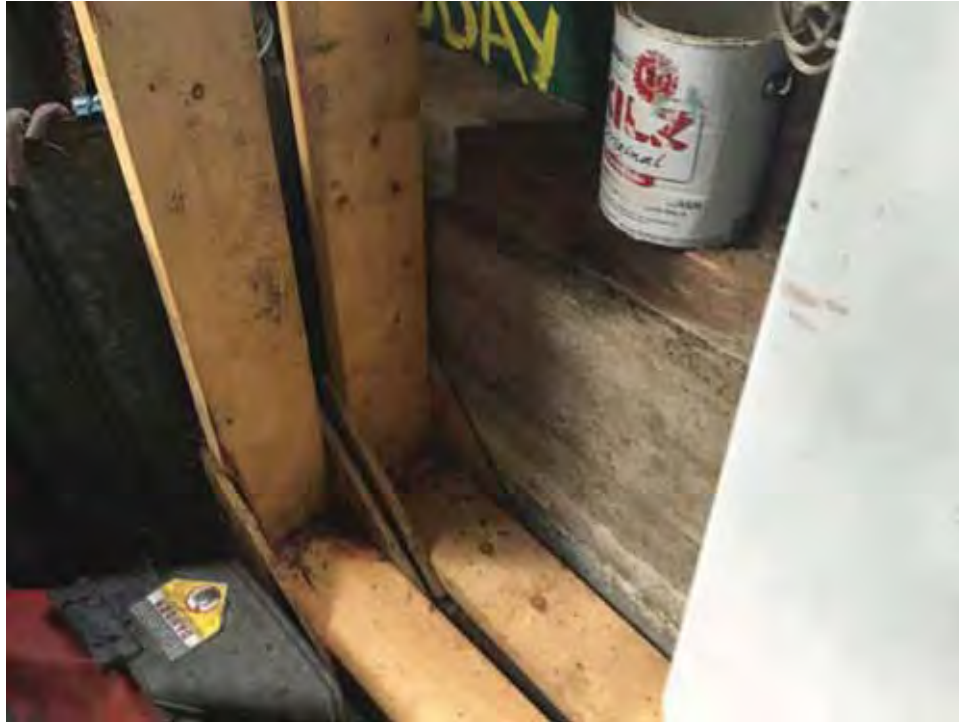
The garage bears on a concrete foundation located at the perimeter and that extends approximately 1 ft above grade (photo 17). The foundation is in good condition and we did not observe any significant deterioration.

Photo 17 – Concrete foundation wall supporting the garage.

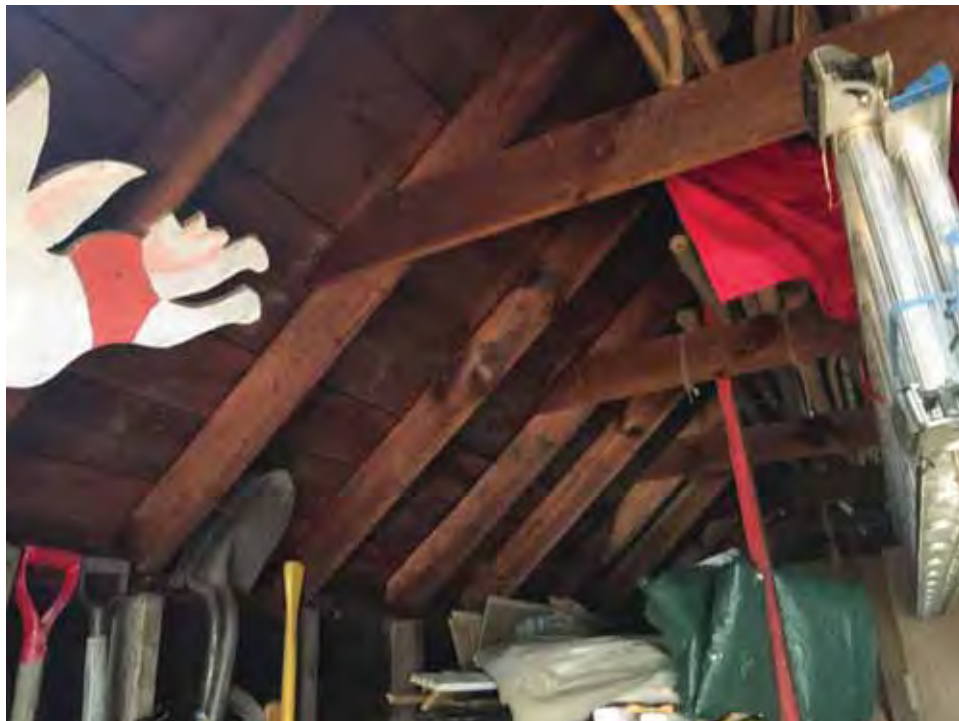
The garage has an asymmetrical gable roof with 2x6 rafters and 1x8 ties every other rafter (photo 18). The garage roof is in good condition and we did not observe any significant deterioration.

Photo 18 – Garage roof framing.

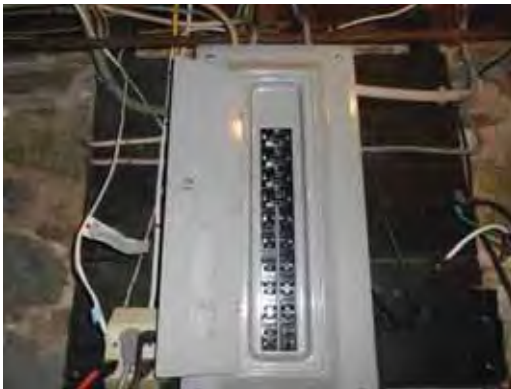
Main Distribution Panel

In general, the electrical distribution system located in the basement is adequate in capacity but is antiquated and in fair condition. Panel should be replaced.

There is one service present at the facility. The service is rated at 100A, 120/240V, 1Ø, 3W. The main distribution panel with the main breaker are manufactured by Push-o-matic. The equipment is original and in fair condition. There is one meter at the exterior of the building.

The existing panel is in poor condition. A new panel should be provided.

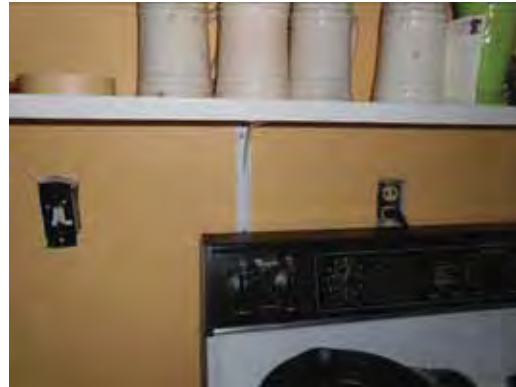
Outlets and switches in the kitchen do not have coverplates. Most are the non-grounding type and some are old and in poor condition.

Outlet & Switch Without Cover

All receptacles and switches should be replaced, rewired and provided with grounding type and coverplates.

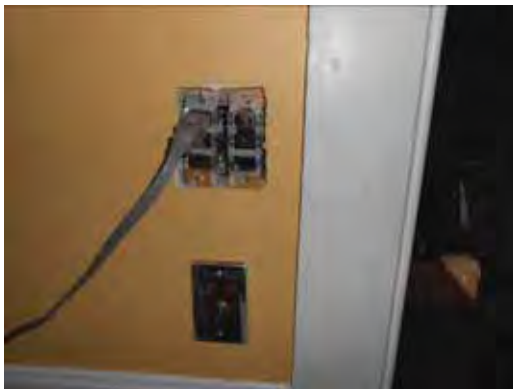
Kitchen Non-Grounding Outlets

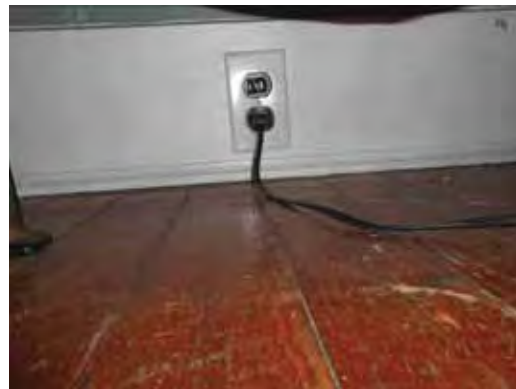
General Non-Grounding Outlet

Bathrooms have GFI type outlets. Most outlets throughout the building are non-grounding and in poor condition. Exterior outlets are not the GFI type.

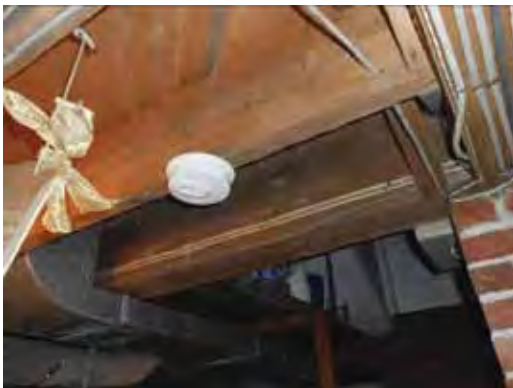
Combo Detector in Basement

Fire alarm devices includes a combination smoke and carbon monoxide detector in the basement. The hallway also has a combination smoke and carbon monoxide detector on both the first floor an second floor.

Fire alarm devices should be replaced with new hard-wired type with battery back-up. Carbon monoxide detectors should be provided in the basement and outside each bedroom.

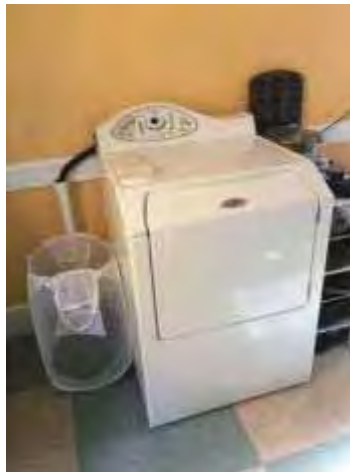
Washing machine is improperly connected to waste and water systems and does not meet current plumbing code.

Washing Machine Connection

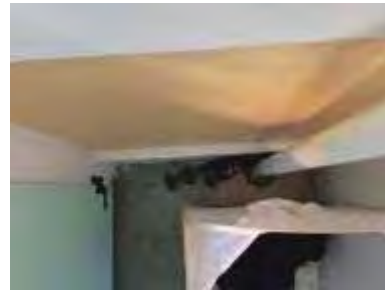
Washing Machine Discharge

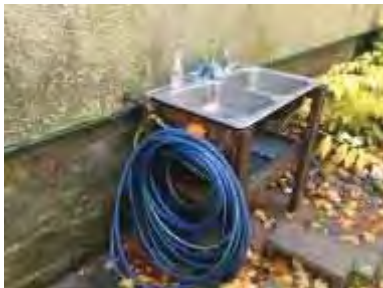
Service sink mounted on exterior face of building is improperly connected and does not meet current plumbing code. Only cold water is supplied to sink. Sink is not covered and is open to the elements.

Exterior Service Sink

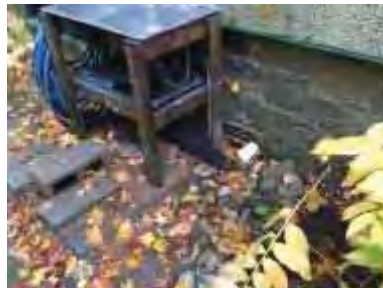
Service Sink Waste Connection

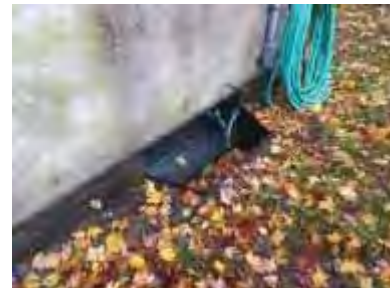
Exterior Hose Bibb

- All plumbing fixtures are in need of replacement, all new fixtures will be water conserving types.
- Plumbing fixtures to be installed per current plumbing code & ADA requirements.
- Provide new pipe hangers and insulation on any piping to remain. All new valves are to be provided on any existing water piping to remain.
- Replace existing electric water heater with new High-Efficiency Electric type Hot Water Heater.
- Provide new exterior wall hydrants with integral vacuum breakers.

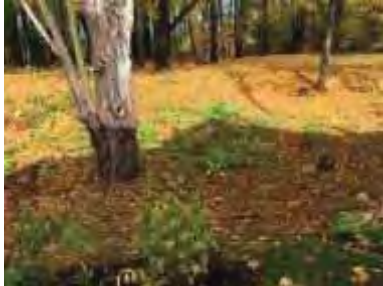
Exterior Septic System

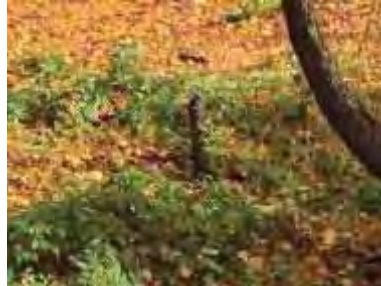
Septic System Vent

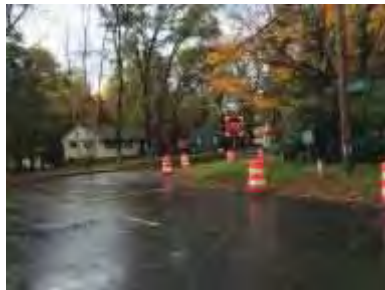
Fire Hydrant

There is a fire hydrant located at the corner of Pine Hill Road & Spring Lane. Hydrant flow test is required to determine the Municipal water supply capacity.
