WHEELLOCK SCHOOL

Location: 17 Elm Street

Year Built: 1968

PHOTOGRAPHIC DOCUMENTATION of RALPH WHEELLOCK SCHOOL, MEDFIELD, MA

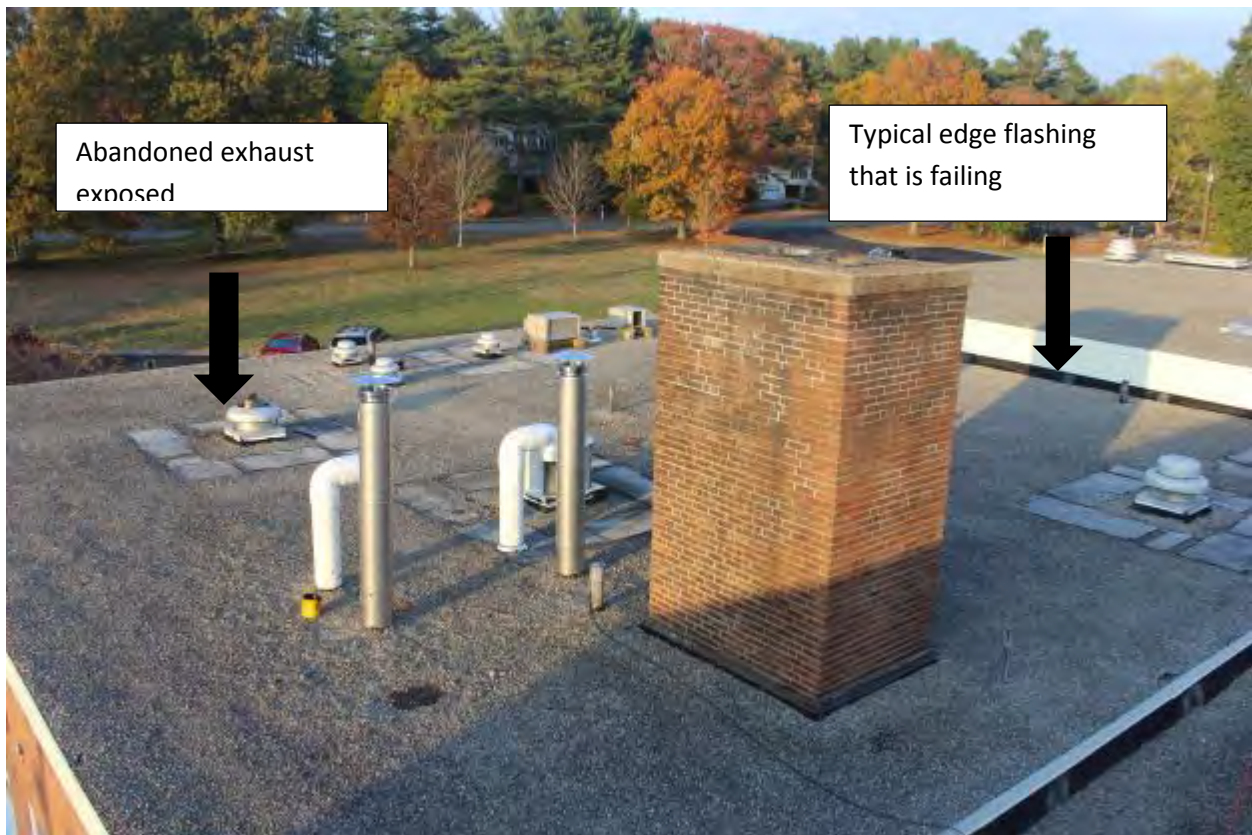
BUR roof Thinning stone ballast, walk pad failing, curb flashing is separating from vertical rise.

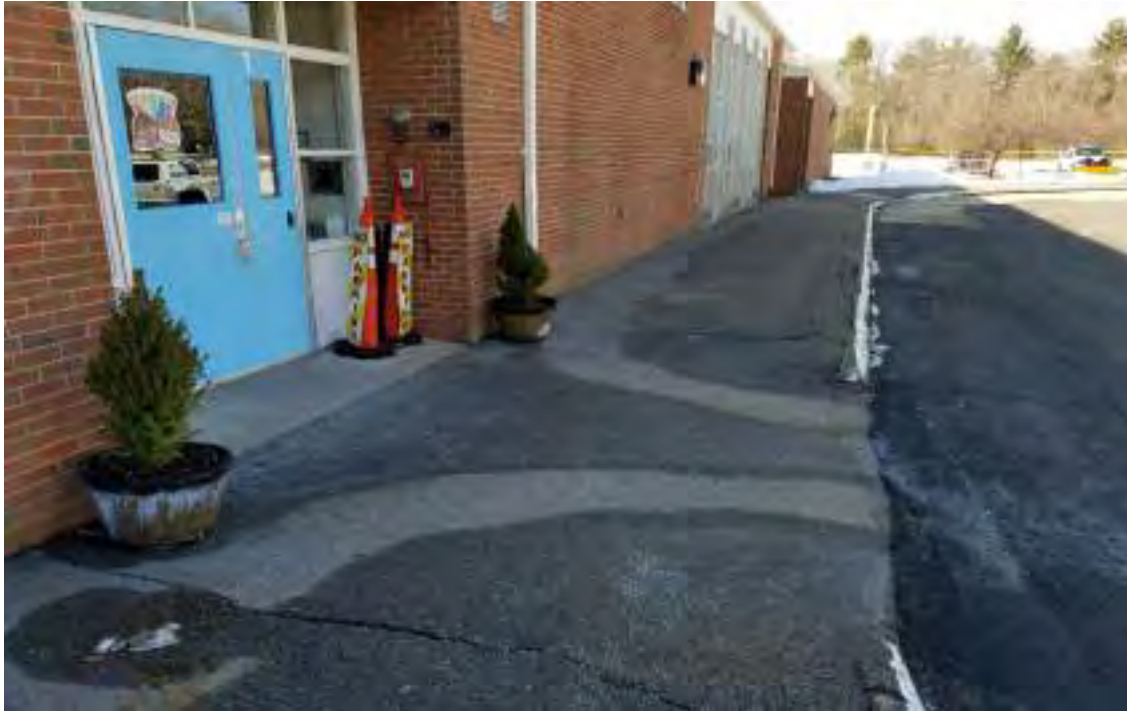
Main Entrance with no 5' level landing and non-compliant slopes. Continuation of egress path into driveway should have cross walk markings

Areas with sloped paving right up to exterior doors should be replaced with a minimum of a 5' x 5' concrete landing meeting MAAB regulations of 2% max slope. \$20,000

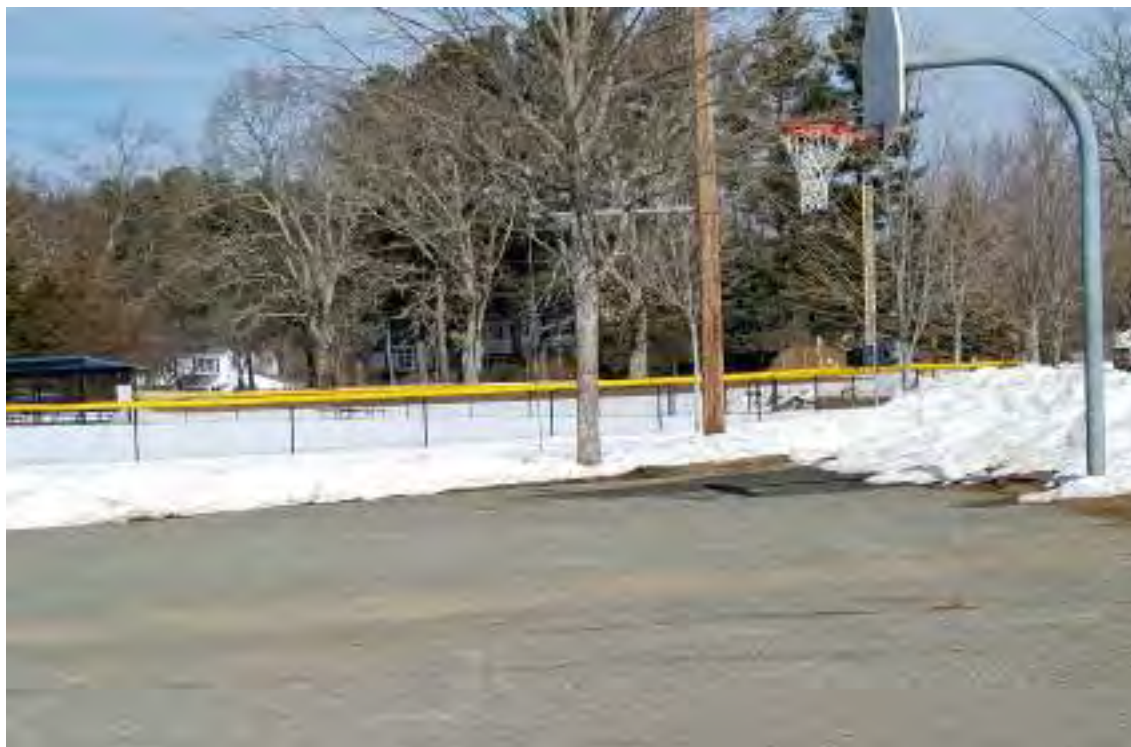
Showing excessive slope in basketball play area

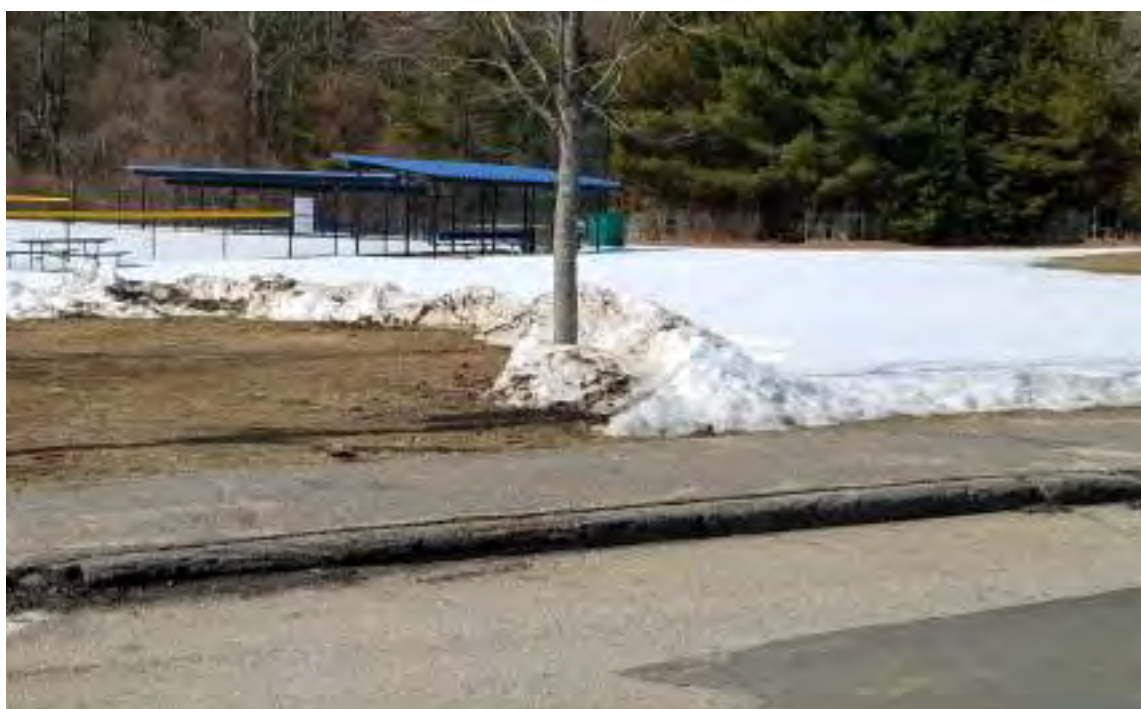
Showing lack of accessible route to ballfield from parking and lawn area used for parking

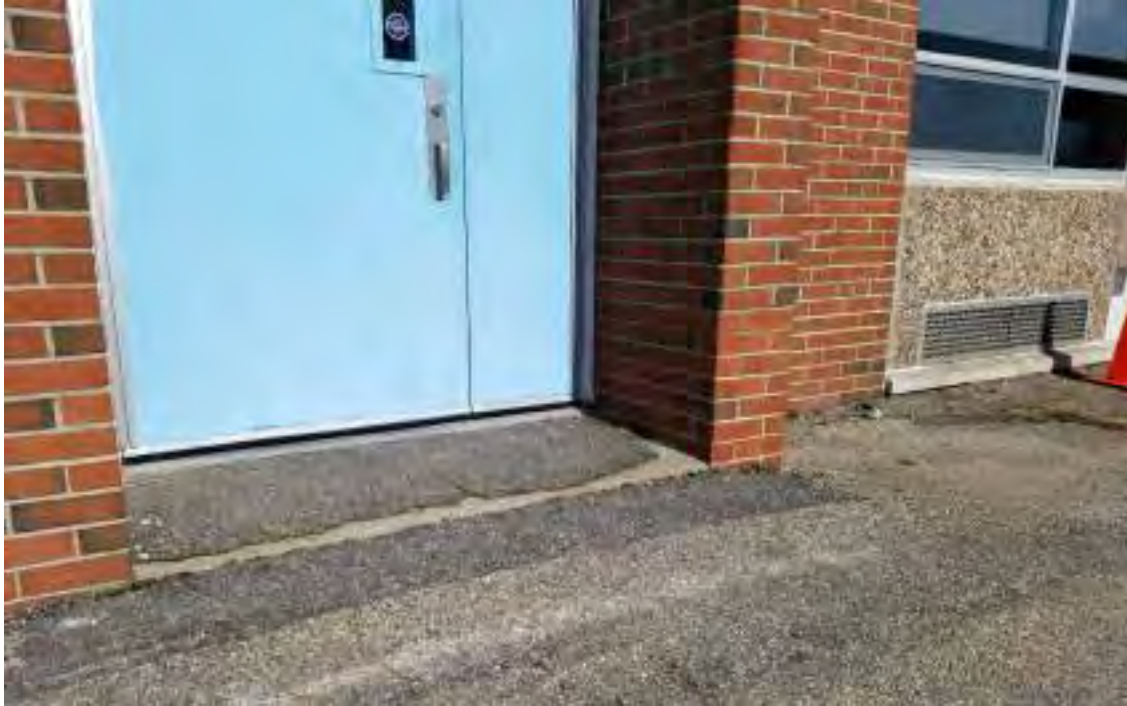
Another example of no 5' level landing at egress doors, currently poorly patched with bituminous

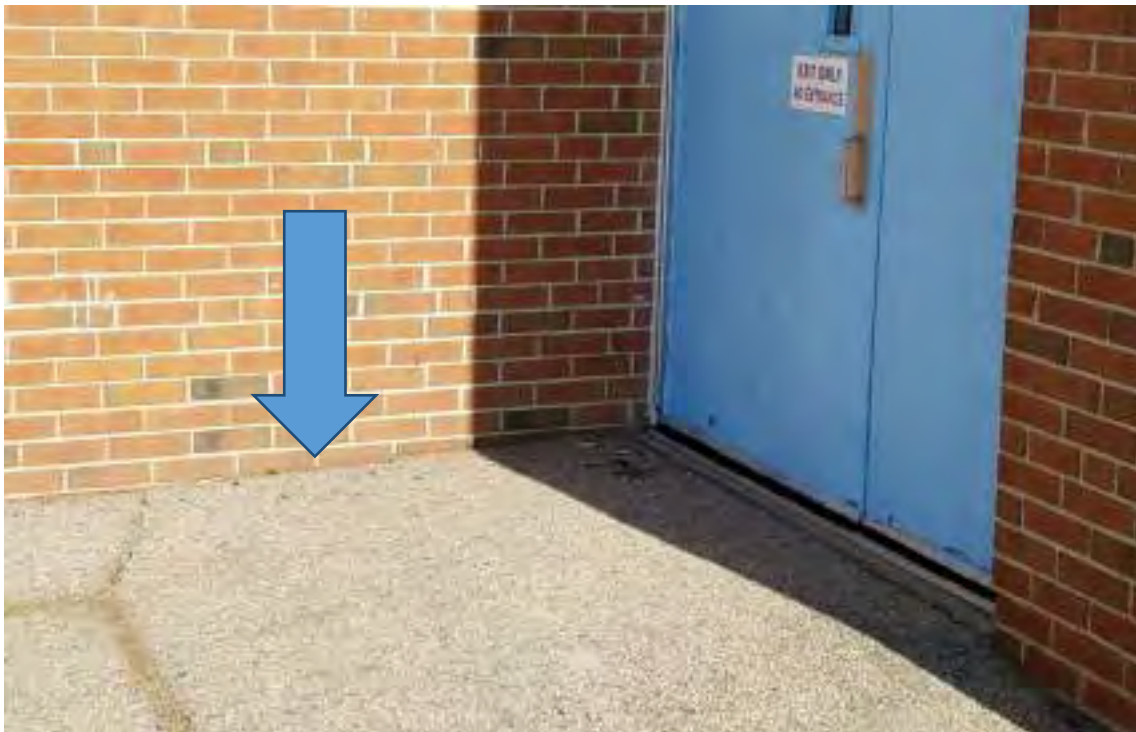
Another example of no 5' level landing at egress door

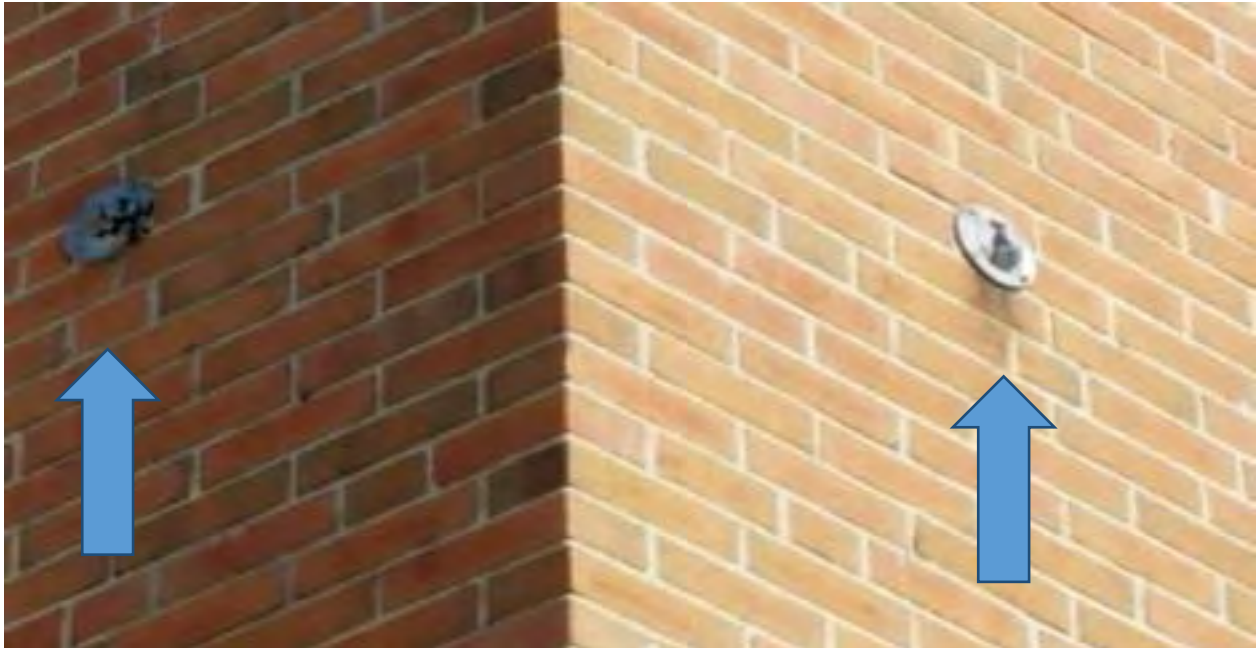
Example of abandoned exterior fixtures that should be capped or removed and infilled with brick

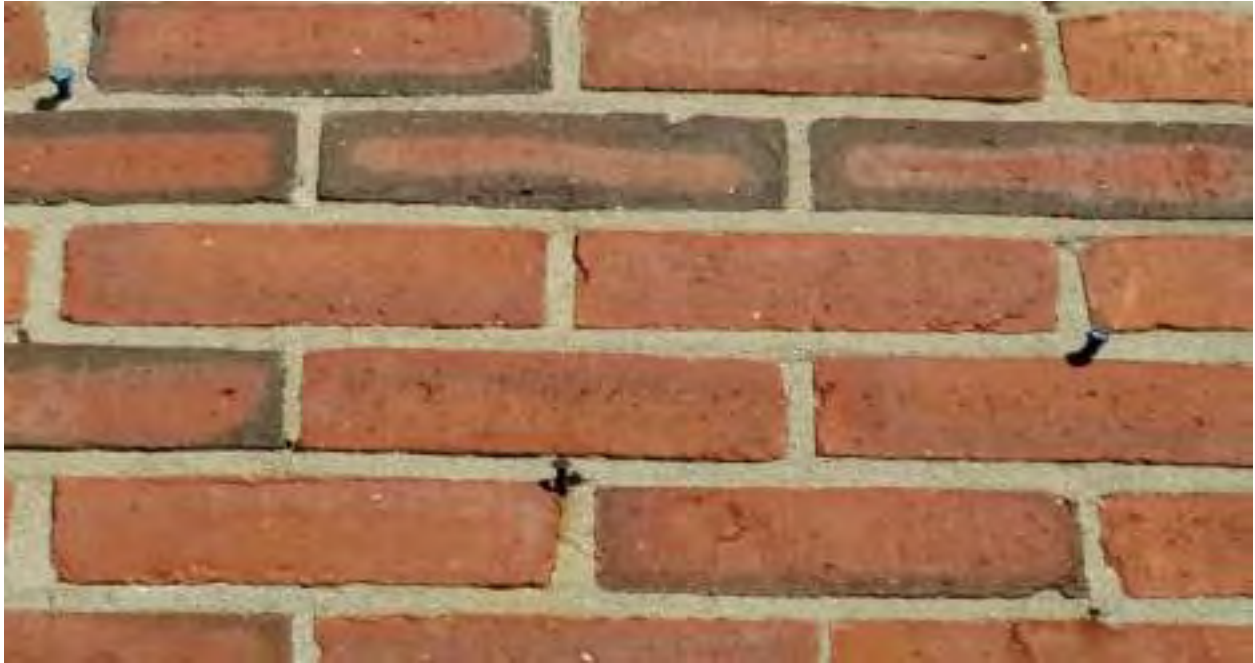
Example of old fasteners that should be removed and patched with mortar or caulking

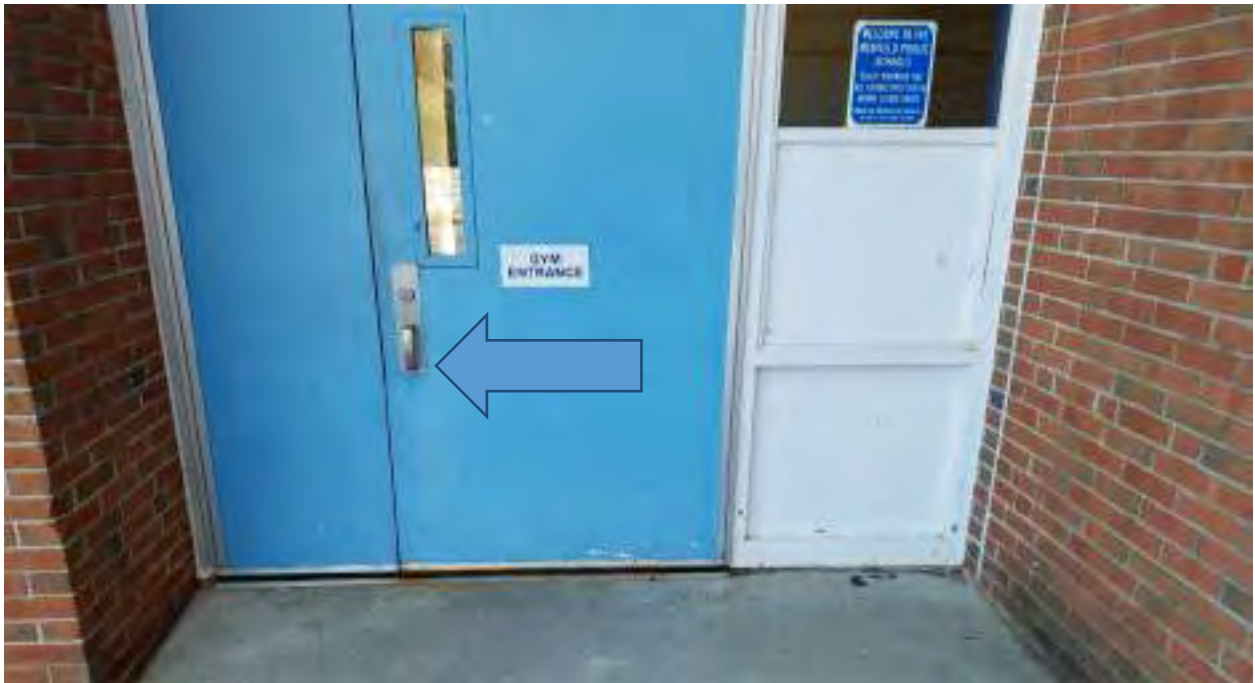
Another example of accessible entrance needing compliant latching hardware

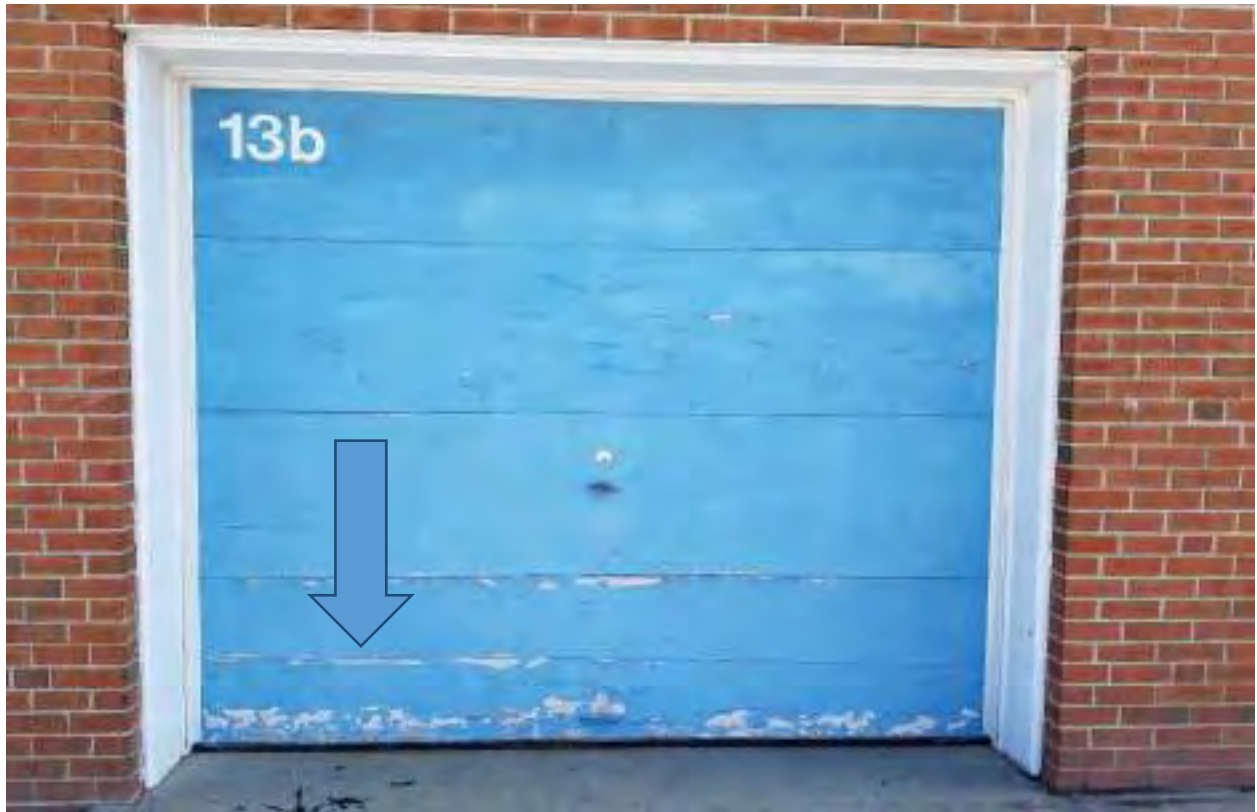
Showing delaminated veneer on garage doors

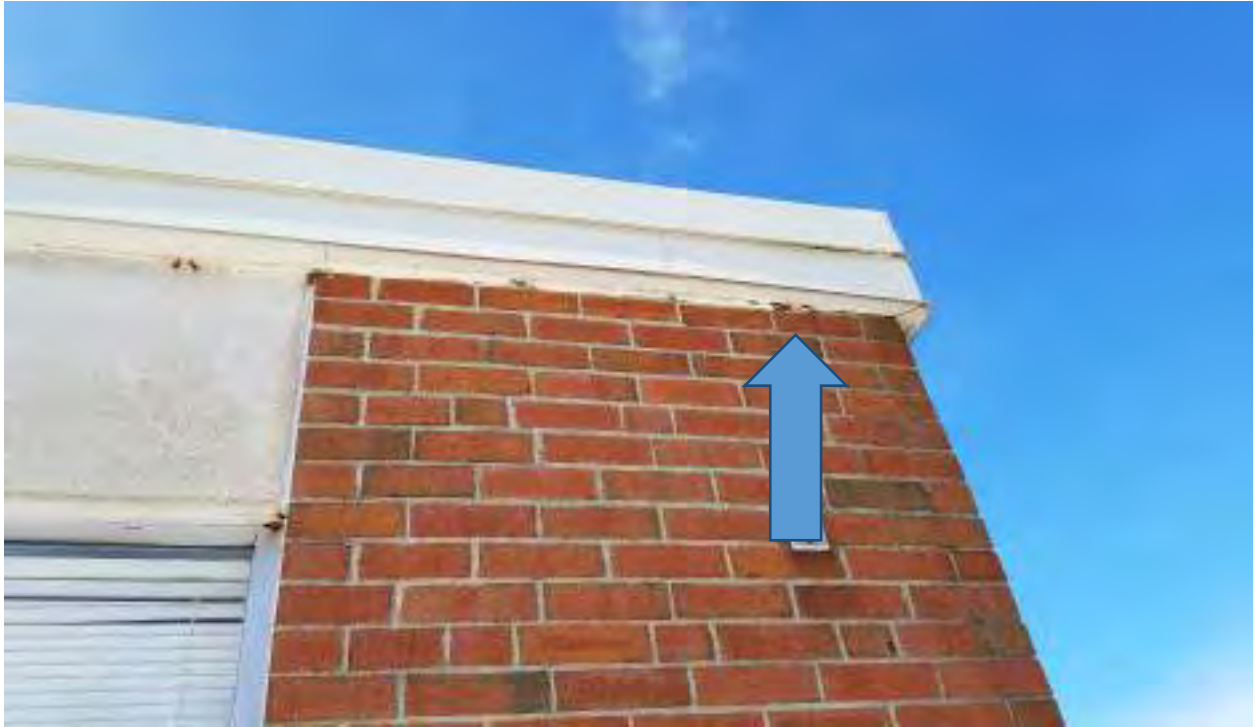
Typical horizontal joint needing to be resealed

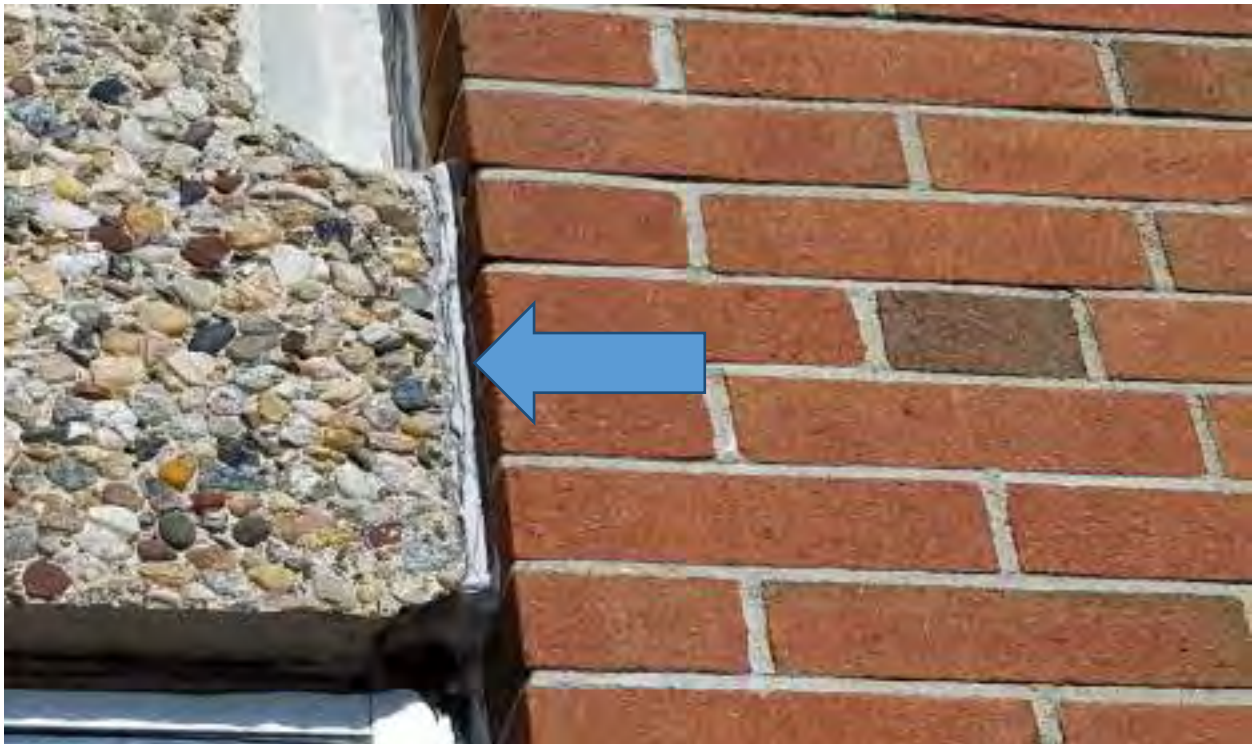
Typical joint between precast and brick needing to be re-sealed

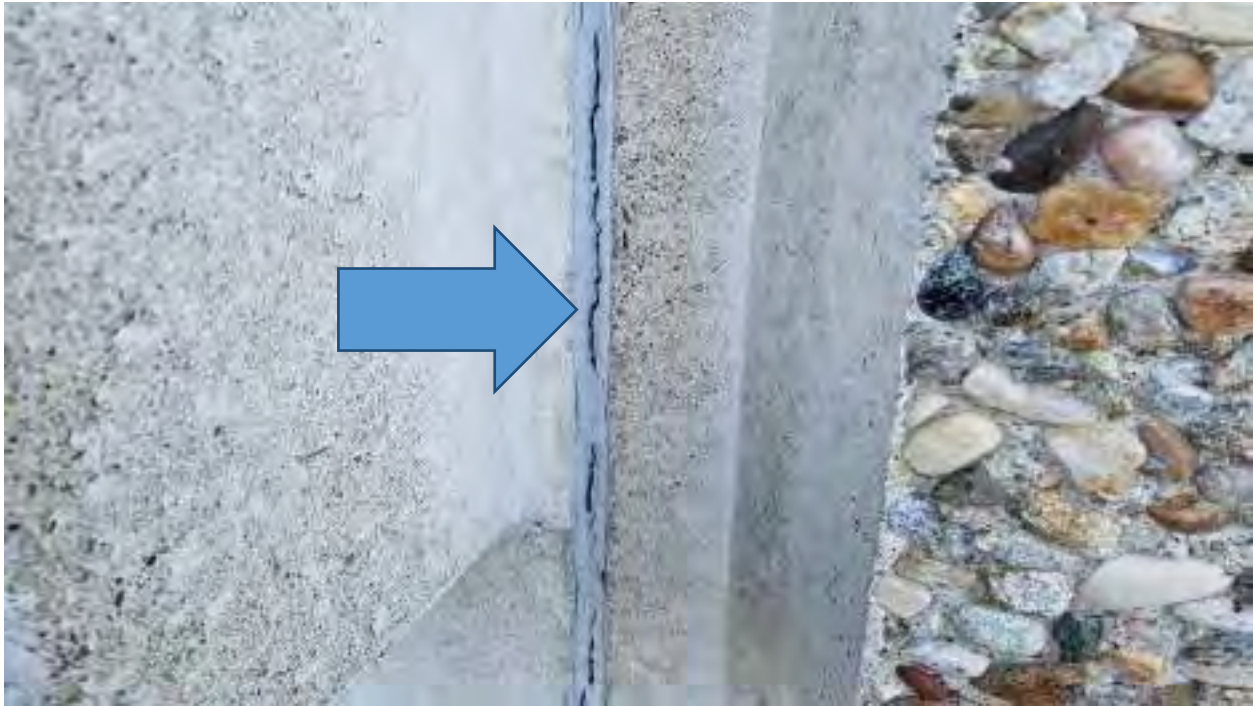
Typical joint between precast members needing to be resealed

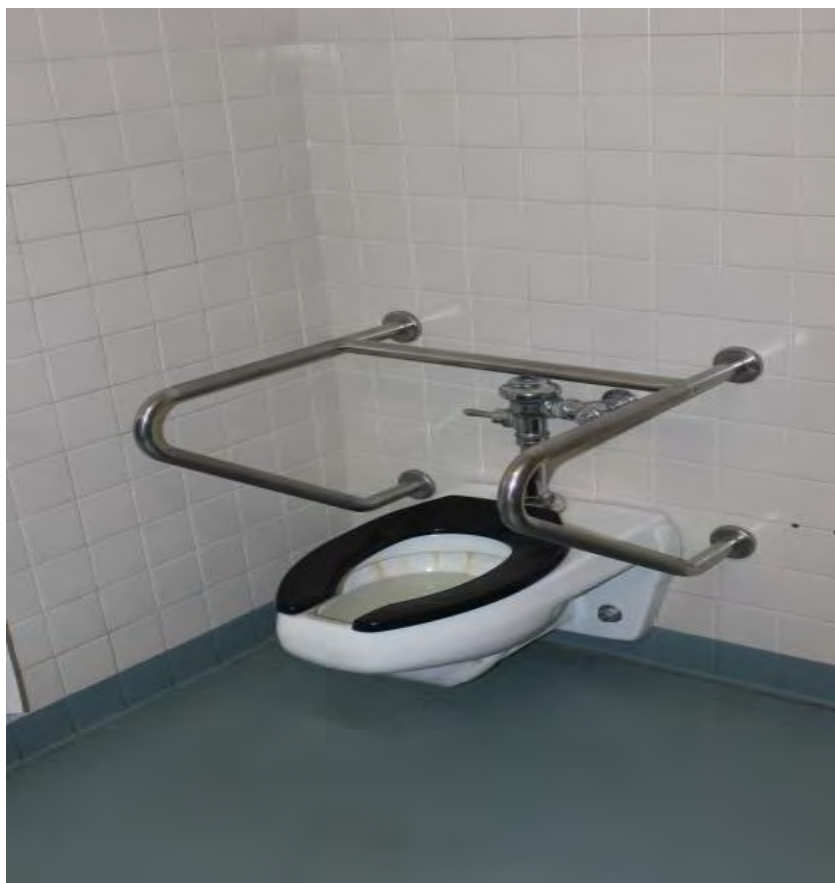
Gang bathroom retrofit for ADA compliance. Removed an adjoining toilet and installed handrail bars

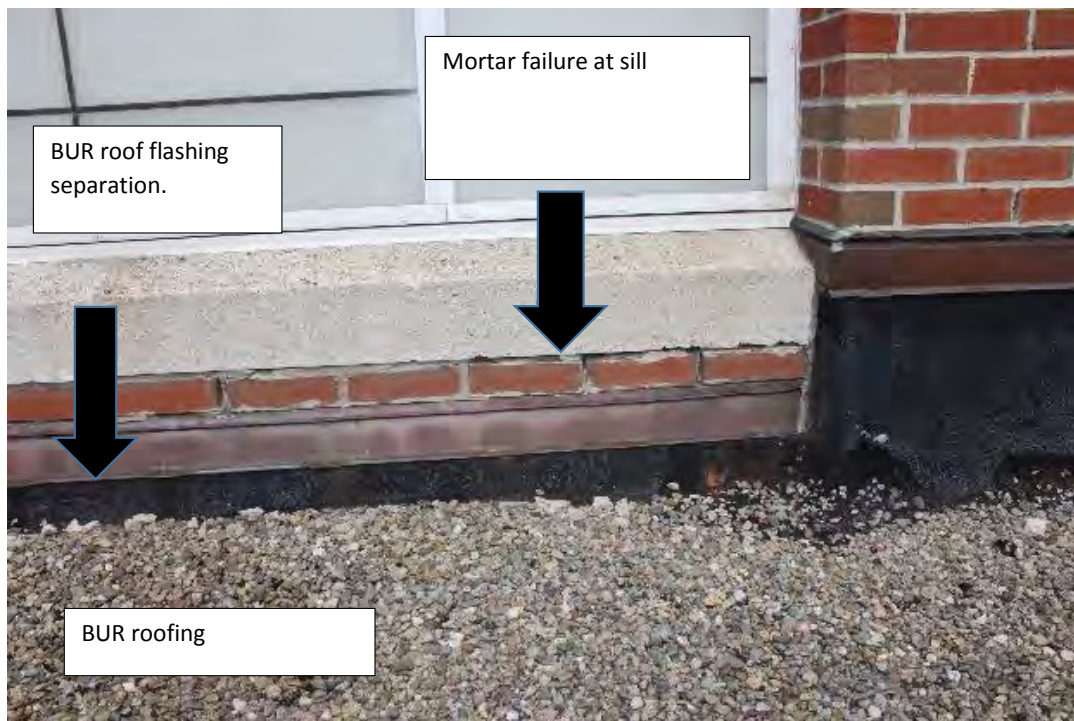
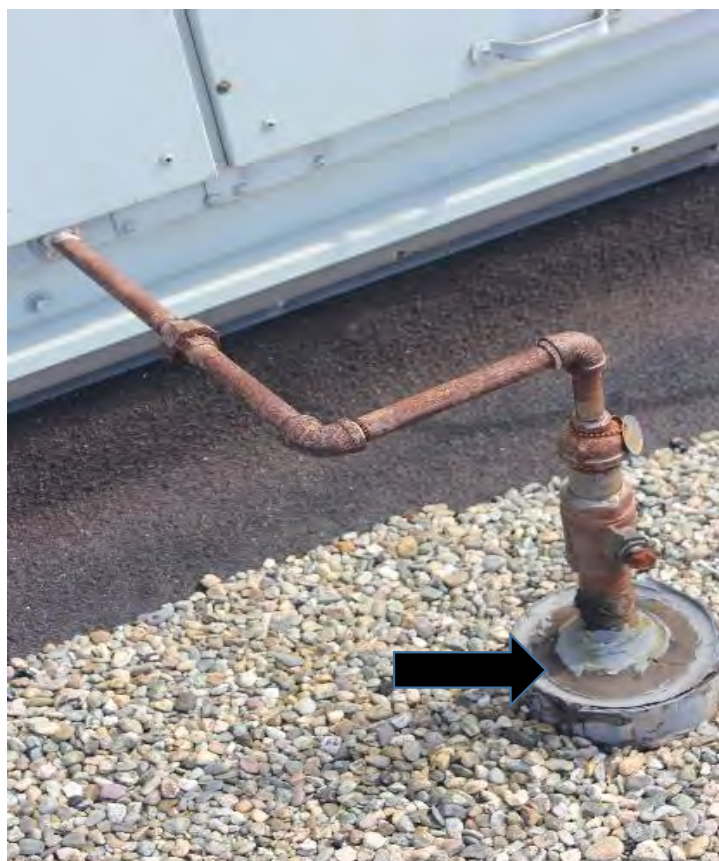
BUR flashing at HVAC and poor pitch pocket

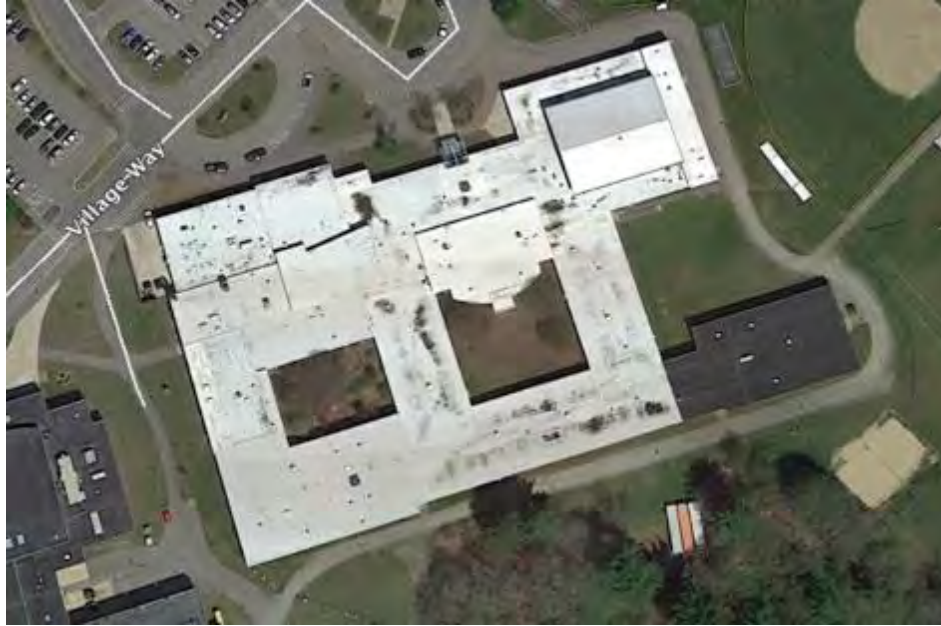
Photo 1

Aerial view of the Blake Middle School.

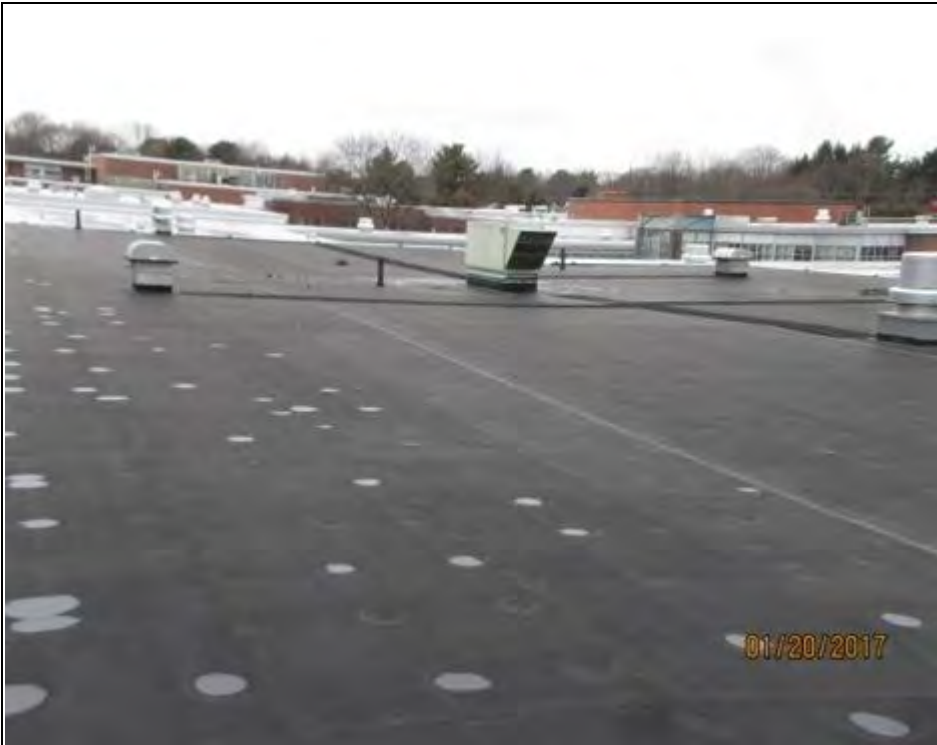
Photo 3

EPDM roof area.

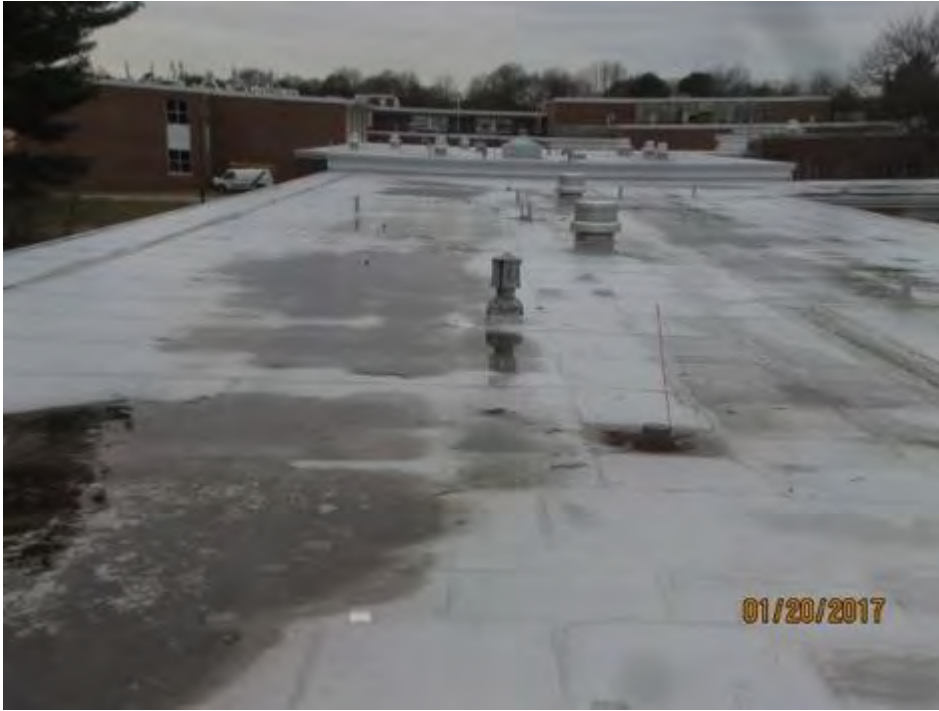
Photo 5

The condition of the PVC roofs is poor to failed. Despite the use of tapered insulation and extended drain sumps, ponded water is evident on most areas except the sloped gymnasium roof. The PVC membrane is brittle and is cracked at many areas including joints in perimeter edge metal assemblies, at corners of curbs and at ridges at insulation joints. Underlying wet rigid board roof insulation is expected to exist in many locations. There are numerous repairs evident. There is debris that is clogging roof drain strainers and collecting in corners.

PVC roof with tapered insulation still ponds water.

This roof is near the end of its service life. Complete removal and replacement within 1 year is recommended.

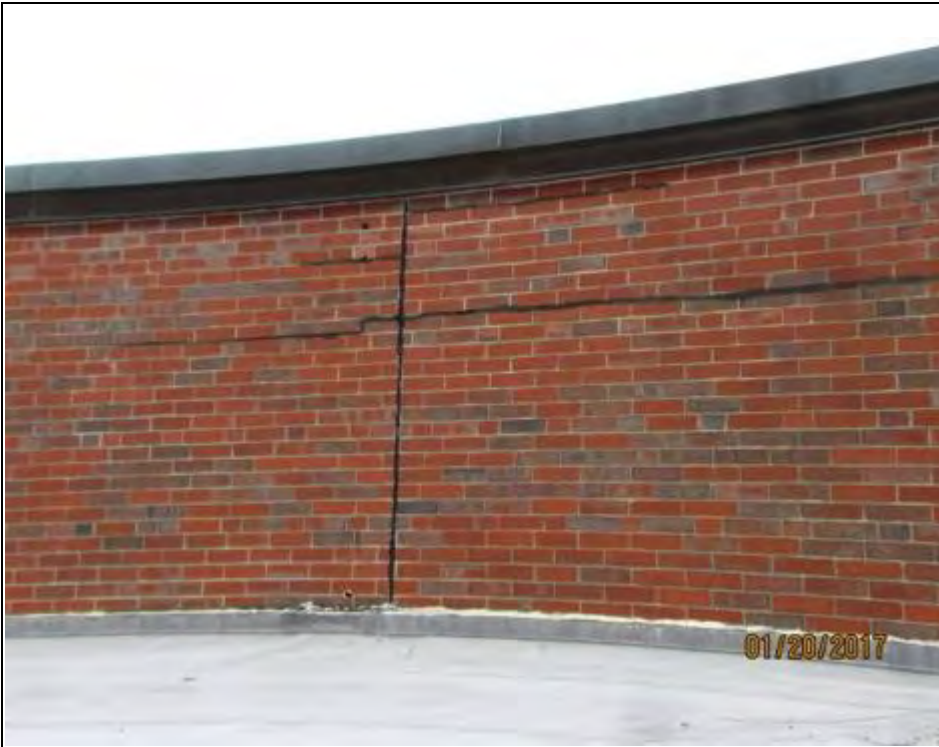
Photo 7

There are current leaks. Leaks are reported to occur adjacent to the original Auditorium. The south Auditorium brick masonry wall is extensively cracked and has failed sealant and mortar joints. The roof below this wall is tied to the wall using a reglet counterflashing detail that cannot intercept any moisture traveling within the masonry wall (not a throughwall flashing). Sealant applied to the reglet flashing is failed. This wall should be covered 100%

South wall of the Auditorium is deteriorated allowing water to bypass the reglet counterflashing below.

with a watertight covering (sheet metal cladding or roof membrane) tied into the roof below. Leaks are also reported to occur along the west Auditorium wall and we believe the sources of these leaks are the low wall flashing heights and deteriorated smoke release vents located within the brick masonry wall. The south gutter serving the sloped gymnasium roof is leaking in several locations and we believe the cause of these leaks is failed seams.

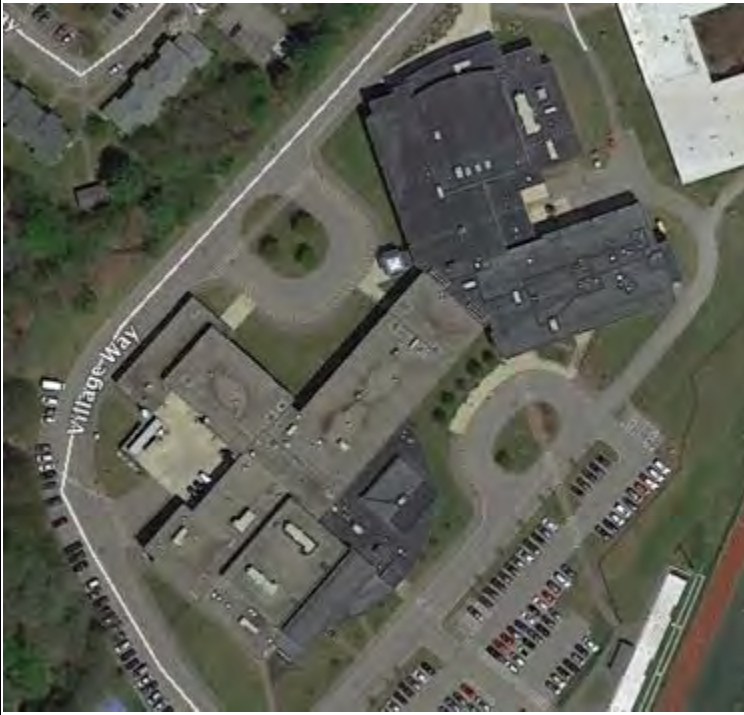
Photo 9

Aerial view.

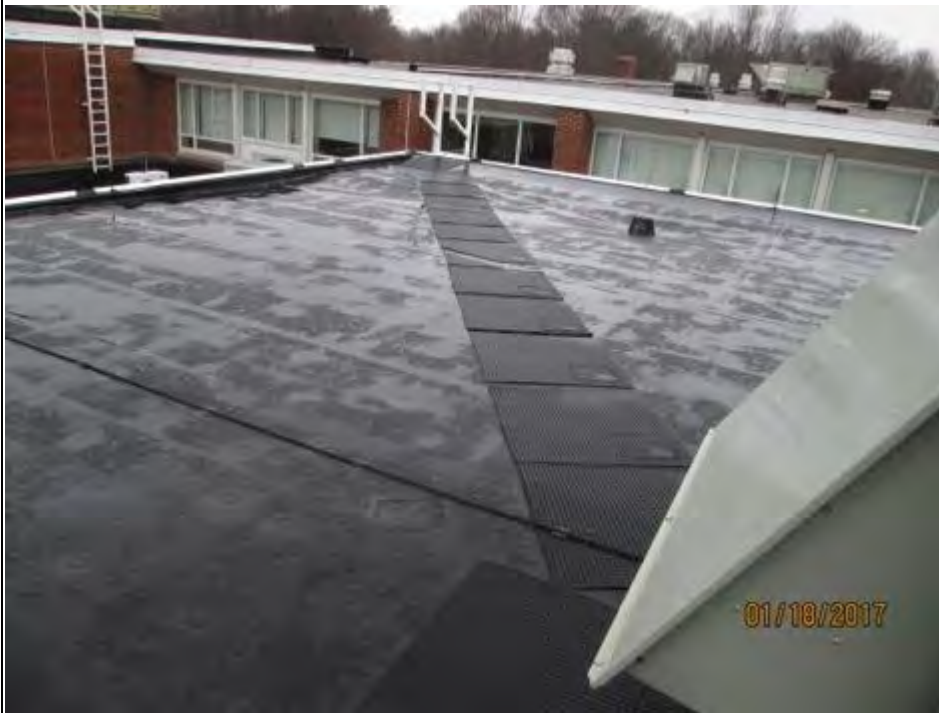
Photo 11

General view of a typical EPDM roof.

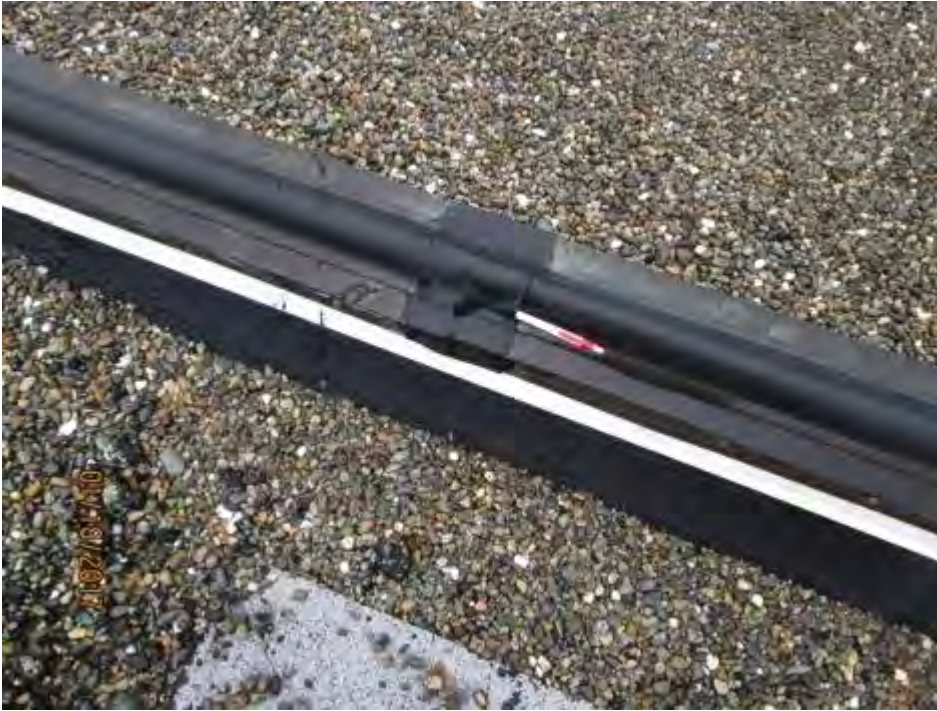
Photo 13

Seams in the expansion joints are failing.

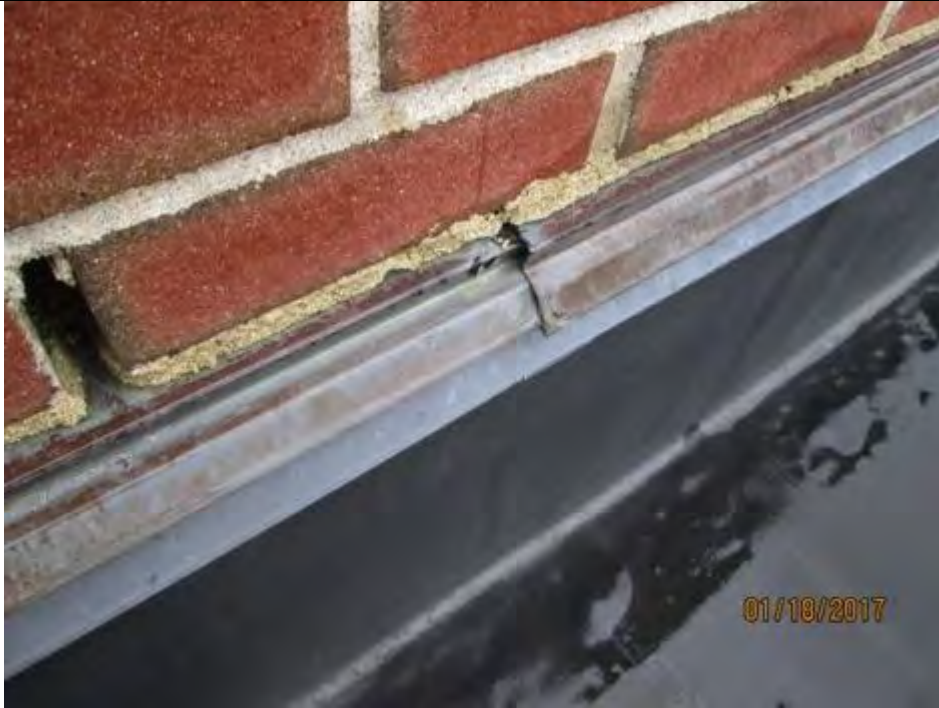
Photo 15

Throughwall flashing in the curved wall above the auditorium do not appear to be sealed.

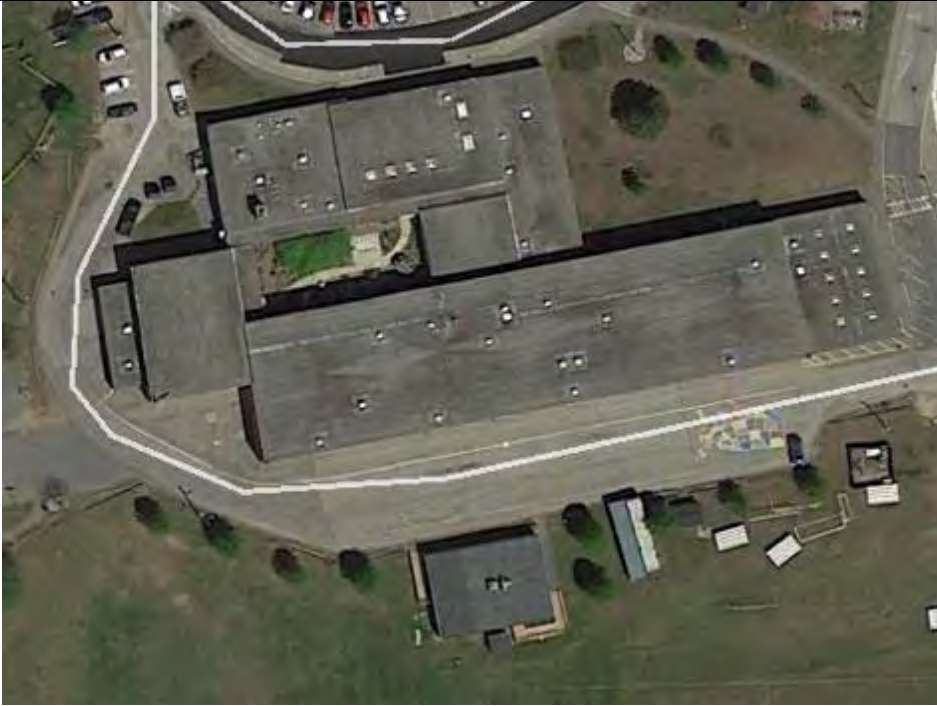
Photo 17

Aerial view.

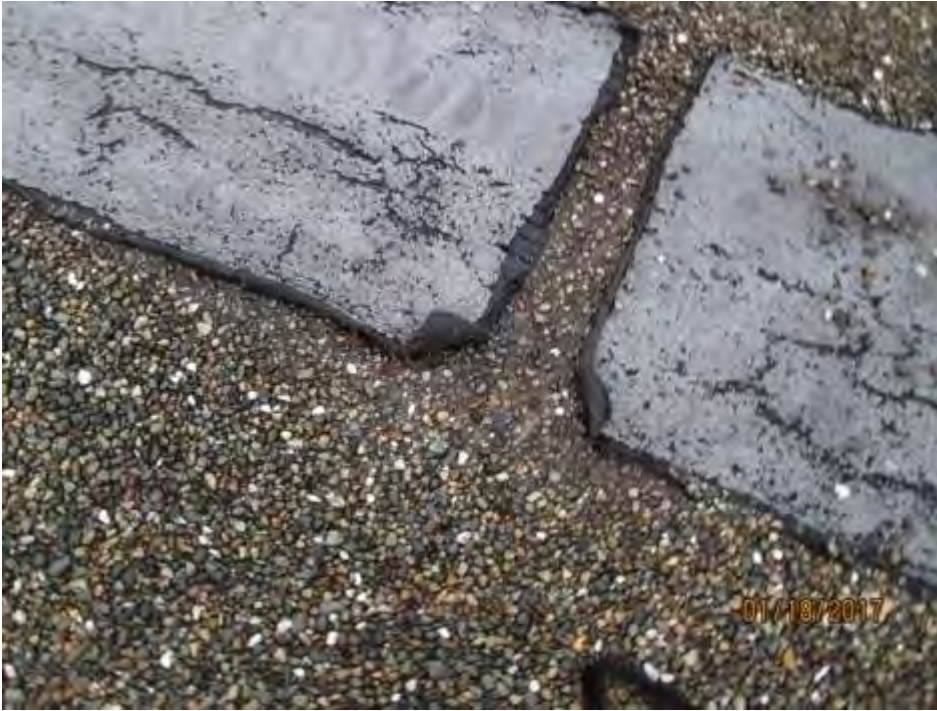
Photo 19

Curling walkway pads.

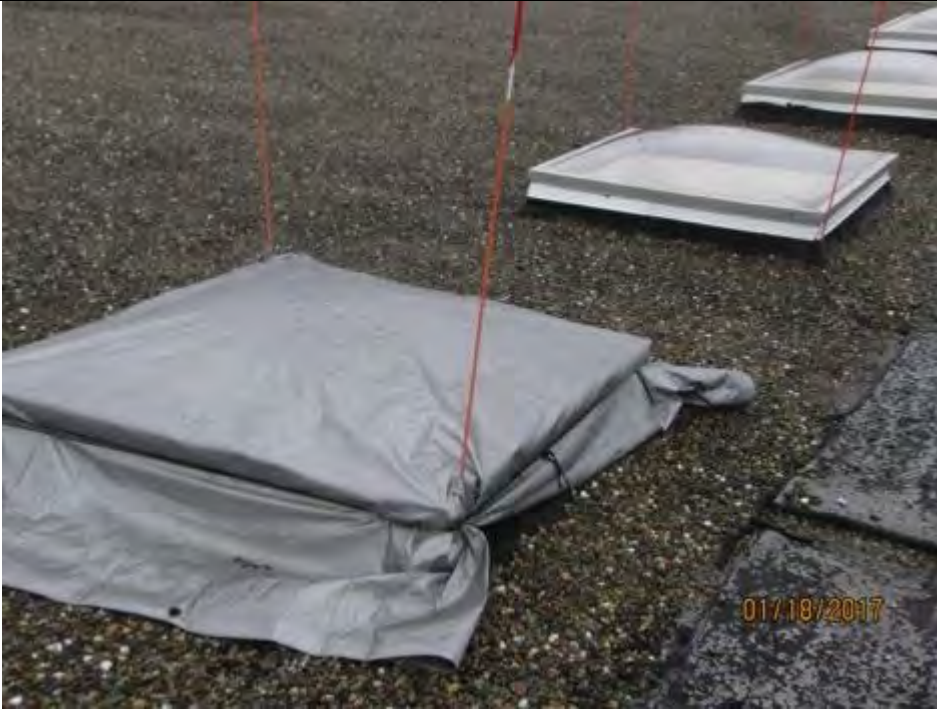
Photo 23

Damaged/
deteriorated
skylight domes.

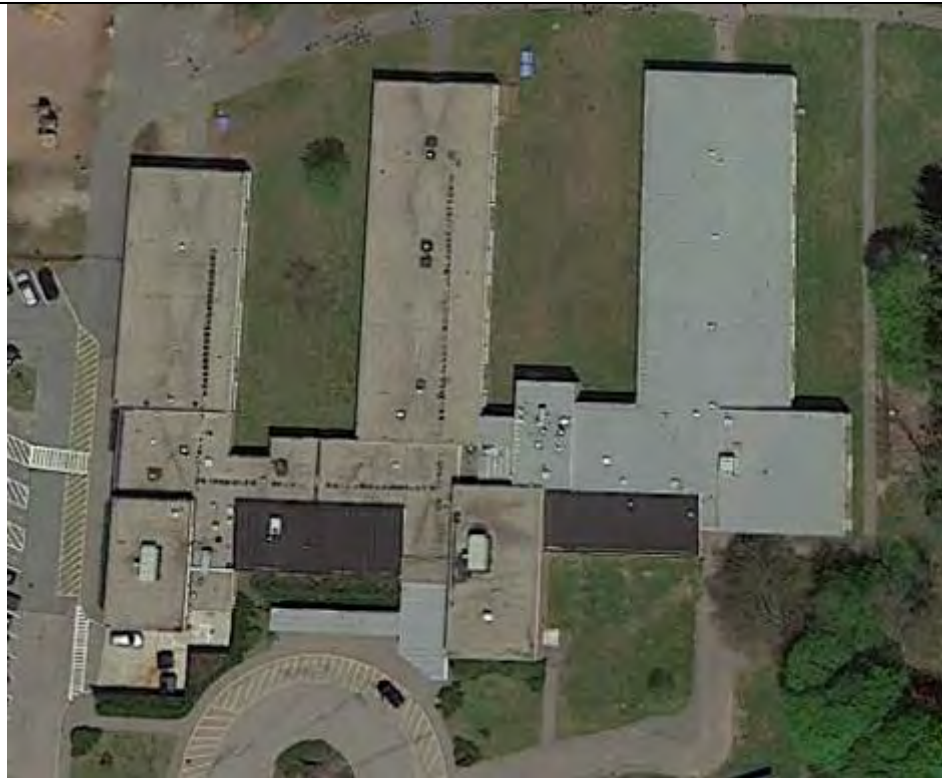
Photo 25

Aerial view.

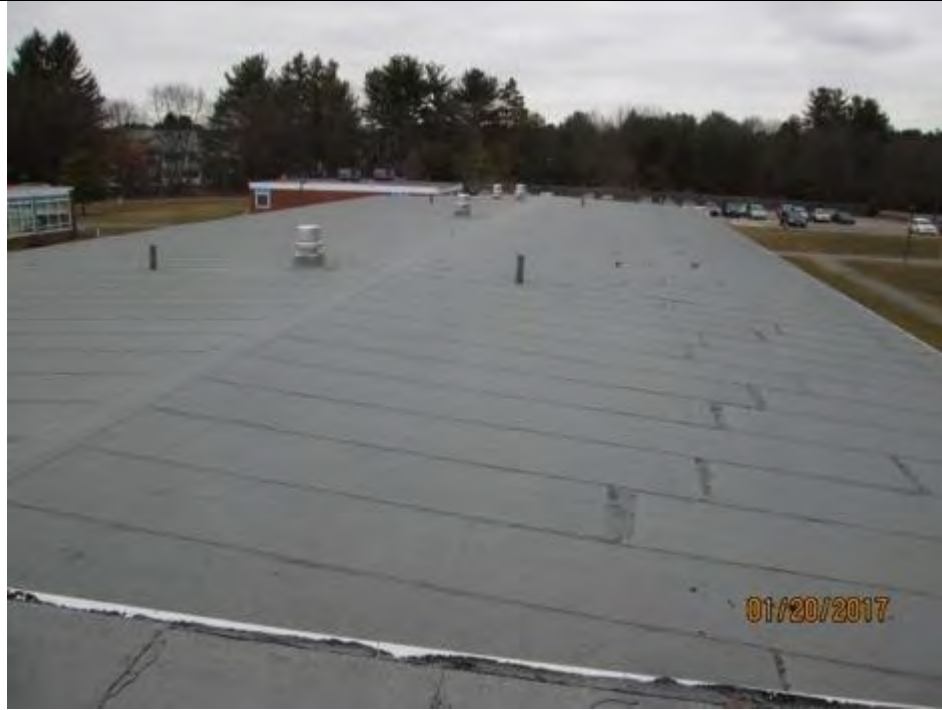
Photo 27

Typical newer
Mod Bit roof
system.
