WHEELLOCK SCHOOL

Location: 17 Elm Street

Year Built: 1968

PHOTOGRAPHIC DOCUMENTATION of RALPH WHEELLOCK SCHOOL, MEDFIELD, MA

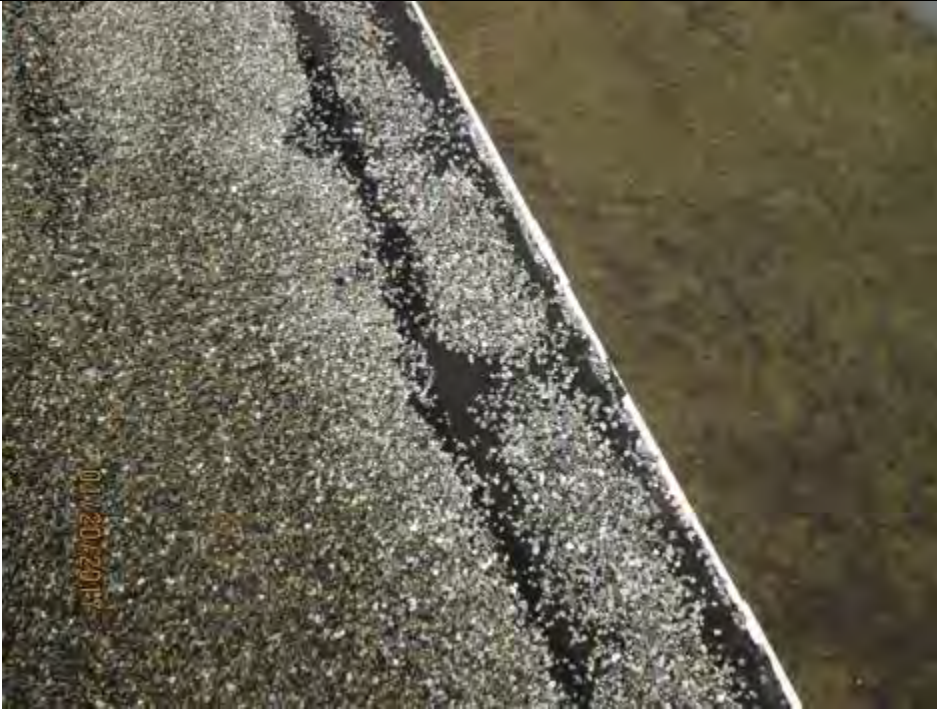
Photo 31

BUR flashing
edges are worn.

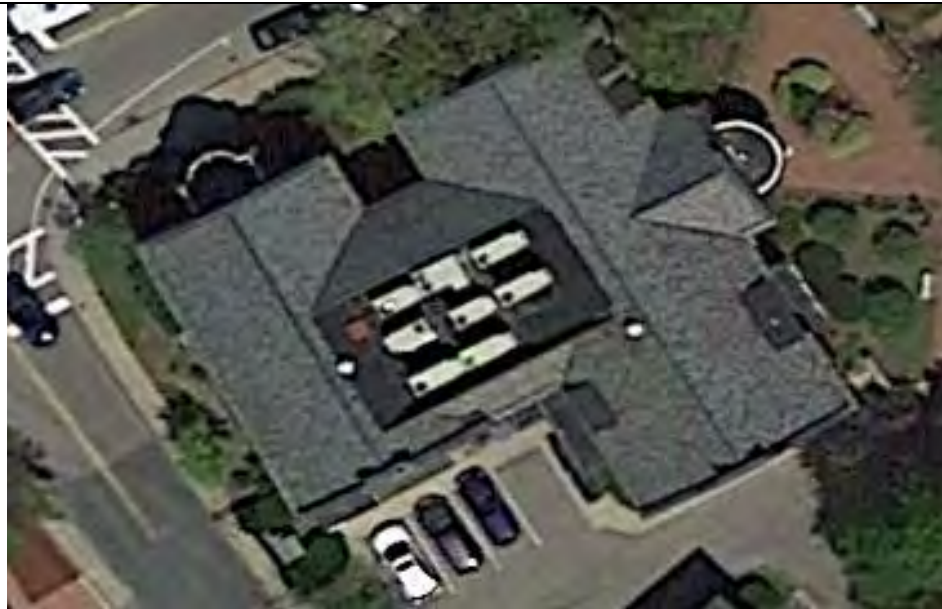
Photo 33

Aerial view.

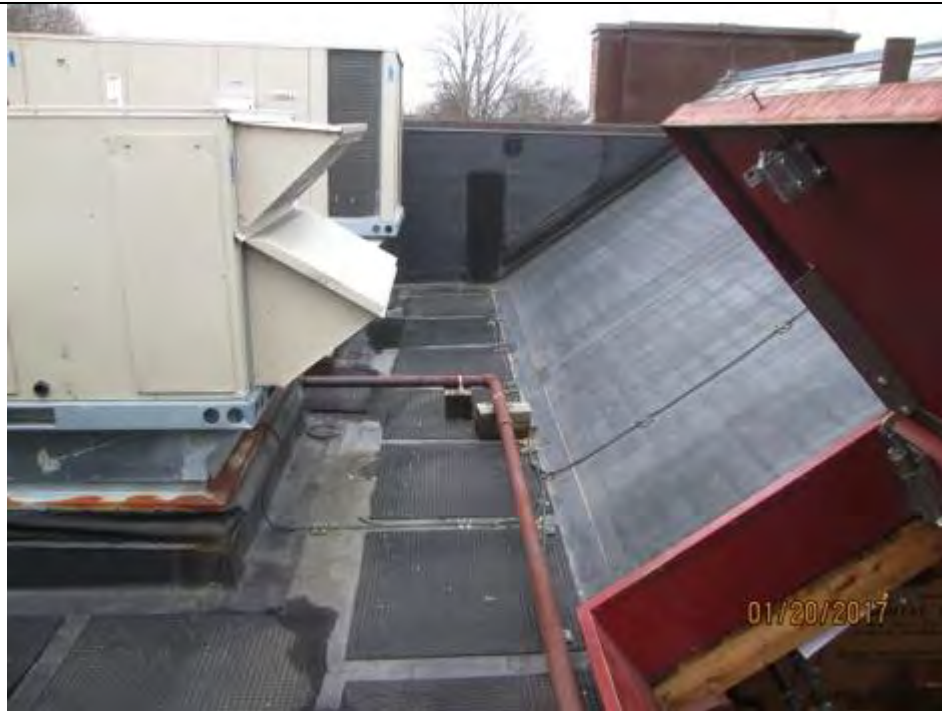
Photo 35

Typical view of center EPDM roof system.

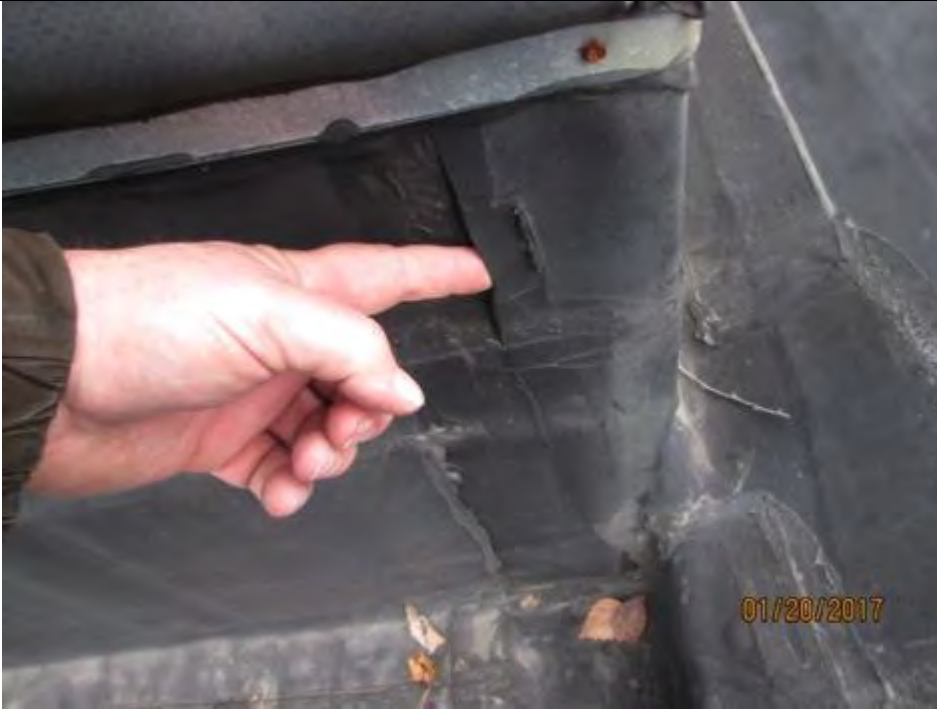
Photo 37

Failing EPDM
seam.

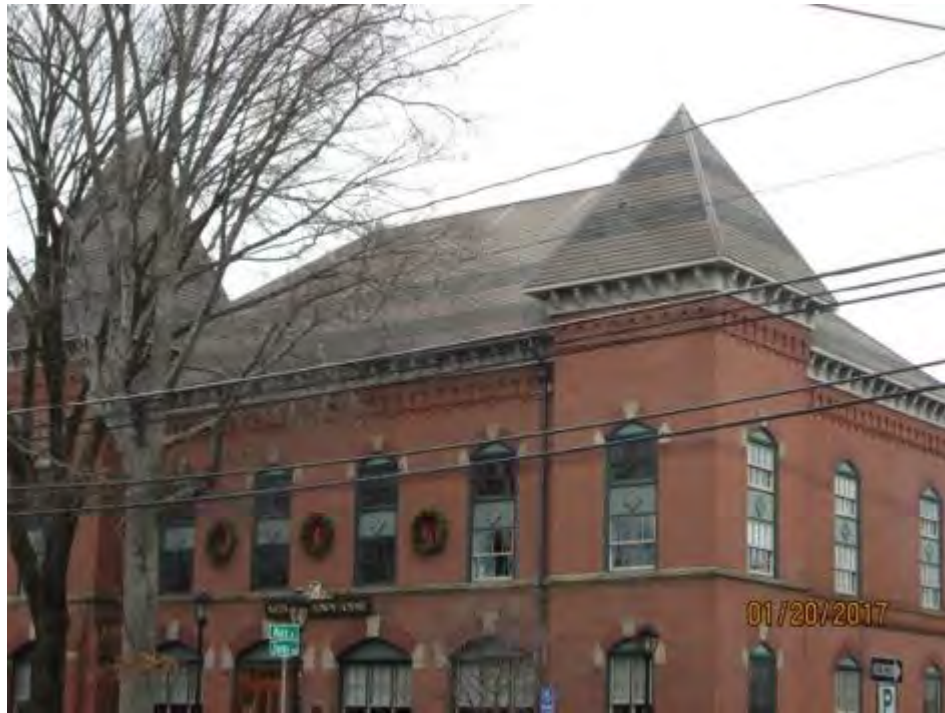
Photo 40

Typical view –
dark spots on roof
are missing
shingle tabs.

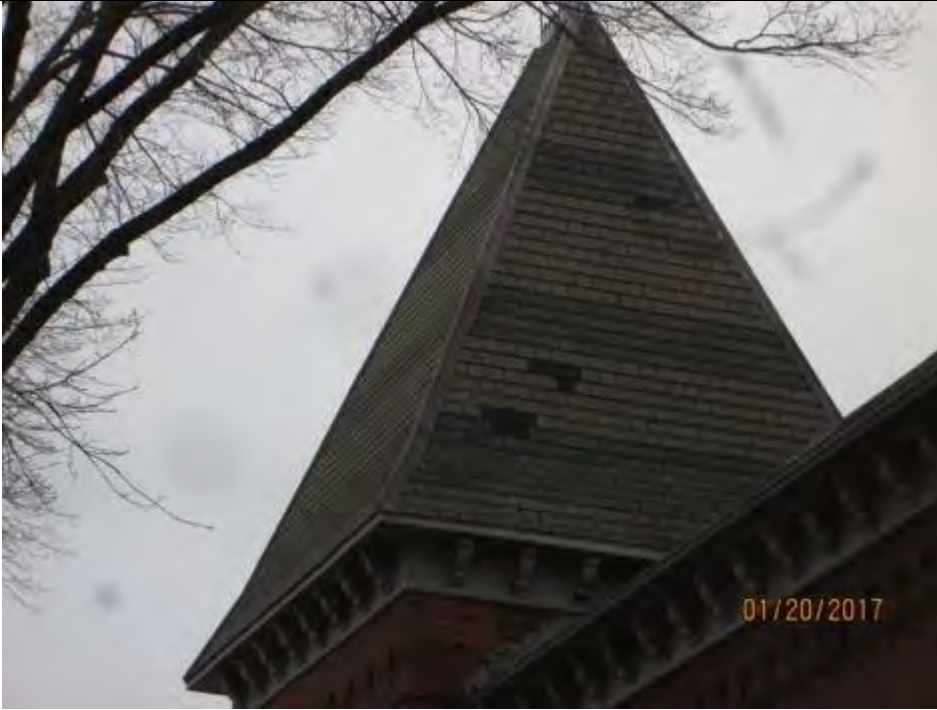
Photo 41

Typical view – dark spots on roof are missing shingle tabs.

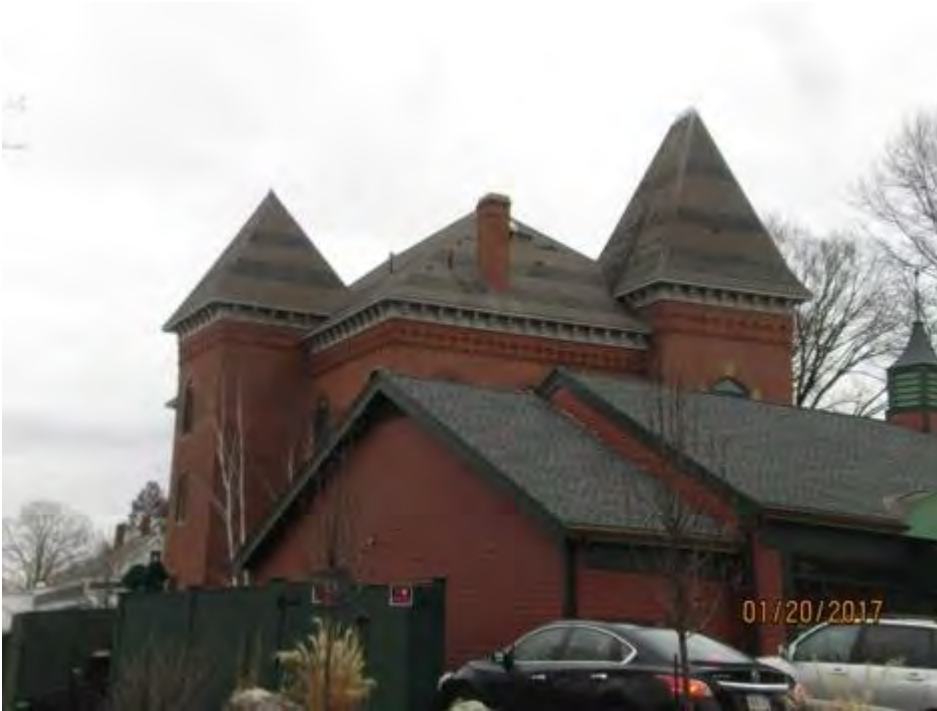
Photo 42

Typical view – dark spots on roof are missing shingle tabs.

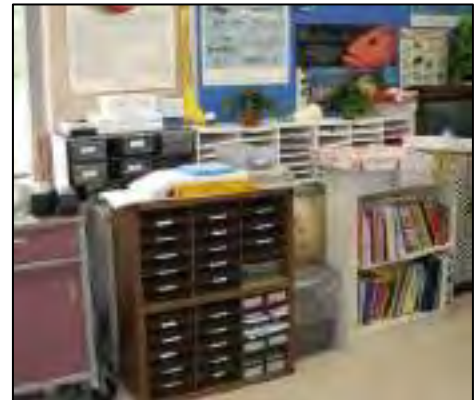
Heating and ventilation is provided to the space by unit ventilators. Supply air leaves the top of the cabinet, and return air enters through front of the cabinet near the floor. The unit ventilators will run more efficiently and more effectively if the air flow is unrestricted. During the site visit, multiple unit ventilators were observed with blocked airflow, including one classroom that has a child with allergies. A sample classroom is shown on the right, with the unit ventilator located behind and under bookshelves and storage units. Teachers should be educated on the importance of maintaining unrestricted air flow from the unit ventilators. The principal has reportedly sent an email encouraging teachers to remove papers from unit ventilators, but further action appears to be necessary. Energy consumption and cost savings from this recommendation are difficult to quantify, so specific values are not included in this report. There is no cost for implementation, so it is recommended regardless of the dollar value of the savings.

► **Action Steps:** *Work with maintenance staff and teachers to remove materials from unit ventilators.*

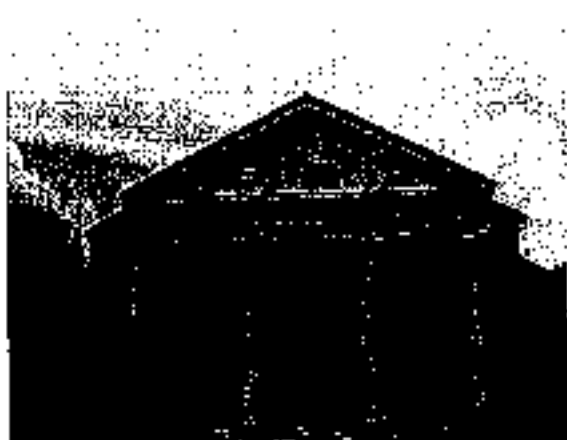
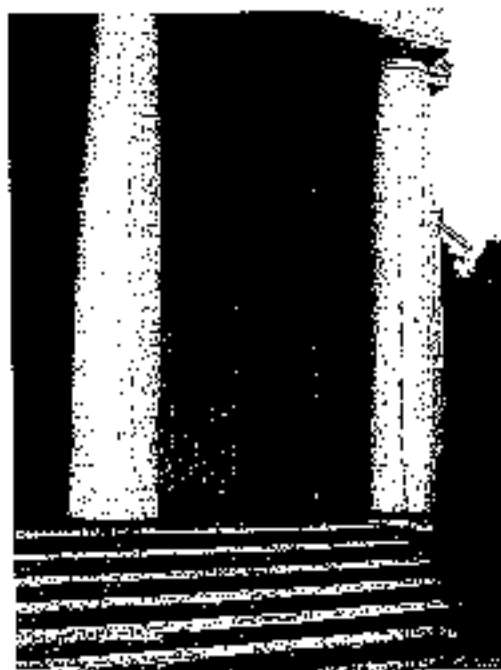
The exterior entrance to the Dale Street gym shows extensive deterioration. This is true of the fascia and soffits as well as the columns. Action is required to prevent further damage. That action is scheduled for this summer and work had started during the course of this report. A detailed inspection should be included as part of that remediation to determine the extent of restoration needed. It may be prudent to replace the original wood columns with fiberglass and reconstruct the fascias, freeze boards and soffits with newer more weather resistant materials.

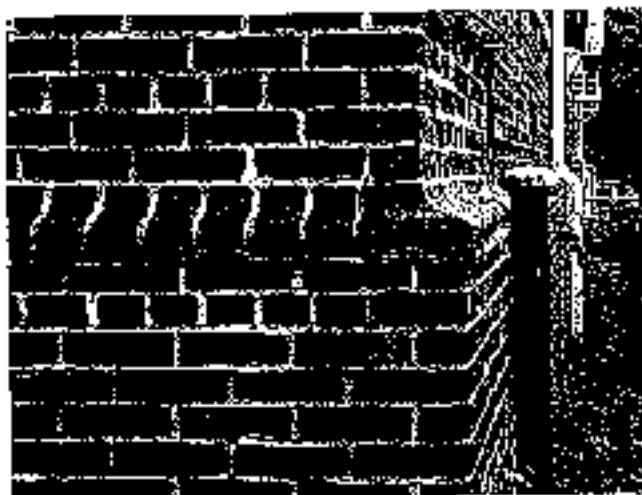
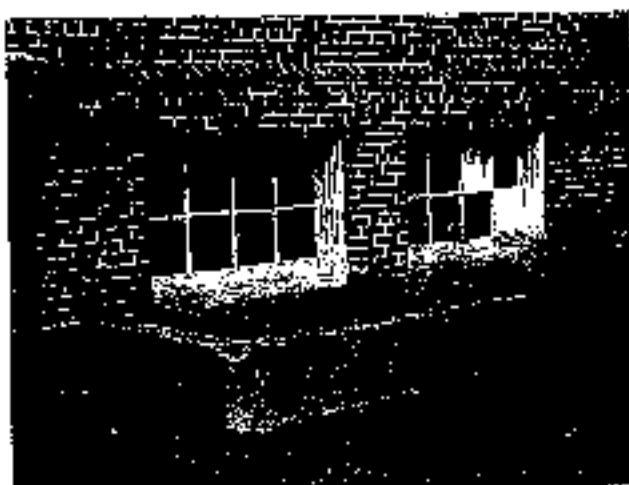
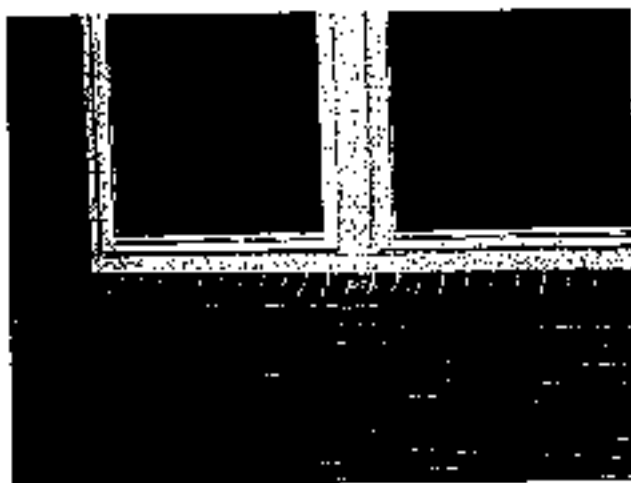
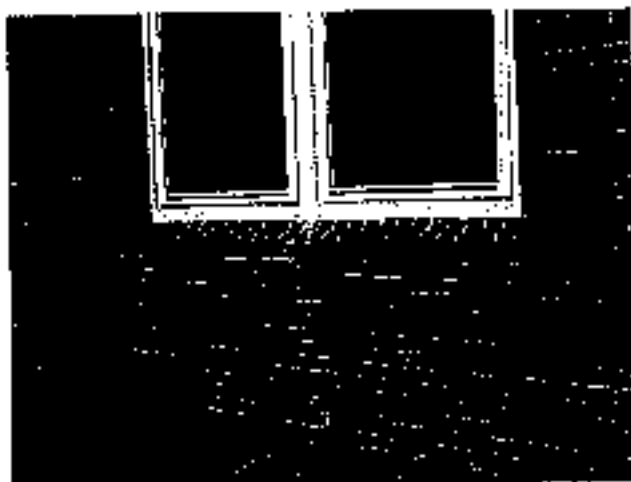
The exterior walls of three sections are brick veneer. The brick on the 1962 and 1996 buildings is in good condition. The brick work on the 1941 building is in good condition for its age however, there are signs of deterioration.

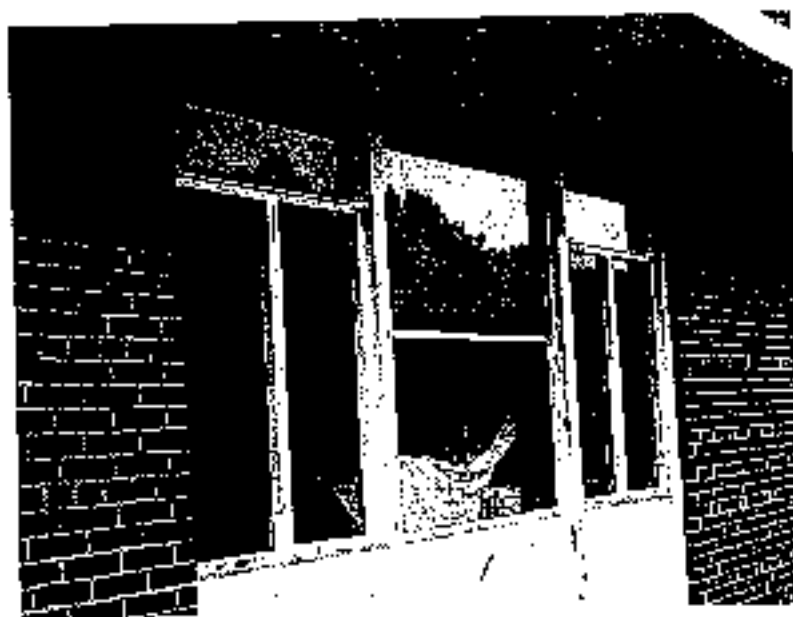
The window wall system in the 1962 building is galvanized hollow metal. As shown in the attached photos, the units are deteriorating and need to be scraped and painted before they are rusted beyond repair. The library gable end window wall system was replaced three years ago.

The Exterior doors and frames as well as the window wall system in the 1962 building are in need of cleaning and painting. If this is not addressed soon, permanent damage will occur. This is particularly true of the gym entrance facade.

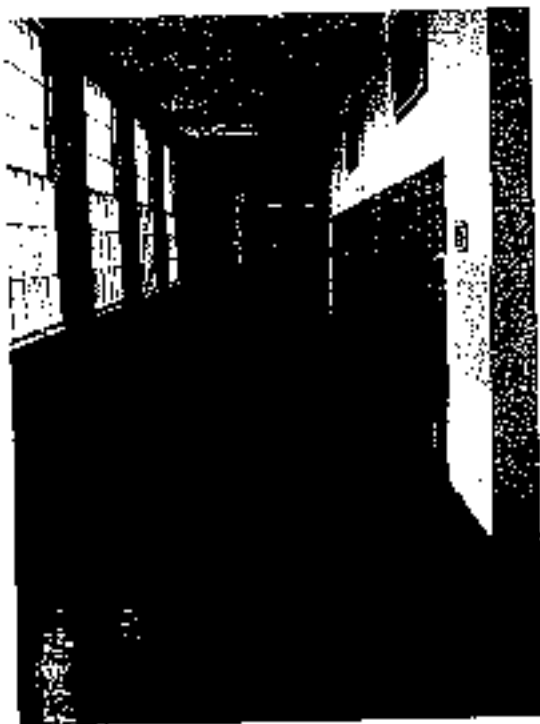
Floor coverings are typically VCT (Vinyl Composition Tile) and VAT (Vinyl Asbestos Tile). It is in good condition in the '62 building and the '96 building. Floor covering in the '41 building is typically VAT and in poor condition. It should be noted however, that none appears to be in a friable condition.

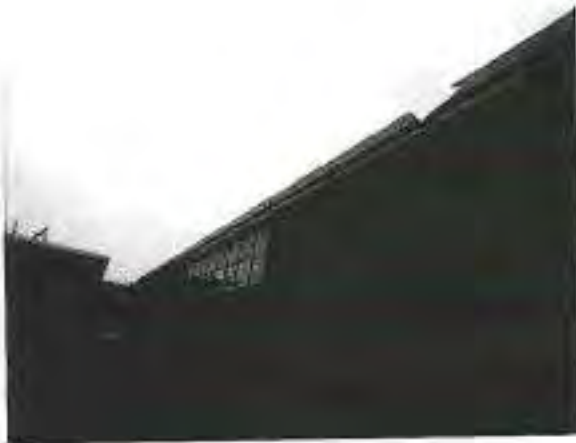
Roof-Wall Intersection Air Sealing – the exterior flashing and finishes at the roof-wall intersection are not constructed to stop air leakage.

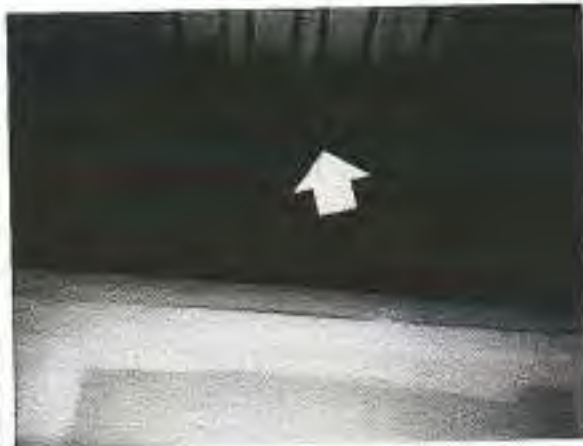
Roof-Wall Intersection Air Sealing – gaps between the roof deck and wall framing are pathways for unwanted infiltration/exfiltration.

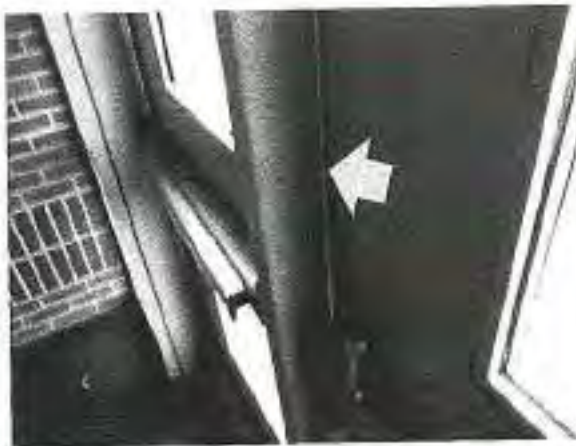
Door Weather Stripping – clear daylight around the door shows a direct pathway for unwanted air leakage.

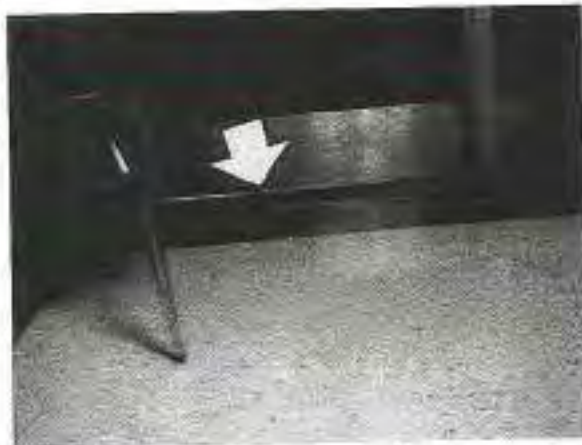
Door Weather Stripping -- clear daylight around the door shows a direct pathway for unwanted air leakage.

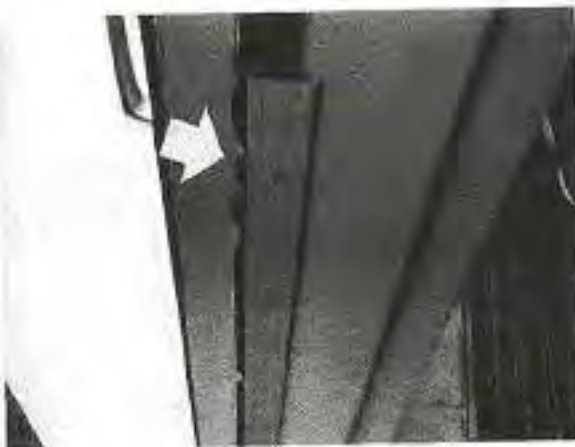
Door Weather Stripping – the gasket material has deteriorated. There is no compression seal at the perimeter of the door and as a result the door is allowing infiltration/exfiltration.

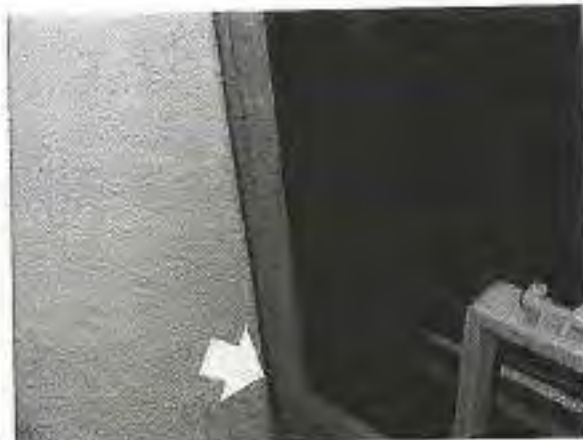
Window Casing Sealing – the joints at the perimeter of the window system are not properly sealed.

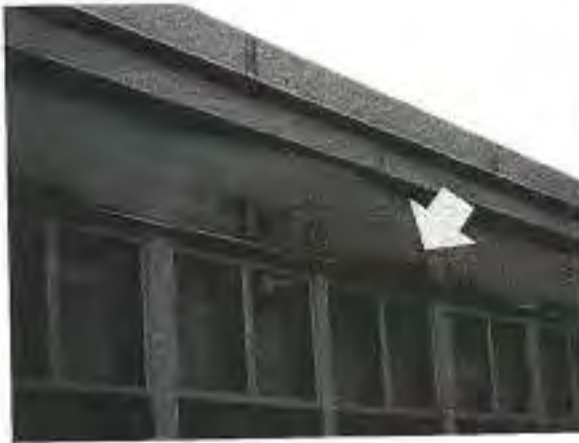
Window Back Prime Sealing - the exterior panels above the window systems in the 100s are failing; the paint was likely the wrong material, but air exfiltration at the joint shown at the right is likely contributing to deterioration.

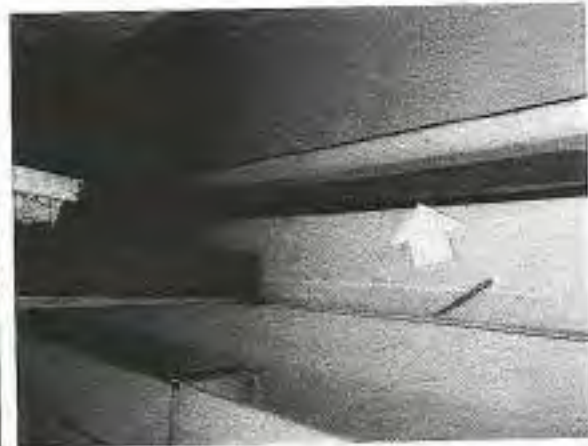
Window Back Frame Sealing - the rough opening gap at the window between the wall and the window frame was not sealed above the drop ceiling in the 100s; this gap is allowing air leakage around the window system.

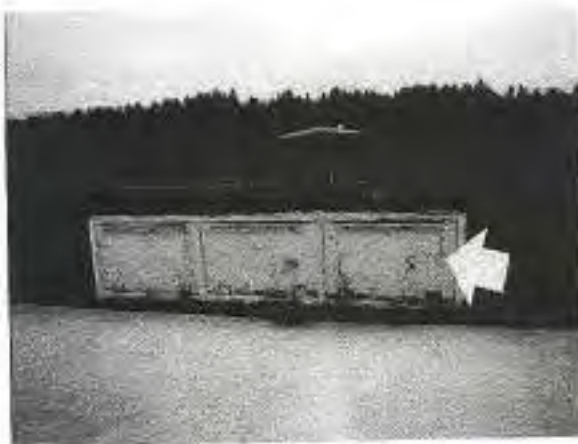
Custom Window Weatherization - the opaque operable "windows" in the auditorium tilt-out; this is not a good design for controlling rain water. Daylight is clear at the perimeter of the windows, which is a pathway for unwanted air leakage.

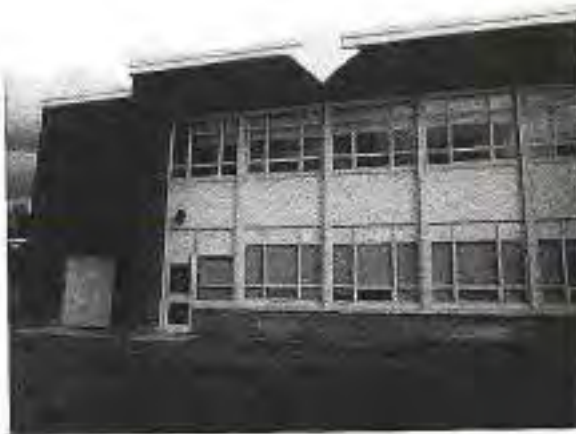
Roof-Wall Intersection Air Sealing - there are exterior vent plugs in place; this construction directs outdoor air at the weak seal (see top right picture) at the roof-wall intersection, leading to excessive infiltration/exfiltration.

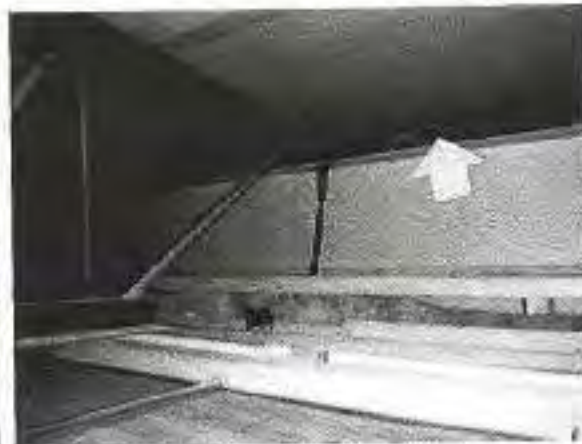
Roof-Wall Intersection Air Sealing - black discoloration of the fiberglass batt is a clear indicator of unwanted air leakage; fiberglass "filters" out dirt and debris as air pass through the material.

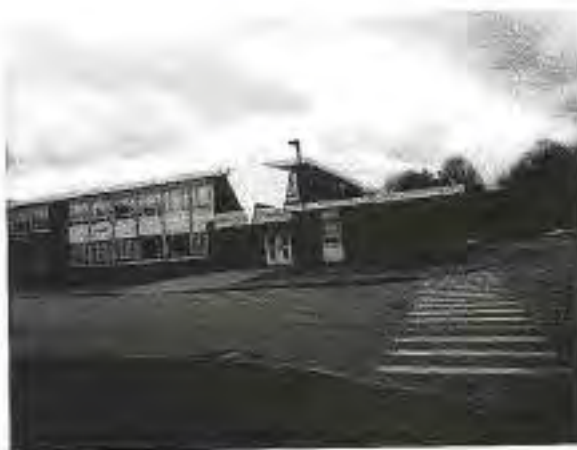
Roof-Wall Intersection Air Sealing - the exterior finishing and finishes at the roof-wall intersection are not constructed to stop air leakage.

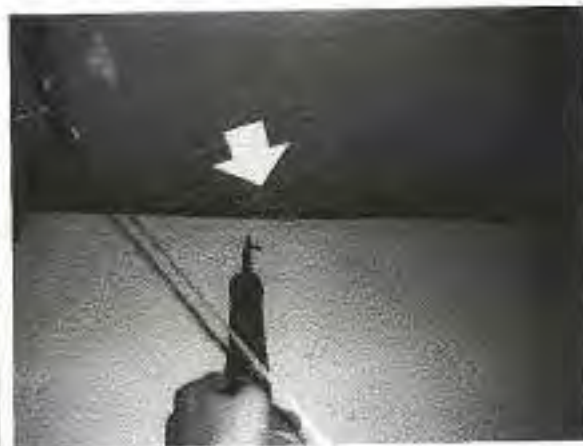
Roof-Wall Intersection Air Sealing - air exfiltration shown by smoke tracer testing at the roof-wall intersection.

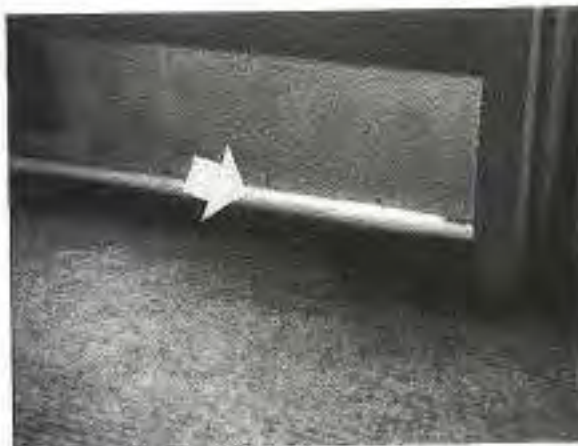
Door Weather Striping - clear daylight around the door shows a direct pathway for unwanted air leakage.

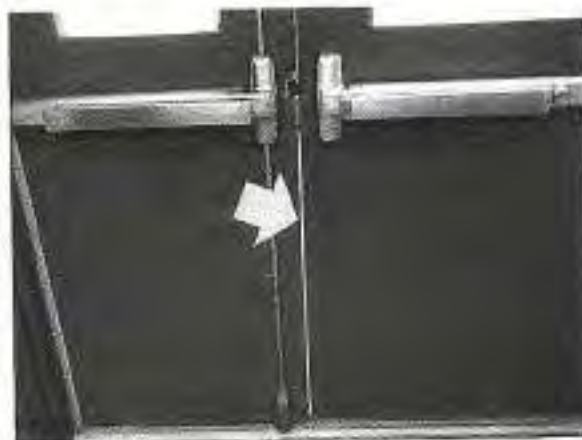
Door Weather Striping - clear daylight around the door shows a direct pathway for unwanted air leakage.

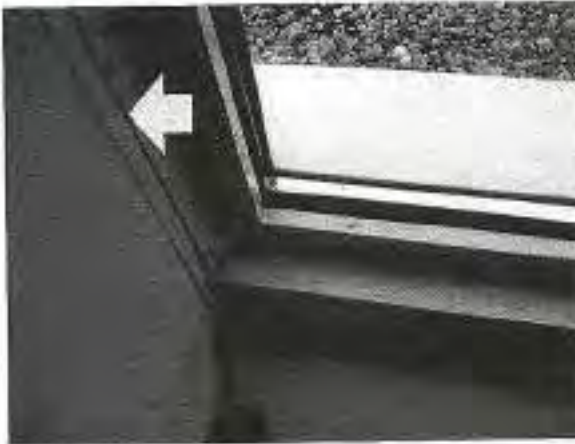
Window Casing Sealing – the perimeter of the interior casing was not sealed properly. The gaps allow air leakage at the rough opening (the gap between window and wall), interior smoke tracer testing leaked outside.

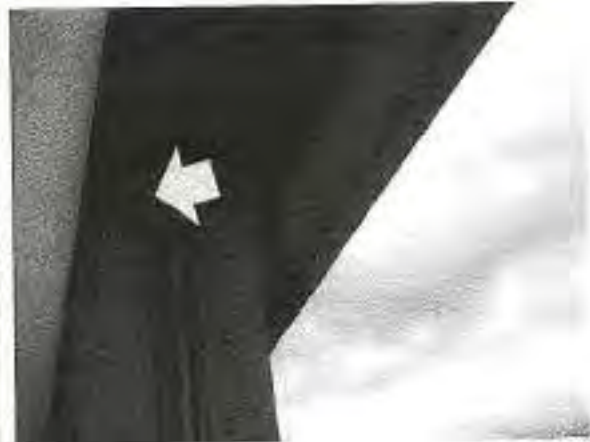
Window Casing Sealing – the joints at the perimeter of the window system are not properly sealed and are allowing unwanted air leakage around the window system.

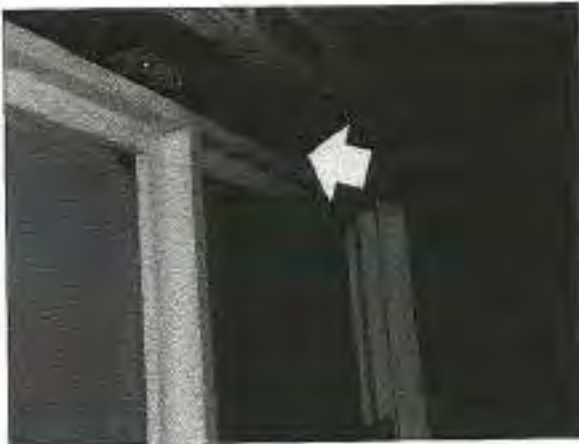
Window Back Frame Sealing – the rough opening gap at the window between the wall and the window frame was not sealed above the drop ceiling; this gap is allowing air leakage around the window system.

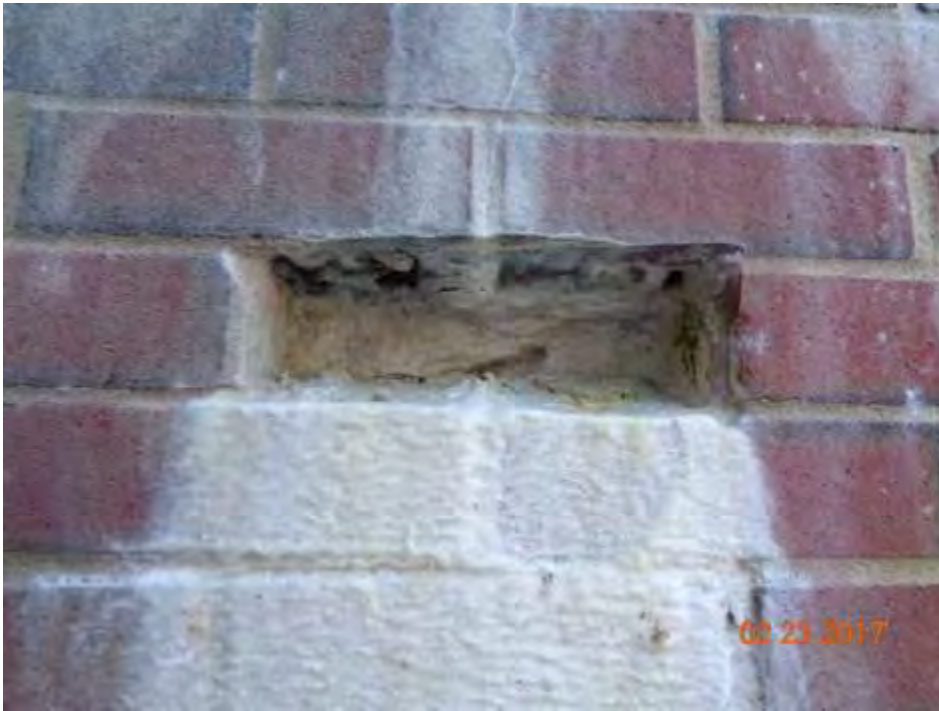
Photo 5

Severe efflorescence at the northwest canopy column. One brick was previously removed some time ago resulting in extraordinary efflorescence.

Icy conditions at the bus canopy should be avoided and we therefore recommend repairing the canopy drainage systems, soffits and columns. We recommend the following scope of work:

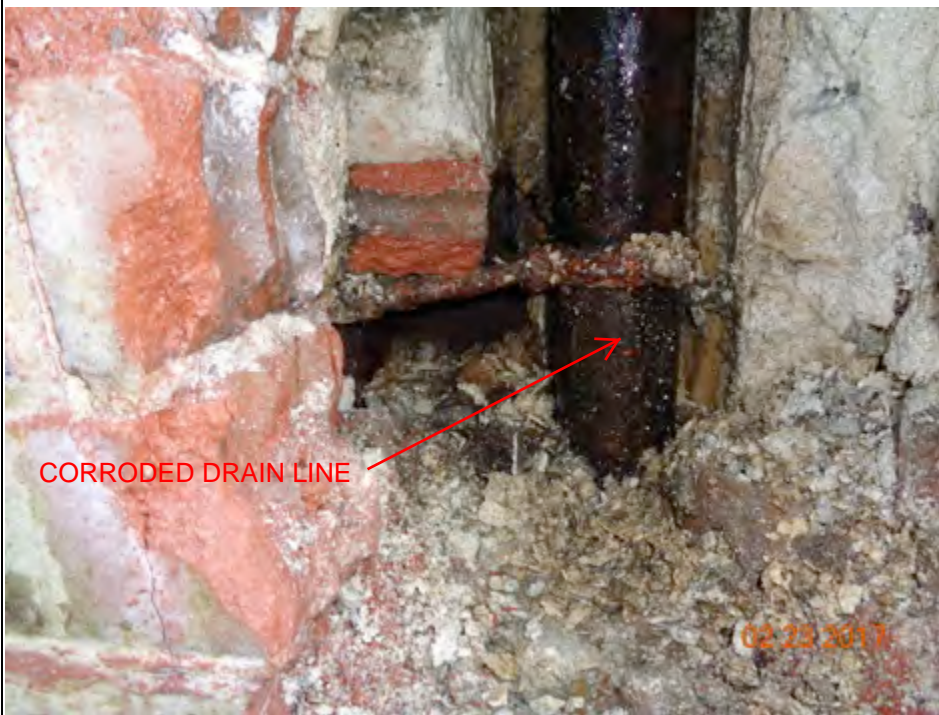
Photo 7

Test cut at bottom of northeast canopy column, east side revealed saturated masonry, deteriorated pipe insulation and corroded steel pipe.

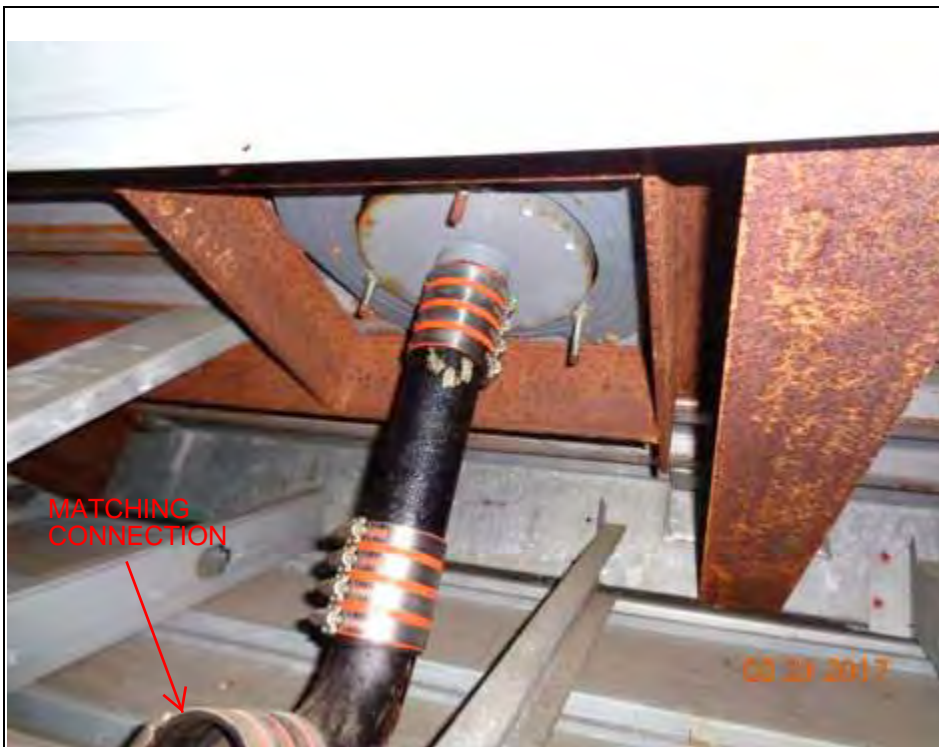
Photo 9

North canopy drain bowl is not connected. Note that the steel components appeared sound.

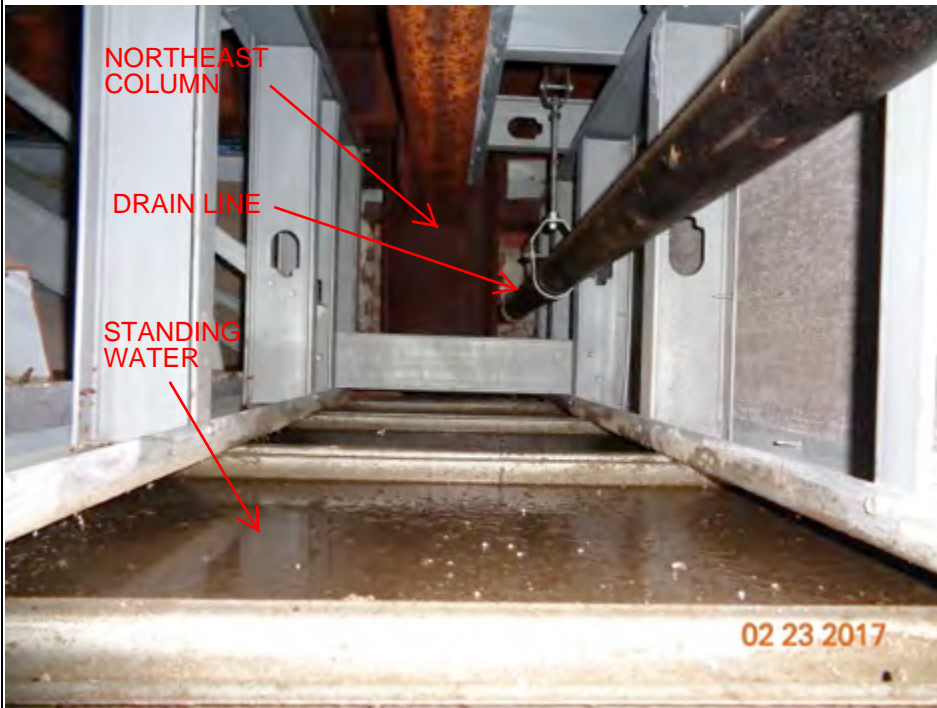
Photo 11

Interior of north bus canopy soffit. Drain line runs to the east side of the northeast column shown and then turns down into the underground drain line. Note the standing water on the top surface of the soffit.

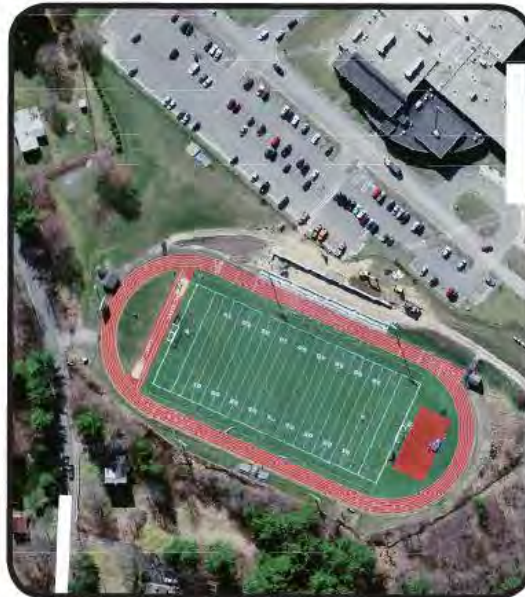
FIELD A: HIGH SCHOOL MULTI-USE SYNTHETIC FIELD AND TRACK

- TURF IS STARTING TO DEGRADE WHICH WILL DECREASE THE SAFE PLAY ON THE FIELD
- TRACK IS READY FOR AN OVERSPRAY
- THERE ARE CURRENTLY ISSUES WITH THE BASE BELOW THE TURF
- THERE ARE DRAINAGE ISSUES IN THE FIELD
- GRASS IN THE FIELD IS NOT A GREAT DESIGN CHOICE
- THE FACILITY NEEDS ADA PARKING
- ATHLETIC FIELD LIGHTING IS IN WORKING CONDITION BUT, NEEDS TO BE UPDATED
- THE CONCESSION STAND SHOULD BE UPGRADED TO MODERN CODES
- STORAGE ON THE SITE SHOULD BE ORGANIZED
- BASIC AMMENITIES WOULDHELP TO IMPROVE THE FACILITY

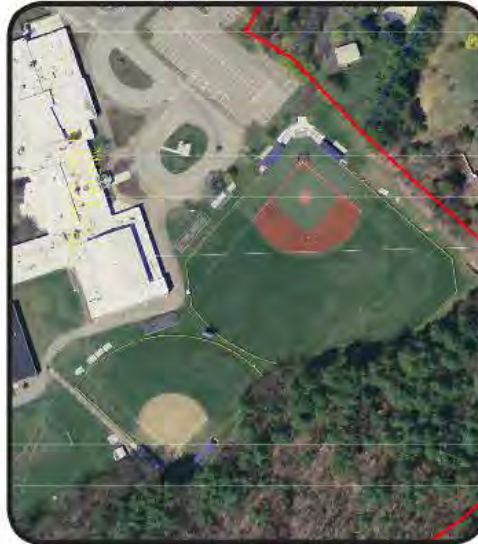
FIELD B: MIDDLE SCHOOL BASEBALL/SOFTBALL

- THE FIELD IS GENERALLY IN GOOD CONDITION
- IT IS RECOMMENDED TO ADD 8' CHAIN LINK AT BOTH THE SOFTBALL AND BASEBALL DUGOUT
- FIELD WILL NEED TO BE REPLACED IN THE NEXT 5 TO 7 YEARS
- ATHLETIC FIELD LIGHTING WOULD EXTEND THE USE OF THE FIELD BUT, LOCATION NEAR NEIGHBORS MAY NOT BE APPROPRIATE
- THE TOWN SHOULD INVESTIGATE THE EXPANSION OF TURF DURING THE NEXT REPLACEMENT
-
- THE EDGE OF THE SYNTHETIC TURF FIELD AND GRASS SHOULD BE ADDRESSED ANNUALLY
-
- THERE ARE SOME GRADING ISSUES WITH THE INFIELD OF THE SOFTBALL FIELD THAT SHOULD BE ADDRESSED

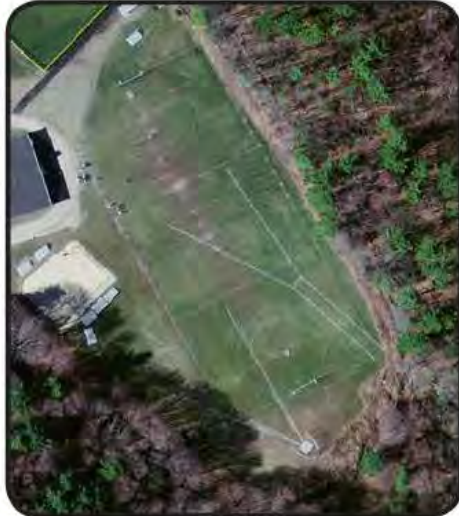
FIELD C:
MIDDLE SCHOOL PRACTICE FIELD

- THE FIELD IS IN THE WORST CONDITION OF ALL THE FIELDS
- THE FIELD IS UNDERSIZED FOR ANY SPORT EXCEPT FOR FOOTBALL
- TRACK THROWING EVENTS OCCUR IN THIS AREA
- THERE ARE WETLANDS AND A STREAM ON THE OUT SKIRTS OF THE FIELD
- THE FIELD IS SURROUNDED BY FOREST AND SECLUDED FROM NEIGHBORS

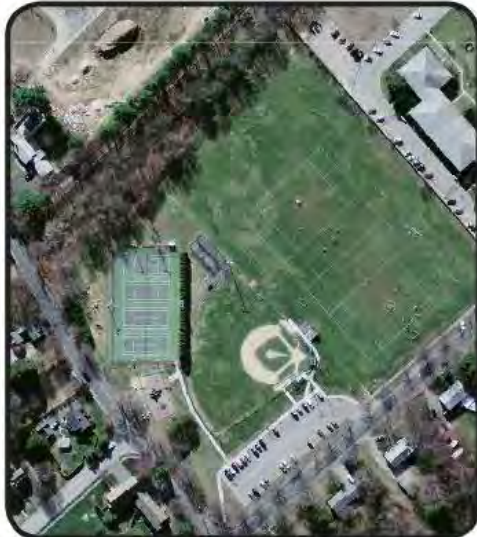
FIELD D: METACOMET PARK FIELDS

- THE FIELD IS SURROUNDED BY RESIDENTIAL NEIGHBORS TO THE NORTH, EAST AND WEST.
- THE FIELD IS LARGE AND IN GOOD CONDITION.
- PARKING IS LIMITED AND THERE ARE SIGNS OF PARKING ON THE STREET.
- DRAINAGE FLOWS TO THE SOUTHWEST
- THE FIELD IS ORIENTED MORE EAST/WEST THAN THE PREFERED NORTH/SOUTH
- THE FIELD COULD USE ADA ACCESS IMPROVEMENTS

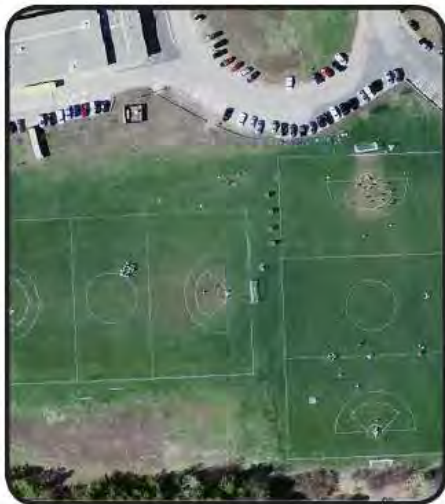
FIELD E:
RALPH WHEELOCK SCHOOL MUTLI-USE FIELDS

- THE FIELDS ARE HEAVILY USED
- ONE OF THE FIELDS IS NOT ORIENTED THE PREFERED NORTH/SOUTH DIRECTION
- PARKING IS AN ISSUE, PARKING IS ON THE GRASS
- DRAINAGE FLOWS TO A SWALE TO THE EAST
- THE FIELD COULD USE ADA ACCESS IMPROVEMENTS
- THE FIELDS ARE SURROUNDED BY FOREST TO THE SOUTH AND EAST

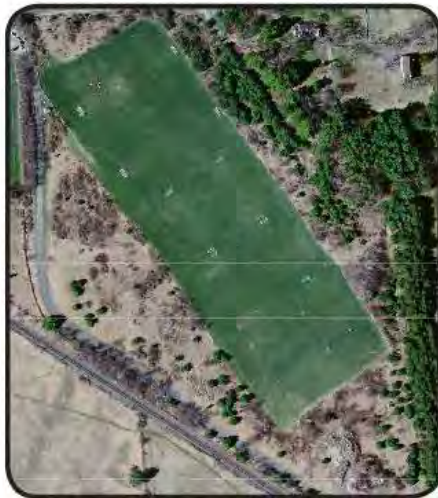
FIELD F:
SOCCER COMPLEX AT RALPH WHEELLOCK

- PARKING IS LIMITED TO THE FACILITY
- THE FIELDS COULD USE ADA ACCESS IMPROVEMENTS
- FIELDS ARE GENERALLY IN GOOD CONDITION WITH IRRIGATION
- FIELDS ARE SURROUNDED BY FOREST AND WOODED AREAS
- FIELDS ARE HEAVILY USED
