Department of Conservation and Recreation

Nantasket Beach Seawall Repair and Reservation – Master Plan Services – Existing Infrastructure

September 2007

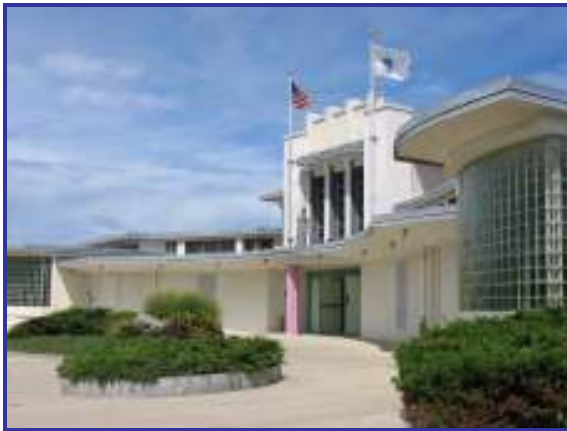
Figure 1-4: View of Mary Jeanette Murray Bath House from Nantasket Avenue

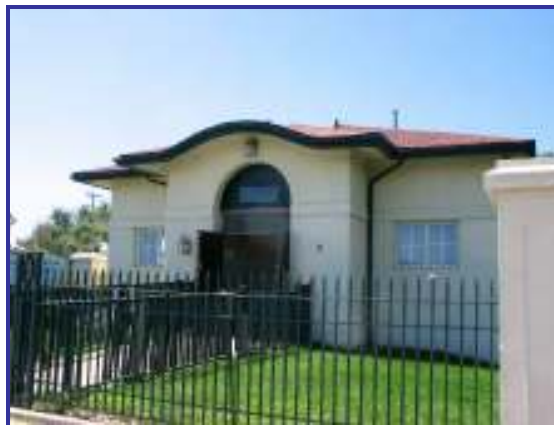
The Comfort Station is across Nantasket Avenue from the beach, located on 205 Nantasket Avenue adjacent to the Clock Tower building and a privately-owned mini golf park. The structure is approximately 1,500 sq. feet in size and used as a public restroom facility. It is in seemingly good condition. The only exceptions are some problems with the one of the gas-fired heating vents and heating pipe.

Figure 1-8: Comfort Station

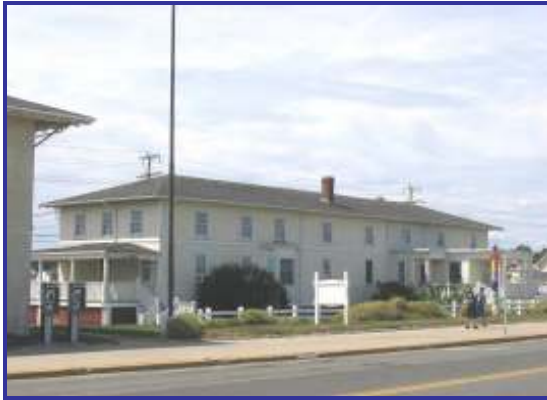
Figure 1-11: Island District Operations Building

The building is in poor condition. The roof was leaking in the past, resulting in damaged walls and ceilings. Plaster is falling in places. The roof was replaced in 1994-1995 as part of exterior renovations. Currently, there is still a leak above one of the first floor offices (supposedly due to a problem with the gutter).

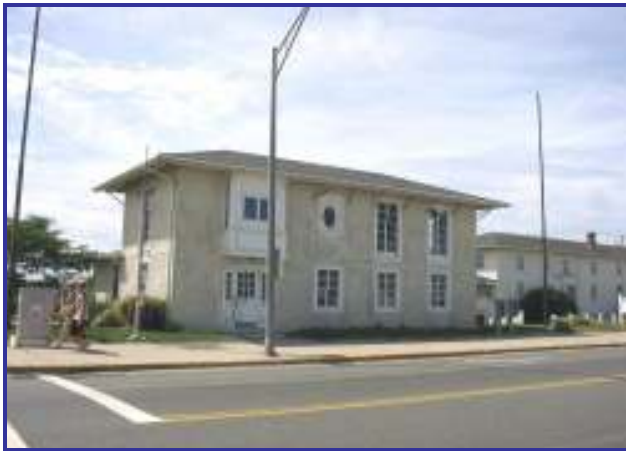
The two-story Police Station building is approximately 4,000 sq. feet in size. It was built in 1904 and used as a police station by the former MDC. Currently, the building is vacant and in very poor condition.

Figure 1-14: Former Police Station

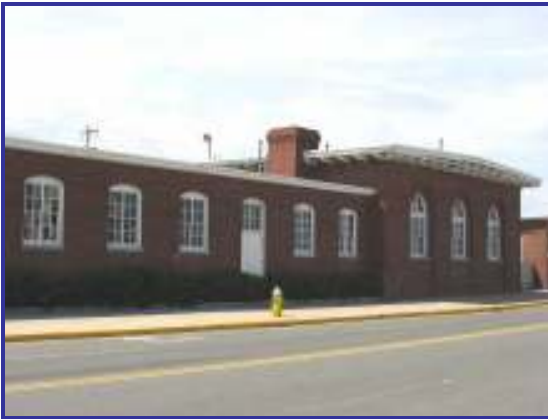
The garage contains a floor drain without an oil/water separator which should be installed. Part of the wall requires reappointing.

Figure 1-19: View of lower Maintenance Garage from Nantasket Avenue

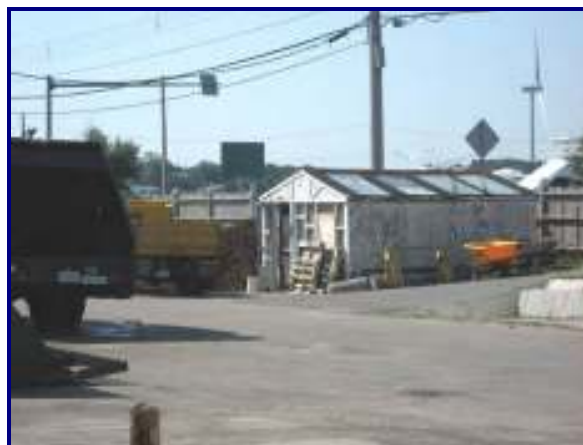
The Greenhouse building is a single story 216 sq. feet structure built in 1998. It is in poor condition.

Figure 1-22: Greenhouse

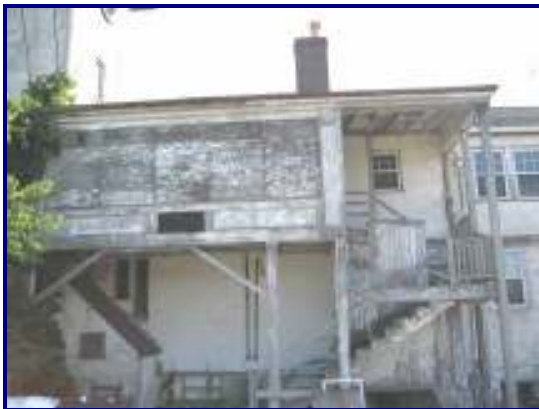
Some structural damage was observed on the clocktower. The facades of the two buildings require painting. The western side of the Clocktower Building facing George Washington Boulevard also could be improved aesthetically (Figure 3-28).

Figure 1-28: Western side of the Clocktower Building

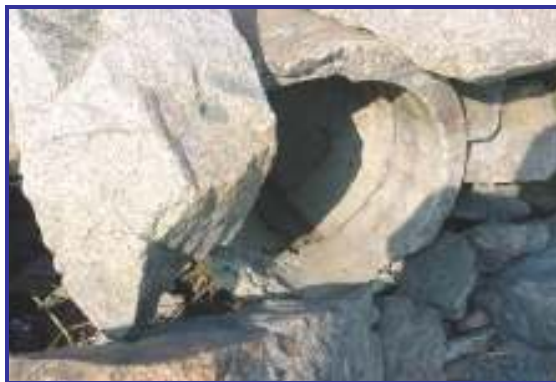
Drainage Line C begins approximately 700 feet north of the Nantasket Avenue and Hull Shore Drive intersection and flows southerly to an 18" outfall by George Washington Boulevard. The 18" reinforced concrete outfall (Outlet C) is shown in Figure 2-2. This drainage system still exists today with only minor adjustments made throughout its history.

Figure 2-2: Outlet C consisting of a 18" RCP outlet

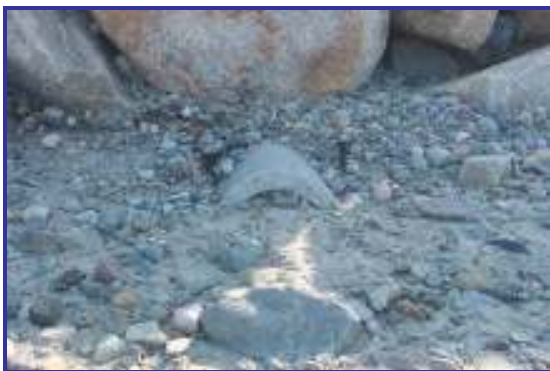
Drainage Line D begins approximately 600 feet south of the Water Street and Hull Shore Drive intersection and flows northerly 1,600 feet to a manhole prior to discharging easterly to the beach via an 18" reinforced concrete pipe (Outlet D). Drainage Line E begins south of Phipps Street and flows 1,000 feet northerly to meet Drainage Line D at a manhole prior to discharging at Outlet D. The 18" reinforced concrete outfall (Outlet D) is shown in Figure 2-4; the outlet is filled with sediment blocking the drainage system. There were modifications made to this drainage line, particularly at the Water Street and Hull Shore Drive intersection.

Figure 2-4: Outlet D consisting of an 18" RCP outlet
