RESOURCE MANAGEMENT PLAN
**NATIONAL MONUMENT
TO THE FOREFATHERS**
PLYMOUTH, MASSACHUSETTS

September 2006

Massachusetts Department of Conservation and Recreation
Division of Planning and Engineering
Resource Management Planning Program

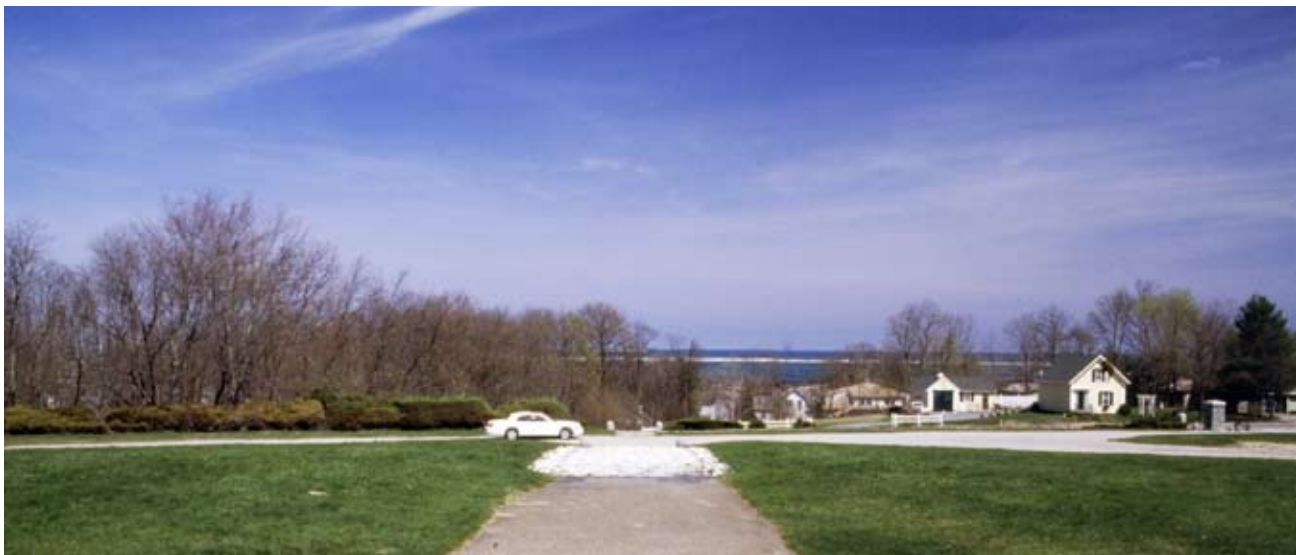
*Views to ocean from monument
in April 2005*

Improve Views to Ocean: The view toward Plymouth Bay can be restored only with the cooperation of the property owners whose trees interrupt the sight line. Because the view is so important to the design of the monument and the experience of visitors, the property owners should be contacted to see if they would be willing to have selected trees removed and replaced with lower growing trees.

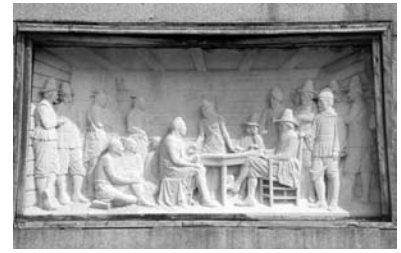
Marble bas-relief

Landing at Plymouth [under Liberty]: This sculpture shows erosion at the most projecting surfaces, particularly the facial features. This type of weathering away of the crystals at the stone surface is referred to as sugaring which results in a roughened surface and loss of detail. The sugaring is most severe where the work is least shielded from wind, rain and salt spray. The edges and recessed areas are in better condition than the central area and projecting features. This tablet shows limited salt accumulation on the surface and has only limited fine cracks in the stone surface and has little surface soiling.

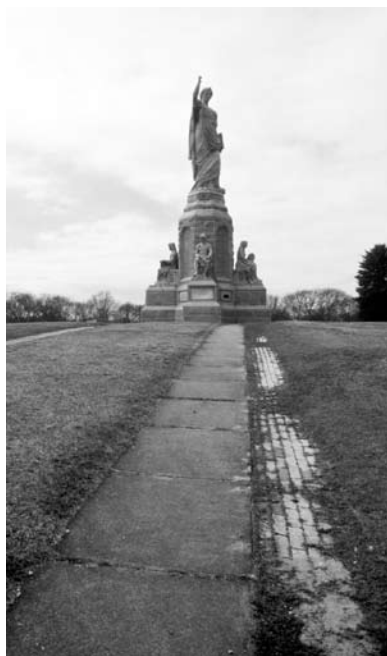
Path to Liberty

Path to Liberty: A pedestrian path leading from the circular drive to the base of the monument at the figure of Liberty has been altered somewhat from its historic appearance. When constructed around 1897, the path was approximately 24' wide, finished with gravel and edged with several courses of asphalt pavers. Currently, the center area is grassed and the asphalt pavers, though still present and partially visible, have become overgrown with turf, narrowing the apparent overall width of the path. 4' wide concrete walks, constructed by the mid-20th century, now mark the edges of the path. Two granite bollards and two carved granite shells are located at the foot of the path. The concrete walks are in good condition.

Path to Liberty: The pedestrian path leading to the statue of Liberty should be restored. The concrete sidewalks should be removed and the historic asphalt pavers, now overgrown with turf, should be exposed, assessed, removed and reset. Missing or broken pavers should be replaced in kind as needed. The lawn center of the path should be replaced with chip seal to facilitate access and be compatible with the historic appearance of gravel. The surface is too steep for gravel without a high level of maintenance because of the erosive probability of a gravel surface.

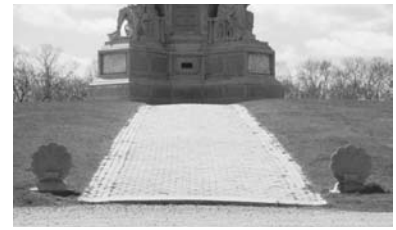
Path to Dedication Panel

Path to Dedication Panel: Beginning at Allerton Street, this path leads directly to the dedication panel. The existing path has concrete steps flanked by granite fence posts at Allerton Street. The concrete steps are uneven and unsafe. The lowest step has been displaced outward toward the street, creating a significant tripping hazard. An 8' wide concrete walk, in fair condition with several patches, leads to eight granite steps flanked by granite cheek walls and posts where the path meets the circular drive. The steps have also become displaced, creating a tripping hazard, and the uppermost tread is broken. An approximately 12' wide by 110' long path continues between the circular drive and the base of the monument, where it is finished with a field of hexagonal asphalt pavers [approximately 8" across] and edged with four courses of 4" x 12" rectangular asphalt pavers. Research indicates that these exposed aggregate finish pavers were installed around 1897. The path was restored in the fall of 2003, when the pavers were removed, the path regraded and all salvageable historic pavers, along with some replacement pavers, were installed on a new subbase. Through this project, about 10-15% of the historic hexagonal pavers were replaced in kind. The path is currently in excellent condition. A granite threshold placed where path intersects the circular drive had been carefully profiled to match the profile of the path. When the edge pavers were reset along the edges of the path, they were not set in the proper profile to create a gutter at the edge of the path as suggested by the granite threshold.

Path to Dedication Panel: Reset the lower concrete step where the path meets Allerton Street. Remove and rebuild the granite steps and cheek walls above. Repair the broken step by providing threaded stainless steel rods set in epoxy across the crack, and use epoxy adhesive to bond the sections. Replace the foundation as required. These stairs have no railings, which may be required if they are reconstructed. The pedestrian path leading to the dedication panel was restored in the fall of 2003 and is in excellent condition. It should be monitored and any pavers that become badly cracked, broken or missing should be replaced in kind. A potential east-west extension of this path across Allerton Street to Court Street was recently precluded with subdivision of the Monument House property and construction of a new home in the axis. The path extension to Court Street could have assisted with and become part of the "Pilgrim Path" walking tour concept that was conceived some years ago by providing a more direct pedestrian connection to Court Street and downtown.

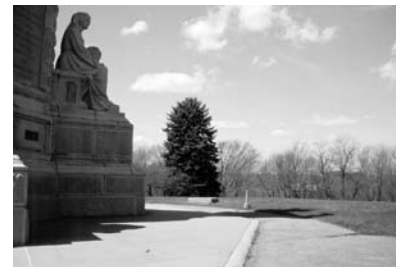
Path at base of monument

Path at Base of Monument: Both of the existing pedestrian paths terminate near the base of the monument. Immediately around the base, an octagonal area, approximately 63' across, is finished in concrete paving within granite curbing. Research indicates that this area was historically finished with a variety of materials, including grass and tiles in the 1890s and a granolithic material beginning in 1900. The granite curb is likely original. The existing concrete was installed in 1987 and exhibits minor cracking and a few spalls where the concrete meets the curb. Most of the sealant joints have become unbonded. No expansion joint was provided at the base of the monument.

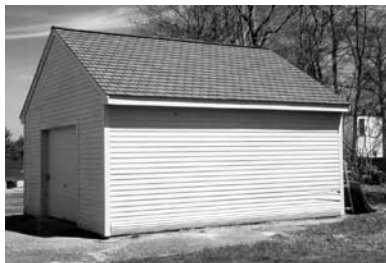
Existing Garage

The garage was built as a gift shop, probably in the late 1960s, and modernized as an equipment storage facility by the Department of Conservation and Recreation around 2001. This is the only building on the three sites maintained by this staff [the National Monument to the Forefathers, Plymouth Rock and the Myles Standish Monument in Duxbury]. Since it began serving as a place for equipment storage, staff travel time has reduced significantly. In good condition, it is a one story, one bay, concrete block building sided with wood clapboards and topped by a front gable, asphalt shingled roof. The facade has been damaged on southwest corner. This building has insufficient size for anticipated equipment storage needs.

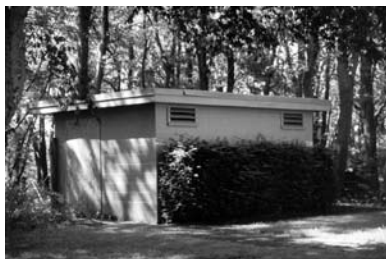
Existing Rest Rooms

The one story, flat roof, concrete block restroom facility, which likely dates from the same period as the garage, is located south of the garage and partially screened by a hedge. It is in poor condition and inoperable although there are water and sewer connections to the town system. No public services are provided by these buildings in their current state.

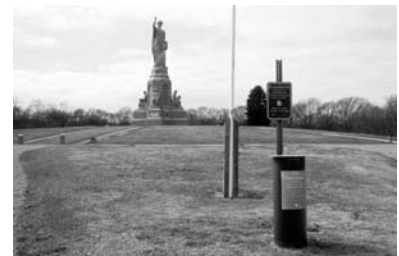
Informational signs

Signs: Improving the signs directing people to the site and providing interpretive information once on the site is highly desirable to publicize the site, provide better connections and directions to it, give it a better identity and enhance the visitor experience. Work with the Town and Massachusetts Highway Department to improve directional or way finding signs on Routes 3, 3A [Court Street], and 44 [Samoset Street]. The park identification sign should be maintained in its current location until the new building is implemented. At that time the location should be reconsidered. Regulatory information should also be provided as part of an overall sign system that is compatible with the historic nature of the site. If the need arises for additional structures on the grounds, like information kiosks and/or wayside signs, they should be sited so that they do not detract from the historic character of the landscape or interrupt views to or from the monument. All new structures/objects should be limited to areas outside the circular drive.

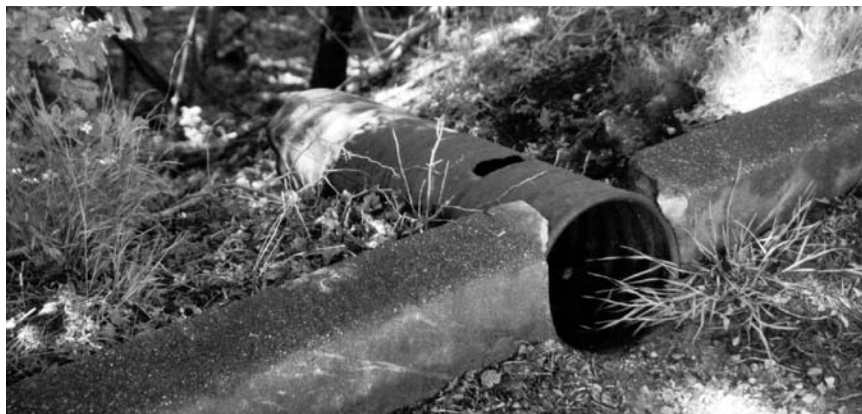
Storm Drainage: For the most part storm water travels overland to the edges of the site. In two areas it is collected at the concrete curbing at the circular drive and piped to point source discharges, creating severe erosion conditions downslope. There is one corrugated metal pipe outlet on the south side. Two drains on the north side, one on each side of drive, appear to be piped to an outlet on the slope.

*Corrugated metal pipe
at the concrete curb
on the circular drive*

Storm Drainage: Eliminate the need for collection and point source discharges of storm water by removing the concrete curb on the outer edge of the circular drive. This will significantly reduce erosion conditions created by these elements.

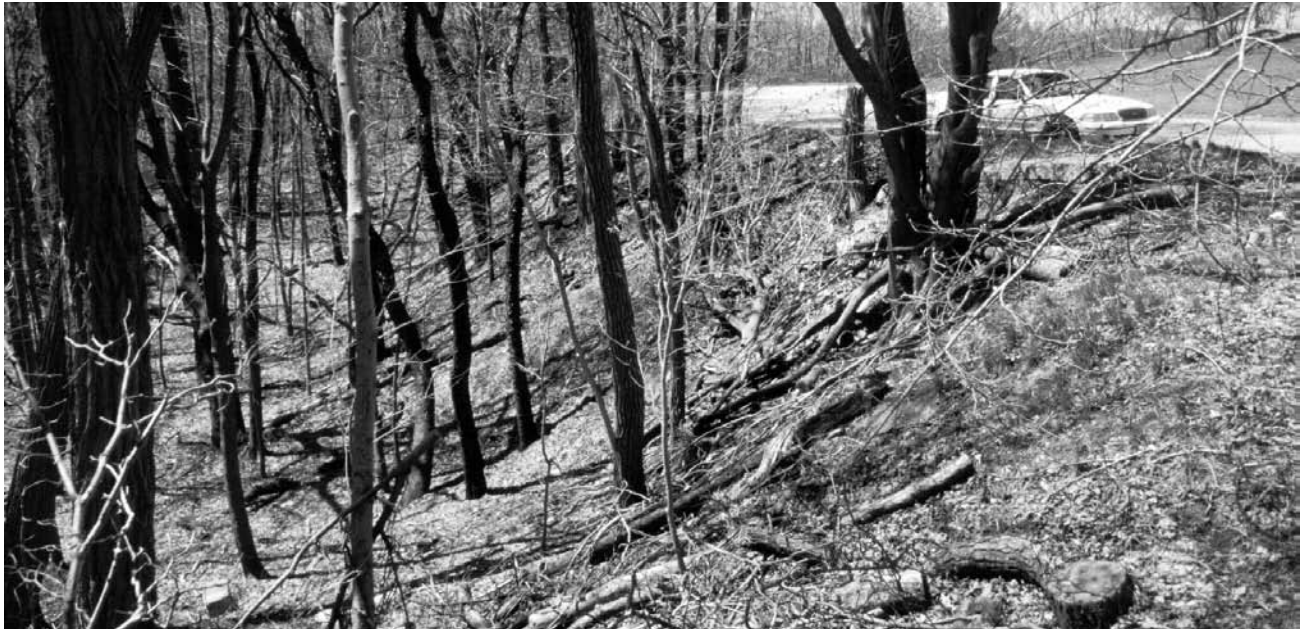
Expansion of paved area at base of Monument

Steep slopes adjacent to circular drive
