*Massachusetts Coastal Infrastructure
Inventory and Assessment Project
Coastal Hazards Commission*

New Bedford

July 6, 2009

**Bourne Consulting Engineering
Franklin, Massachusetts**

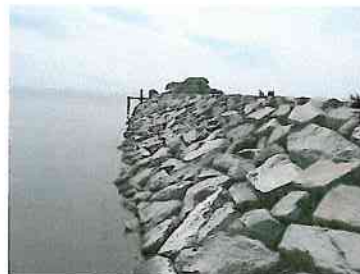
The place stone revetment has stones that are approximately 6 feet by 6 feet by 3 feet in size. The stones are on a 1 to 1 slope. The stones are not placed tightly together. Understones are visible in many areas. The crest is 15 feet wide. There is no visible scour.

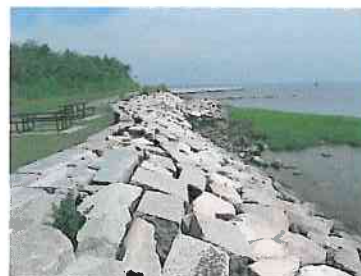
The placed stone revetment is at a 1 on 2 slope. The stones are average 3 feet by 2 feet by 2 feet in size. There is minor stone settling and movement. There is no visible scour. There is a small park behind the revetment

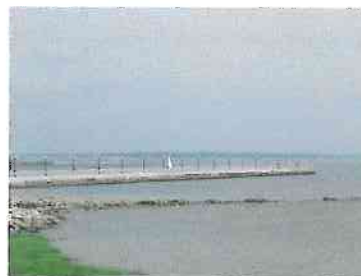
The dumped stone groin is submerged at mean high water. The stones are approximately 4 feet by 2 feet by 3 feet in size. The stones were not placed tightly and there are signs of stone movement.

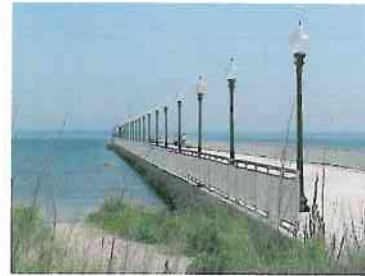
The stone blocks have a cast in place walkway on top of them. The walkway is approximately 15 feet high. The stones are well set. There is no visible scour or stone movement.

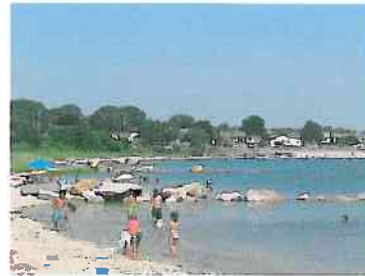
The set of 2 dumped stone groins have stones that are approximately 4 feet by 3 feet by 3 feet in size. There are also pieces of concrete and granite block. There are signs of stone movement and section loss.

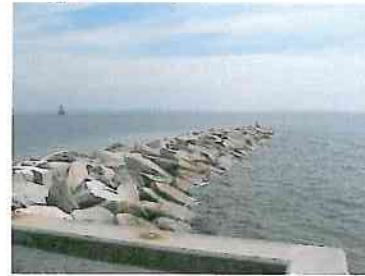
The dumped stone groin has a slope of 1 on 2. There is minor stone movement and settling. There is no visible scour.

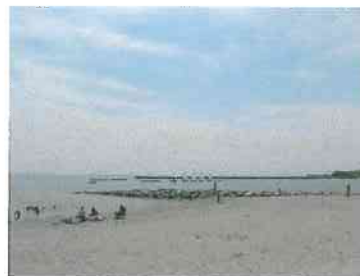
The placed stone groin has stones that are approximately 4 feet by 2 feet by 3 feet in size. The crest is one stone wide. There is no sign of scour or stone movement.

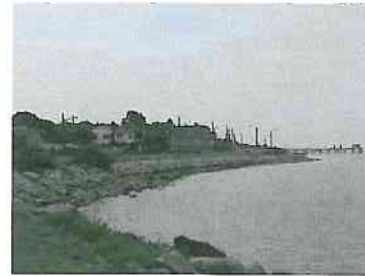
The placed stone revetment has stones that are approximately 4 feet by 3 feet by 2 feet in size. The stones are at a 1 on 1 slope. There are areas of stone movement. There is visible erosion and minor scour at the toe of the slope. Boardwalk, road, and houses are located behind the structure.

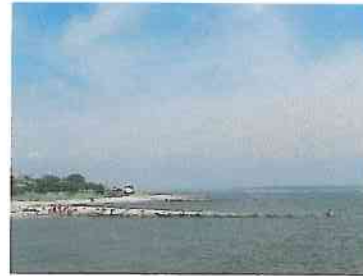
Three placed stone groins with moderate voids and section loss, but no visible scour. The stones are approximately 4 feet by 2 feet by 2 feet in size.

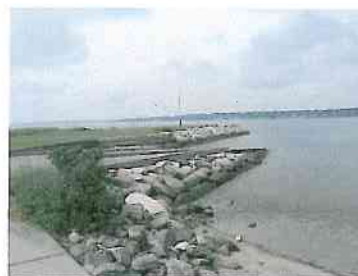
Placed riprap at a 1 on 1 slope against a boat ramp. There is minor stone movement and visible scour. The stones are placed tightly throughout.

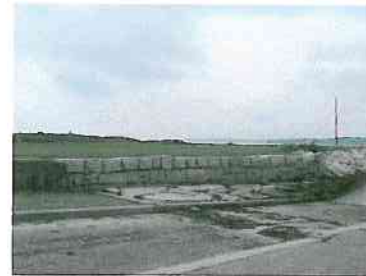
The stone block seawall is mortared. The stones average 2 feet by 1.5 feet by 2 feet in size. The corners are beginning to unravel and there is some settling.

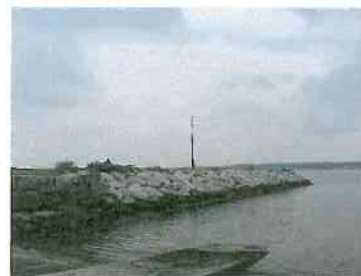
Placed stone revetment is at a 1 on 1 slope. The stones are approximately 4 feet by 3 feet in size. There are areas of erosion and stone movement. The crest is one stone length wide.

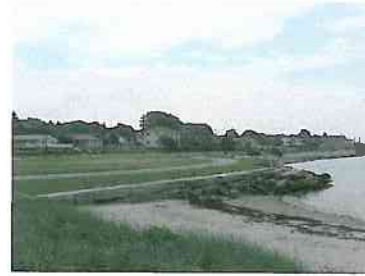
The stone block seawall is mortared. The stones average 2 feet by 1.5 feet by 2 feet in size. The corners are beginning to unravel and there is some stone settling.

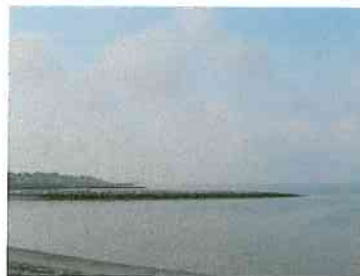
Set of three placed stone groins with stone that are approximately 5 feet by 3 feet. The stones are set at a 1 on 1 slope. There is minor scour and stone movement is visible. There is no visible scour at the toe.

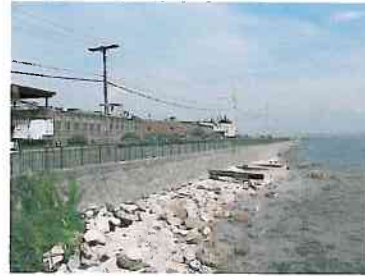
The stone bulkhead is mortarted together. The stones average 3 feet by 2 feet in size. There is a cast in place cap on the bulkhead. There is a sidewalk, small park, a factory, and street located behind the structure. Moderate scour at the toe and many areas of section loss and stone loss.

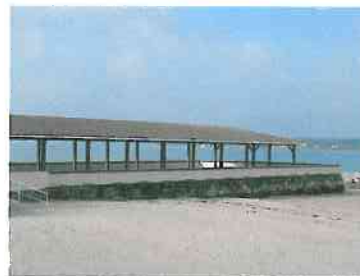
The mortared, stacked stones are approximately 3 feet by 1 foot in size. There is a cast in place concrete picnic area above the stones. There are many areas of section loss in the mortar. There are minor areas of scour.

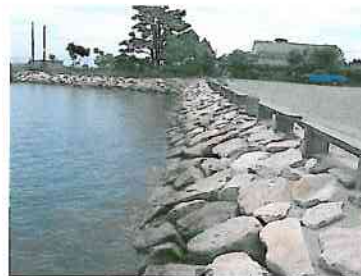
The placed stone revetment has a 1 on 2 slope with stones that average 4 feet by 2 feet in size. The stones are mortared together. There is moderate mortar loss and stone settlement.

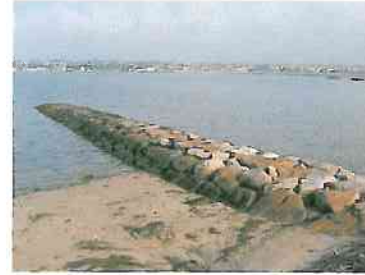
Set of two placed stone groins. Stones are approximately 5 feet by 3 feet by 2 feet in size. The stones are at a 1 on 1 slope. The crest is made up of 5 stones making it approximately 10 feet wide. There is no sign of stone movement or scour.
