## NORTH SHORE WATERSHEDS

# North Shore Watersheds

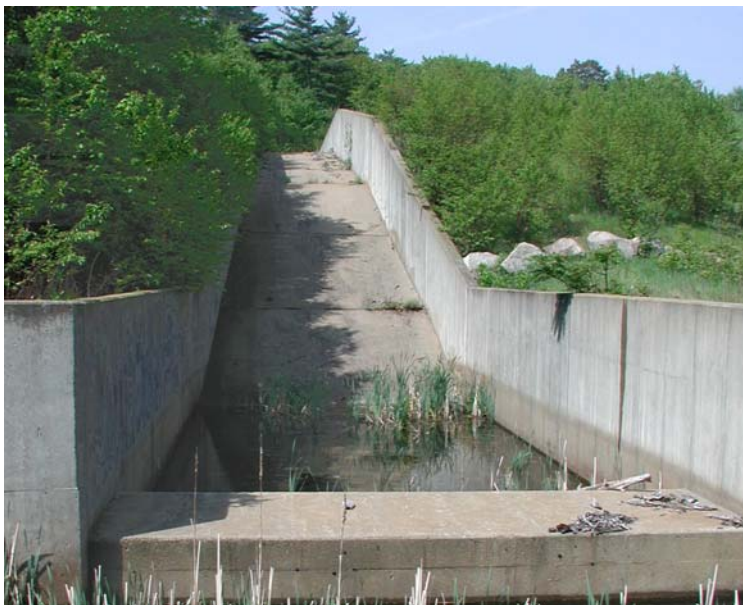
Lower section of Dykes Pond Dam

This stream has its source in Dykes Pond, a 110 acre water supply reservoir. It then flows to 34 acre Lily Pond and subsequently to the Annisquam River estuary. Four obstructions are formed along its course, the first of which is a rapid elevation change at the West Gloucester Water Treatment Facility. This is surmounted by a weir-pool fishway, which passes river herring adequately when properly adjusted. The second obstruction includes an elevation change and the Lily Pond dam. Stone stream baffles allow herring to traverse the elevation change, and a wooden Denil ladder, replaced in 2000, provides passage at Lily Pond Dam. The third obstruction is the dam at Dykes Pond. The lack of consistent outflow due to withdrawals from this impoundment eliminates it as a potential spawning habitat and Lily Pond provides the primary spawning/nursery area for the system. Rainbow smelt spawn in the river near Rt. 133.

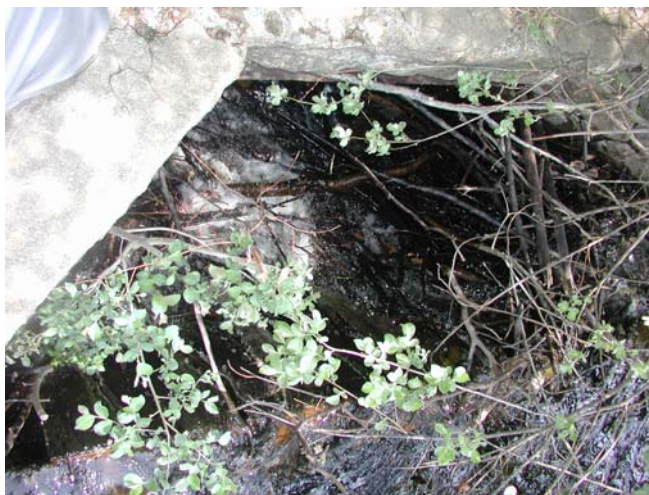
View looking down on Loop Pond Dam

Little potential river herring spawning habitat exists here. On one occasion smelt eggs were observed above the head of the tide but no evidence of spawning has been found since.

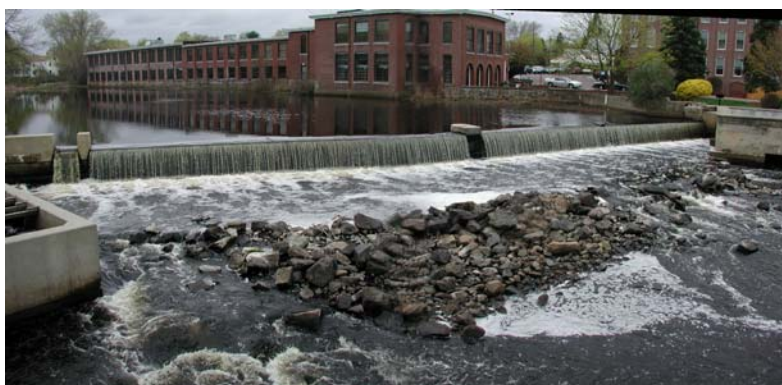
Ipswich Mills Dam

The Ipswich River appears to offer significant potential for river spawning anadromous fish such as blueback herring and American shad. While no sizeable impoundments or ponds are available, many miles of riverine habitat are potentially available for these species. An inefficient ladder at Ipswich Mills was replaced with a modern Denil design in 1995 and a second obstruction, a dam at Willowdale with an inefficient fishway, is being considered for removal. In addition, DMF has stocked the stream with a total of 31,147 blueback herring from 1990 to 2002. Local volunteers have monitored up-running adults at the first fishway and have documented modest returns.

1. Continue to monitor adult river herring returns in the Ipswich River at the Ipswich Mills fishway. If significant increases in returns are observed, consider removal of the Willowdale dam with fishway construction as an alternative.

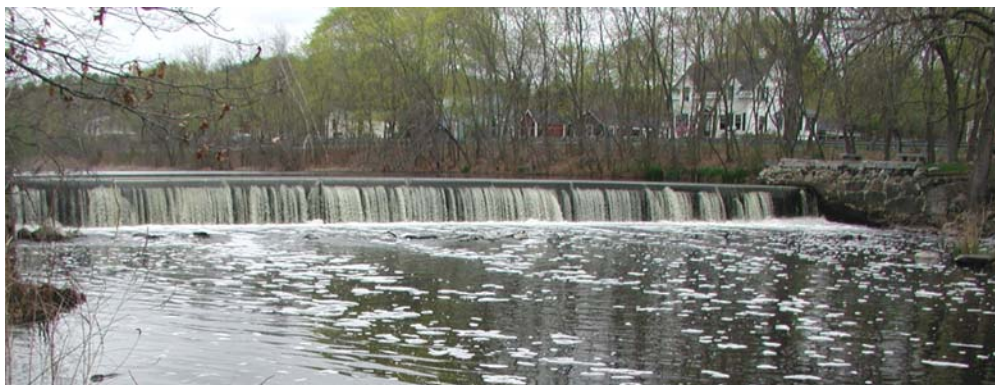
Willowdale Dam

<b>Design</b>	<b>Material</b>	<b>Length (ft)</b>	<b>Inside W (ft)</b>	<b>Outside W (ft)</b>	<b># of Baffles</b>	<b>Baffle H (ft)</b>	<b>Notch W (ft)</b>	<b>Pool L (ft)</b>	<b>Condition/Function</b>
Notched weir-pool	Concrete	61.0	3.1	5.0	13	Varied (2.6-5)	1.6	Varied (4-6.5)	Poor Inefficient passage

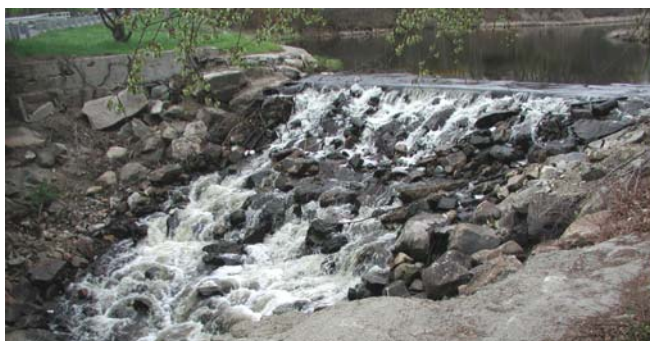
Woolen Mill Dam

Design	Material	Length (ft)	Inside W (ft)	Outside W (ft)	# of Baffles	Baffle H (ft)	Notch W (ft)	Pool L (ft)	Condition/Function
Notched weir-pool	Concrete and stone	104.0	Varied (3-10)	Varied (2-3)	12	1.8	3.0	Varied (5-16.3)	Fair Passable

3. Replace the Snuff Mill and River Street ladders on the Parker River with more efficient designs.
4. Provide a low water passage channel for juvenile herring at the Woolen Mill dam on the Parker River.

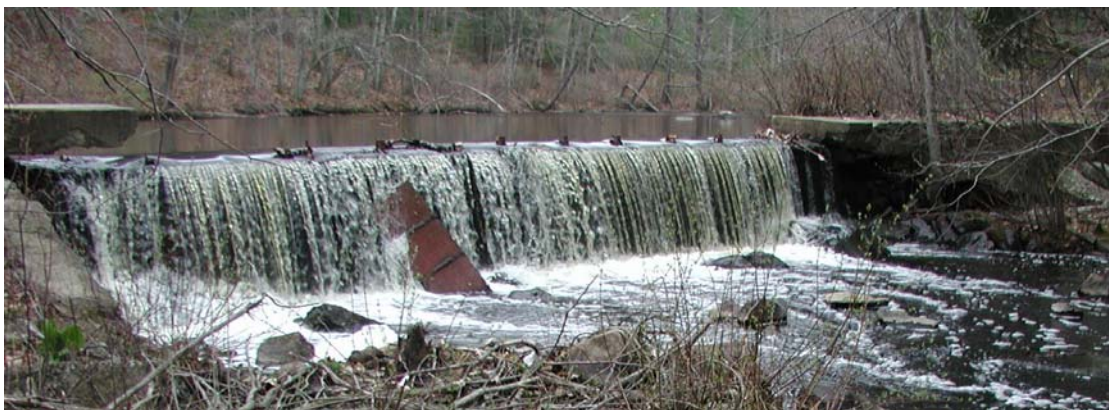
Larkin Road Dam

<b>Design</b>	<b>Material</b>	<b>Length (ft)</b>	<b>Inside W (ft)</b>	<b>Outside W (ft)</b>	<b># of Baffles</b>	<b>Baffle H (ft)</b>	<b>Notch W (ft)</b>	<b>Pool L (ft)</b>	<b>Condition/ Function</b>
Notched weir-pool	Concrete and stone	152.0	Varied (2.4-4.1)	Varied (4.0-6.7)	14	Varied (0.7-1.4)	1.3	11.2	Fair Passable

The second fishway, at Larkin Street, was improved 1997 by volunteers who modified the entrance to increase attraction flow. The ladder now functions adequately. The next fishway, at the Snuff Mill dam, is inefficient and needs to be redesigned and replaced. The fourth fishway at the Blacksmith Shop dam was replaced in 2001 with an aluminum Alaskan Steepass ladder. A notched weir-pool fishway at River St. is passable but in poor condition and will need repair work in the near future. And finally, a new aluminum steeppass ladder was installed in 2000 at the outlet of Pentucket Pond. Access for cleaning and a screen in the spillway channel of the dam are needed to provide maximum efficiency for this facility.

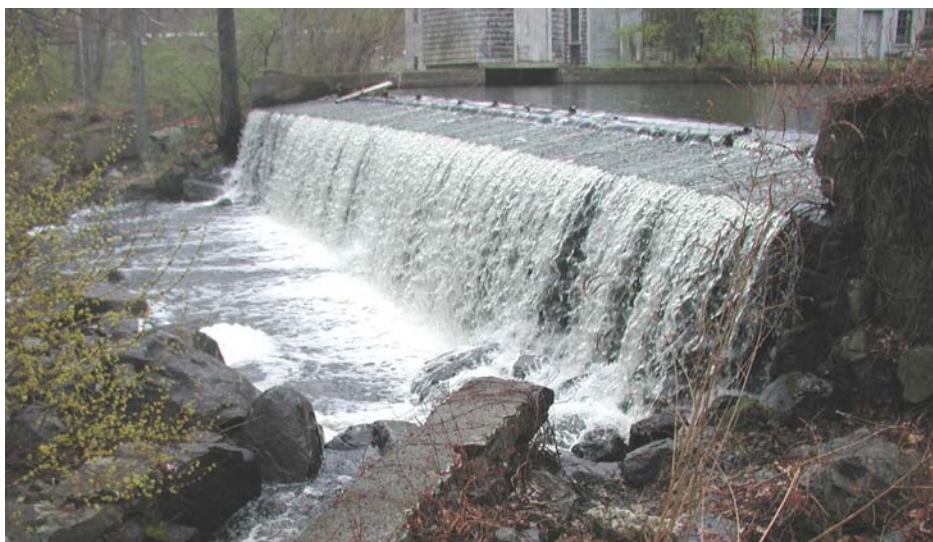
Snuff Mill Dam

<b>Design</b>	<b>Material</b>	<b>Length (ft)</b>	<b>Inside W (ft)</b>	<b>Outside W (ft)</b>	<b># of Baffles</b>	<b>Baffle H (ft)</b>	<b>Notch W (ft)</b>	<b>Pool L (ft)</b>	<b>Condition/Function</b>
Notched weir-pool	Concrete and stone	106.0	Varied (2.2-4.6)	Varied (4.1-5.8)	13	1.9	1.5	Varied (8.3-10.4)	Fair Inefficient passage

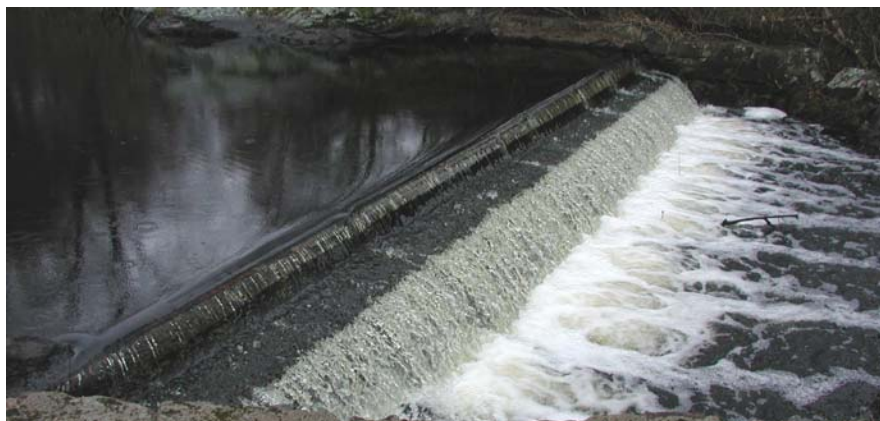
River Street Dam

Design	Material	Length (ft)	Inside W (ft)	Outside W (ft)	# of Baffles	Baffle H (ft)	Notch W (ft)	Pool L (ft)	Condition/Function
Notched weir-pool	Stone and concrete	65.0	3.9	7.0	8	1.5	3.1	Varied (7.1, 8.4, 6.9)	Poor Passable
