# MassDEP Field Assessment and Support Team

## After Incident Report

NE-10-06603

## Peabody High School Mercury Spill Incident

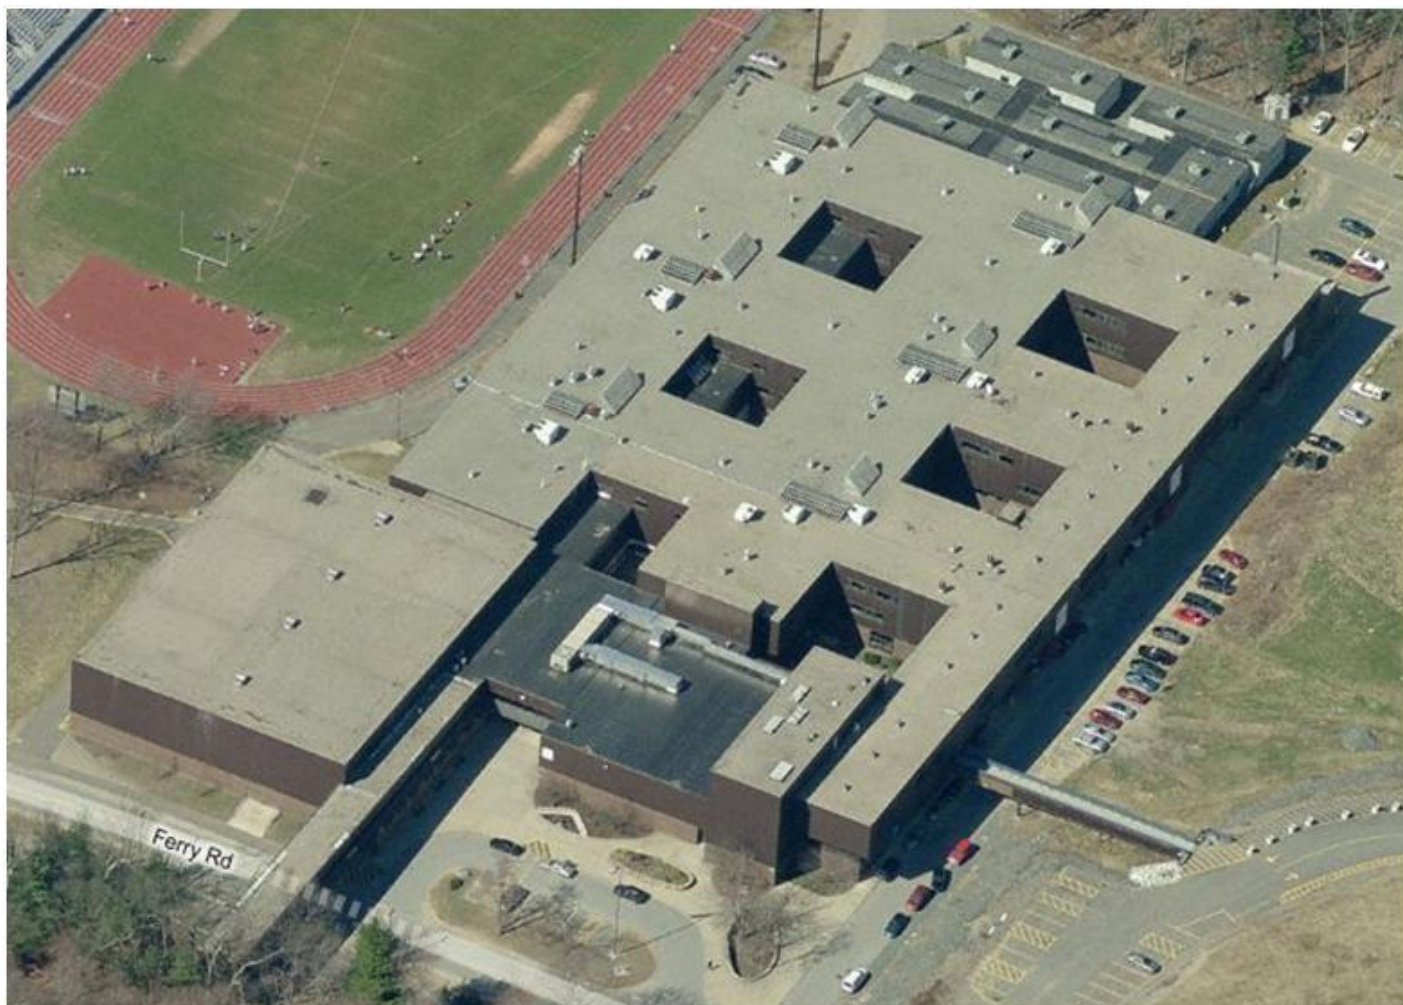
The barometer was being stored in the Science Laboratory Stockroom, between Classroom Science Labs C-268 and C-269, located on the second floor in the northwest corner of the building (see Figure 1). It was hand-carried through room C-268 and then into the corridor, where it was moved in a southerly direction for about 300 feet to the Science Office. It was then carried easterly to a nearby staircase, where it was transported downstairs. At some point, the custodian had noted that a small amount of elemental mercury had spilled onto his hand (less than one teaspoon), and he returned to the Science Office, where the science teacher helped him pack and secure the barometer in a plastic bag/trash can. The trash can was moved down the stairs and into the nearby mechanical storage room. These movements are illustrated via the blue arrows in Figure 1.
