***South Shore Coastal Infrastructure Inventory
and Assessment Demonstration Project
Coastal Hazards Commission***

Town of Plymouth

**Prepared for:
Office of Coastal Zone Management
Boston, MA**

February 28, 2007

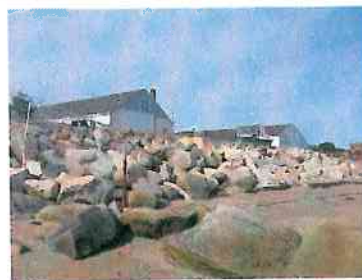
This structure is a stone revetment fronting a concrete seawall. The stone is weathered and becoming unraveled. The wall is not visible for evaluation.

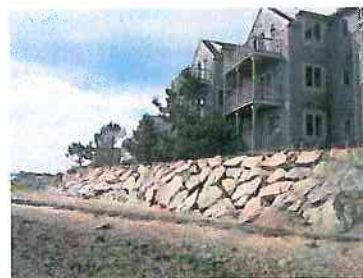
This structure is a stone revetment. The side slopes are very steep and also vertical in some sections. The northern corner is grouted. There are many areas of shifted and displaced armor stones. The oversteepened side slopes are a stability concern.

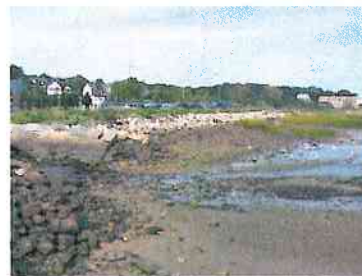
This structure is a small stone revetment fronting a parking lot. The stone is weathered and the side slopes have slumped along most of the section.

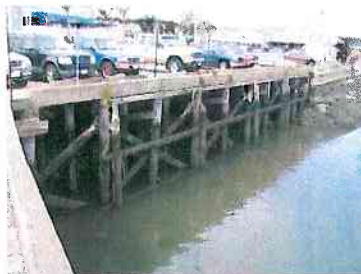
This structure is a stone revetment beneath a wooden quay wall supported by timber piles. There is no access to evaluate the structure. Even visual assessment is difficult.

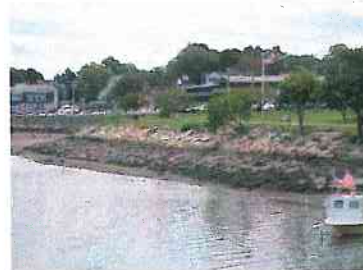
This structure is a stone revetment fronting a small park. The bottom half of the armor stone is grouted. The top and bottom sections are not well connected, with the top being slumped in sections.

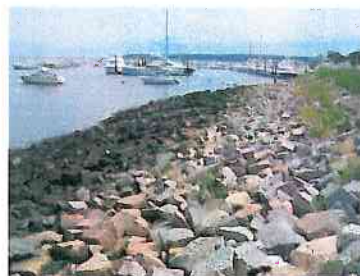
The structure is a stone revetment fronting a park. The stone is weathered and slumped. A backing of granite stone has become exposed. There is no defined side slope.

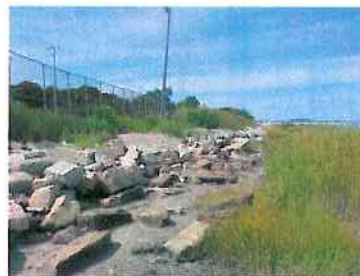
This structure is line of strewn rubble and stone lying parallel to the shoreline. The is no slope or interlocking of stones/debris.

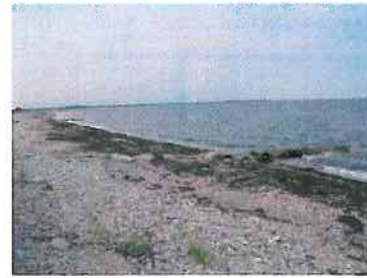
This is a field of 5 stone groins. The stones have become largely unraveled so that no crest or side slopes are discernable. The groins are not serving much purpose.

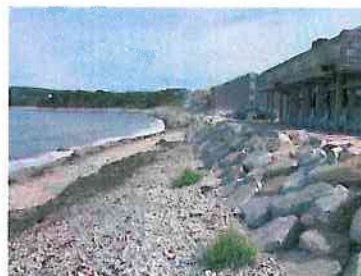
This structure is a stone revetment. It fronts a concrete seawall and has a wave return face in some sections. Along the center of the structure there are armor stone along the toe which have become displaced. This has resulted in some areas of a slumping crest.

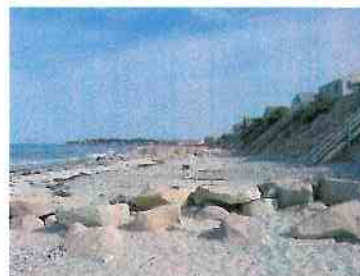
This is a field of 6 stone groins, with approximately 200 foot spacing between them. The groins show no crest or side slopes and appear instead to be a linear pile of large stone. A majority of the length of each groin is above mean low water, so they have little to no impact on sediment transport along the beach. Each groin is approximately 100 feet long.

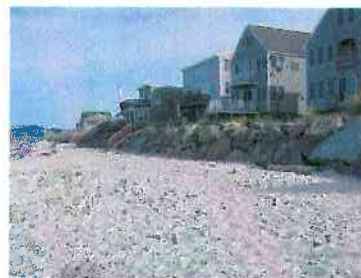
This structure is an almost vertical stone revetment. There are areas of displaced armor stone and slumped crest.

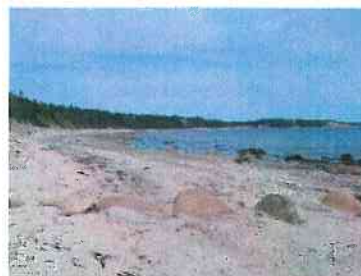
This is a field of 13 stone groins. The tips extend approximately to mean low water. A majority of the groins are unraveled and not trapping sand. Each groin is about 75 to 100 feet long.

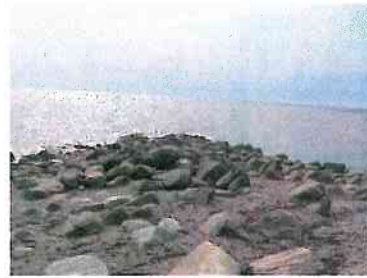
This structure is a pile of stone at a small bend in the beach. This could either be a very old groin or simply natural armoring of a small promontory.

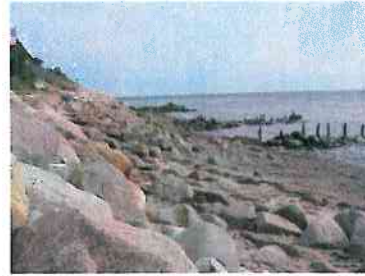
This structure is a stone revetment. It is grouted at the southern end and not grouted at the northern end. There are areas of slumped armor and voids between the stones. An old concrete seawall is visible behind some sections of the structure.

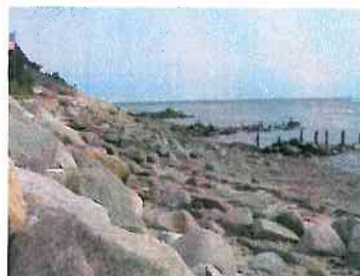
This is a field of 7 stone groins. A majority of each groin is unraveled. The tips of the groins extend approximately to mean low water. The groins are essentially non-functional. Each groin is approximately 50 feet long.
