## INCIDENT HIGHLIGHTS

**REPORT#:** 18MA035

## Property Maintenance Worker Caught between Industrial Sweeper and Low Ceiling—Massachusetts

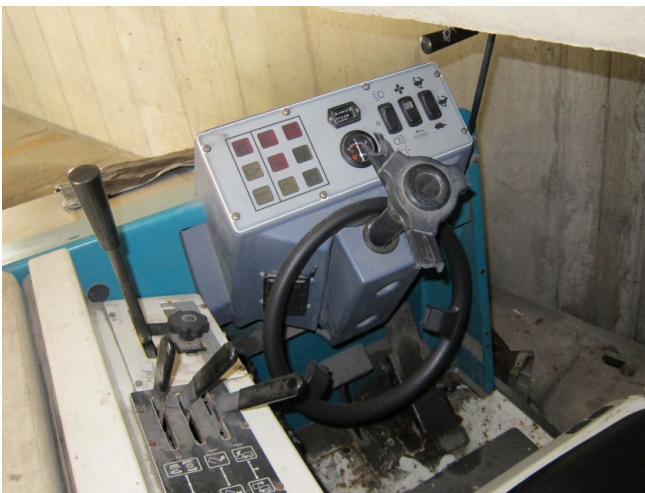
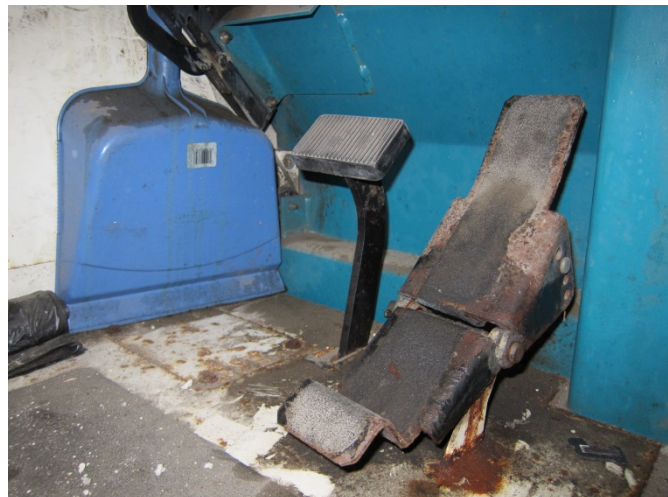
Figure 4 – Industrial sweeper, front view.

The machine weighed 3,520 pounds and had a hopper capacity of 14 cubic feet and up to 1,200 pounds. The sweeper had a main brush that was cylindrical and was 45 inches wide. The front right corner brush had a diameter of 26 inches. The sweeper brushes were linked to a hydraulic system and the brushes were lowered or raised using control levers located in the operator's area. The hopper was raised and dumped using control levers also located in the operator's area. The discharge height of the sweeper was up to 60 inches and the collected debris was discharged into a dumpster at the site.

The sweeper had a maximum ground speed of 10 mph in forward and 2.5 mph in reverse. Steering was provided by the single rear-wheel that located in the center at the rear of the machine. The sweeper had a central brake pedal and a directional pedal that controlled forward and reverse motion. The pedal was pressed with the toe to accelerate forward or pressed with the heel to move in reverse. It had an integrated heel rest to help the operator position their foot. Removing pressure on the pedal would allow it to return to neutral. This was one way to stop the machine's motion. The brake pedal could also be used to stop the machine. A parking brake lever was located to the left of the brake pedal.

The sweeper had two external warning decals in the operator's area that included simple messaging about reading the manual before operation and describing the toxic gas emissions and the need for ventilation. The manufacturer-developed operator's manual detailed these hazards as well as pinch points, moving fans and belts, and hot surfaces. The manual was made available to operators and was used in training.

The unit was purchased used in 2004 from the manufacturer and was estimated to be 17 years old at the time of the incident. The operation clock was up to 650 hours at the time of the incident. The sweeper was serviced by the dealer twice each year and had been serviced the week prior to the incident and was tested and found to be operating normally.
