*Massachusetts Coastal Infrastructure  
Inventory and Assessment Project  
Coastal Hazards Commission*

**Boston Harbor - South**

Quincy  
Milton  
Braintree  
Weymouth

**July 6, 2009**

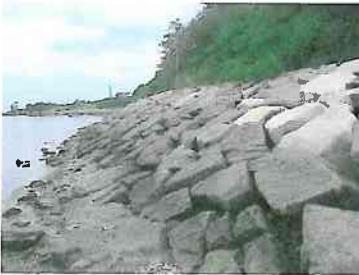
Property Owner:	Location:	Date:
Local	Island Avenue	6/21/2007
Presumed Structure Owner:	Based On Comment:	
Local		
Owner Name:	Earliest Structure Record:	Estimated Reconstruction/Repair Cost:
Quincy	Unknown	\$39,039.00

325 Feet	Feet NAVD 88	AE	10 Feet NGVD	
Primary Type:	Primary Material:	Primary Height:		
Revetment	Stone	5 to 10 Feet		
Secondary Type:	Secondary Material:	Secondary Height:

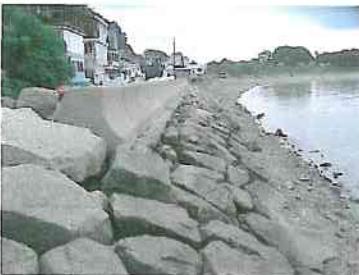
Property Owner:	Location:	Date:
Local	Nut Island Avenue	6/21/2007
Presumed Structure Owner:	Based On Comment:	
Local		
Owner Name:	Earliest Structure Record:	Estimated Reconstruction/Repair Cost:
Quincy	Unknown	\$53,196.00

260 Feet	Feet NAVD 88	AE	10 Feet NGVD	
Primary Type:	Primary Material:	Primary Height:		
Bulkhead/ Seawall	Concrete	Under 5 Feet		
Secondary Type:	Secondary Material:	Secondary Height:		
Revetment	Stone	5 to 10 Feet

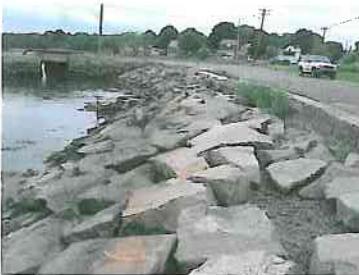
180 Feet	Feet NAVD 88	AE	12 Feet NGVD	
Primary Type:	Primary Material:	Primary Height:		
Bulkhead/ Seawall	Stone	Under 5 Feet		
Secondary Type:	Secondary Material:	Secondary Height:		
Revetment	Stone	5 to 10 Feet		
Structure Summary : The mortared stone block seawall has stones that are approximately 3 feet by 1.5 feet by 1.5 feet. The wall has areas of undermine and erosion. The placed riprap is approximately 3 feet by 2 feet by 1 foot with a 1 on 4 slope. There is some settling. There is a flood relief drain in the slope.				
<i>Condition</i>	B	<i>Priority</i>	II	
<i>Rating</i>	Good	<i>Rating</i>	Low Priority	
<i>Level of Action</i>	Minor	<i>Action</i>	Future Project Consideration	
<i>Description</i>	Structure observed to exhibit very minor problems, superficial in nature. Minor erosion to landform is present. Structure / landform adequate to provide protection from a major coastal storm with no damage. Actions taken to prevent / limit future deterioration and extend life of structure.	<i>Description</i>	Inshore Structures Present with Limited potential for Significant Infrastructure Damage

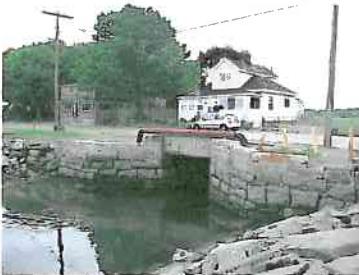
Property Owner:	Location:	Date:
Local	Rockland Street	6/14/2007
Presumed Structure Owner:	Based On Comment:	
Local		
Owner Name:	Earliest Structure Record:	Estimated Reconstruction/Repair Cost:
Quincy	1991	\$275,880.00

110 Feet	Feet NAVD 88	AE	12 Feet NGVD	
Primary Type:	Primary Material:	Primary Height:		
Bulkhead/ Seawall	Stone	10 to 15 Feet		
Secondary Type:	Secondary Material:	Secondary Height:

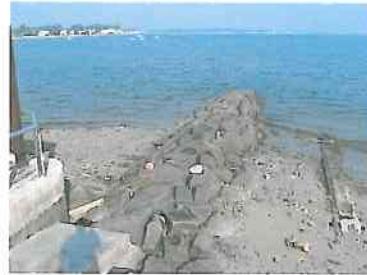
Property Owner:	Location:	Date:
Local	Post Island	6/27/2007
Presumed Structure Owner:	Based On Comment:	
Local		
Owner Name:	Earliest Structure Record:	Estimated Reconstruction/Repair Cost:
Quincy	1941	\$519,600.00

2165 Feet	VE Feet NAVD 88	14	Feet NGVD	
Primary Type:	Primary Material:	Primary Height:		
Groin/ Jetty	Stone	5 to 10 Feet		
Secondary Type:	Secondary Material:	Secondary Height:

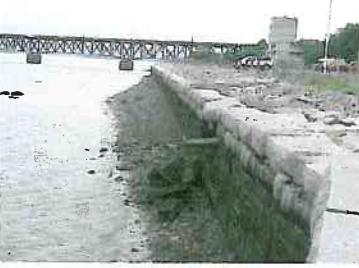
Property Owner:	Location:	Date:
Local	Moon Island - Boston Fire Academy	6/11/2009
Presumed Structure Owner:	Based On Comment:	
Local		
Owner Name:	Earliest Structure Record:	Estimated Reconstruction/Repair Cost:
Boston	Unknown	\$212,850.00

1075 Feet	FEET NAVD 88	VE	14 Feet NGVD	
Primary Type:	Primary Material:	Primary Height:		
Bulkhead/ Seawall	Stone	Over 15 Feet		
Secondary Type:	Secondary Material:	Secondary Height:

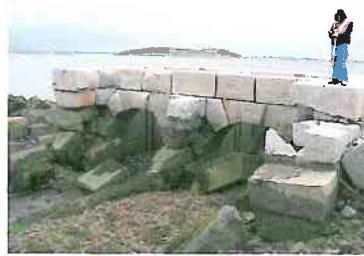
Stone block structure built for the now abandoned drainage system behind it. Blocks are set six courses high and approximately 6 feet by 3 feet by 4 feet. Moderate to heavy stone movement and unraveling. The brick pipes behind have failed.

<i>Condition</i>	D	<i>Priority</i>	II
<i>Rating</i>	Poor	<i>Rating</i>	Low Priority
<i>Level of Action</i>	Major	<i>Action</i>	Future Project Consideration
<i>Description</i>	Structure exhibits advanced levels of deterioration, section loss, cracking, spalling, undermining, and/or scour. Structure has strong risk of significant damage and possible failure during a major coastal storm. Structure should be monitored until repairs/reconstruction can be initiated. Actions taken to reconstruct structure to regain full capacity to resist a major coastal storm. Landform eroded, stability threatened. Landform not adequate to provide protection during major coastal storm. Actions taken to recreate landform to adequate limits for full protection from a major coastal storm.	<i>Description</i>	Inshore Structures Present with Limited potential for Significant Infrastructure Damage

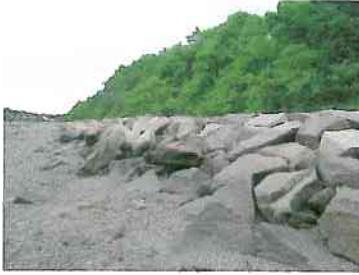
Placed Stone rip rap with stone approximately 3 feet by 3 feet. Behind is the only road to Moon and Long Islands. This is the south side of the causeway. Moderate stone movement and shifting. No visible scour. Creast is one stone wide.

<i>Condition</i>	C	<i>Priority</i>	V
<i>Rating</i>	Fair	<i>Rating</i>	Immediate / Highest Priority
<i>Level of Action</i>	Moderate	<i>Action</i>	Consider For Immediate Action Due to Public Safety and Welfare Issues
<i>Description</i>	Structure is sound but may exhibit minor deterioration, section loss, cracking, spalling, undermining, and/or scour. Structure adequate to withstand major coastal storm with little to moderate damage. Actions taken to reinforce structure to provide full protection from major coastal storm and for extending life of structure. Moderate wind or wave damage to landform exists. Landform may not be sufficient to fully protect shoreline during a major coastal storm. Actions taken to provide addition material for full protection and extended life.	<i>Description</i>	Critical Inshore Structures Present with Potential for Infrastructure Damage and/or High Density Residential Dwellings Condition of structure may warrant emergency stabilization as failure may result in potential loss of property and/or life. (>10 dwellings impacted / 100 feet of shoreline )

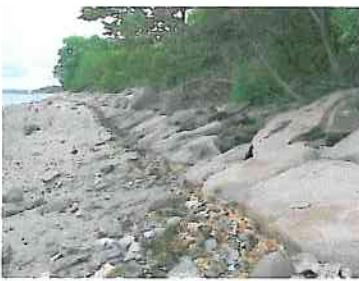
<i>Condition</i>	C	<i>Priority</i>	IV
<i>Rating</i>	Fair	<i>Rating</i>	High Priority
<i>Level of Action</i>	Moderate	<i>Action</i>	Consider for Next Project Construction Listing
<i>Description</i>	Structure is sound but may exhibit minor deterioration, section loss, cracking, spalling, undermining, and/or scour. Structure adequate to withstand major coastal storm with little to moderate damage. Actions taken to reinforce structure to provide full protection from major coastal storm and for extending life of structure. Moderate wind or wave damage to landform exists. Landform may not be sufficient to fully protect shoreline during a major coastal storm. Actions taken to provide additional material for full protection and extended life.	<i>Description</i>	High Value Inshore Structures with Potential for Infrastructure Damage and/or Moderate Density Residential Dwellings ( 1-10 dwellings impacted / 100 feet of shoreline)

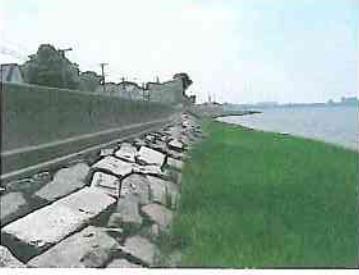
Condition	C	Priority	IV
Rating	Fair	Rating	High Priority
Level of Action	Moderate	Action	Consider for Next Project Construction Listing
Description	Structure is sound but may exhibit minor deterioration, section loss, cracking, spalling, undermining, and/or scour. Structure adequate to withstand major coastal storm with little to moderate damage. Actions taken to reinforce structure to provide full protection from major coastal storm and for extending life of structure. Moderate wind or wave damage to landform exists. Landform may not be sufficient to fully protect shoreline during a major coastal storm. Actions taken to provide addition material for full protection and extended life.

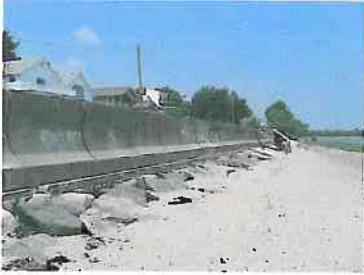
The precast wall with wave return face is 2 feet wide by 4 feet high. The riprap is on a 1 to 2 slope. The dumped stones are approximately 2 feet by 1 foot by 1 foot. The toe is burried. There is no visible scour. Some shifting in the stones. There is minor cracking in the wall.

<i>Condition</i>	B	<i>Priority</i>	III
<i>Rating</i>	Good	<i>Rating</i>	Moderate Priority
<i>Level of Action</i>	Minor	<i>Action</i>	Consider for Active Project Improvement Listing
<i>Description</i>	Structure observed to exhibit very minor problems, superficial in nature. Minor erosion to landform is present. Structure / landform adequate to provide protection from a major coastal storm with no damage. Actions taken to prevent / limit future deterioration and extend life of structure.	<i>Description</i>	Inshore Structures with potential for Infrastructure Damage and/or Limited Residential Dwellings (<1 dwelling impacted / 100 feet of shoreline)

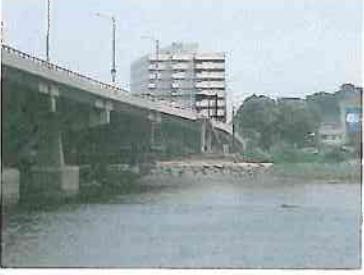
<i>Condition</i>	B	<i>Priority</i>	V
<i>Rating</i>	Good	<i>Rating</i>	Immediate / Highest Priority
<i>Level of Action</i>	Minor	<i>Action</i>	Consider For Immediate Action Due to Public Safety and Welfare Issues
<i>Description</i>	Structure observed to exhibit very minor problems, superficial in nature. Minor erosion to landform is present. Structure / landform adequate to provide protection from a major coastal storm with no damage. Actions taken to prevent / limit future deterioration and extend life of structure.	<i>Description</i>	Critical Inshore Structures Present with Potential for Infrastructure Damage and/or High Density Residential Dwellings Condition of structure may warrant emergency stabilization as failure may result in potential loss of property and/or life. (>10 dwellings impacted / 100 feet of shoreline )

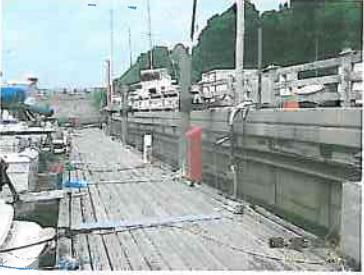
The seawall consists of steel H-Pile soldier piles spaced approximately every 6 feet with concrete panels spanning in between. There is also a double channel wale across the face of the wall with tie rods approximately every 6 feet. The concrete is in good condition with a typical weathered appearance and the exposed portions of the steel wale appear to be in good condition, but are uncoated.

<i>Condition</i>	B	<i>Priority</i>	IV
<i>Rating</i>	Good	<i>Rating</i>	High Priority
<i>Level of Action</i>	Minor	<i>Action</i>	Consider for Next Project Construction Listing
<i>Description</i>	Structure observed to exhibit very minor problems, superficial in nature. Minor erosion to landform is present. Structure / landform adequate to provide protection from a major coastal storm with no damage. Actions taken to prevent / limit future deterioration and extend life of structure.	<i>Description</i>	High Value Inshore Structures with Potential for Infrastructure Damage and/or Moderate Density Residential Dwellings ( 1-10 dwellings impacted / 100 feet of shoreline)

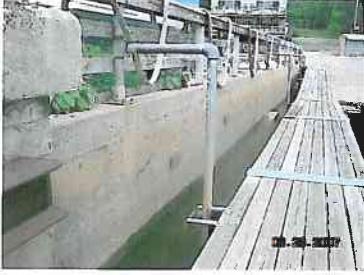
85 Feet	Feet NAVD 88	AE	12 Feet NGVD	
Primary Type:	Primary Material:	Primary Height:		
Bulkhead/ Seawall	Concrete	Under 5 Feet		
Secondary Type:	Secondary Material:	Secondary Height:		
Structure Summary : A poured concrete retaining wall along the edge of a boat ramp. The wall has a fence fixed along the top with a floating dock in front of it. The concrete is in good condition with only minor abrasions.				
<i>Condition</i>	B	<i>Priority</i>	III	
<i>Rating</i>	Good	<i>Rating</i>	Moderate Priority	
<i>Level of Action</i>	Minor	<i>Action</i>	Consider for Active Project Improvement Listing	
<i>Description</i>	Structure observed to exhibit very minor problems, superficial in nature. Minor erosion to landform is present. Structure / landform adequate to provide protection from a major coastal storm with no damage. Actions taken to prevent / limit future deterioration and extend life of structure.	<i>Description</i>	Inshore Structures with potential for Infrastructure Damage and/or Limited Residential Dwellings (<1 dwelling impacted / 100 feet of shoreline)

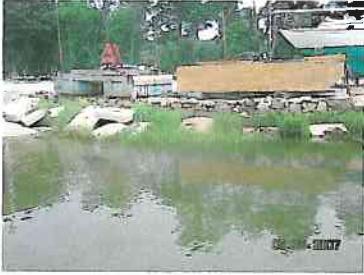
A low level, dry set stone wall with stone sizes varying from small cobbles to 3 feet diameter stones. The wall is situated along the edge of the water and has wetland areas offshore and supports a parking lot to the rear. The wall is in good condition with most of the stones still in place and properly aligned.

<i>Condition</i>	B	<i>Priority</i>	III
<i>Rating</i>	Good	<i>Rating</i>	Moderate Priority
<i>Level of Action</i>	Minor	<i>Action</i>	Consider for Active Project Improvement Listing
<i>Description</i>	Structure observed to exhibit very minor problems, superficial in nature. Minor erosion to landform is present. Structure / landform adequate to provide protection from a major coastal storm with no damage. Actions taken to prevent / limit future deterioration and extend life of structure.	<i>Description</i>	Inshore Structures with potential for Infrastructure Damage and/or Limited Residential Dwellings (<1 dwelling impacted / 100 feet of shoreline)

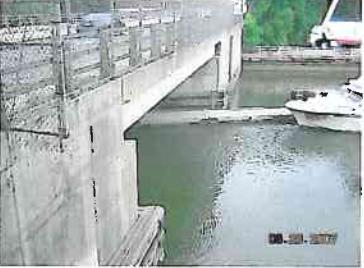
A mortared seawall that ties into a bridge abutment and consists of a granite block foundation with an average block size of 2 feet by 3 feet. A poured concrete wall is located on top of the granite block foundation. The granite block foundation is in good condition but the concrete wall on top is showing signs of deterioration with evidence of spalling and cracking.

<i>Condition</i>	B	<i>Priority</i>	III
<i>Rating</i>	Good	<i>Rating</i>	Moderate Priority
<i>Level of Action</i>	Minor	<i>Action</i>	Consider for Active Project Improvement Listing
<i>Description</i>	Structure observed to exhibit very minor problems, superficial in nature. Minor erosion to landform is present. Structure / landform adequate to provide protection from a major coastal storm with no damage. Actions taken to prevent / limit future deterioration and extend life of structure.	<i>Description</i>	Inshore Structures with potential for Infrastructure Damage and/or Limited Residential Dwellings (<1 dwelling impacted / 100 feet of shoreline)

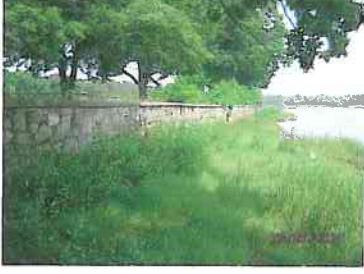
A granite block seawall with mortar between the blocks. The average size of the blocks is approximately 1 foot by 2 feet. The wall is capped with a 4 inch thick concrete cap. All of the structure looks in good condition including stone, mortar, and cap.

<i>Condition</i>	B	<i>Priority</i>	II
<i>Rating</i>	Good	<i>Rating</i>	Low Priority
<i>Level of Action</i>	Minor	<i>Action</i>	Future Project Consideration
<i>Description</i>	Structure observed to exhibit very minor problems, superficial in nature. Minor erosion to landform is present. Structure / landform adequate to provide protection from a major coastal storm with no damage. Actions taken to prevent / limit future deterioration and extend life of structure.	<i>Description</i>	Inshore Structures Present with Limited potential for Significant Infrastructure Damage

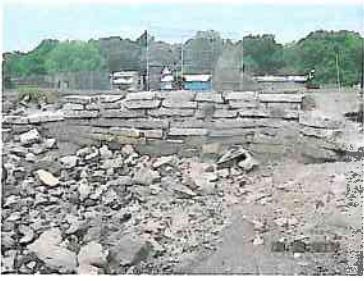
<i>Condition</i>	C	<i>Priority</i>	II
<i>Rating</i>	Fair	<i>Rating</i>	Low Priority
<i>Level of Action</i>	Moderate	<i>Action</i>	Future Project Consideration
<i>Description</i>	Structure is sound but may exhibit minor deterioration, section loss, cracking, spalling, undermining, and/or scour. Structure adequate to withstand major coastal storm with little to moderate damage. Actions taken to reinforce structure to provide full protection from major coastal storm and for extending life of structure. Moderate wind or wave damage to landform exists. Landform may not be sufficient to fully protect shoreline during a major coastal storm. Actions taken to provide addition material for full protection and extended life.	<i>Description</i>	Inshore Structures Present with Limited potential for Significant Infrastructure Damage

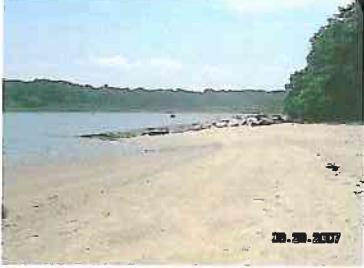
A stone jetty constructed of placed armor stone with an average stone size of 3 feet by 3 feet. The revetment is located at the south end of the beach. It appears to be in good condition with none of the armor stone missing or displaced.

<i>Condition</i>	B	<i>Priority</i>	III
<i>Rating</i>	Good	<i>Rating</i>	Moderate Priority
<i>Level of Action</i>	Minor	<i>Action</i>	Consider for Active Project Improvement Listing
<i>Description</i>	Structure observed to exhibit very minor problems, superficial in nature. Minor erosion to landform is present. Structure / landform adequate to provide protection from a major coastal storm with no damage. Actions taken to prevent / limit future deterioration and extend life of structure.	<i>Description</i>	Inshore Structures with potential for Infrastructure Damage and/or Limited Residential Dwellings (<1 dwelling impacted / 100 feet of shoreline)

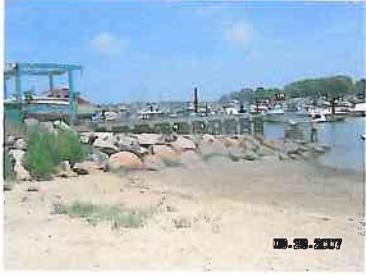
A stone jetty constructed of placed armor stone with an average stone size of 3 feet by 3 feet. The revetment is located at the north end of the beach. It appears to be in good condition with none of the armor stone missing or displaced.

<i>Condition</i>	B	<i>Priority</i>	III
<i>Rating</i>	Good	<i>Rating</i>	Moderate Priority
<i>Level of Action</i>	Minor	<i>Action</i>	Consider for Active Project Improvement Listing
<i>Description</i>	Structure observed to exhibit very minor problems, superficial in nature. Minor erosion to landform is present. Structure / landform adequate to provide protection from a major coastal storm with no damage. Actions taken to prevent / limit future deterioration and extend life of structure.	<i>Description</i>	Inshore Structures with potential for Infrastructure Damage and/or Limited Residential Dwellings (<1 dwelling impacted / 100 feet of shoreline)

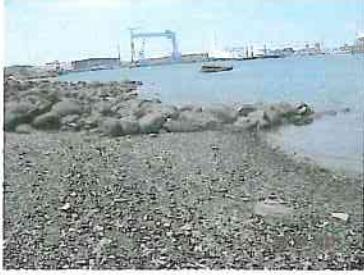
The revetment consist of very loosely dumped 1 to 3 foot diameter stones on top of an existing gravelly beach. The stone appears to provide little protection due to the loose placement.

<i>Condition</i>	D	<i>Priority</i>	III
<i>Rating</i>	Poor	<i>Rating</i>	Moderate Priority
<i>Level of Action</i>	Major	<i>Action</i>	Consider for Active Project Improvement Listing
<i>Description</i>	Structure exhibits advanced levels of deterioration, section loss, cracking, spalling, undermining, and/or scour. Structure has strong risk of significant damage and possible failure during a major coastal storm. Structure should be monitored until repairs/reconstruction can be initiated. Actions taken to reconstruct structure to regain full capacity to resist a major coastal storm. Landform eroded, stability threatened. Landform not adequate to provide protection during major coastal storm. Actions taken to recreate landform to adequate limits for full protection from a major coastal storm.	<i>Description</i>	Inshore Structures with potential for Infrastructure Damage and/or Limited Residential Dwellings (<1 dwelling impacted / 100 feet of shoreline)

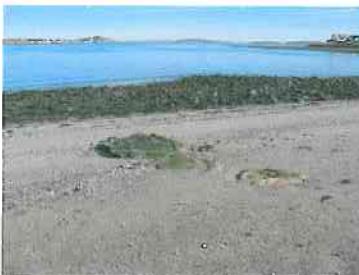
<i>Condition</i>	F	<i>Priority</i>	I
<i>Rating</i>	Critical	<i>Rating</i>	None
<i>Level of Action</i>	Immediate	<i>Action</i>	Long Term Planning Considerations
<i>Description</i>	Conditions of structure/landform may warrant emergency stabilization as failure may result in potential loss of property and/or life. Landform eroded, loss of integrity. Structure exhibits critical levels of deterioration, section loss, cracking, spalling, undermining, and/or scour. Structure provides little or no protection from a major coastal storm. Actions taken to totally reconstruct structure to regain full capacity. Landform stability is severely compromised, rate of erosion/material loss may be increasing, and landform does not provide adequate protection from a major coastal storm. Actions taken to recreate landform to adequate limits for full protection from a major coastal storm.	<i>Description</i>	No Inshore Structures or Residential Dwelling Units Present

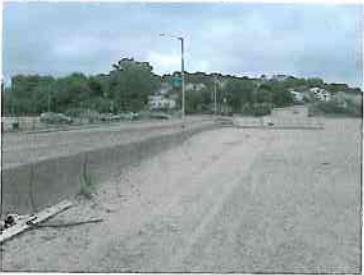
<i>Condition</i>	B	<i>Priority</i>	II
<i>Rating</i>	Good	<i>Rating</i>	Low Priority
<i>Level of Action</i>	Minor	<i>Action</i>	Future Project Consideration
<i>Description</i>	Structure observed to exhibit very minor problems, superficial in nature. Minor erosion to landform is present. Structure / landform adequate to provide protection from a major coastal storm with no damage. Actions taken to prevent / limit future deterioration and extend life of structure.	<i>Description</i>	Inshore Structures Present with Limited potential for Significant Infrastructure Damage

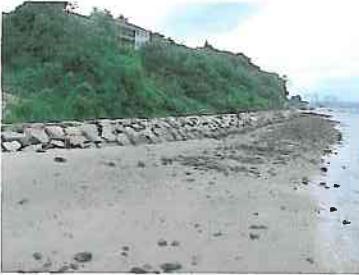
<i>Condition</i>	B	<i>Priority</i>	III
<i>Rating</i>	Good	<i>Rating</i>	Moderate Priority
<i>Level of Action</i>	Minor	<i>Action</i>	Consider for Active Project Improvement Listing
<i>Description</i>	Structure observed to exhibit very minor problems, superficial in nature. Minor erosion to landform is present. Structure / landform adequate to provide protection from a major coastal storm with no damage. Actions taken to prevent / limit future deterioration and extend life of structure.	<i>Description</i>	Inshore Structures with potential for Infrastructure Damage and/or Limited Residential Dwellings (<1 dwelling impacted / 100 feet of shoreline)

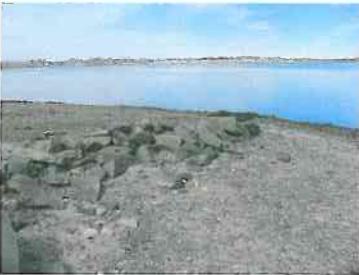
<i>Condition</i>	C	<i>Priority</i>	I
<i>Rating</i>	Fair	<i>Rating</i>	None
<i>Level of Action</i>	Moderate	<i>Action</i>	Long Term Planning Considerations
<i>Description</i>	Structure is sound but may exhibit minor deterioration, section loss, cracking, spalling, undermining, and/or scour. Structure adequate to withstand major coastal storm with little to moderate damage. Actions taken to reinforce structure to provide full protection from major coastal storm and for extending life of structure. Moderate wind or wave damage to landform exists. Landform may not be sufficient to fully protect shoreline during a major coastal storm. Actions taken to provide addition material for full protection and extended life.		
			No Inshore Structures or Residential Dwelling Units Present

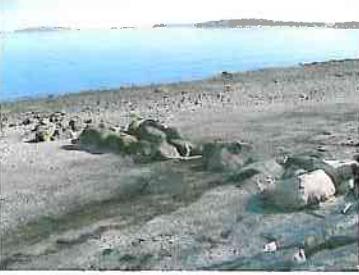
<i>Condition</i>	D	<i>Priority</i>	I
<i>Rating</i>	Poor	<i>Rating</i>	None
<i>Level of Action</i>	Major	<i>Action</i>	Long Term Planning Considerations
<i>Description</i>	Structure exhibits advanced levels of deterioration, section loss, cracking, spalling, undermining, and/or scour. Structure has strong risk of significant damage and possible failure during a major coastal storm. Structure should be monitored until repairs/reconstruction can be initiated. Actions taken to reconstruct structure to regain full capacity to resist a major coastal storm. Landform eroded, stability threatened. Landform not adequate to provide protection during major coastal storm. Actions taken to recreate landform to adequate limits for full protection from a major coastal storm.	<i>Description</i>	No Inshore Structures or Residential Dwelling Units Present

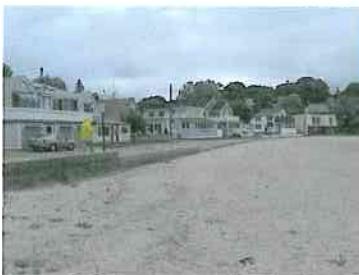
The precast concrete wall is 1.5 feet wide. The beach is in front of the structure, and a road and houses are behind it. There is minor cracking. There is no scour.

<i>Condition</i>	B	<i>Priority</i>	IV
<i>Rating</i>	Good	<i>Rating</i>	High Priority
<i>Level of Action</i>	Minor	<i>Action</i>	Consider for Next Project Construction Listing
<i>Description</i>	Structure observed to exhibit very minor problems, superficial in nature. Minor erosion to landform is present. Structure / landform adequate to provide protection from a major coastal storm with no damage. Actions taken to prevent / limit future deterioration and extend life of structure.	<i>Description</i>	High Value Inshore Structures with Potential for Infrastructure Damage and/or Moderate Density Residential Dwellings ( 1-10 dwellings impacted / 100 feet of shoreline)

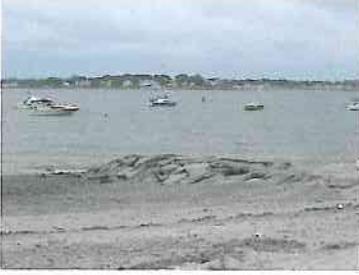
<i>Condition</i>	B	<i>Priority</i>	I
<i>Rating</i>	Good	<i>Rating</i>	None
<i>Level of Action</i>	Minor	<i>Action</i>	Long Term Planning Considerations
<i>Description</i>	Structure observed to exhibit very minor problems, superficial in nature. Minor erosion to landform is present. Structure / landform adequate to provide protection from a major coastal storm with no damage. Actions taken to prevent / limit future deterioration and extend life of structure.	<i>Description</i>	No Inshore Structures or Residential Dwelling Units Present

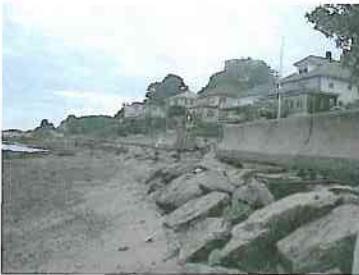
The precast wall with a wave return face. The riprap has stones of approximately 3 feet by 2 feet by 2 feet size. Some of the stones are buried by the sand at sections. Houses are located 15 feet behind the structures. There is no scour or erosion. There are some localized areas of cracking and section loss.

<i>Condition</i>	C	<i>Priority</i>	IV
<i>Rating</i>	Fair	<i>Rating</i>	High Priority
<i>Level of Action</i>	Moderate	<i>Action</i>	Consider for Next Project Construction Listing
<i>Description</i>	Structure is sound but may exhibit minor deterioration, section loss, cracking, spalling, undermining, and/or scour. Structure adequate to withstand major coastal storm with little to moderate damage. Actions taken to reinforce structure to provide full protection from major coastal storm and for extending life of structure. Moderate wind or wave damage to landform exists. Landform may not be sufficient to fully protect shoreline during a major coastal storm. Actions taken to provide addition material for full protection and extended life.	<i>Description</i>	High Value Inshore Structures with Potential for Infrastructure Damage and/or Moderate Density Residential Dwellings ( 1-10 dwellings impacted / 100 feet of shoreline)

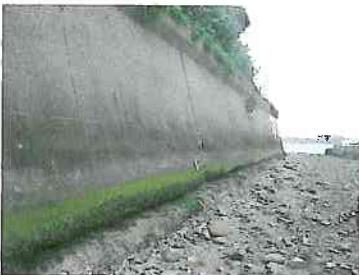
The cast in place wall has a wave return face that is 2 feet wide. There is scour and undermine at localized areas of the wall. There is cracking and spalling on the wall. There is an old wall or footing that the wall was built on that is still visible.

Condition	C	Priority	IV
Rating	Fair	Rating	High Priority
Level of Action	Moderate	Action	Consider for Next Project Construction Listing
Description	Structure is sound but may exhibit minor deterioration, section loss, cracking, spalling, undermining, and/or scour. Structure adequate to withstand major coastal storm with little to moderate damage. Actions taken to reinforce structure to provide full protection from major coastal storm and for extending life of structure. Moderate wind or wave damage to landform exists. Landform may not be sufficient to fully protect shoreline during a major coastal storm. Actions taken to provide addition material for full protection and extended life.	Description	High Value Inshore Structures with Potential for Infrastructure Damage and/or Moderate Density Residential Dwellings ( 1-10 dwellings impacted / 100 feet of shoreline)

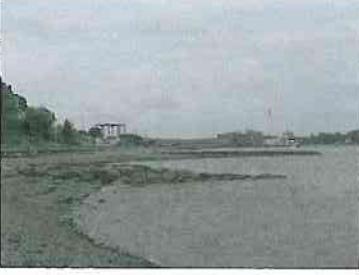
<i>Condition</i>	B	<i>Priority</i>	III
<i>Rating</i>	Good	<i>Rating</i>	Moderate Priority
<i>Level of Action</i>	Minor	<i>Action</i>	Consider for Active Project Improvement Listing
<i>Description</i>	Structure observed to exhibit very minor problems, superficial in nature. Minor erosion to landform is present. Structure / landform adequate to provide protection from a major coastal storm with no damage. Actions taken to prevent / limit future deterioration and extend life of structure.	<i>Description</i>	Inshore Structures with potential for Infrastructure Damage and/or Limited Residential Dwellings (<1 dwelling impacted / 100 feet of shoreline)

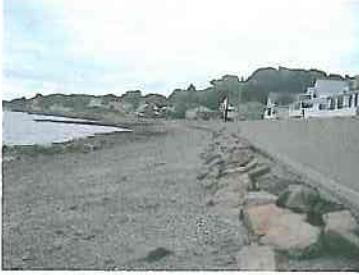
The cast in place wall is 2.5 feet wide by 3 feet high. The riprap is located in front of the wall. It is 3 feet by 2 feet by 2 feet. There is a beach in front of the structures. There is no scour or erosion. There is minor cracking.

<i>Condition</i>	C	<i>Priority</i>	IV
<i>Rating</i>	Fair	<i>Rating</i>	High Priority
<i>Level of Action</i>	Moderate	<i>Action</i>	Consider for Next Project Construction Listing
<i>Description</i>	Structure is sound but may exhibit minor deterioration, section loss, cracking, spalling, undermining, and/or scour. Structure adequate to withstand major coastal storm with little to moderate damage. Actions taken to reinforce structure to provide full protection from major coastal storm and for extending life of structure. Moderate wind or wave damage to landform exists. Landform may not be sufficient to fully protect shoreline during a major coastal storm. Actions taken to provide addition material for full protection and extended life.	<i>Description</i>	High Value Inshore Structures with Potential for Infrastructure Damage and/or Moderate Density Residential Dwellings ( 1-10 dwellings impacted / 100 feet of shoreline)

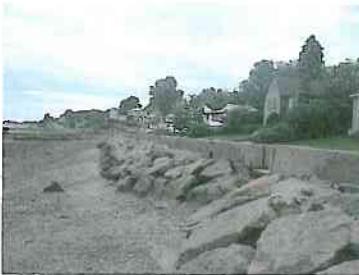
The cast in place wall is 1 foot wide. There are many sections of loss, cracking, erosion and exposed rebar. The beach is located in front of the structures and houses are behind the structures.

<i>Condition</i>	D	<i>Priority</i>	IV
<i>Rating</i>	Poor	<i>Rating</i>	High Priority
<i>Level of Action</i>	Major	<i>Action</i>	Consider for Next Project Construction Listing
<i>Description</i>	Structure exhibits advanced levels of deterioration, section loss, cracking, spalling, undermining, and/or scour. Structure has strong risk of significant damage and possible failure during a major coastal storm. Structure should be monitored until repairs/reconstruction can be initiated. Actions taken to reconstruct structure to regain full capacity to resist a major coastal storm. Landform eroded, stability threatened. Landform not adequate to provide protection during major coastal storm. Actions taken to recreate landform to adequate limits for full protection from a major coastal storm.

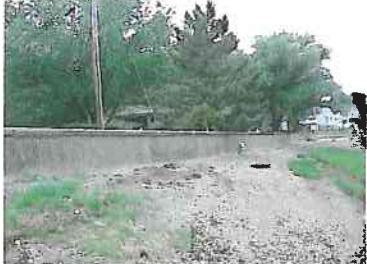
The cast in place wall is 1.5 feet wide by 5 feet high. The beach is in front of the wall and houses are behind it. There is no scour or undermining. There is minor cracking and spalling.

<i>Condition</i>	B	<i>Priority</i>	III
<i>Rating</i>	Good	<i>Rating</i>	Moderate Priority
<i>Level of Action</i>	Minor	<i>Action</i>	Consider for Active Project Improvement Listing
<i>Description</i>	Structure observed to exhibit very minor problems, superficial in nature. Minor erosion to landform is present. Structure / landform adequate to provide protection from a major coastal storm with no damage. Actions taken to prevent / limit future deterioration and extend life of structure.
