Request for Proposals for the Rehabilitation, Reuse and Maintenance of:

Beartown Headquarters House Building Conditions Survey Update
Beartown State Forest, Monterey, MA

BEARTOWN STATE FOREST
OLD SUPERINTENDENT'S HOUSE
MONTEREY, MA

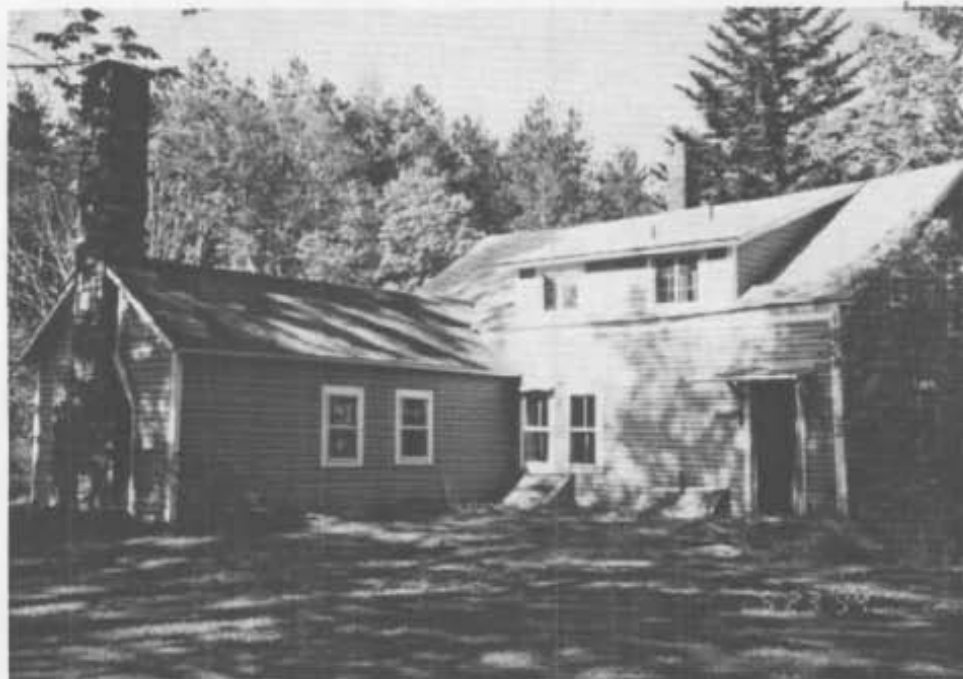
Figure 1

The Superintendent's House is an el-shaped, one and one-half story building (Figure 1) constructed on a level site. The oldest area, a post-and-beam structure built about 1800, includes a full basement with a concrete floor and mortared fieldstone walls; a 7'-7" foot high first floor with a kitchen and three large rooms; and a 6'-3" foot high second floor with four bedrooms and one bathroom. Shed dormers were added to the roof in modern times to improve the headroom in the bedrooms. The attic is low and unusable under the remaining upper area of the original roof.

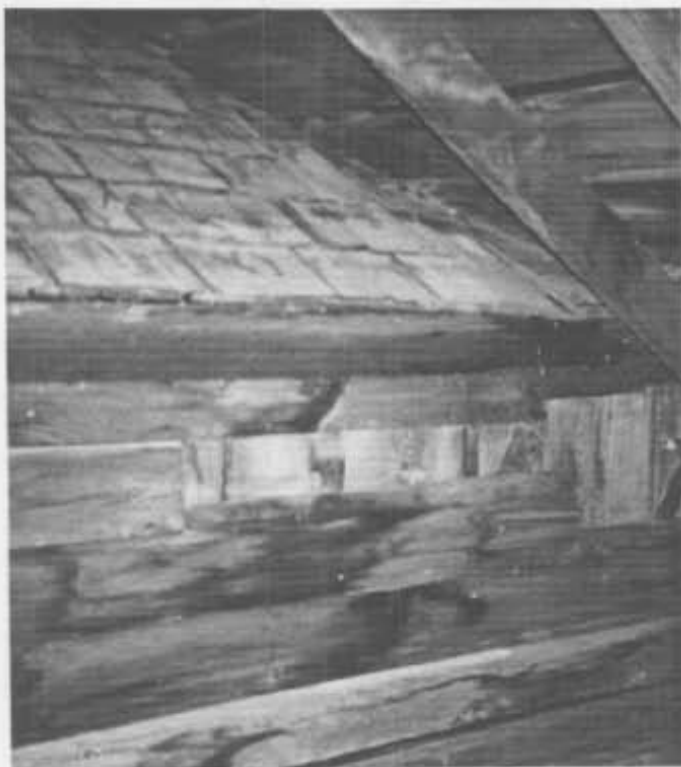
Figure 2

Because the eave of the wing is lower than the eave of the older part of the house, a section of the original wall "fabric" is encapsulated inside the attic of the wing (Figure 2). Instead of stud wall framing, the wall structure consists of two-inch thick vertical planks attached to the outside of the timber frame. Thick, unpainted seven inch wide weatherboards are shaved along their upper, lapping edge, leaving a five inch exposure. The inside surface of this wall is sheathed with horizontal boards and finished with wallpaper. A simple trim board and tilted eave soffit complete the wall construction. The planked wall is fairly common in houses built shortly after the Revolutionary War in the western areas of Massachusetts, New Hampshire and Vermont. Unusual, however, is the combination of the vertical plank construction with traditional post construction. According to Jan Lewandoski, an intellectual traditional framer who works in Vermont,

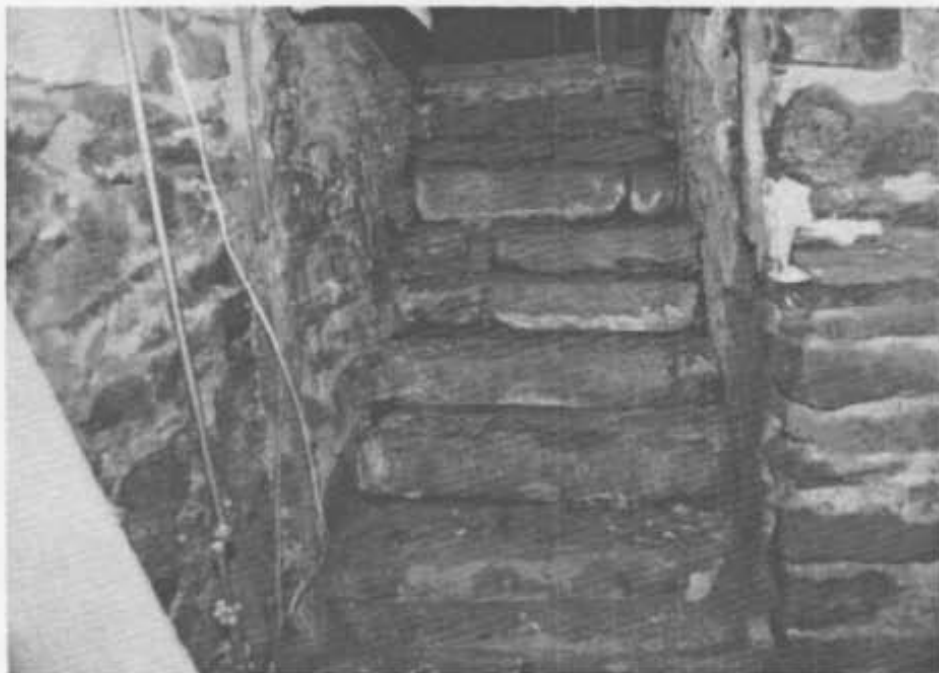
Figure 5

Foundations and Sills. The basement walls are mortared fieldstone in generally good condition. There is some dampness due to weeping of water through the stones for about four to five feet above the floor. The stone stairs leading out of the basement through the bulkhead are functional but irregular (Figure 5).

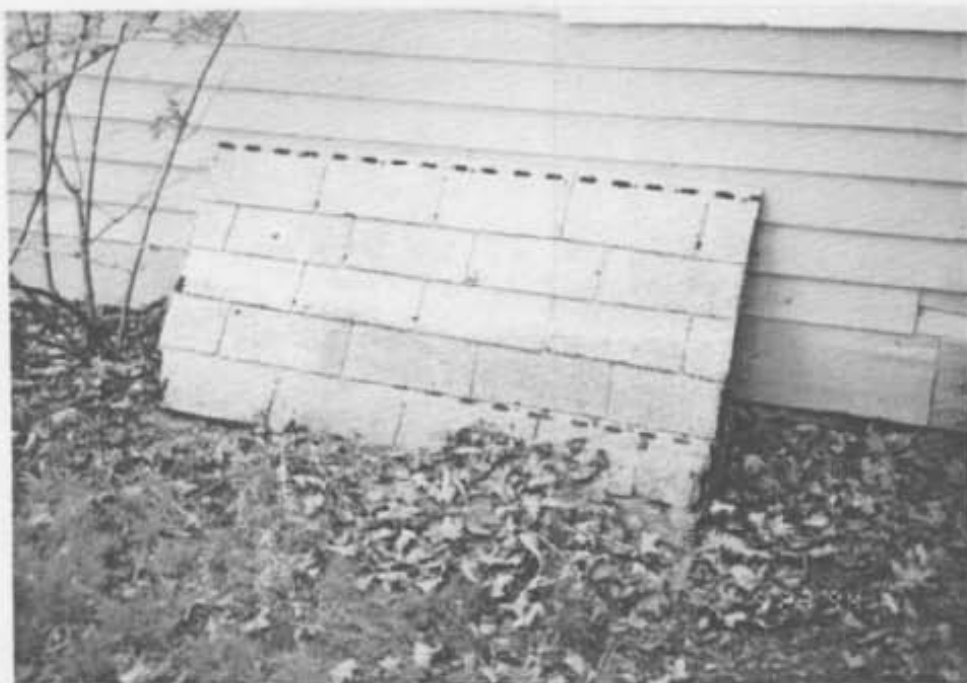
Figure 6

Small stone-lined window wells occur at the basement windows. As catchments for leaves and water the windows frames are in poor condition. Most of these windows are presently protected with shingled hatches (Figure 6).

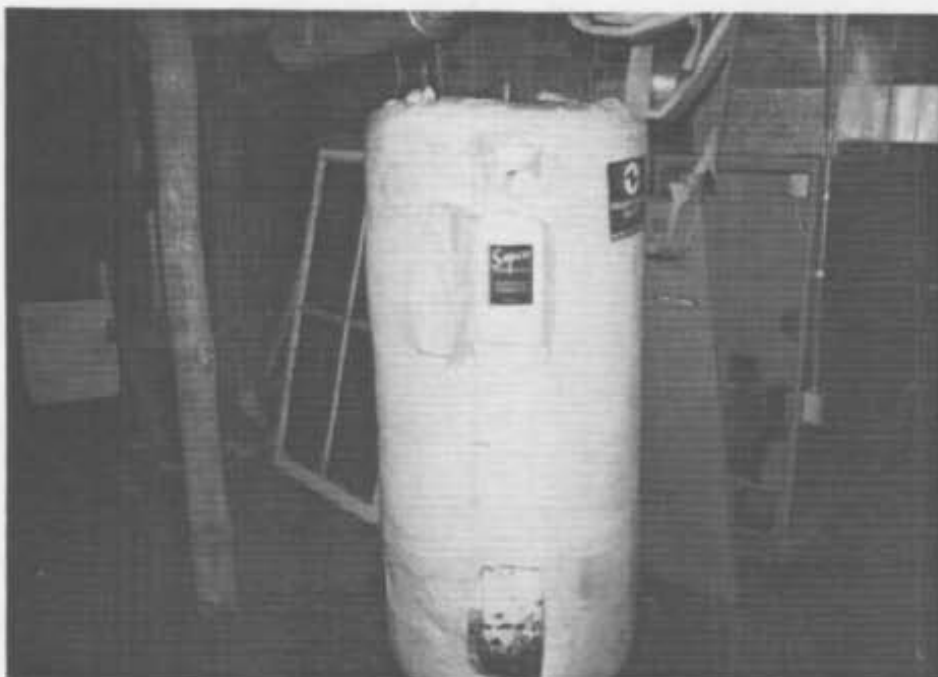
Figure 7

Plumbing. The water source reportedly is a well. A one inch galvanized or lead pipe enters the basement through the foundation wall near the bulkhead and is connected to a 1/2 inch copper pipe that feeds a severely rusted, 80 gallon Sepco electric hot water heater (Figure 7). All piping is disconnected. There is no pump or cold water storage tank. Supply piping is copper and drainage piping is PVC. The fixtures in both bathrooms and kitchen are basic and functional (Figures 8 and 9).

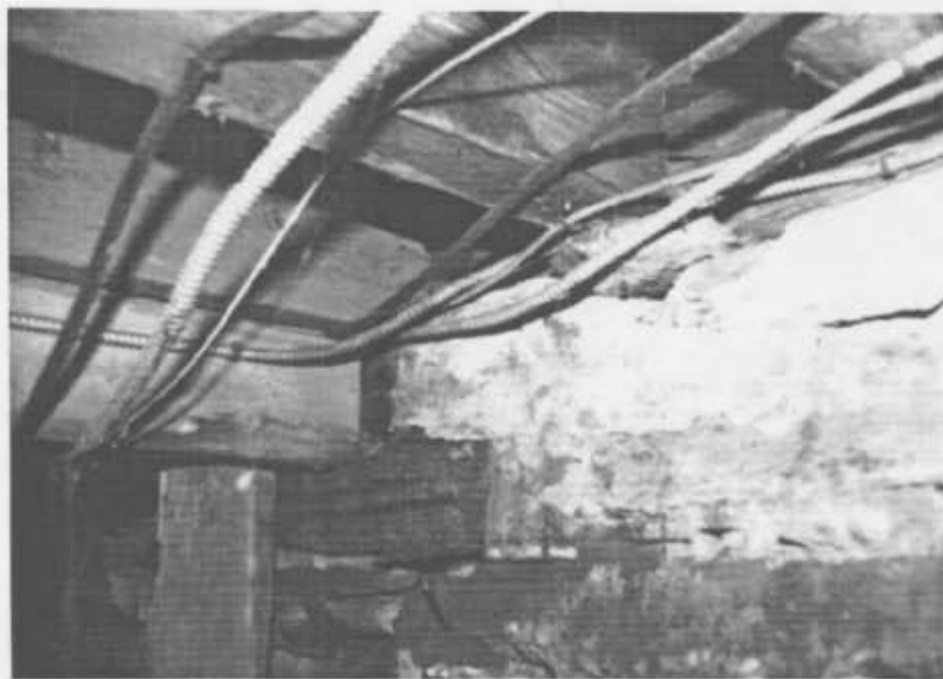
Figure 10

Electrical. The overhead service from the street is currently energized. There is a 100 amp electrical panel in the basement with overload protection by circuit breaker. Distribution wiring is a combination of nonmetallic sheathed cable and BX armored cable (Figure 10). There are typically three duplex outlets in each room but few switches. The entire electrical system including service entrance, wiring, and devices should be checked by a licensed electrician and upgraded as needed.

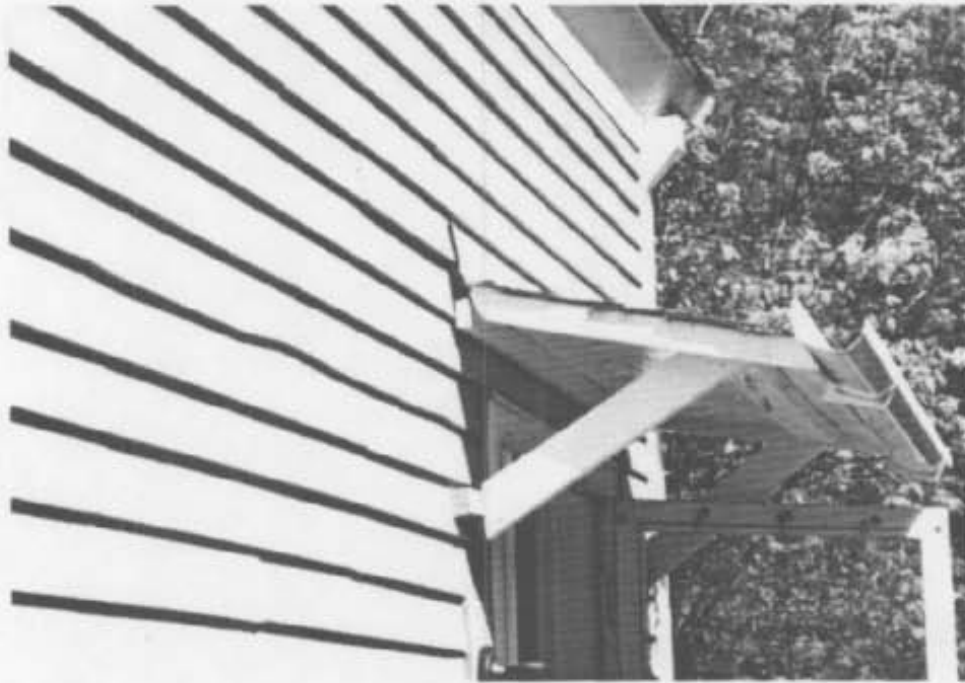
Figure 11

1. The flashing is incorrectly installed above the back door. It appears that there are two pieces of flashing. One is an inner piece correctly placed but with a large gap on its vertical edge; the other piece lays directly on top of the roof and allows water to enter from underneath and at its side (Figure 11).
2. The flashing is incorrectly installed between the small or east dormer wall and the roof. It has been woven into the clapboards so that there results a vertical gap and a vertically exposed edge that wind driven rain can penetrate.
3. The edges of the roof sheathing carry over the top of the fascia trim and bargeboards rather than being covered by them. This results in the vulnerable end grain of the sheathing being exposed to the weather and allows rain to weep under the sheathing into the soffit.

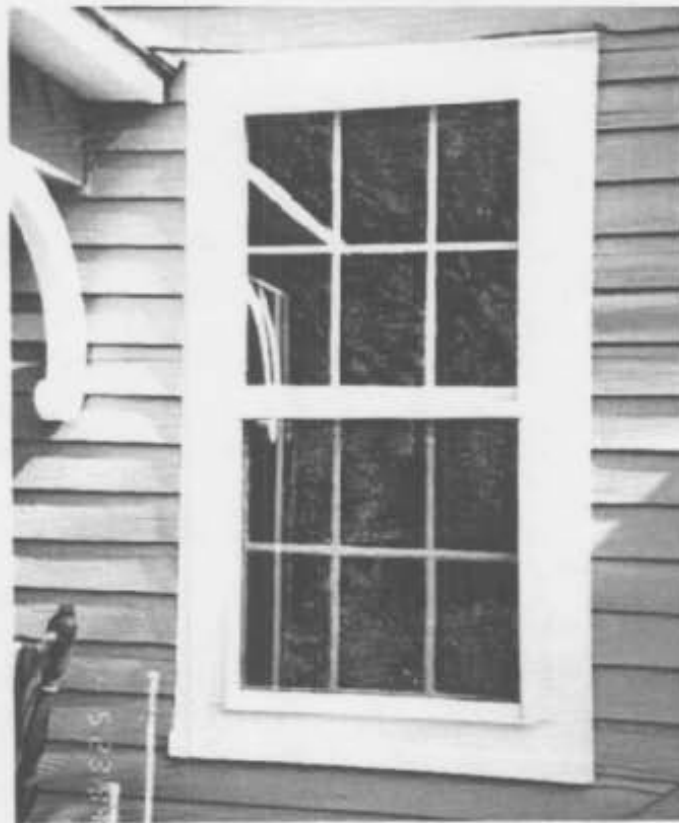
Figure 12

New aluminum screen and storm sets cover all but one window on the north side. Except for this one window, all window sashes, sills and trim boards have been recently restored and painted and are in excellent condition (Figure 12). The one window has the storm frame in place but the glass and screen are missing; the paint on the this window's muntins and stiles is peeling (Figure 14). The sill at this window is also punky.

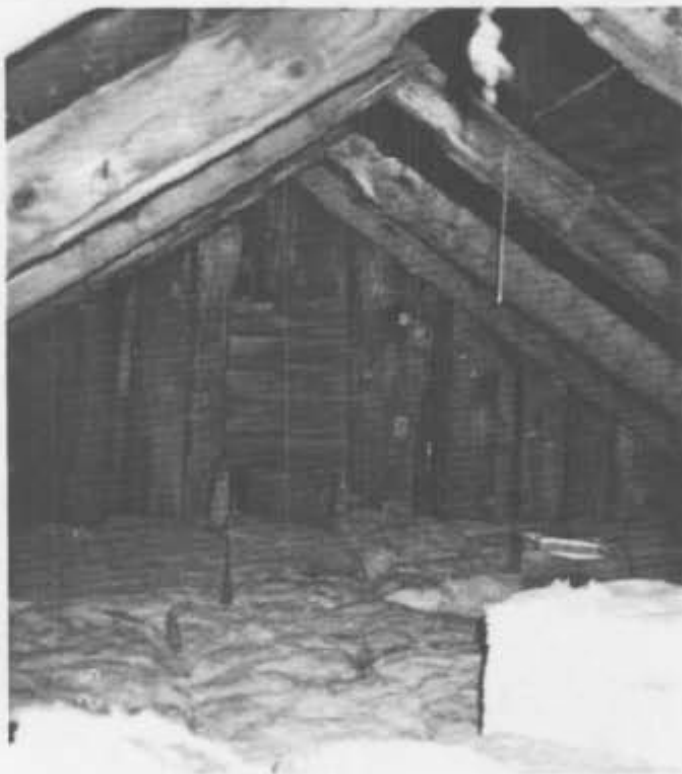
Figure 13

At the present time there are no gable vents in the attic nor any soffit vents. However, as seen on the inside of the attic, gable vents or windows once existed at both ends of the attic (Figure 13).

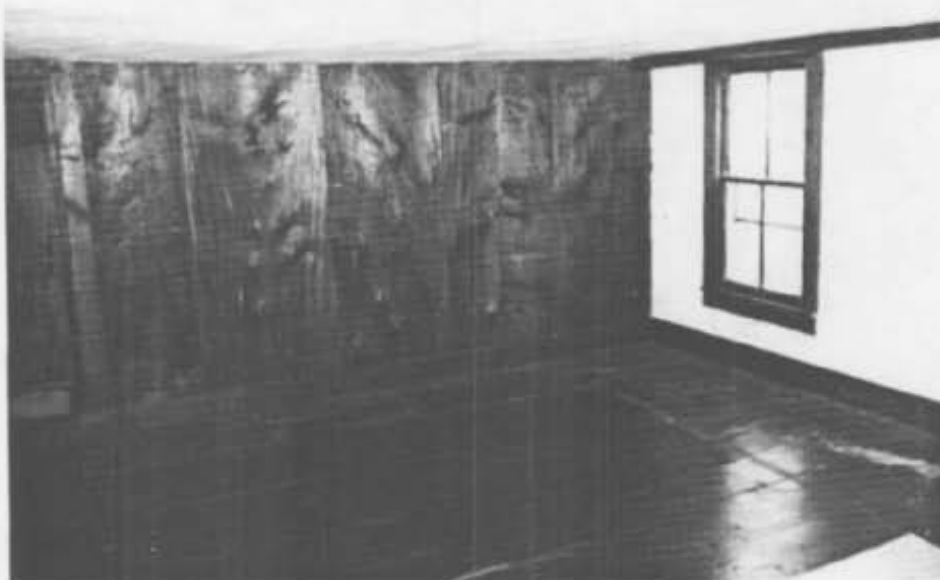
Figure 15

Minor decorating work, such as wallpapering, patching and painting of plaster walls is all that is needed in the kitchen, entry, bathrooms and some bedrooms (Figure 15). However, the parlor and living room need major work on the walls in order to restore them insofar as they are covered with an inexpensive, prefinished paneling, presumably over existing cracked plaster. The superintendent's office is completely finished (walls and ceiling) with plywood and batten. The dining room walls are finished in v-match pine five to seven inches in width and need only a fresh coat of varnish. Some of the walls in the second floor rooms appear to be original and feature plaster and vertical pine boards up to 30 inches wide (Figure 16). The wide boards, which also occur on the stairway walls, are the finest feature of the house.

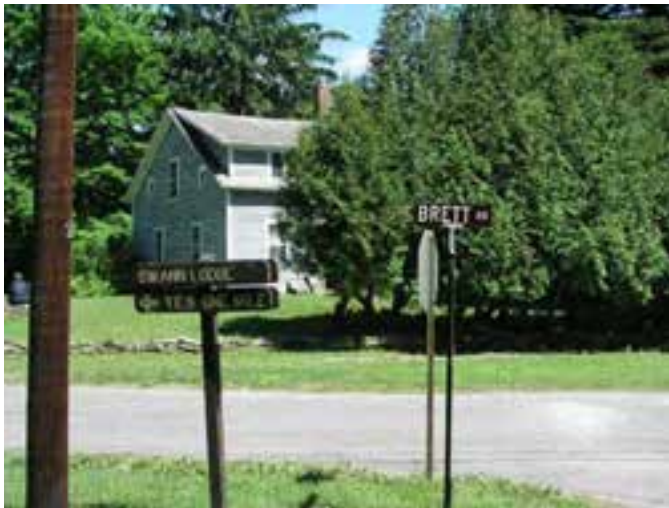
Fig. 1.2. View of property from across intersection. Parking areas are best located to the left, away from the intersection and the stone retaining wall.

Accessible parking serving the Headquarters House could be accommodated adjacent to the building. Regrading and the construction of one or more wheelchair ramps would be required to provide access to the interior of the house.

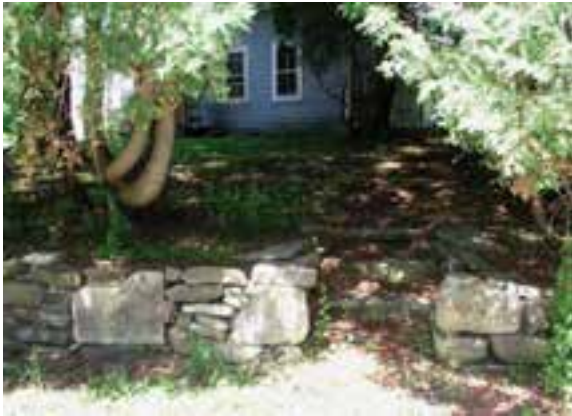
Fig. 1.3. View from Blue Hill Road; note stone steps and retaining wall.

The property contains extant plant materials and structural landscape features (e.g., stone walls and steps) significant to the evolution of the agricultural and forest landscape surrounding the Headquarters. As such, these features should be preserved and maintained to the maximum extent possible.

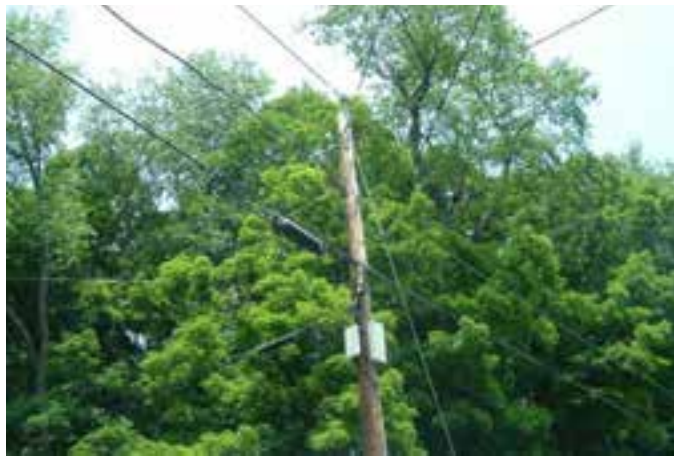
The electrical overhead service is derived from a utility pole on Blue Hill Road (Fig. 4.3). A service meter is located on the exterior of the building. The main service disconnect, sized at 100 amps, is located within a panelboard at the basement level (Fig. 4.4.). There is a 30-amp disconnect adjacent to the panelboard that serves the electric water heater. Branch circuit wiring consisted of non-metallic sheathed cable and BX armored cable. Minimal light fixtures are powered at this time.

Fig. 4.3. Existing utility pole.

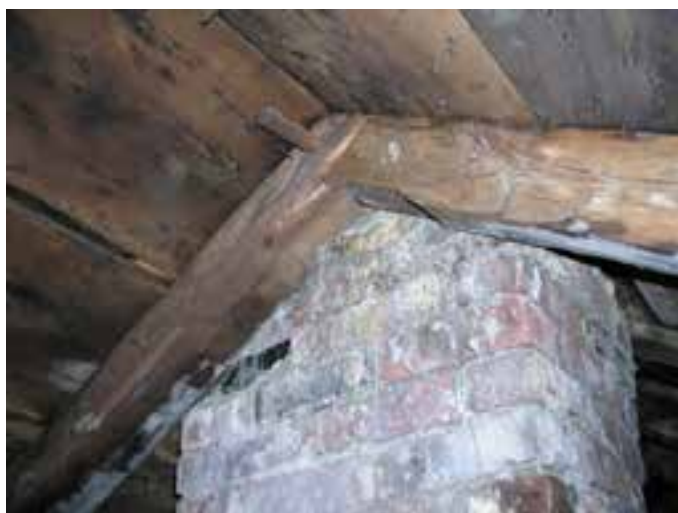
The brick chimney (reconstructed as a heating system-flue at some point) is in extremely poor condition above the roof and needs to be rebuilt (Fig. 5.10). As part of this process, the clay-tile flue liner should be inspected and repaired. From the attic (Fig. 5.11), the masonry appears to be in fair to good condition, but should be inspected in more detail, nonetheless, to check for leaks.

Fig. 5.11. Chimney at attic.

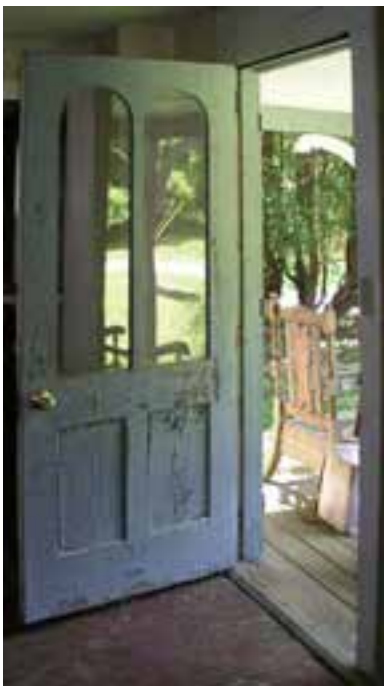
Fig. 5.12. Italianate-style front door.

Historic doors should be preserved and maintained. In particular, the Italianate-style front door, with its double-arched glass lights (Fig. 5.12), and the Colonial-Revival door at the ell (Fig. 5.13) should be restored.

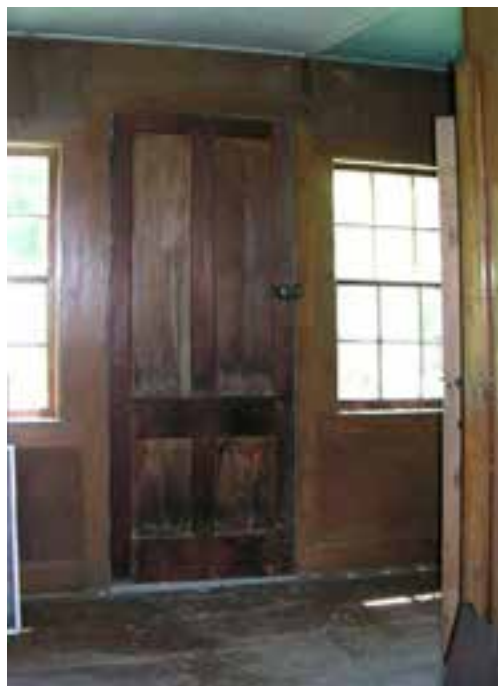
Fig. 5.13. Interior face of recessed-panel door at ell.

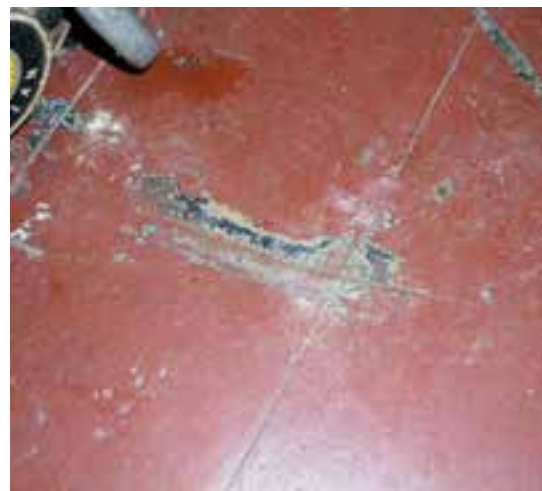
Fig. 6.4. Scratches on painted pine wood floor at NW parlor reveal an interesting "paint history."

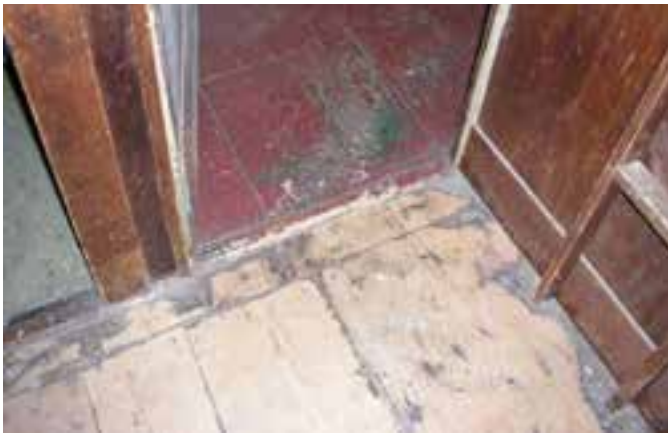
Original flooring at the first and second floor levels survives in good condition, despite the fact that the floors pitch at an angle or sag in a number of areas, due to structural alterations made during modern times (refer to structural assessment). Extant joints and patches in the floor provide an interesting record of changes over time (Fig. 6.4), and should be documented and analyzed. The wide-board flooring must be preserved in place, and any changes or floor coverings should avoid damage to the surfaces and be easily reversible. Similarly, the hardwood flooring at the Dining Room and ell should be preserved and maintained.

Fig. 6.4. Joints in wide-board pine flooring at second floor seems to indicate prior changes to the floor plan.

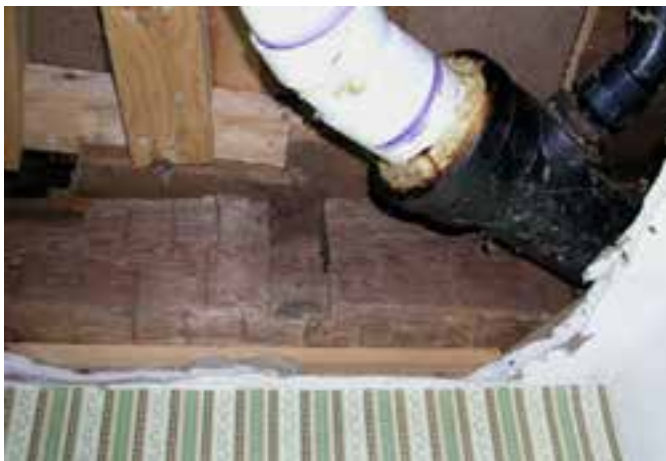
Fig. 6.11. Hand-hewn beam and modern additions.
