PREPARED FOR:  
NEW BEDFORD PORT AUTHORITY

**ROUTINE INSPECTION REPORT UPDATE  
PORT OF NEW BEDFORD  
POPE'S ISLAND MARINA**

JULY 2020

**ROUTINE INSPECTION REPORT UPDATE  
POPE'S ISLAND MARINA  
NEW BEDFORD, MASSACHUSETTS**

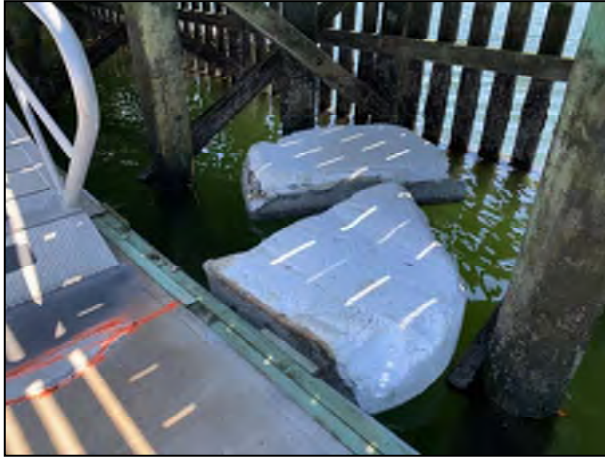
Pare visited the site on May 20, 2020 to observe damage to Dock D after a seasonal storm. The finger float for slip 137 appears to have become shifted, potentially from displaced polystyrene floatation units and several large pieces of polystyrene float modules have become dislodged from the concrete floats on Dock D, which appear to be from between slips 103/104 of the main floats. Several of the PVC rollers on the pile guides were observed to be cracked during the initial inspection, and Pare noted that after the storm several of the PVC rollers were missing, including at the finger floats for slips 108/109, 110/111, and 116/117, and along the main floats between slips 111-112.

*Displaced polystyrene float units after seasonal storm*

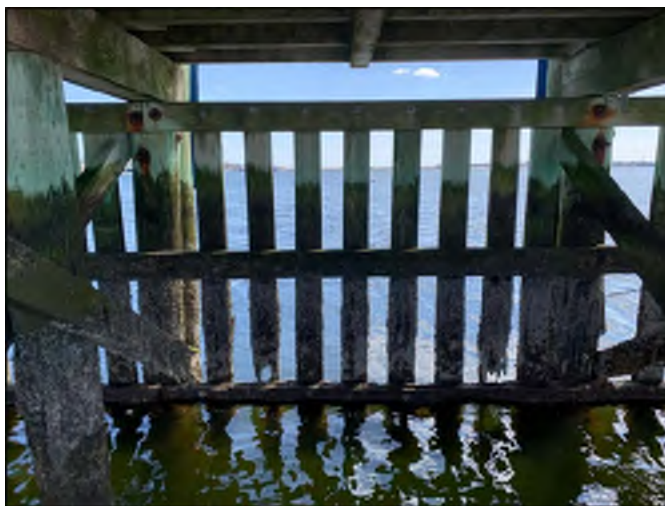
The timber wave fence is in poor to severe condition, with the majority of deterioration near mean low water. Deterioration of the bottom of the wave fence panels and severe corrosion of connection hardware was typical, and the lower wale was observed to be in critical condition or missing along the length.

*Timber wave fence along T-head of pier*

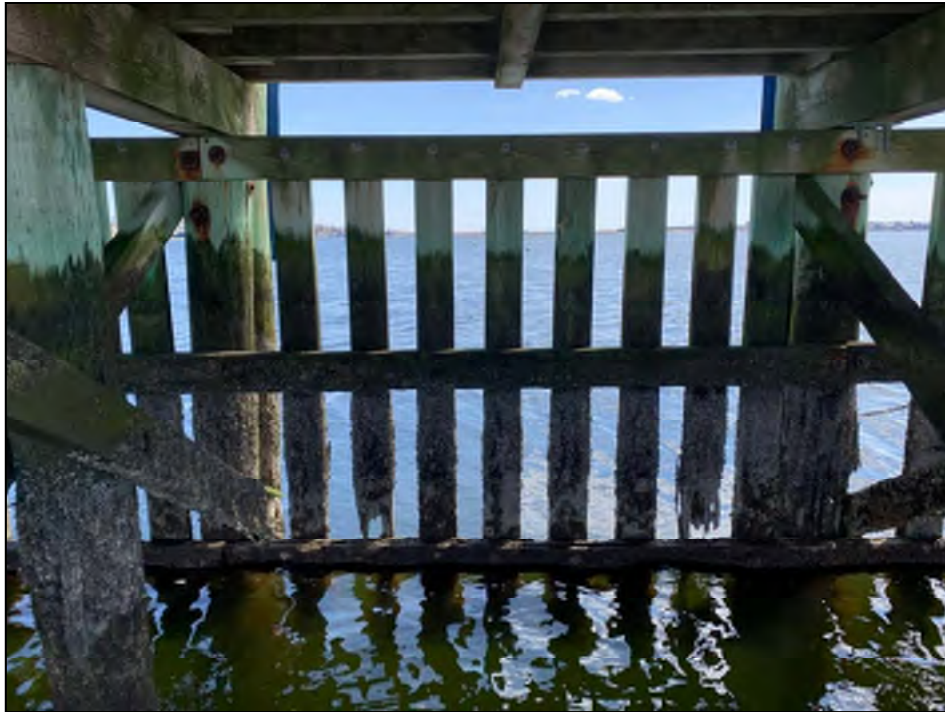
Photo No. 45: Deteriorated timber wave fence.
