**REPORT#:** 19MA072

**REPORT DATE:** December 18, 2023

## Rigging Crew Leader Crushed by Light Tower Weight — Massachusetts

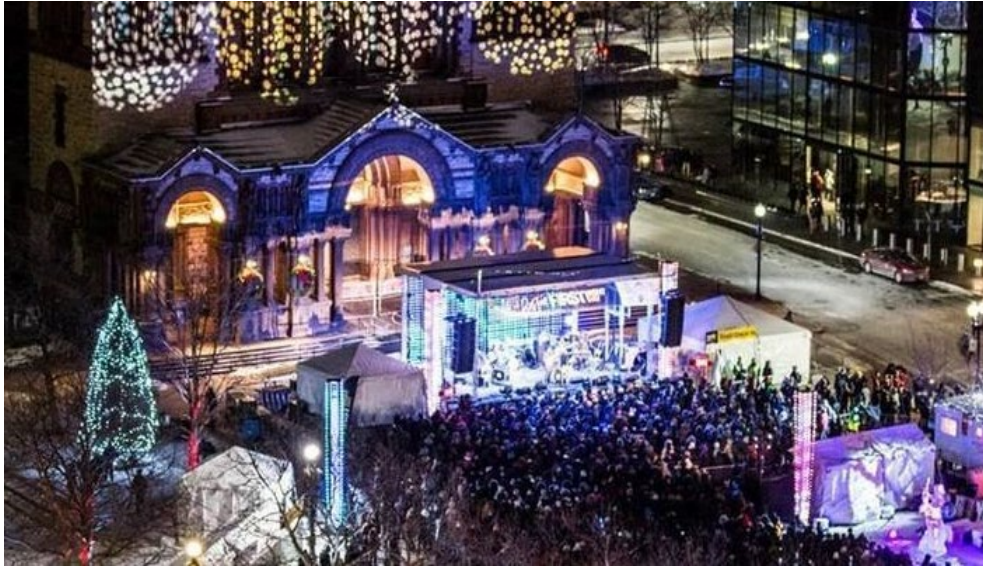
**Figure 8 – Stage and venue in use** (image from First Night Boston X/Twitter, @firstnight)

The incident occurred at a park in a city center (Figure 7). The open area public space was being converted into an entertainment venue (Figure 8). The paver stone space that held the entertainment rigging and staging was approximately 12,200 square feet of the outdoor space. The lawn space in front of the stage area was approximately 16,500 square feet. The outdoor cobblestone and green space were mostly flat.
