Road-Stream Crossing Assessment Technical Memorandum

*Town-Wide Road Stream Crossing Assessment and
Climate Change Adaptation Plan*

TOWN OF BELCHERTOWN, MASSACHUSETTS

RE: Town-Wide Road-Stream Crossing Assessment and Climate Change Adaptation Plan – MVP Action Grant
Road-Stream Crossing Assessment Technical Memorandum

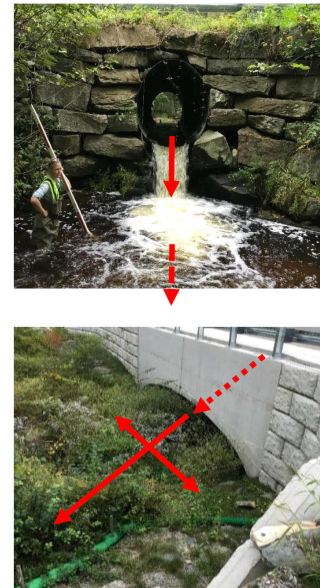
Figure 8. Geomorphic Vulnerability Ratings consider factors such as outlet drops which contribute to scour, the bankfull width of the stream, and alignment of the stream with the structure. The North Street/Scarboro Brook crossing (top) scored a 5 due to the freefall and scour pool conditions. The Hickory Hills crossing (bottom) has good alignment and no constriction and scored a 1.

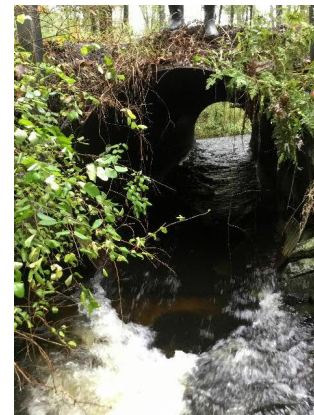
Ludlow Street crosses Roaring Brook several hundred feet north of Granby Road. The crossing consists of a single 5-foot diameter corrugated metal pipe, making the crossing width less than one third of Roaring Brook's bankfull width. Due to the severe constriction at the crossing, flow velocities in the culvert are significantly faster than the surrounding stream. These conditions pose a barrier to aquatic passage and have also resulted in creation of a large scour pool at the outlet and downstream deposition of displaced sediment. The outlet has been extensively armored in an attempt to prevent erosion, but the severity of the stream's constriction and high-velocity flows will continue to cause scour. The crossing can pass the existing 10-year peak flow, but is undersized for larger recurrence interval peak flows that were analyzed (25-year, 50-year, and 100-year) and estimated peak flows given future climate change projections.

Image 3: View of current crossing outlet, October 3, 2018.

- Replace the existing undersized culvert with a bridge of approximately 22 foot span to accommodate the 1.2 times bankfull width design standard of the Massachusetts River and Stream Crossing Standards.
- Restore the stream banks and streambed to repair the existing scour pool and erosion, and match the substrate characteristics of the natural stream channel.
- The proposed culvert replacement design concept will:
 - Improve the alignment of the stream to the crossing structure
 - Provide increased hydraulic capacity to reduce flooding risk
 - Reduce erosion and scour by decreasing flow velocity through the crossing

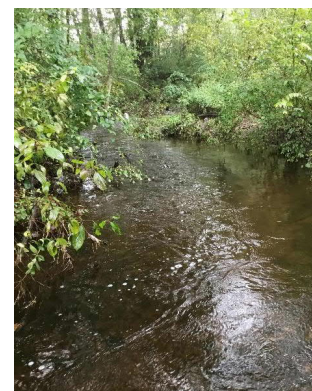
Granby Road crosses Roaring Brook a few hundred feet east of Ludlow Street. The crossing consists of a single corrugated metal pipe of approximately 6 feet in diameter, making the crossing width less than one third of Roaring Brook's bankfull width. Due to the severe constriction at the crossing, flow velocities in the culvert are significantly faster than the surrounding stream. These conditions pose a barrier to aquatic passage and have also resulted in creation of a large scour pool at the outlet and downstream deposition of displaced sediment. The crossing is significantly undersized for all of the recurrence interval peak flows that were analyzed (10-year, 25-year, 50-year, and 100-year), as well as the estimated peak flows given future climate change projections. Several crayfish were noted at the crossing during the field assessment, indicating that the stream provides important wildlife habitat and underscoring the relevance of aquatic organism passage at this site. The crossing is also scored as among the top 15% of culverts identified for replacement in the Massachusetts Wildlife Climate Action Tool.

Image 3: View of upstream channel, October 3, 2018.

- Replace the existing undersized culvert with a bridge of approximately 22 foot span to accommodate the 1.2 times bankfull width design standard of the Massachusetts River and Stream Crossing Standards.
- Reconstruct stream banks at the crossing to match the existing stream channel up and downstream of the crossing, and match the substrate characteristics of the natural stream channel.
- The proposed culvert replacement design concept will:
 - Provide increased hydraulic capacity to reduce flooding risk
 - Reduce erosion and scour by decreasing flow velocity through the crossing

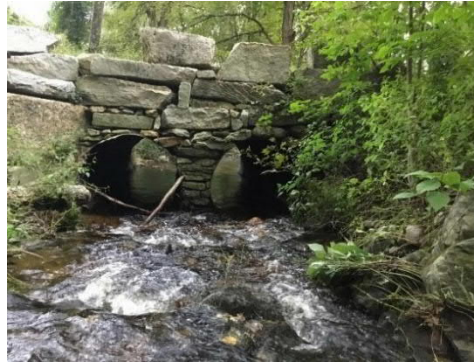
Gulf Road and Scarboro Brook cross several times as the road and stream wind down a steep slope at the northern end of Belchertown. Three of these crossings were identified as among the top priorities for replacement. Each of the crossings consists of two corrugated metal pipes of approximately 4-5 feet in diameter, resulting in repeated constrictions of the stream's approximately 17-foot bankfull width. Road fill over the structures ranges from 1.5 feet to 3.7 feet. Downstream sediment deposition and high erosion are typical of the system as a whole and were present at each of the priority structures. The surrounding area is lightly developed, but the potential for flooding impacts is increased by the large number of undersized crossings in sequence. Only the most downstream of the three crossings is sized to pass the existing 10-year peak flow; when climate change projections are considered, none of the crossings is adequately sized to pass the estimated future 10-year peak flow. Scarboro Brook is a high-velocity, high-gradient stream in a heavily wooded area. The ability of structures to pass woody debris and sediment is of high concern to prevent blockages and related culvert failures.

Image 1: View of current structure inlet at the most downstream of the three crossings; September 21, 2018

- Replace the upstream and middle crossings with bridges, and install an open-bottom arch at the downstream crossing, reconstructing the streambed and banks at each crossing to match the natural channel and spanning 1.2 x bankfull width at each crossing to meet the Massachusetts River and Stream Crossing standards (approximately 21-feet).
- Restore the stream banks and streambed to repair existing scour pool and erosion and realign the middle crossing to eliminate the potential for sediment and debris to accumulate at the inlet.
- The proposed culvert replacement design concept will:
 - Provide increased hydraulic capacity
 - Increase aquatic passage in a high-quality, coldwater stream system
 - Good potential for funding through DER Culvert Grant (rated highly on the Massachusetts Wildlife Climate Action Tool and potential flood risk)

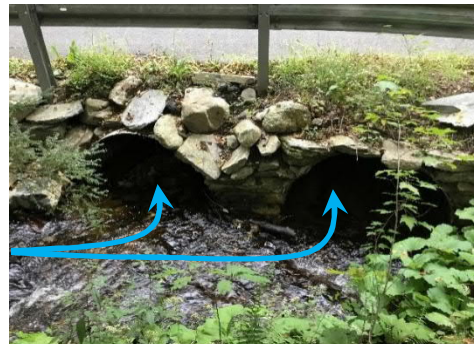
Image 2: View of inlet to middle crossing, September 17, 2018. As indicated by flow arrows, Scarboro takes a near-90-degree turn into the culvert.

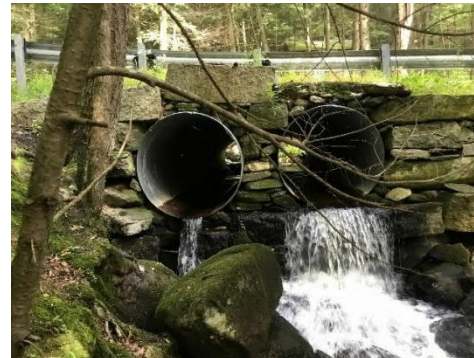
Image 3: Outlet of the most upstream of the three crossings, September 17, 2018.

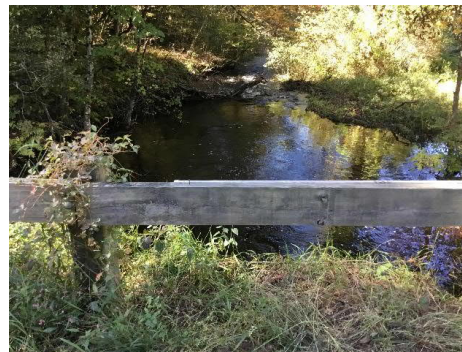
Image 2: Looking downstream from the crossing. Note the width of the scour pool immediately downstream of the crossing relative to the bankfull width of the channel further downstream.

Armoring in critical condition
Severe constriction
Large scour pool

- Replace the existing corrugated metal pipe culvert with a bridge, reconstructing the crossing to meet the Massachusetts River and Stream Crossing standards, including a design span of at least 19.2 feet to span 1.2 times the stream's bankfull width.
- Restore the downstream banks and streambed to repair existing scour pool and erosion, and match the substrate characteristics of the natural stream channel.
- The proposed culvert replacement design concept will:
 - Provide increased hydraulic capacity to reduce flooding risk and allow water and debris associated with larger storms to pass.
 - Reduce geomorphic risk associated with erosion and scour
 - Decrease attractiveness to beaver by reducing sounds of flowing water associated with the current constriction condition
 - Decrease potential for backwatering above the crossing inlet

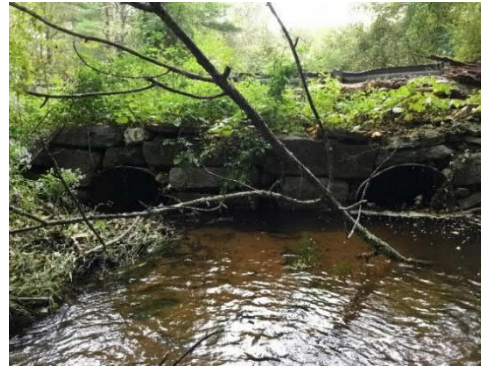
Montague Brook crosses North Street at a bend in the road approximately 400 feet west of Route 9. The crossing consists of two corrugated metal elliptical pipes, each approximately 3.5 feet wide, severely constricting Montague Brook's 14-foot bankfull width. The headwall at the outlet is in critical condition; several of the large headwall stones have fallen into the stream and partially block the outlet of one of the two structures. The crossing is hydraulically undersized, with total capacity only about a quarter of the estimated 10-year peak flow. A large outlet scour pool indicates that water is forced through the culverts at high velocity during storm events. This has led to significant bank erosion and is likely responsible for the failure of the outlet headwall.

Image 1: View of current crossing inlet taken during field assessment on September 21, 2018.

Outlet headwall in critical condition
High bank erosion
Severe constriction
Large scour pool
Inlet drop at one structure

- Replace the existing undersized culvert with an open-bottom arch with an approximately 17-foot span to accommodate the 1.2 times bankfull width design standard of the Massachusetts River and Stream Crossing Standards.
- The proposed culvert replacement design concept will:
 - Provide increased hydraulic capacity to reduce flooding risk
 - Reduce erosion and scour by decreasing flow velocity through the crossing
 - Protect North Street from undermining and failure risk

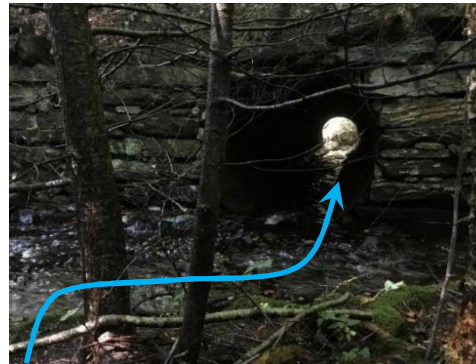
Image 1: View of current structure inlet taken during field assessment on September 17, 2018. Arrow indicates approximate flow path of Scarboro Brook.

- Shift the dam's spillway north to realign the upstream channel, eliminate the s-bend and reduce geomorphic risk, and reduce erosion of Gulf Road.
- Replace the existing undersized culvert with an open-bottom arch that spans 1.2 times bankfull width in compliance with the Massachusetts River and Stream Crossing Standards.
- The proposed culvert replacement design concept will:
 - Provide increased hydraulic capacity to reduce flooding risk
 - Increase aquatic passage in a high-quality, coldwater stream system
 - Protect Gulf Road from undermining and erosion

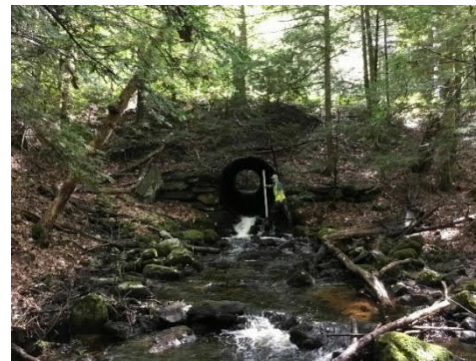
Image 2: View of outlet to middle crossing, September 17, 2018. Note that Scarboro Brook enters from the left of image and takes a near-90 degree turn into the culvert.

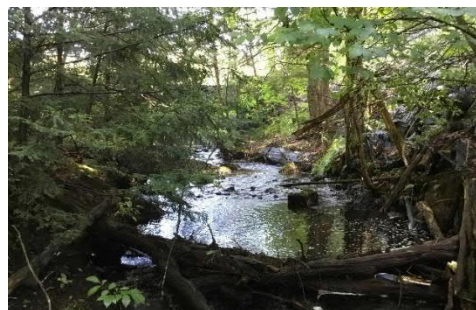
Image 3: View upstream from the crossing; September 17, 2018. Red arrow indicates location of the upstream dam.

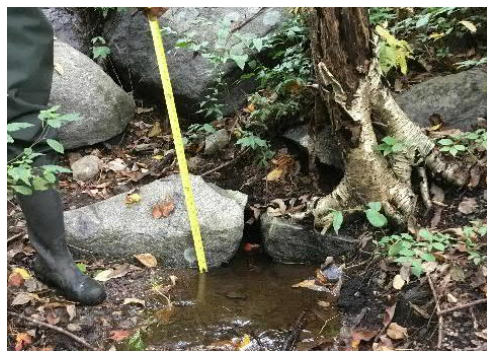
Image 2: View of the blocked outlet at Ledgewood Circle taken during field assessment on October 4, 2018.

Severe constriction
Critical invert deterioration
Critical structural integrity at two crossings
Clogged/blocked inlets at two crossings
Outlet blocked by boulders at one crossing
Upstream/downstream sediment deposition
Frogs and mammal tracks noted at crossings

- Replace the existing undersized and deteriorated crossings at Forest Road and Ledgewood Circle with embedded box culverts approximately 6 feet wide by 4 feet high, designed to meet the Massachusetts River and Stream Crossing Standards.
- Refine bankfull width measurement and realign and enlarge the Ledgewood Drive crossing with an approximately 12-foot wide open bottom arch to provide direct connection between the stream inlet and outlet and improve flow conveyance and wildlife passage.
- The proposed culvert replacement design concept will:
 - Provide increased hydraulic capacity to reduce flooding risk
 - Remedy the current potential for structural failure at all crossings
 - Reduce sediment deposition and associated blockages
 - Improve terrestrial and aquatic passage conditions to connect forested wetlands throughout the neighborhood

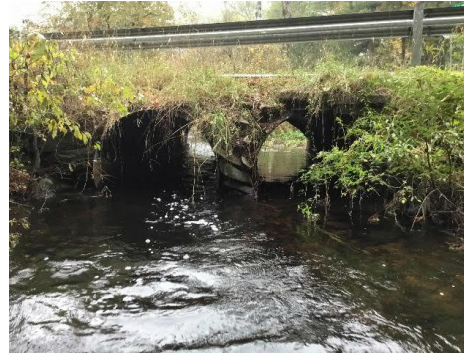
The Boardman Street/Weston Brook crossing is located immediately east of the intersection with Eskett Road and consists of two round corrugated metal pipes of approximately 5 feet in diameter (both are slightly deformed). The combined width of the structures is slightly greater than half of the stream's bankfull width, representing a severe constriction. One of the two structures is well-aligned with the stream and receives more of the existing flow at low-flow conditions, while the other is poorly aligned and therefore receives less flow. The crossing is sized to pass the existing 10-year peak flow, but is undersized for the other recurrence interval peak flows that were analyzed (25-year, 50-year, and 100-year). Furthermore, the crossing is expected to be undersized for the 10-year peak flow given future climate change projections.

Image 1: View of current structure outlet taken during field assessment on October 15, 2018

- Replace the existing corrugated metal pipe culvert with a bridge, reconstructing the crossing to meet the Massachusetts River and Stream Crossing Standards, including a design span of at least 21.6 feet to span 1.2 times the stream's bankfull width.
- Restore the stream banks and streambed to repair the existing scour pool and erosion, and match the substrate characteristics of the natural stream channel.
- The proposed culvert replacement design concept will:
 - Provide increased hydraulic capacity to reduce flooding risk and allow water and debris associated with larger storms to pass.
 - Decrease potential of road overtopping during heavy precipitation
 - Reduce geomorphic risk associated with erosion and scour
 - Create a single span to eliminate risks of road undermining due to erosion and piping between the two existing structures

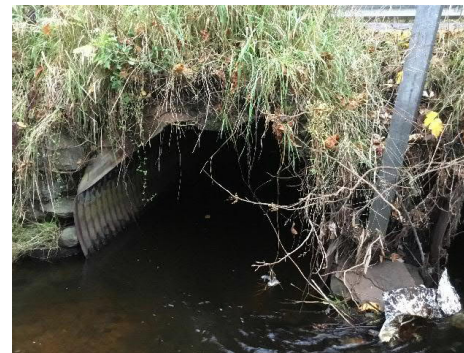
Image 2: Erosion of fill and protective armoring between the two structures at the crossing inlet.

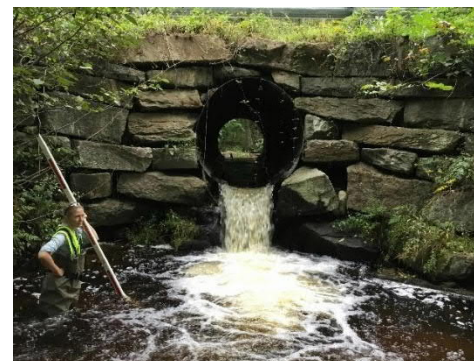
Image 2: View of crossing outlet, September 21, 2018.

High bank erosion
Severe constriction
Large scour pool
Downstream sediment accumulation
Poor headwall condition at inlet

- Replace the existing undersized culvert with an approximately 30-foot span bridge span to accommodate the 1.2 times bankfull width design standard of the Massachusetts River and Stream Crossing Standards.
- Construct a new streambed to match the slope, width, and substrate of the existing natural channel.
- The proposed culvert replacement design concept will:
 - Provide increased hydraulic capacity to reduce flooding risk and impacts to upstream crossings
 - Decrease geomorphic risk by reducing scour and sediment deposition
 - Increase aquatic passage in a high-quality, coldwater stream system
 - Good potential for funding through DER due to listing as a coldwater stream and top 10% culvert for replacement in the Massachusetts Wildlife Climate Action Tool

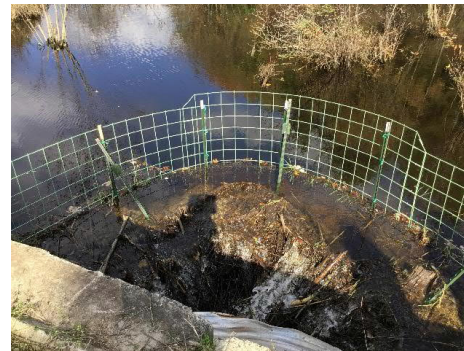
Image 2: View from above looking down on the structure inlet, beaver deceiver, and existing beaver dam/accumulated debris.

- Replace the existing metal pipe culvert with a bridge or open-bottom arch of approximately 24 feet in width, reconstructing the crossing to meet the Massachusetts River and Stream Crossing Standards and span 1.2 times the stream's bankfull width.
- Remove existing beaver dam and beaver deceiver.
- The proposed culvert replacement design concept will:
 - Provide increased hydraulic capacity to reduce flooding risk and allow water and debris associated with larger storms to pass.
 - Decrease potential of road overtopping during heavy precipitation.
 - Decrease attractiveness of the site to beavers by eliminating constriction of the stream and decreasing the sound of flowing water.

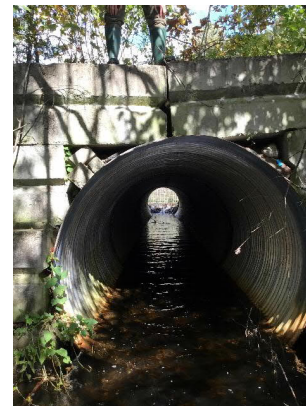
Image 3: View of current structure outlet taken during field assessment on October 10, 2018.

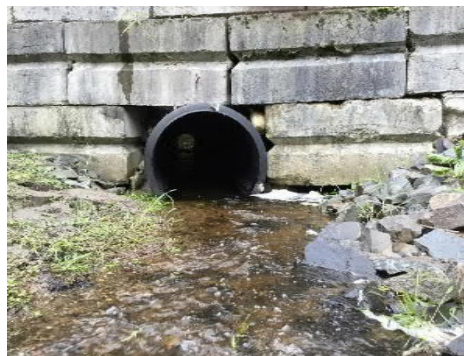
Franklin Street/Route 181 crosses an unnamed stream approximately 300 feet north of Pease Street. The existing structure is a 2.5-foot diameter plastic pipe, resulting in a severe constriction of the stream's 6-foot bankfull width. This condition has contributed to the development of a large downstream scour pool, and sediment deposition was noted both upstream and downstream of the crossing. Both the inlet and outlet are surrounded by headwalls built of concrete blocks. As shown at right, the blocks do not fit tightly against the existing pipe. The crossing is undersized for all recurrence interval peak flows that were analyzed, including the 10-year peak flow.

Image 1: View of current structure inlet taken during field assessment on October 1, 2018.

- Replace the existing plastic pipe culvert with an embedded box culvert or open-bottom arch of approximately 7.5 feet in width, reconstructing the crossing to meet the Massachusetts River and Stream Crossing Standards and span 1.2 times the stream's bankfull width.
- The proposed culvert replacement design concept will:
 - Provide increased hydraulic capacity to reduce flooding risk and allow water and debris associated with larger storms to pass.
 - Decrease potential of road overtopping during heavy precipitation.

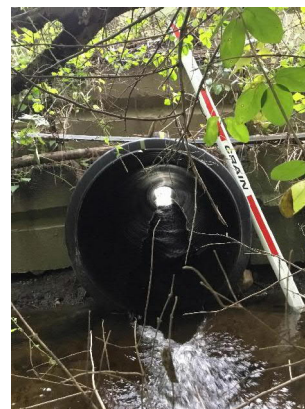
Image 2: View of current structure outlet taken during field assessment on October 1, 2018.

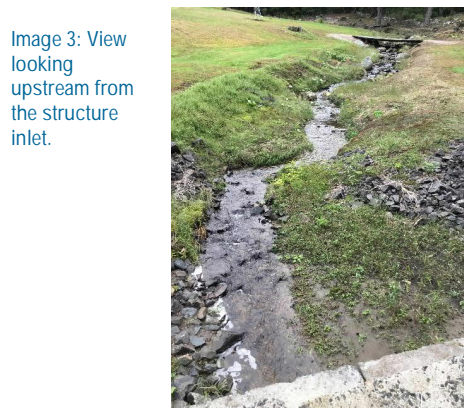
Image 3: View looking upstream from the structure inlet.
