*Massachusetts Coastal Infrastructure
Inventory and Assessment Project
Massachusetts Department of Conservation and Recreation
Office of Waterways*

North Coastal

July 6, 2009

**Bourne Consulting Engineering
Franklin, Massachusetts**

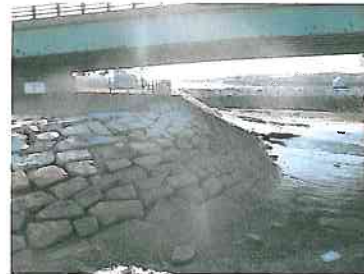
Placed stone revetment in front of the bridge abutment. No visible scour, some stone rotation. Stones are 3 feet by 2 feet by 2 feet. Crest is one stone width. Slope is 1 on 1.

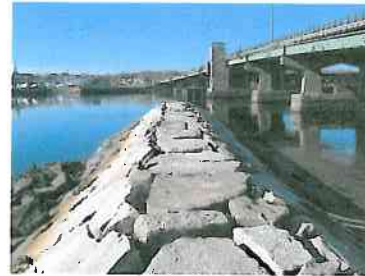
Placed stone groin with stone that are approximately 3 feet by 3 feet by 3 feet. Slope is approximately one on one. Minor unreveling at the head of the groin. The creast is one stone wide. There appears to be one layer of armor stone.

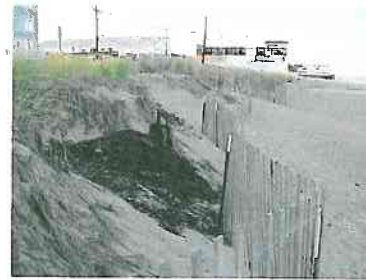
A dune with sand fence and some dune grass at the crest. There is some recently dumped sand and some ocean side erosion. There is street parking behind the dune.

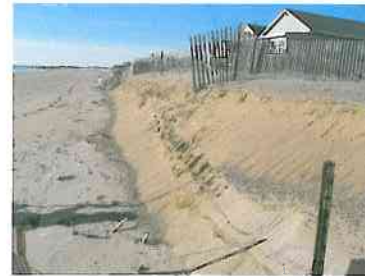
Dune fronting small houses. Many areas of low spots and voids. Not a consistent shape. Slope is eroded throughout. In front of it is a sandy beach.

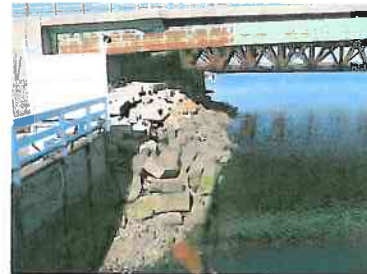
Stone blocks that are approximately 4 feet by 2 feet by 2 feet with dumped stone that varies in size in front of them. Most of the dumped stones are 3 feet in diameter. Heavy rotation and movement of the stones behind structure is the bridge abutment for Gillis Bridge.

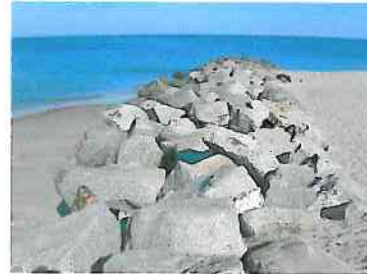
A stone groin in satisfactory condition and functioning to retain sand to the south. This structure was built by the Army Corps of Engineers.

Structure observed to exhibit very minor problems, superficial in nature. Minor erosion to landform is present. Structure / landform adequate to provide protection from a major coastal storm with no damage. Actions taken to prevent / limit future deterioration and extend life of structure.

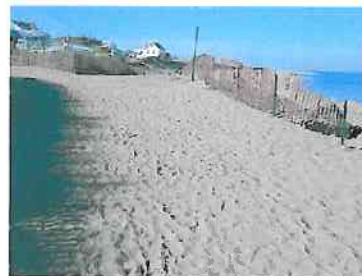
Sand nourishment of a beach access ramps with sand fence, in good condition.*Condition***B***Rating***Good***Level of Action***Minor***Description*

Structure observed to exhibit very minor problems, superficial in nature. Minor erosion to landform is present. Structure / landform adequate to provide protection from a major coastal storm with no damage. Actions taken to prevent / limit future deterioration and extend life of structure.

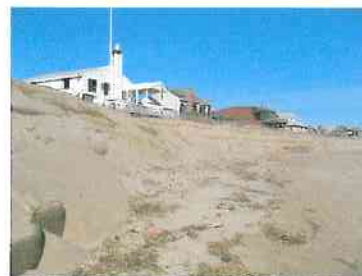
Sand dune that has a part of it that was recently repaired with coco mats. Signs of moderate erosion and storm damage. No visible dune grass

Structure is sound but may exhibit minor deterioration, section loss, cracking, spalling, undermining, and/or scour. Structure adequate to withstand major coastal storm with little to moderate damage. Actions taken to reinforce structure to provide full protection from major coastal storm and for extending life of structure. Moderate wind or wave damage to landform exists. Landform may not be sufficient to fully protect shoreline during a major coastal storm. Actions taken to provide additional material for full protection and extended life.

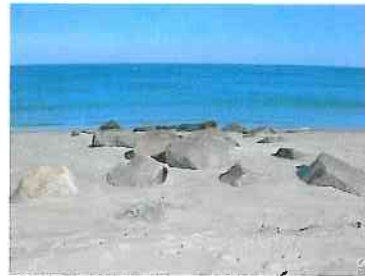
A unravalled stone groin that is not functioning to retain sand.

Structure exhibits advanced levels of deterioration, section loss, cracking, spalling, undermining, and/or scour. Structure has strong risk of significant damage and possible failure during a major coastal storm. Structure should be monitored until repairs/reconstruction can be initiated. Actions taken to reconstruct structure to regain full capacity to resist a major coastal storm. Landform eroded, stability threatened. Landform not adequate to provide protection during major coastal storm. Actions taken to recreate landform to adequate limits for full protection from a major coastal storm.

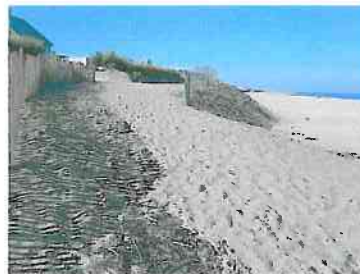
Beach nourishment shaped into a two way walking ramp with sand fencing.

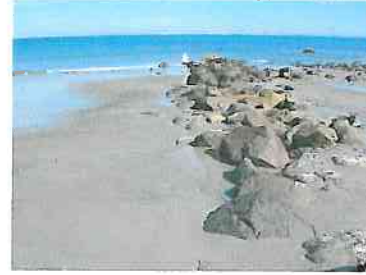
A stone groin which is substantially unravelled and has reduced function as a groin. There are no nearby structures. The offshore end is in the water at low tide.
